**Inspection Photo
O'toole A3
API# 045-13752
Inspection # 689301172**

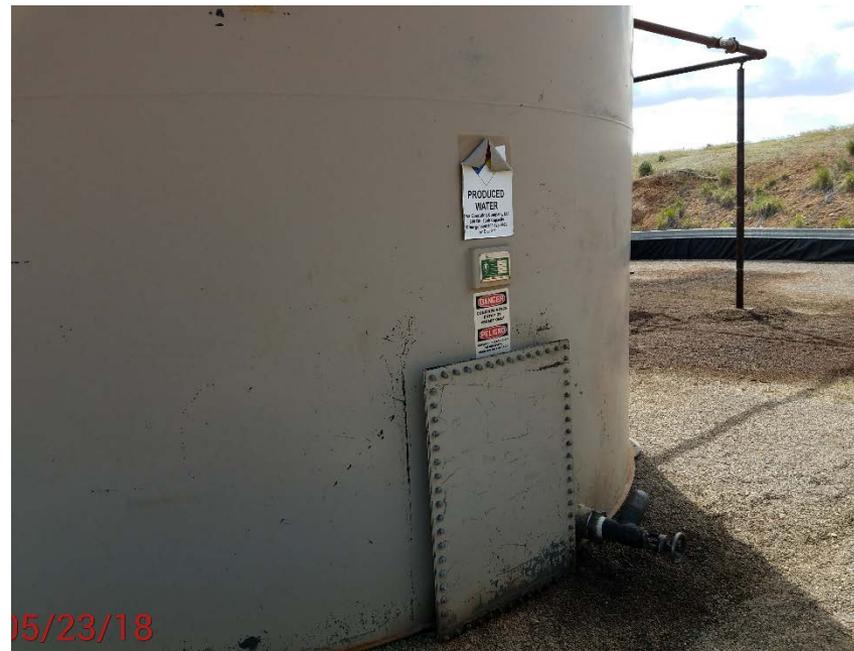
Location Photo #2 Sign peeling on tank

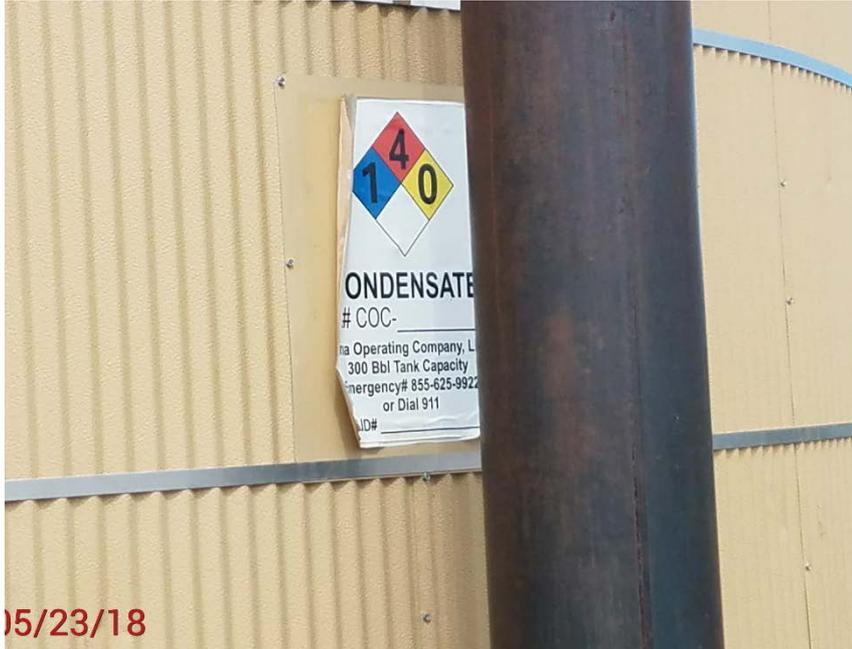
Location Photo #3, sign peeling on tank

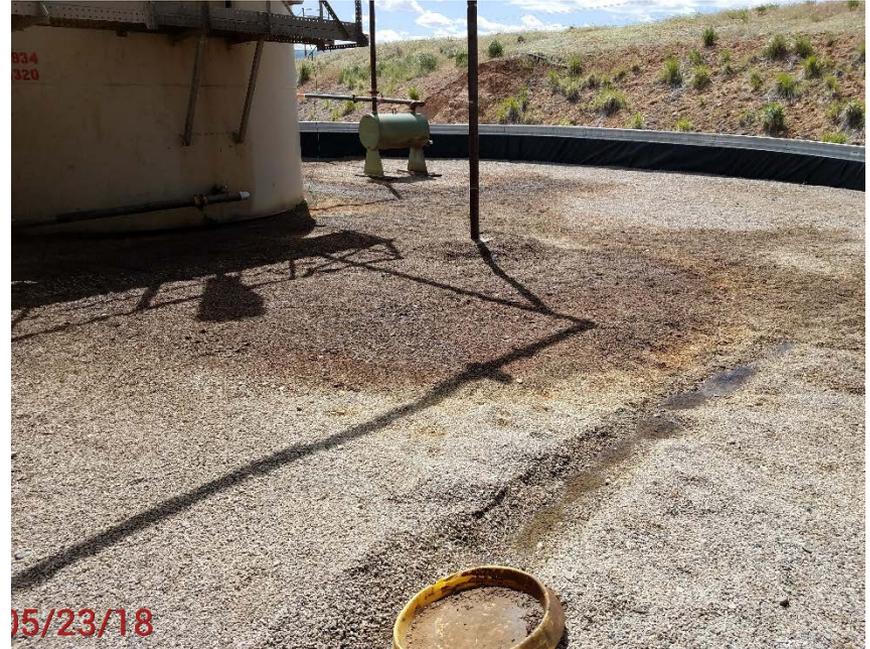
Location Photo #4, stained material in battery containment

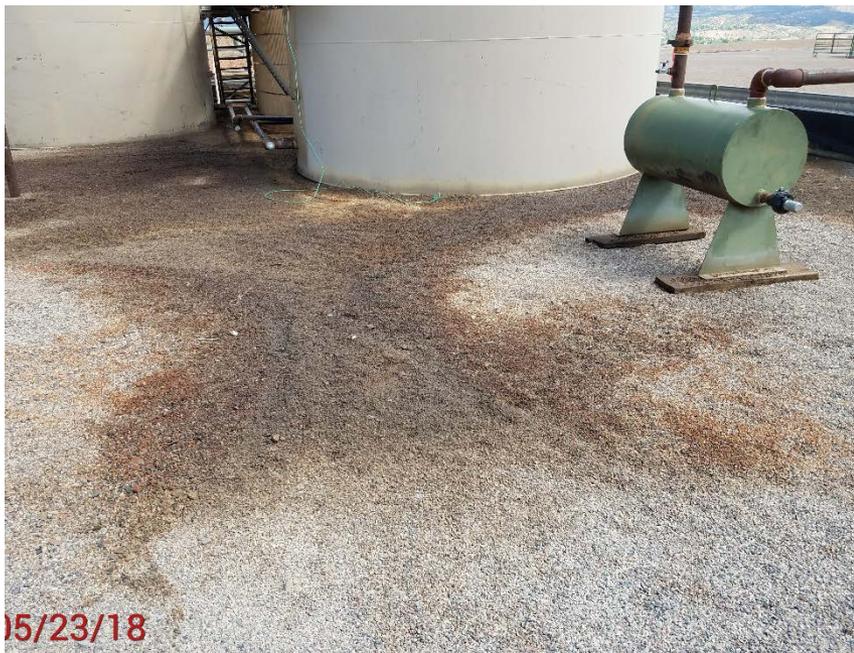
**Location Photo #5, stained material in
battery containment**

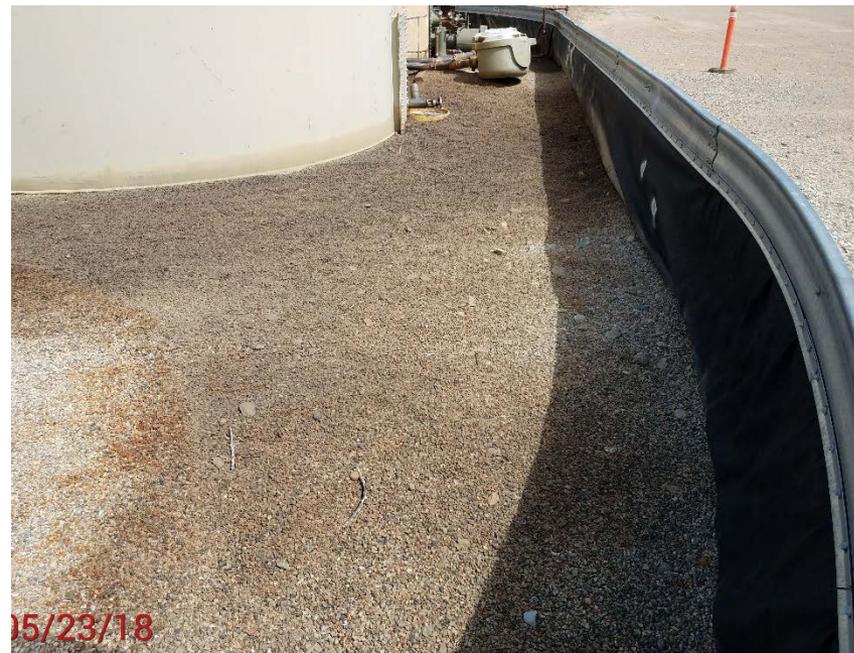
**Location Photo #6, stained material in
battery containment**

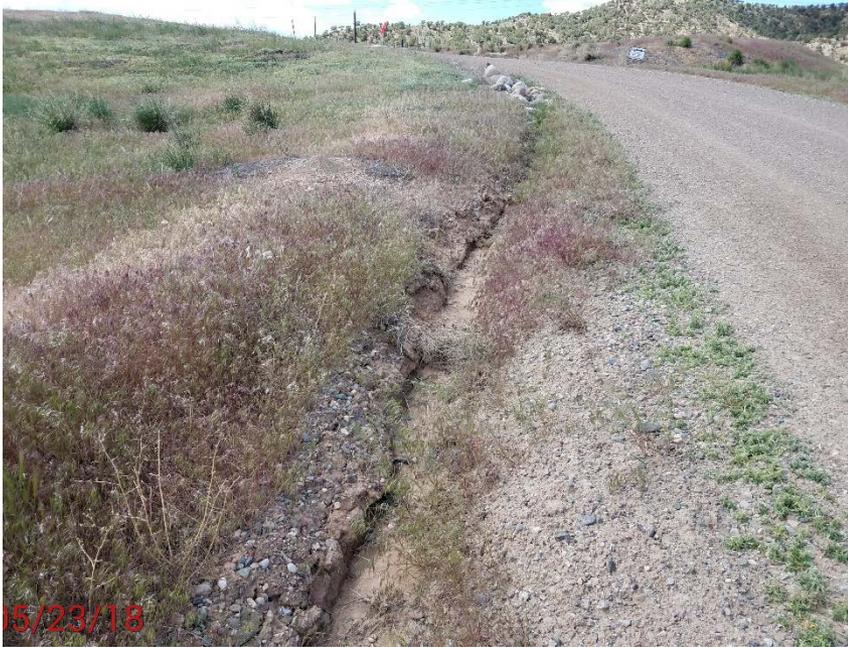
Location Photo #7, Ditch erosion along side of road on east side

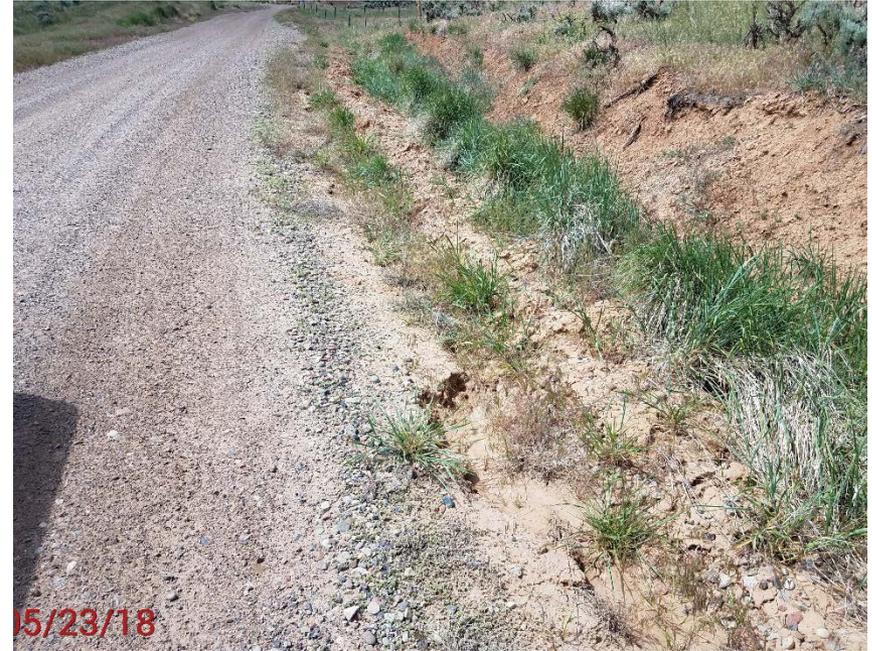
Location Photo #8 , Ditch erosion along side of road on east side. Looking down hill

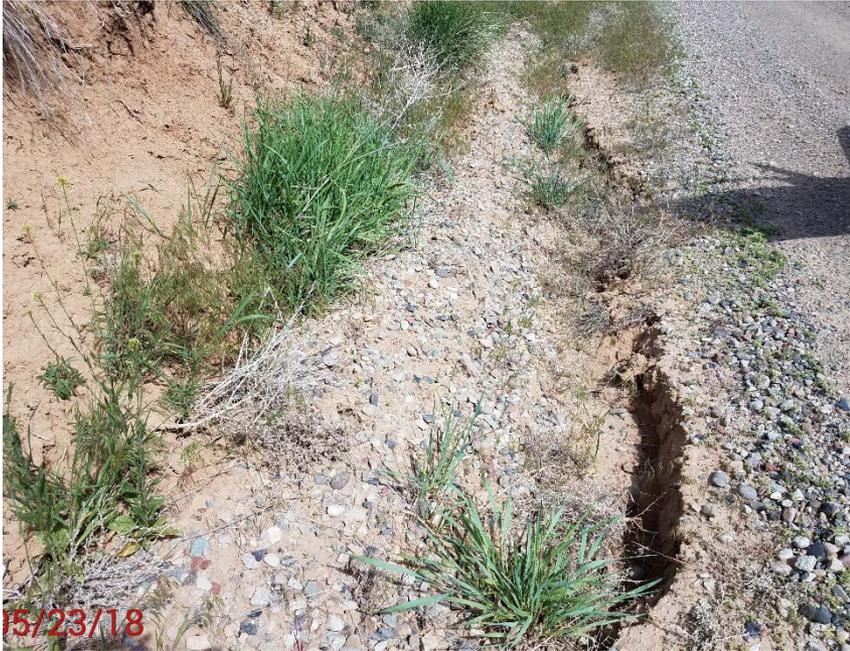
Location Photo #9, Ditch erosion along side of road on West side. Looking down hill

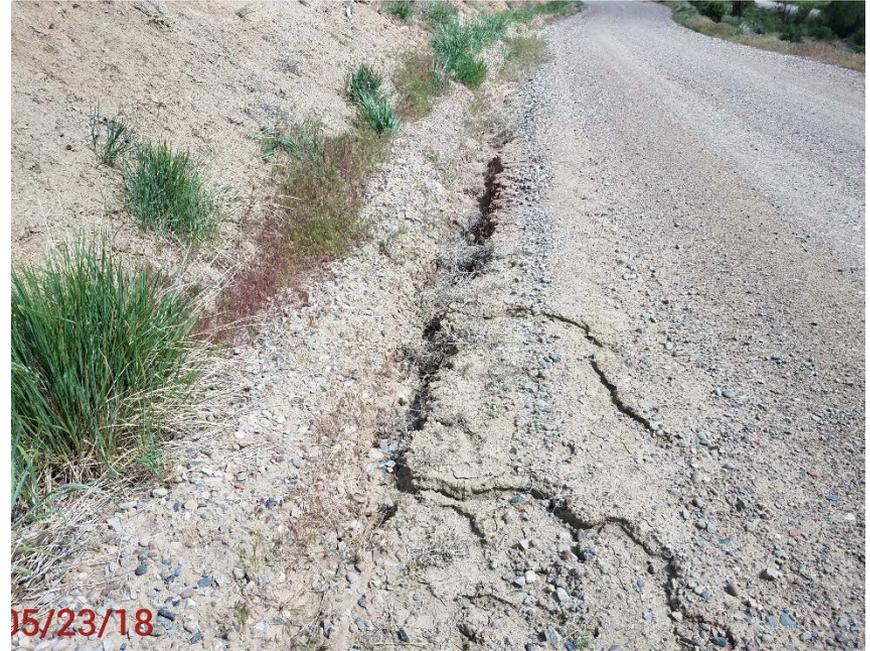
Location Photo #10, Ditch erosion along side of road on West side. Looking downhill

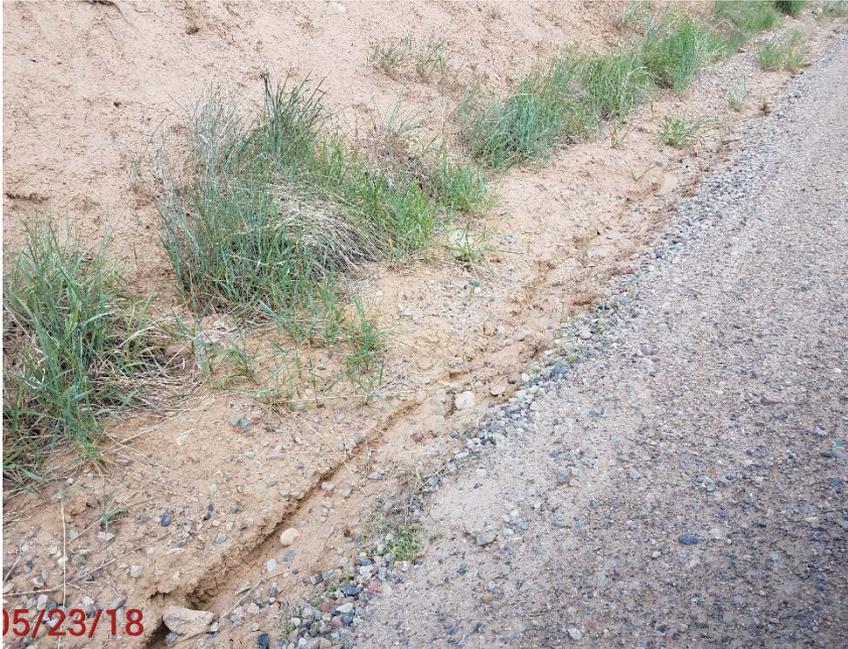
Location Photo #11, Ditch erosion along side of road on east side near curve

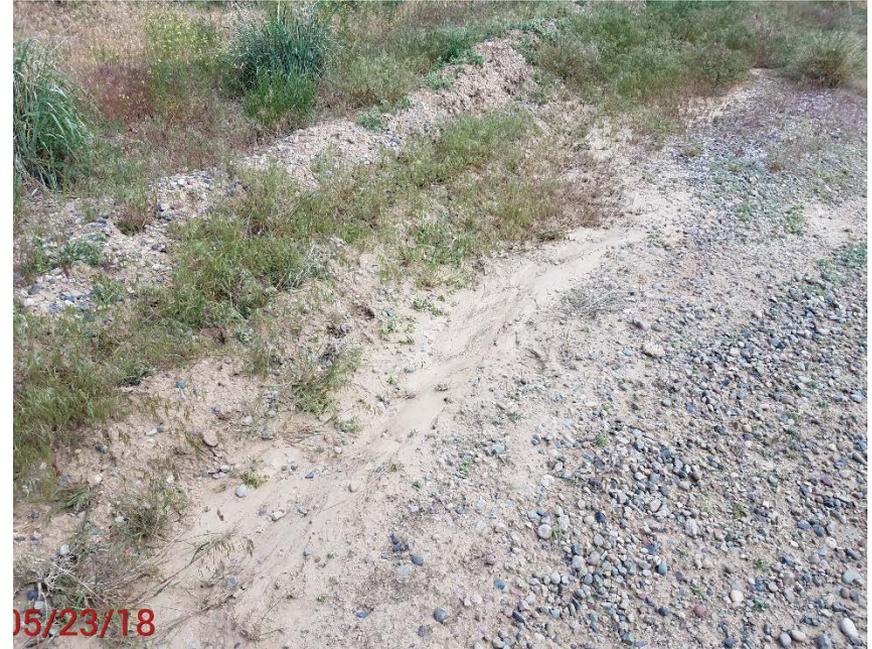
Location Photo #12, Ditch erosion along side of road on east side near curve

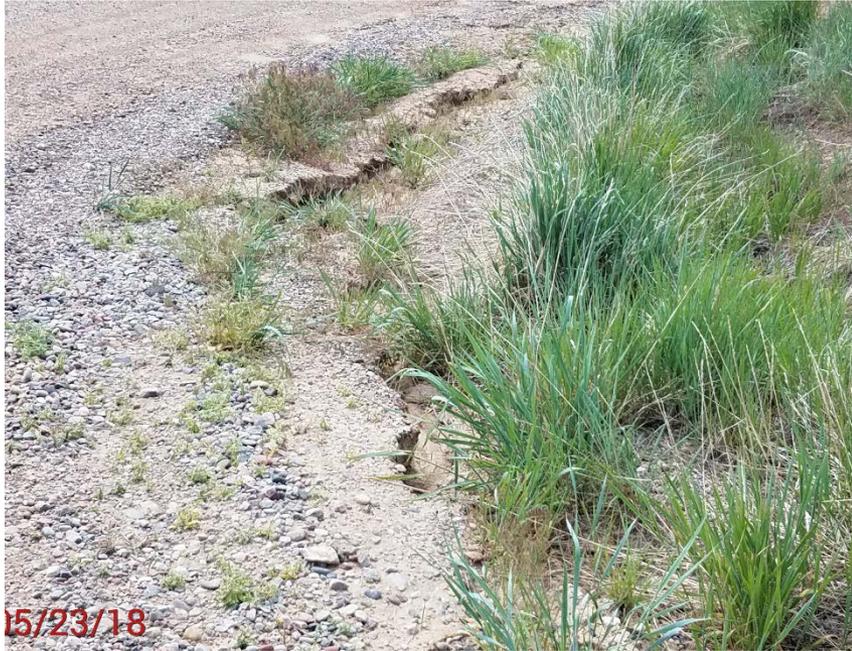
Location Photo #13, Ditch erosion along side of road on east side at the curve

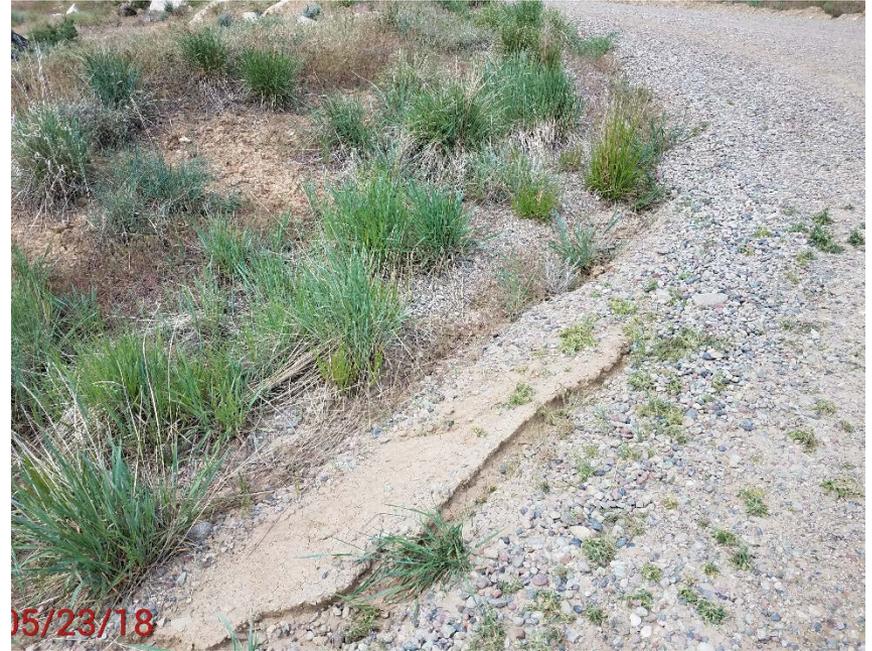
Location Photo #14, Ditch erosion along side of road on east side at the curve
