Daily Inspection Report  
Laramie Energy, LLC, Stormwater Management, 2018

**Buzzard Creek Project Area**

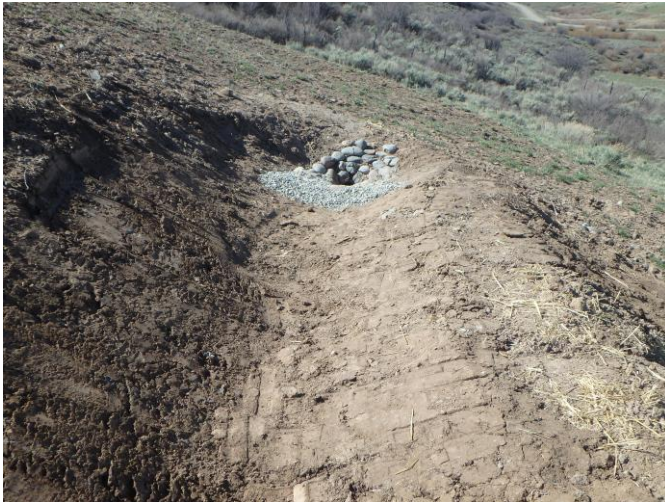
EI corrected a stormwater deficiency on the BCU 12B pad that was previously identified by COGCC. A water bar installed on the upper end of the fill slope had breached where a rock check held back too much runoff. EI repaired the breach and maintained the entire water bar. EI removed the rock check where the breach occurred and re-installed the material immediately in front of the flex hose outlet. EI also lowered all rock checks in the water bar to reduce the likelihood of reoccurrence.

**Breach in Water Bar on BCU 12B after Repairs**

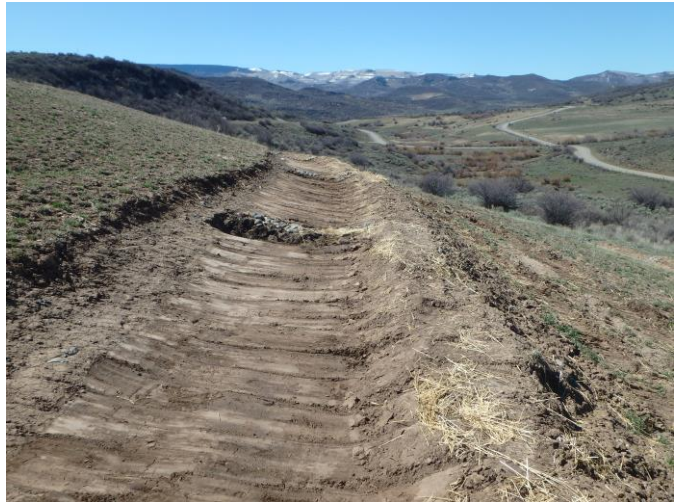
**Water Bar on BCU 12B after Maintenance**
