**Inspection Photos**  
**Location Name: Dilka 6-12**  
**API: 05-123-23783**

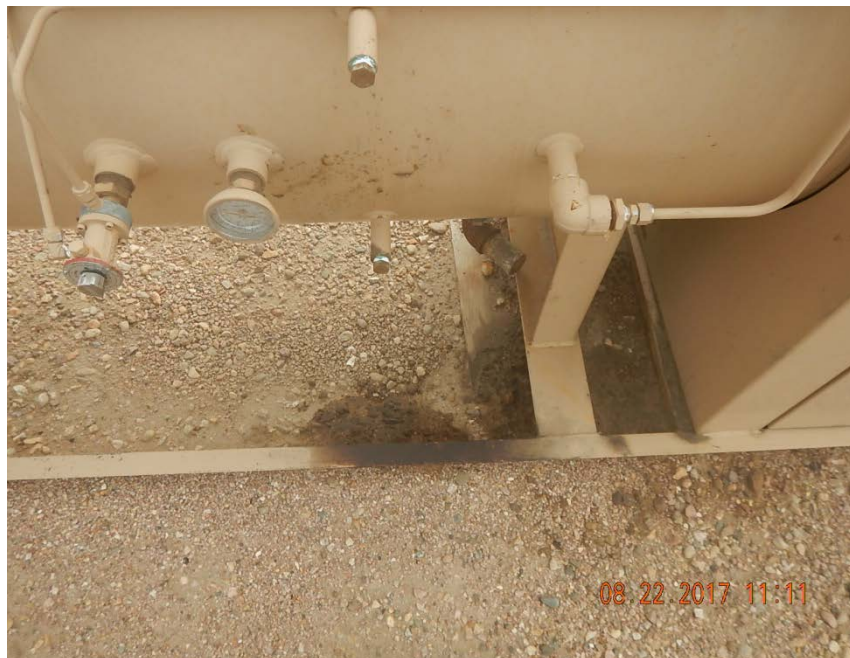
**Photo from prior inspection for comparison**

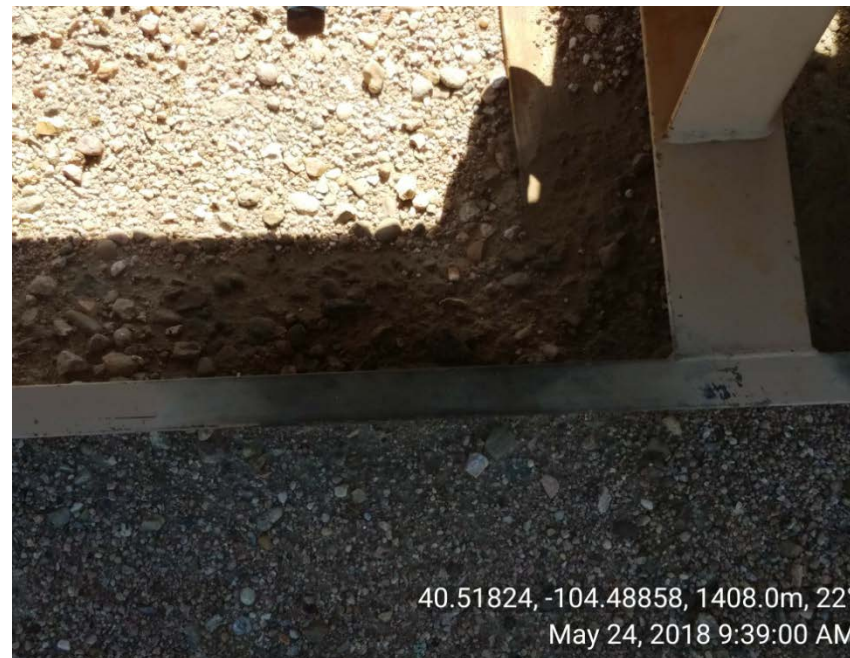
**Photo 3: Stained soil outside of separator**

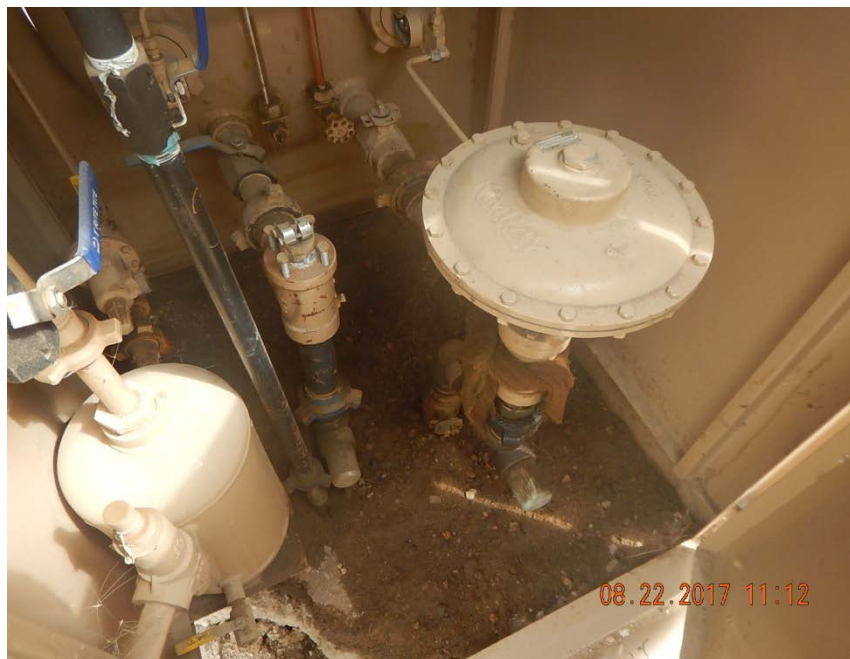
**Photo from prior inspection for comparison**

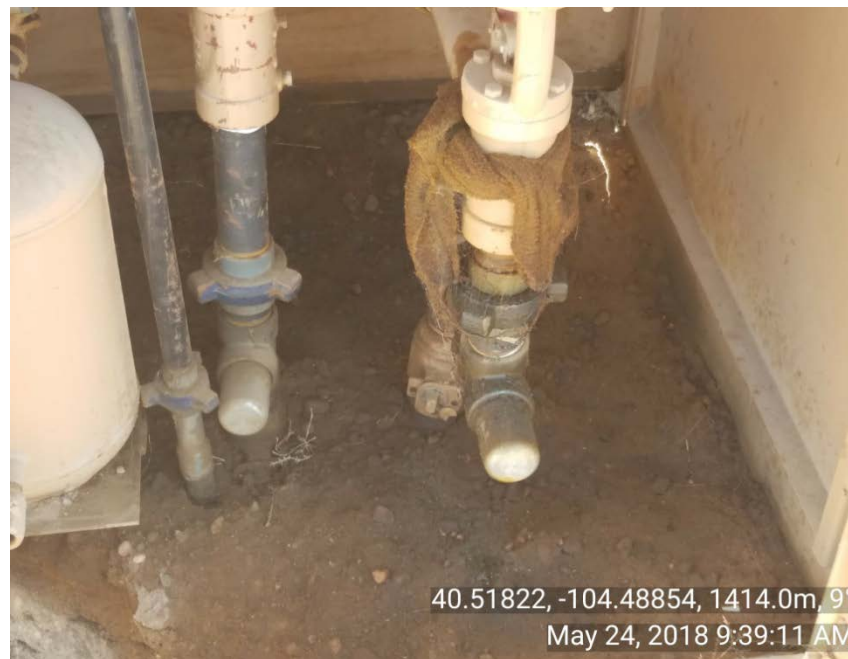
**Photo 4: Stained soil in separator**

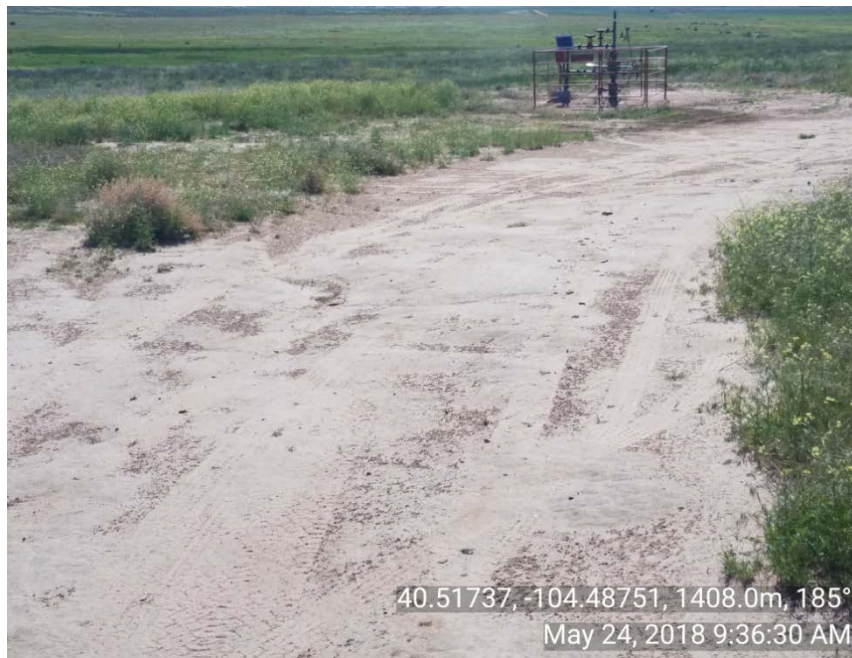
**Photo 5: Stormwater erosion NW of wellhead**

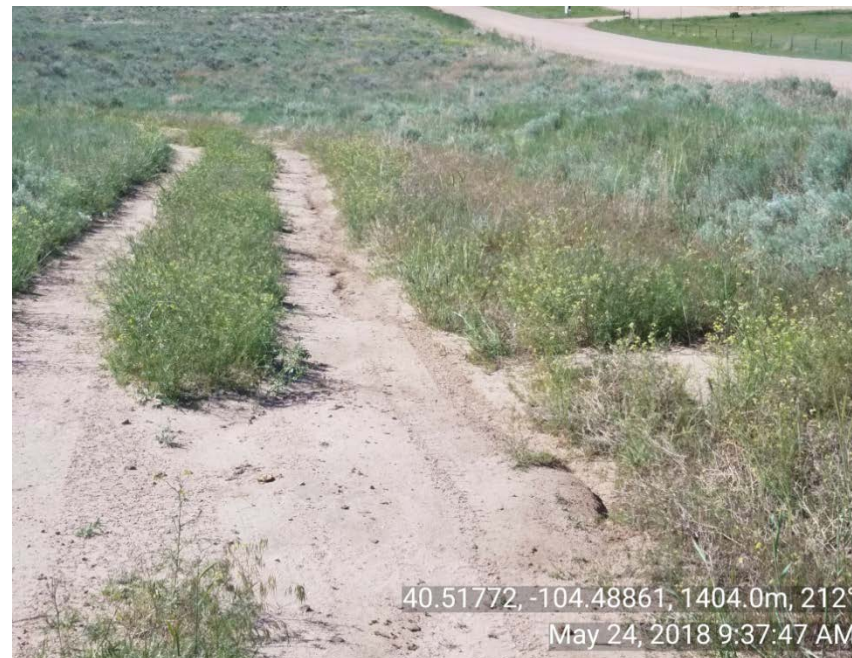
**Photo 6: Stormwater erosion S of battery**
