Inspection Photos
Location Name: Chavez #1
API: 05-007-06120

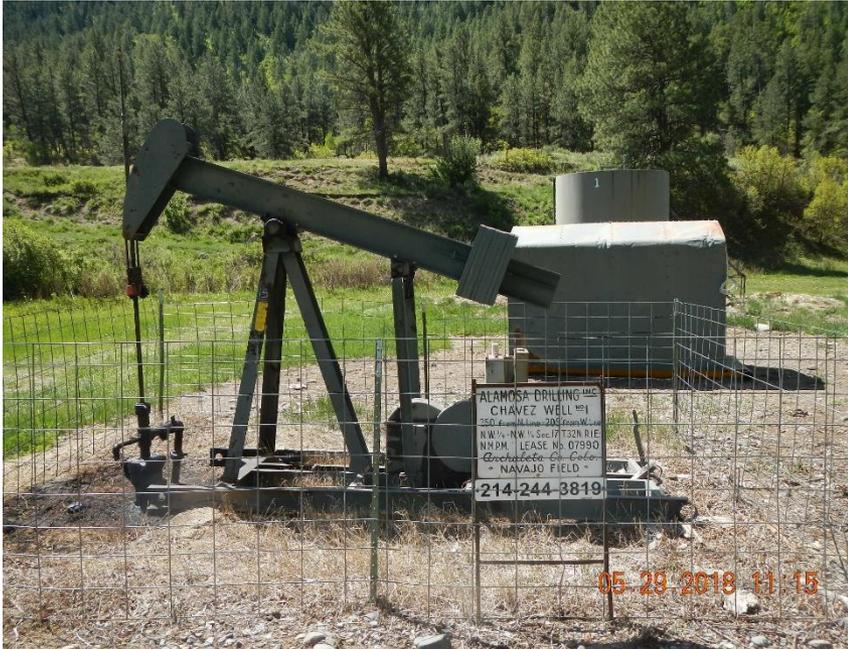
Chavez #1 location photo.

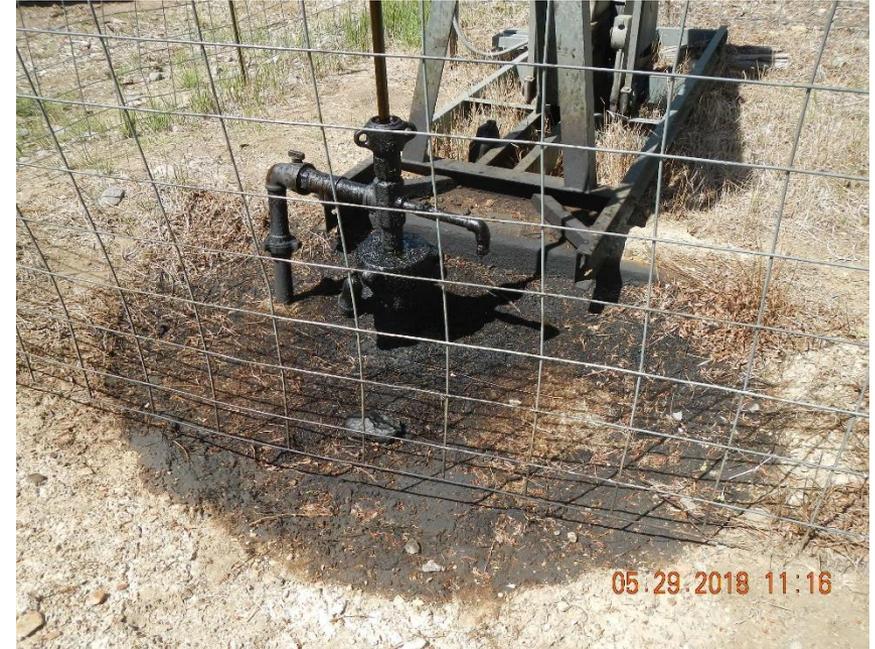
Stained soil around wet well head, noted in previous inspection report.

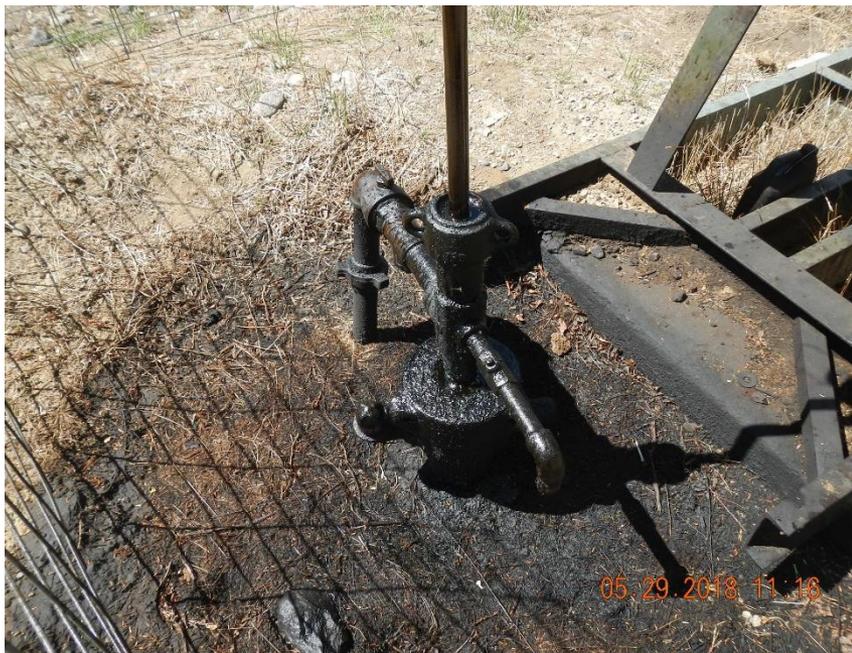
Well head is wet with oil. Area surrounding well head is stained.

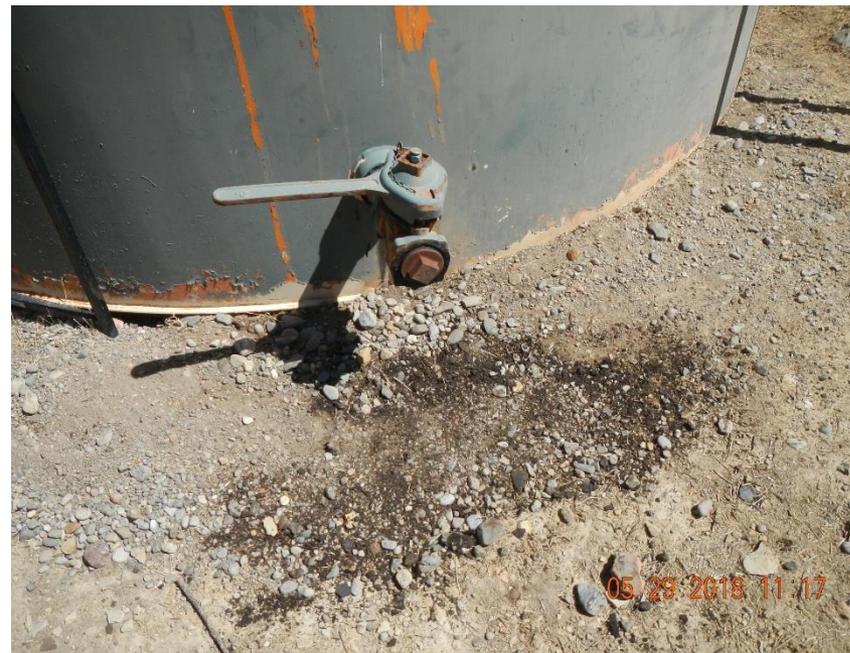
Stained soil beneath load out valve on AST.
