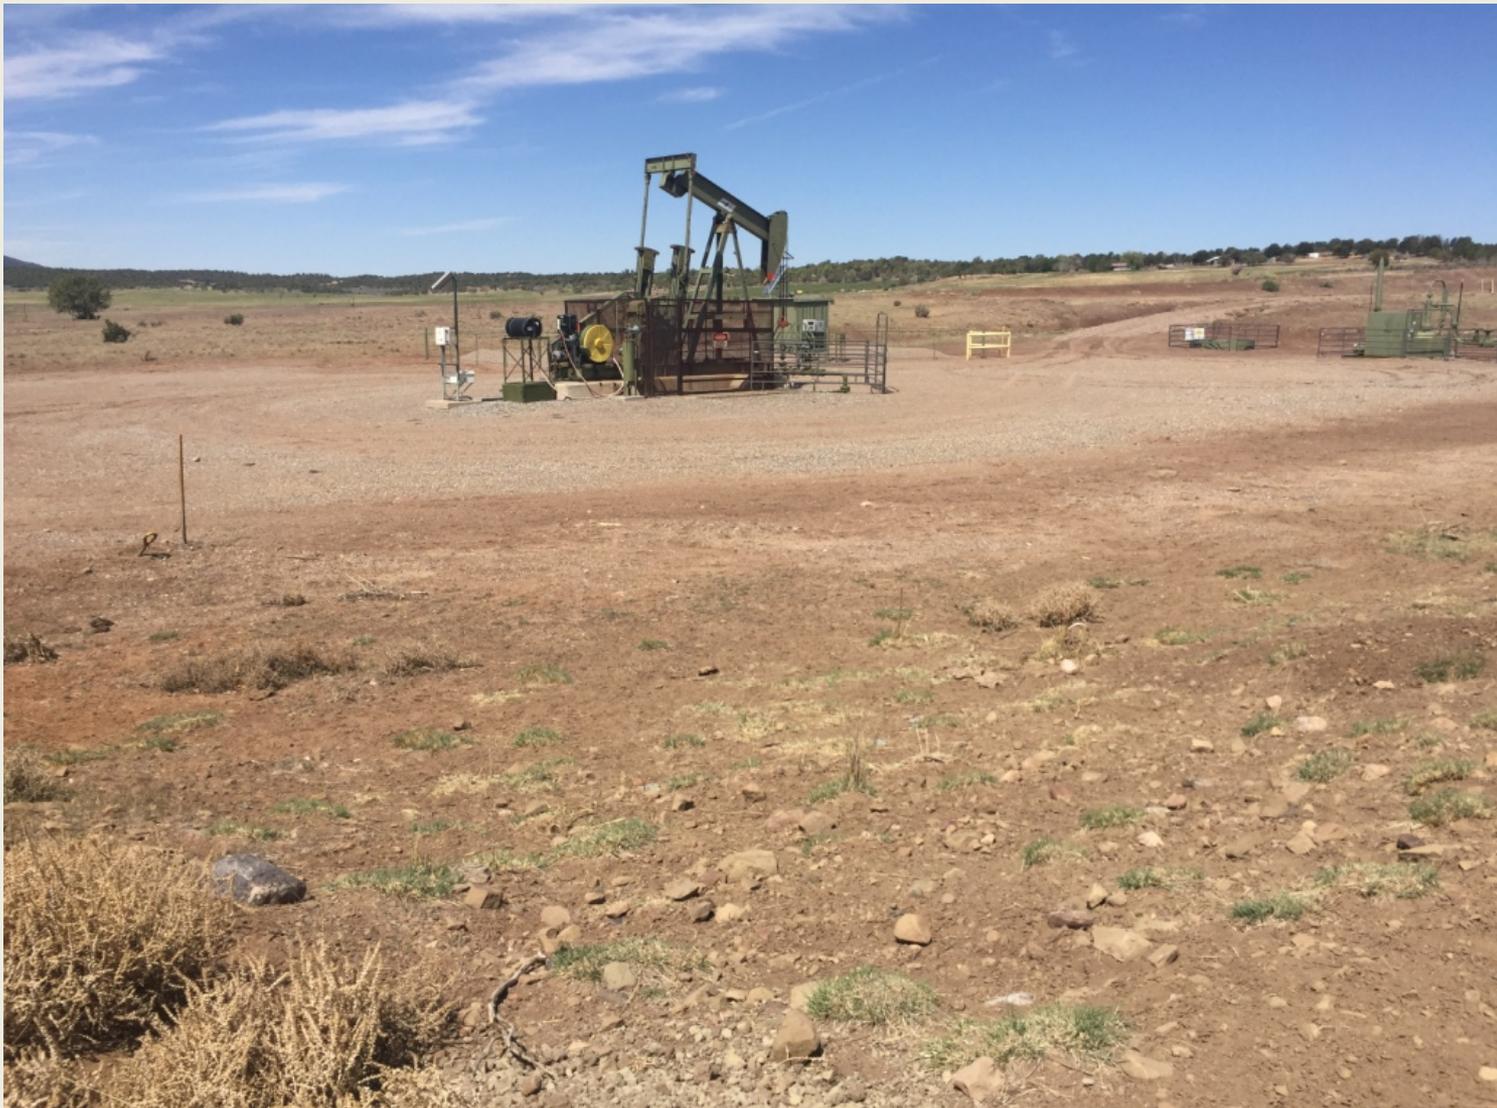
**Photo 1. View of the project area from the southeastern corner facing center.**

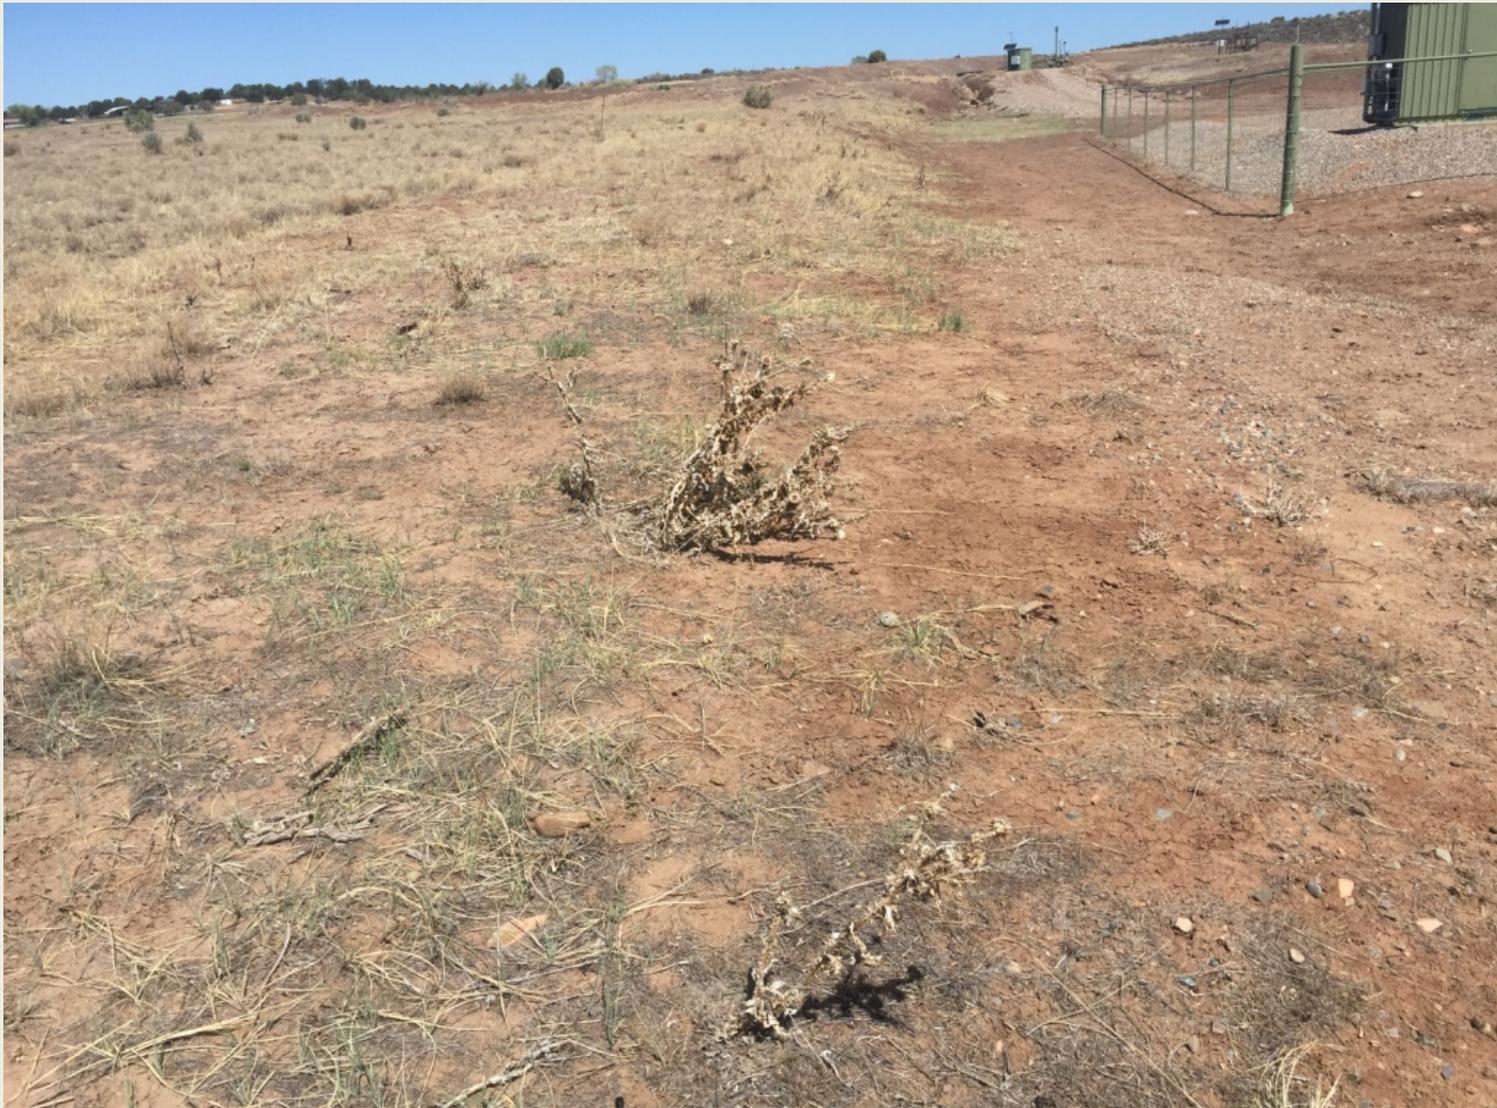
**Photo 2. View of the western portion of the project area from the southwestern corner facing northward. Approx. 100 musk thistles (*Carduus nutans*) from the 2018 growing season were observed. Thistles will need to be treated this year if rosettes observed. Seeds will remain viable for 5-7 years and therefore, subsequent monitoring and treatment will be needed.**

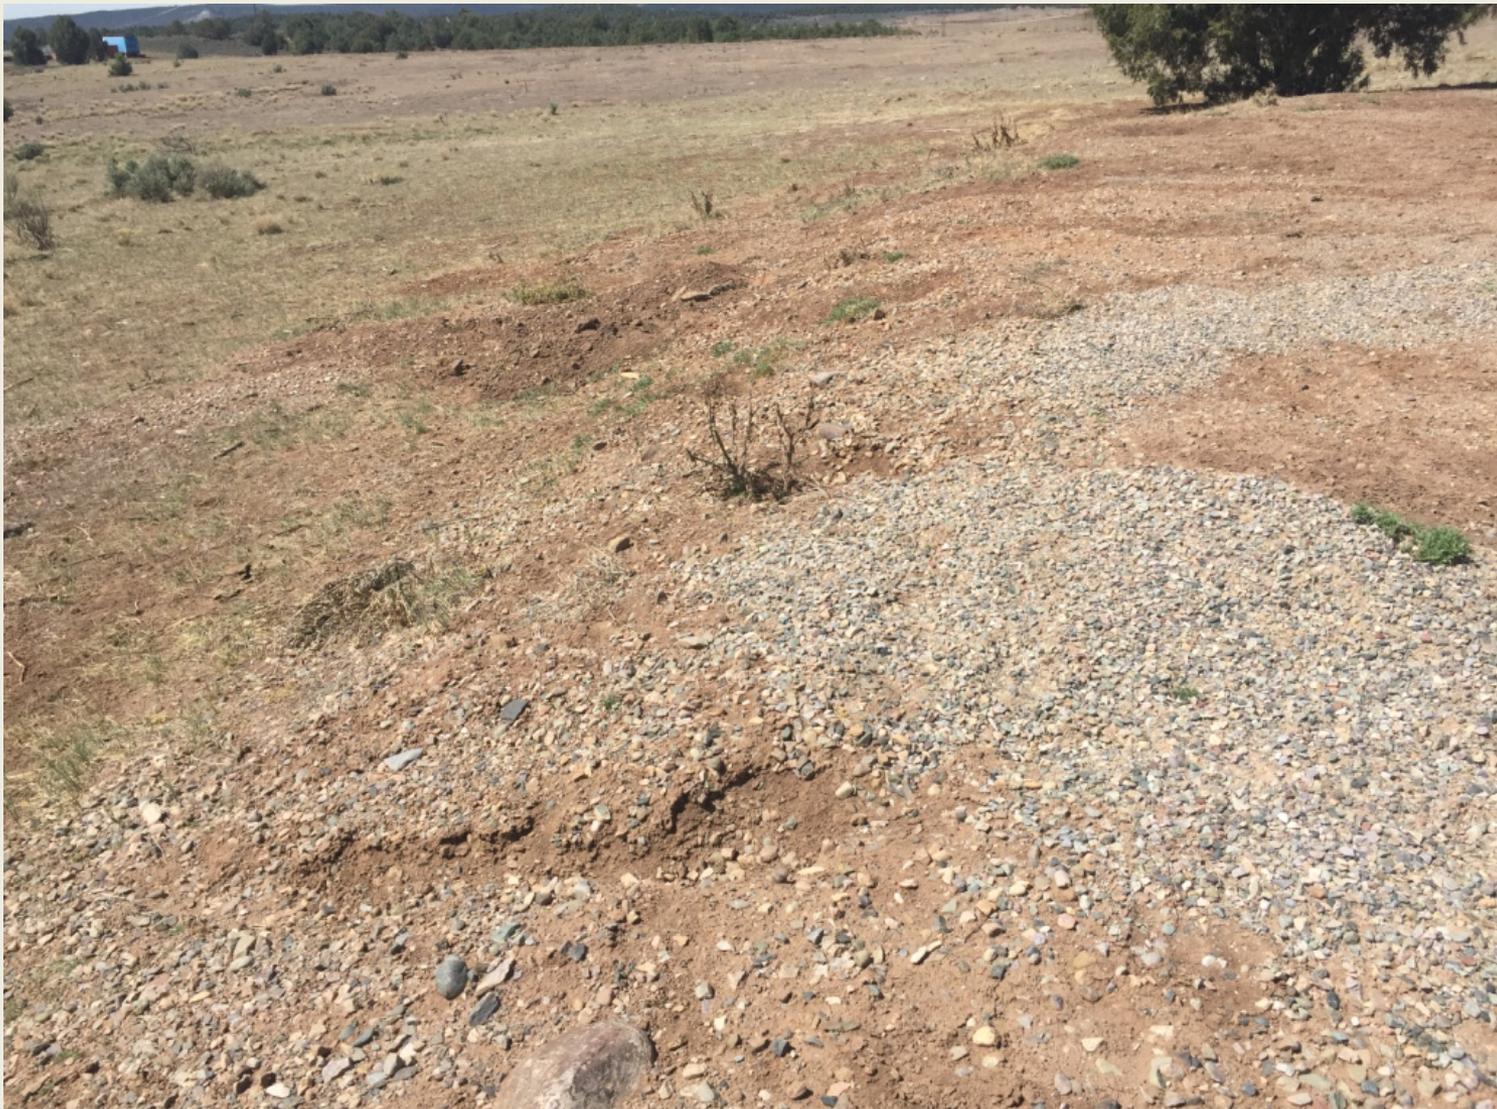
**Photo 3. View of erosional channels forming in the southern portion of the project area.**

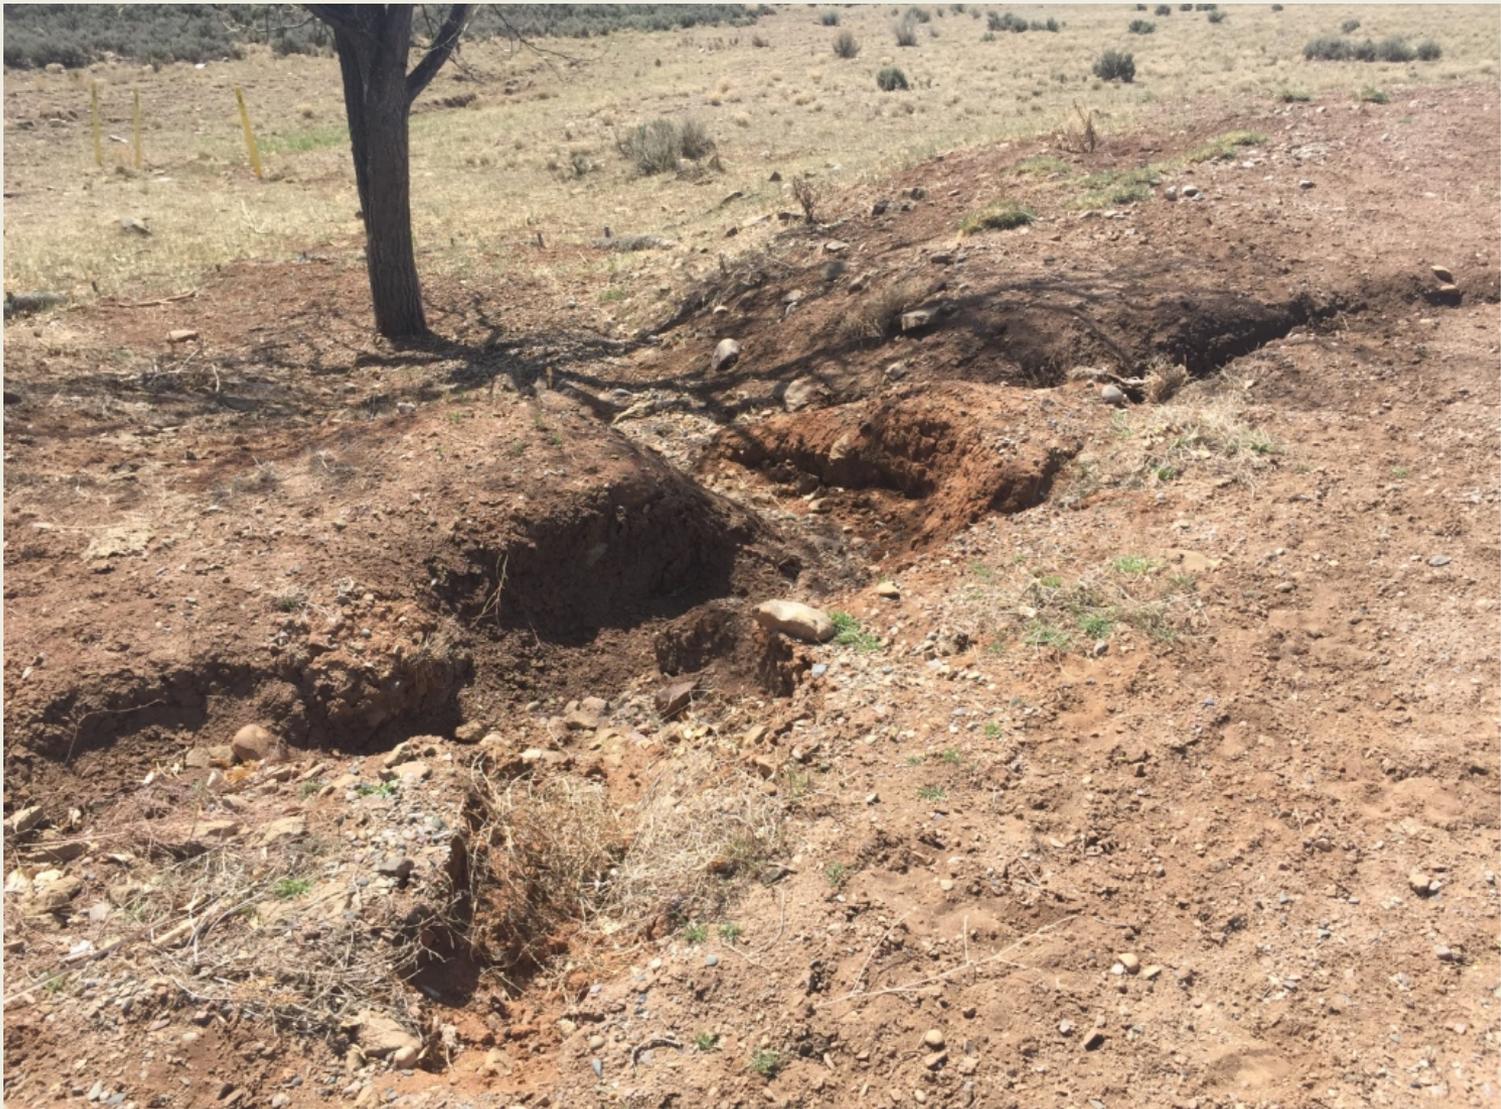
**Photo 4. View of erosional channel approximately 3 feet wide and up to 2 feet deep in the southeastern portion of the project area.**

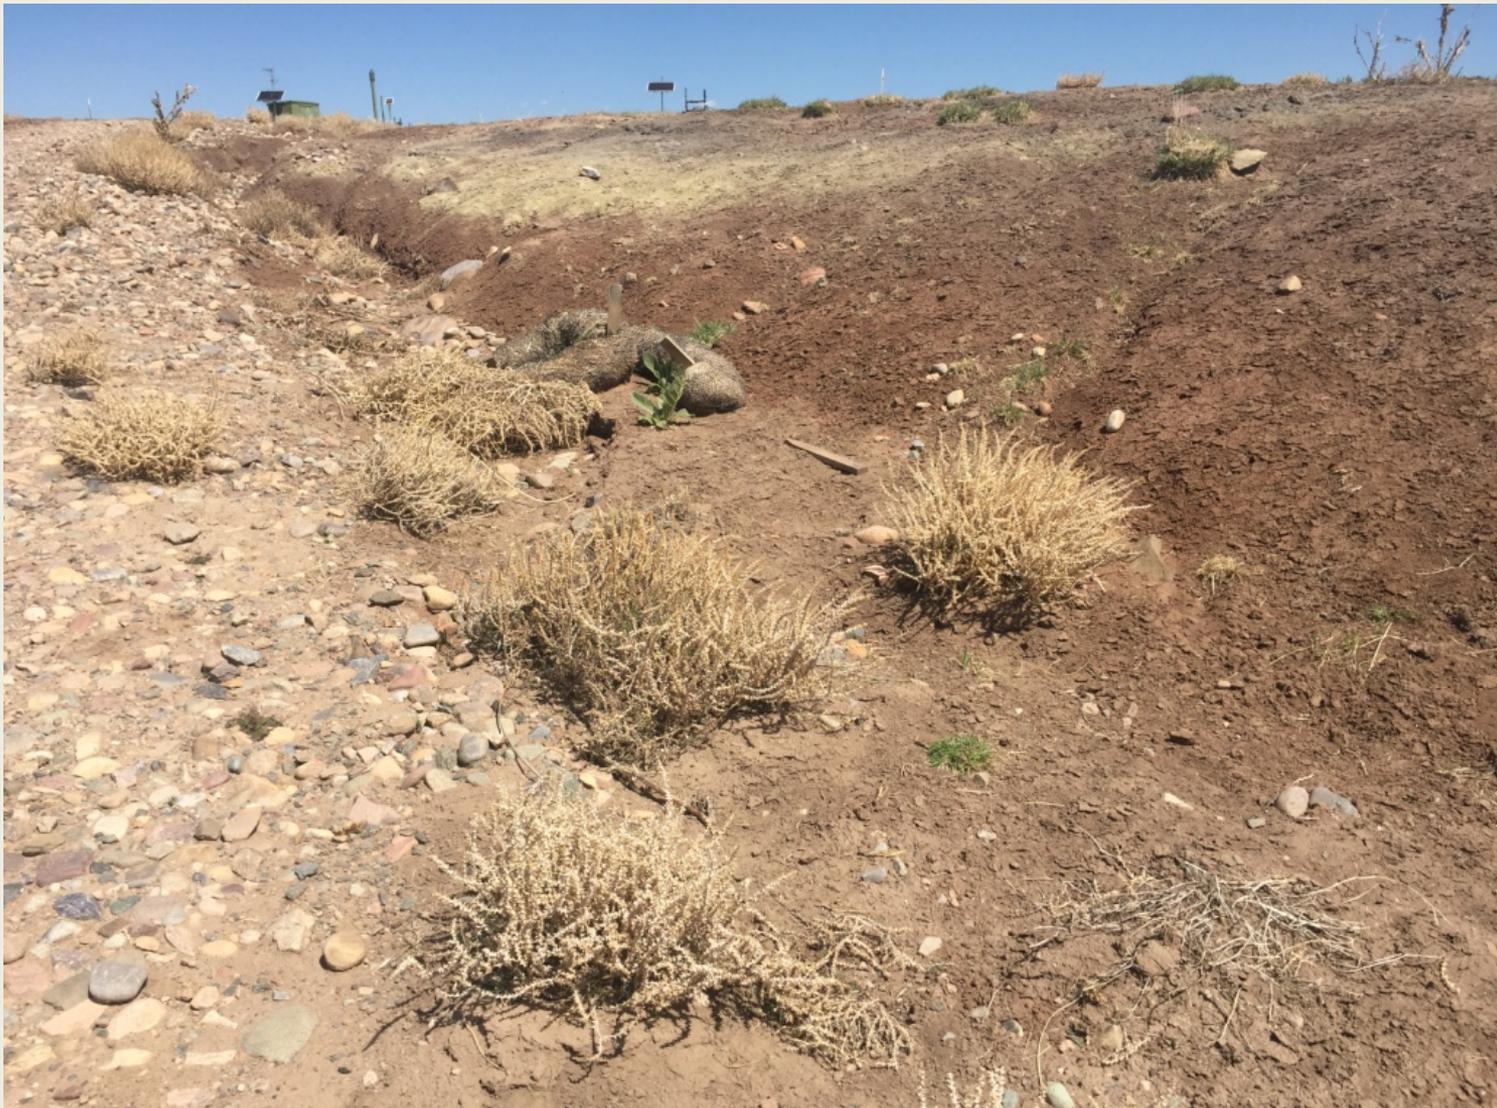
**Photo 5. View of wattles no longer functioning and insufficient, and eroding channel along northeastern edge of the access road. Slope above channel is not stabilized and is eroding into the channel.**

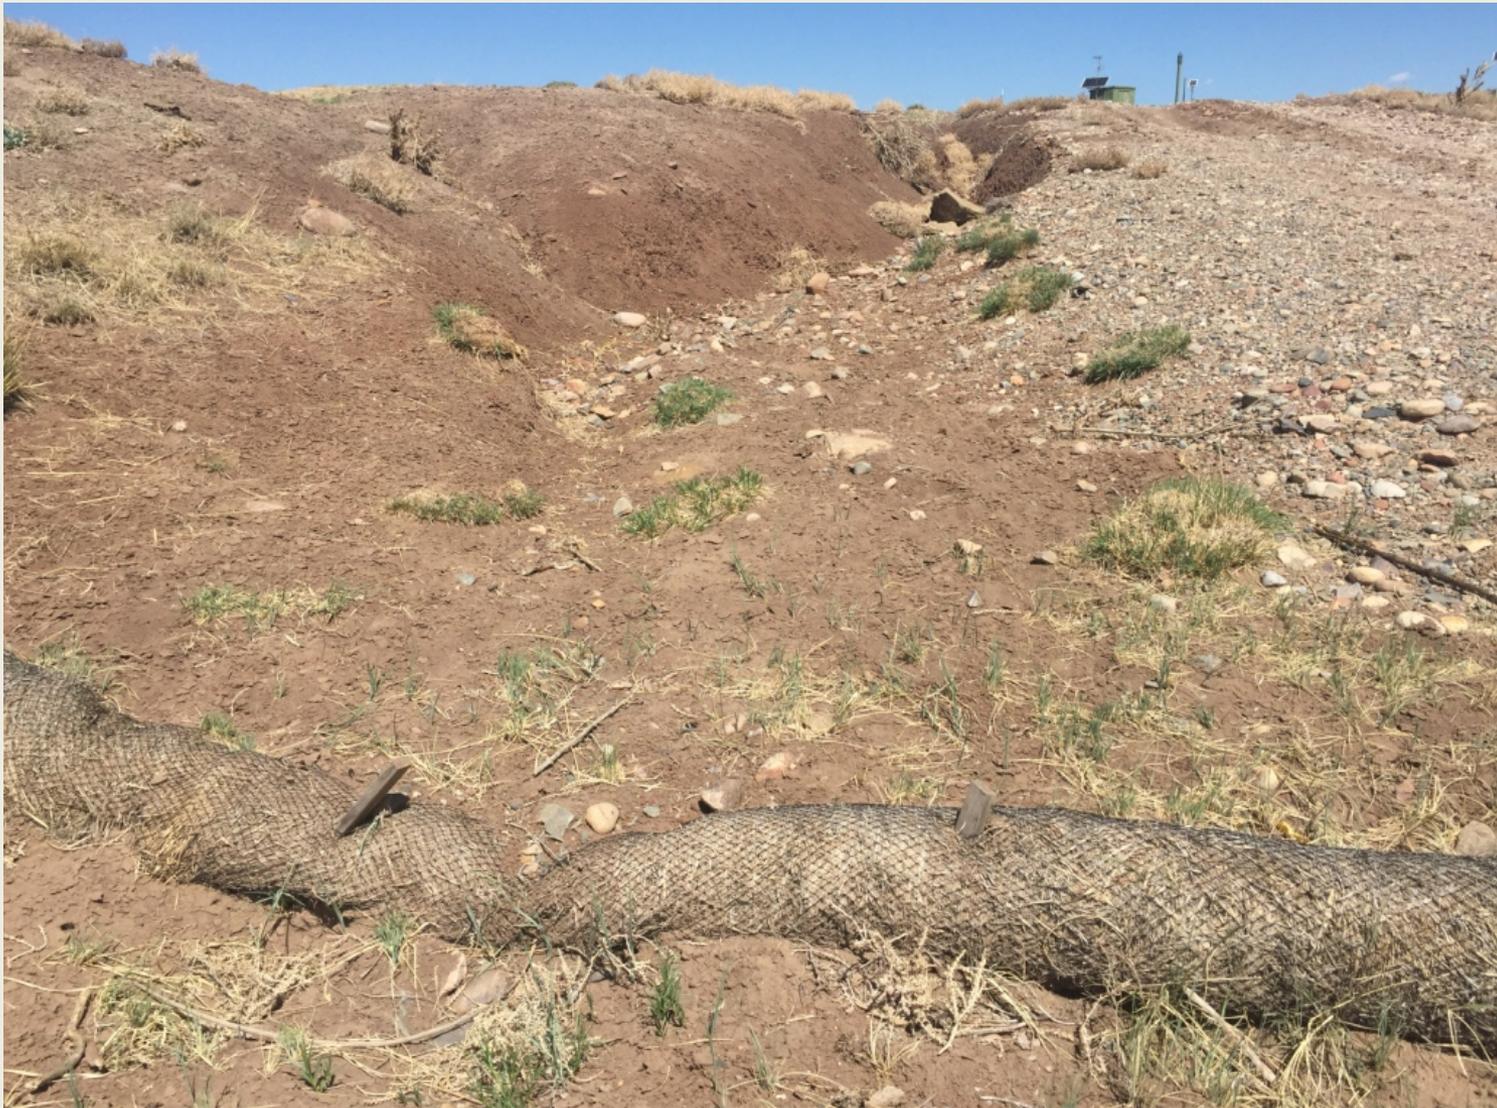
**Photo 6. View of eroding channel along northwestern edge of the access road. Slope above channel is not stabilized and is eroding into the channel. Wattle is not sufficient erosion control here and is full of sediment.**

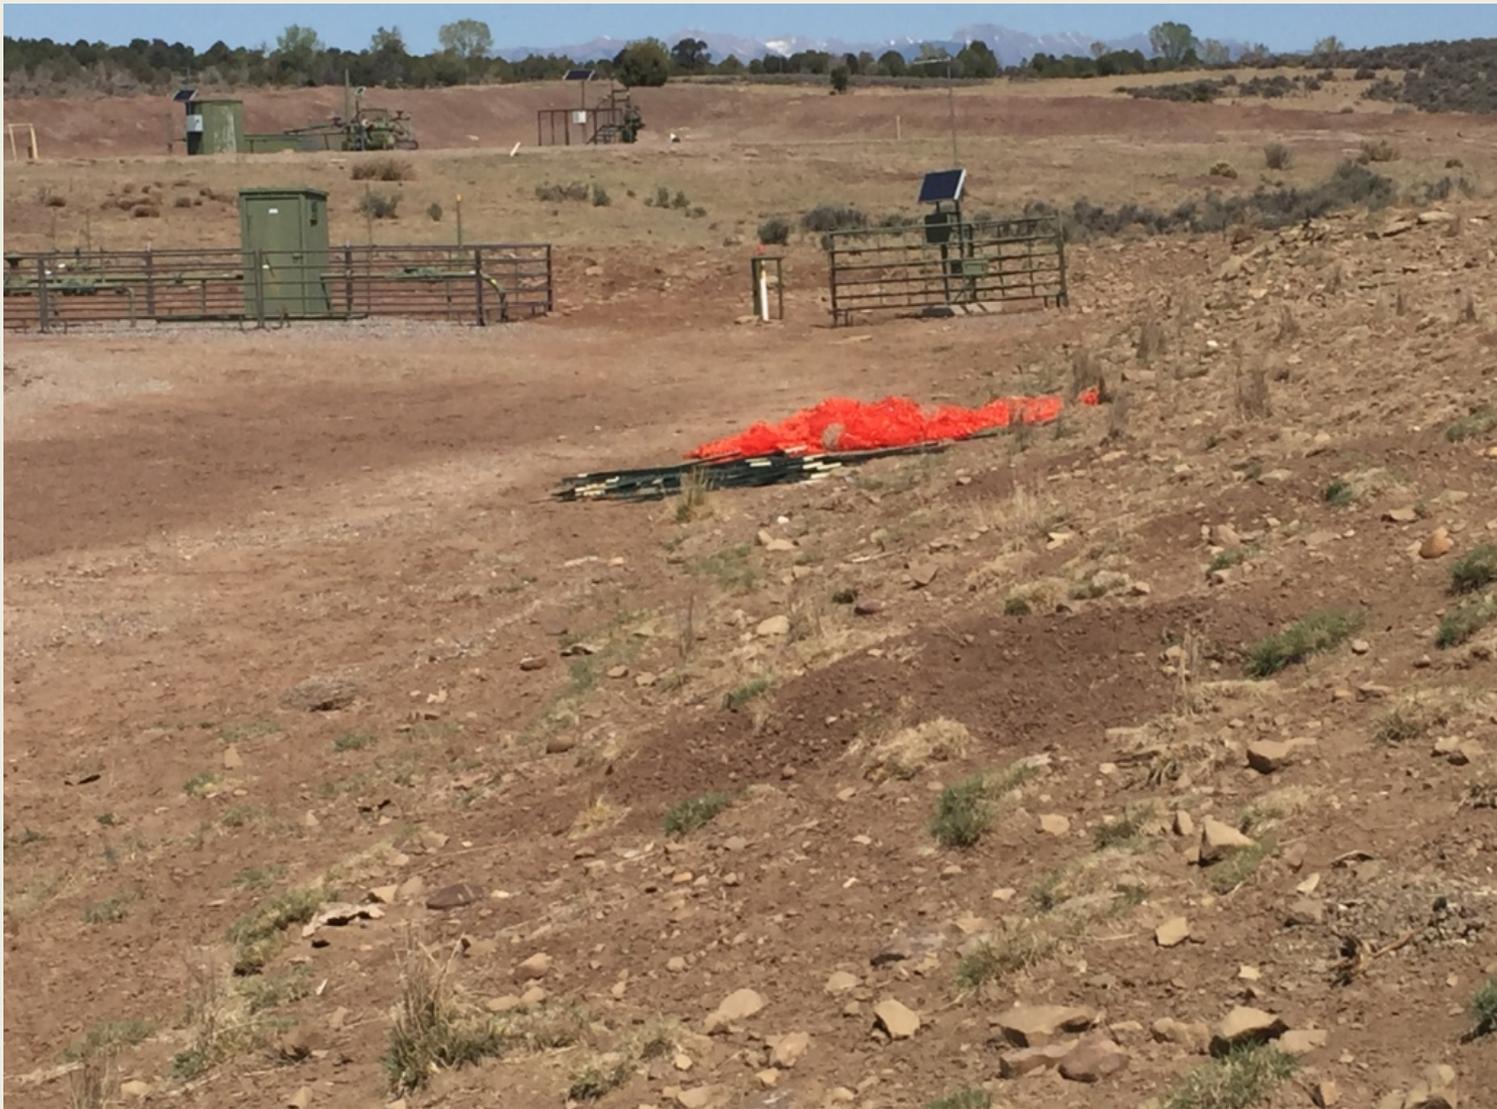
**Photo 7. View of fence debris in the eastern portion of the project area.**

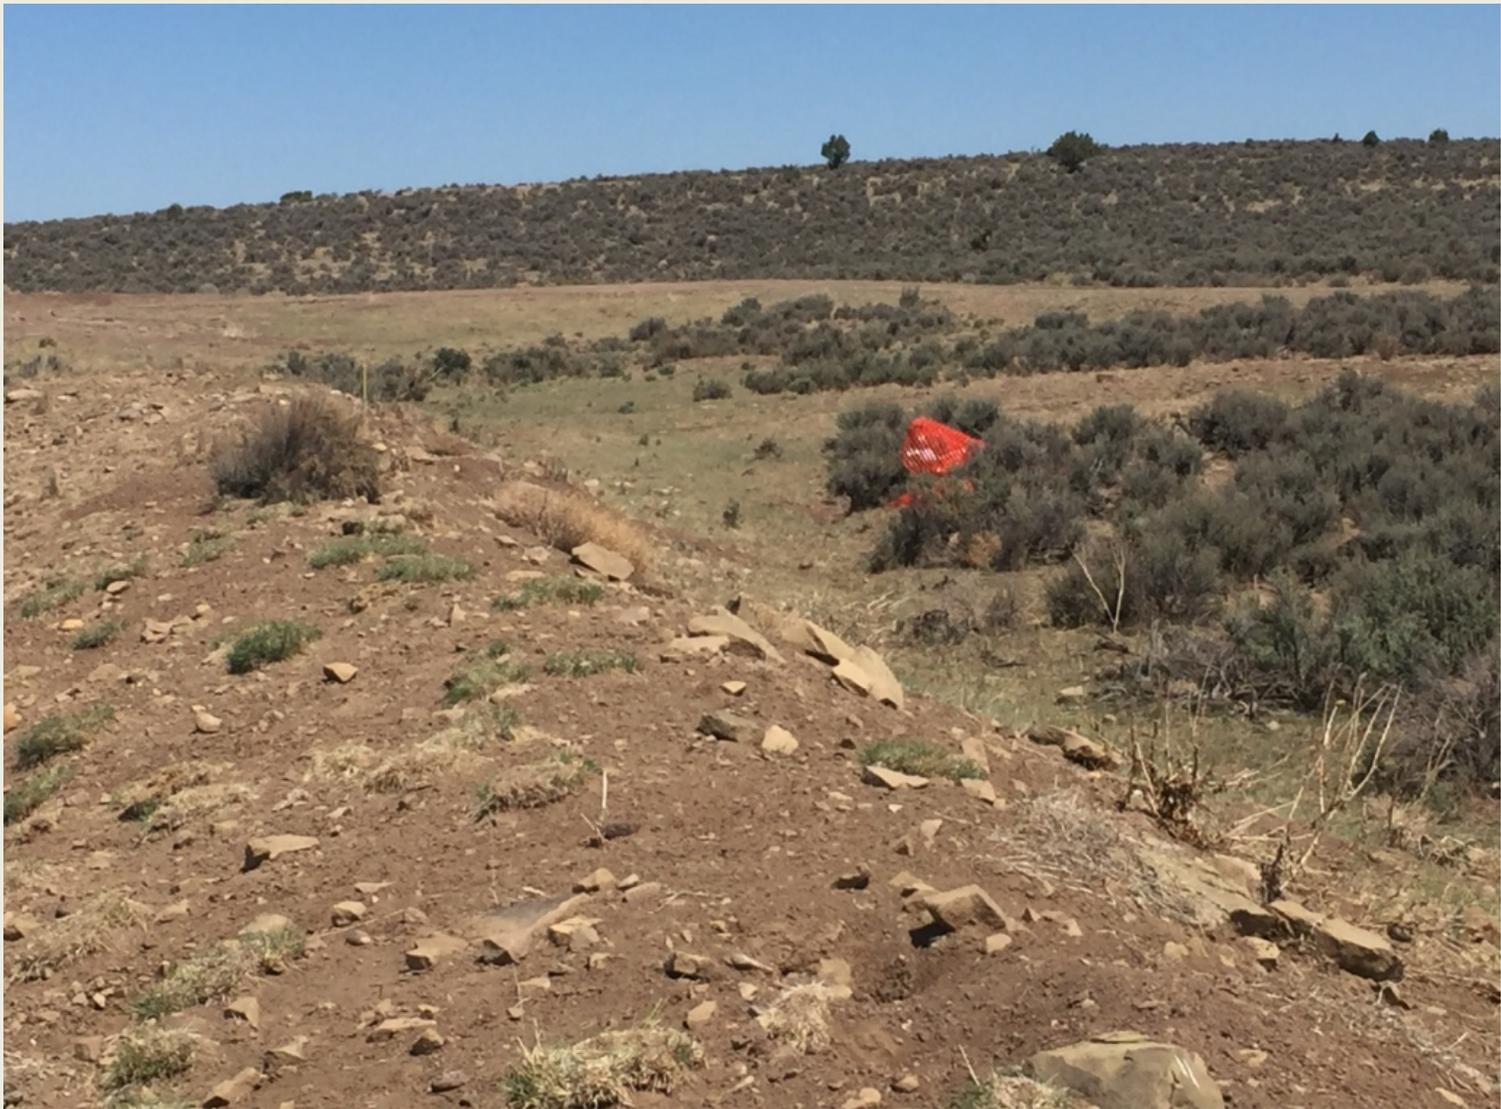
**Photo 8. View of more fence debris east of the well pad that appears to have blown off of the project area.**
