Inspection Photos
Location Name: Moyer Unit 11-29
Location: 317535

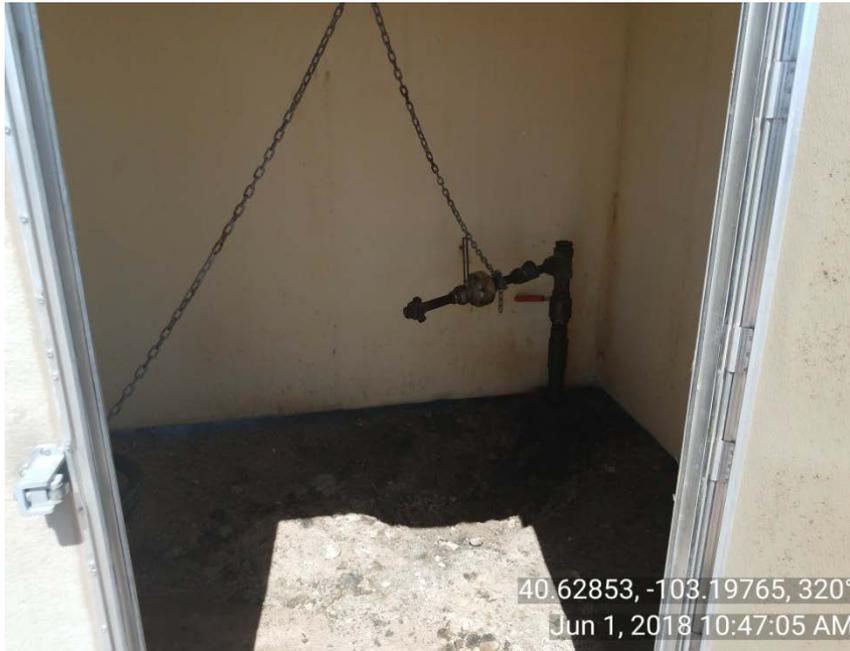
Photo 1: Wellhead, currently TA.

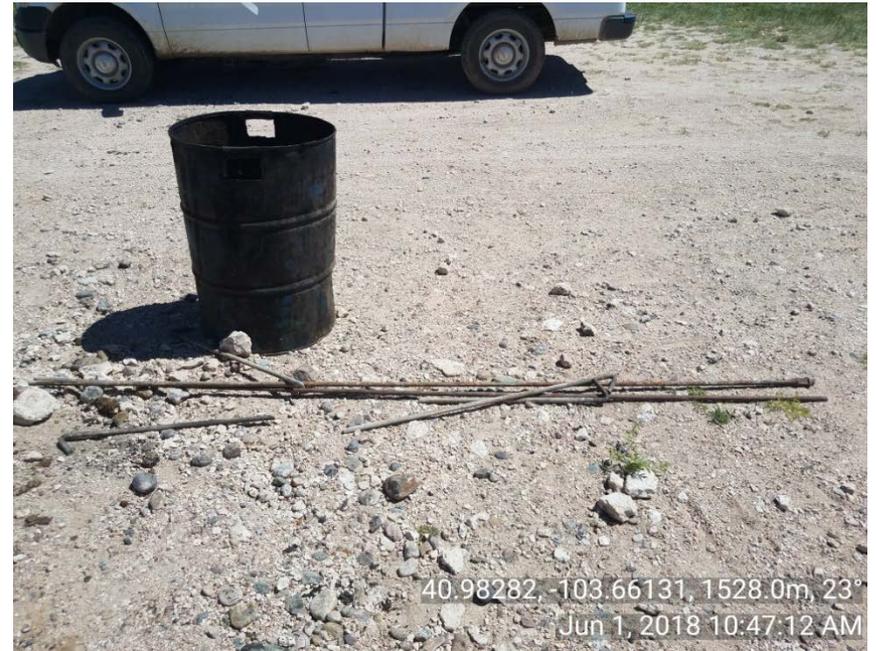
Photo 2: Unused equipment on location.

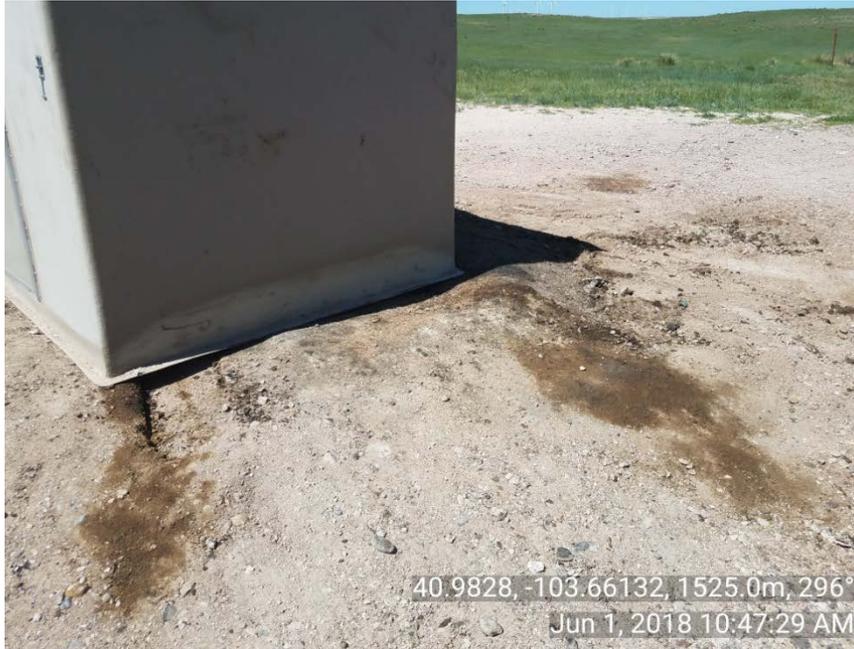
Photo 3: Stained soil on location, around wellhead.
