Inspection Photos
Location Name: Moyer 'A'-612N56W
Locid#433344

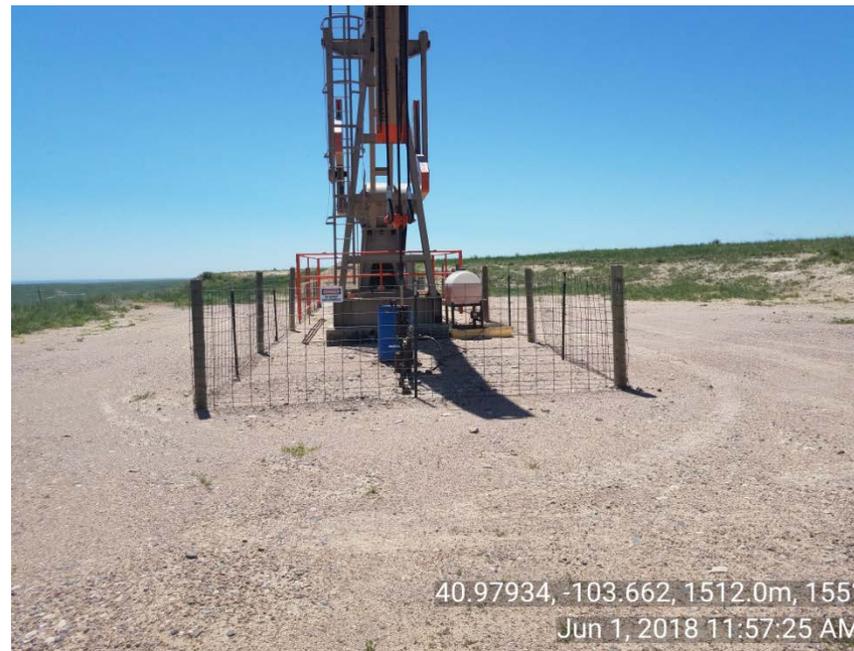
Photo 2: Wellhead

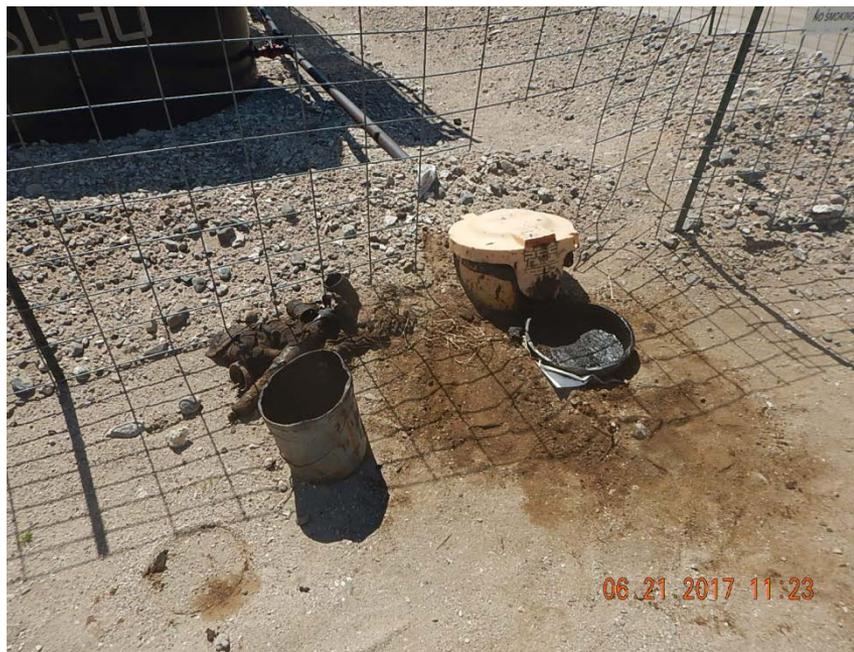
Photo from prior inspection for comparison

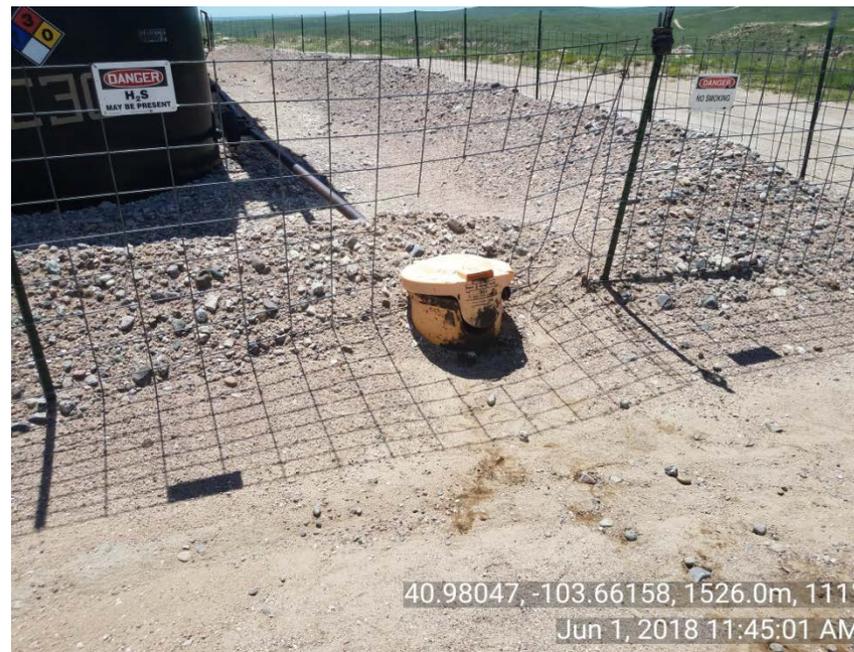
Photo 3: Stained soil removed, trash removed

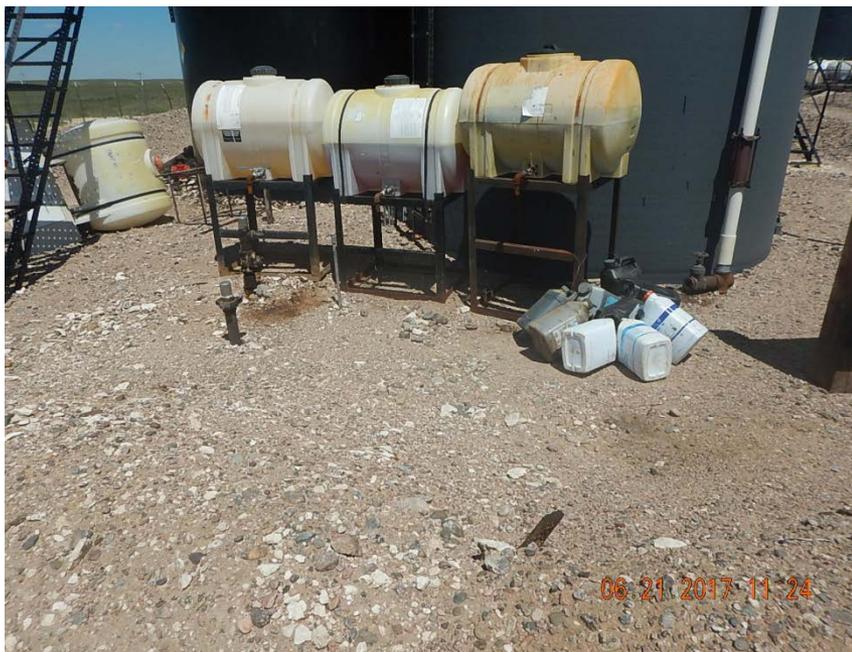
Photo from prior inspection for comparison

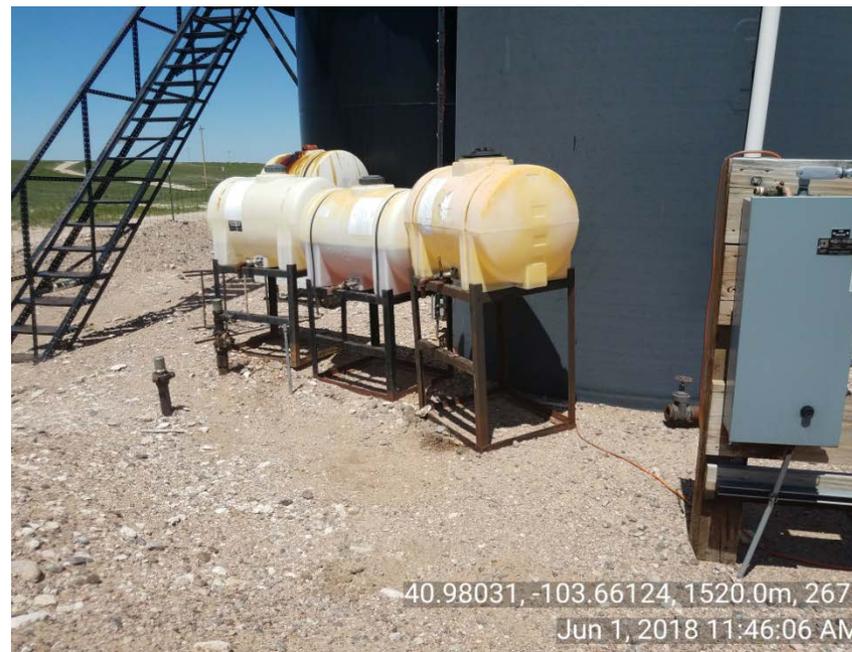
Photo 4: Trash removed.

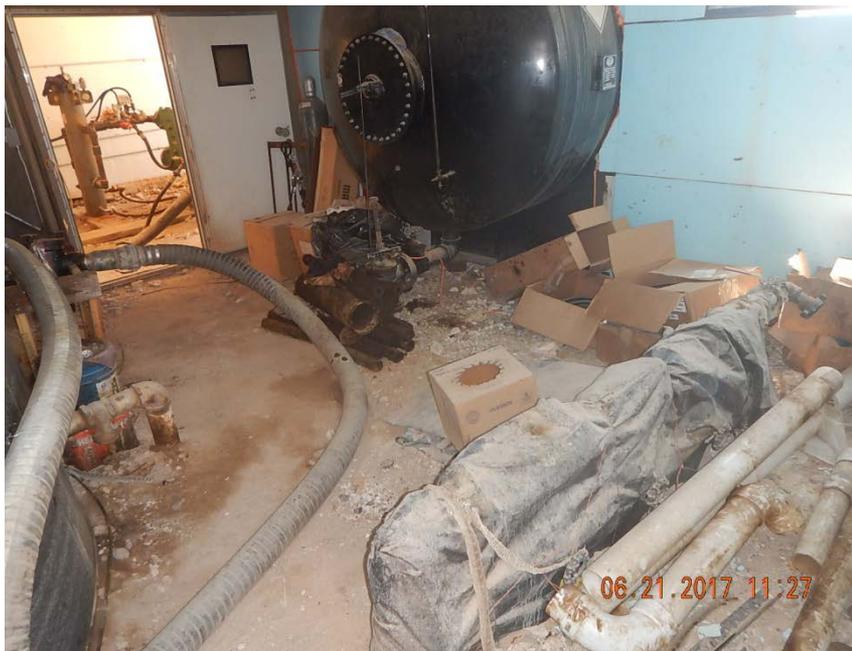
Photo from prior inspection for comparison

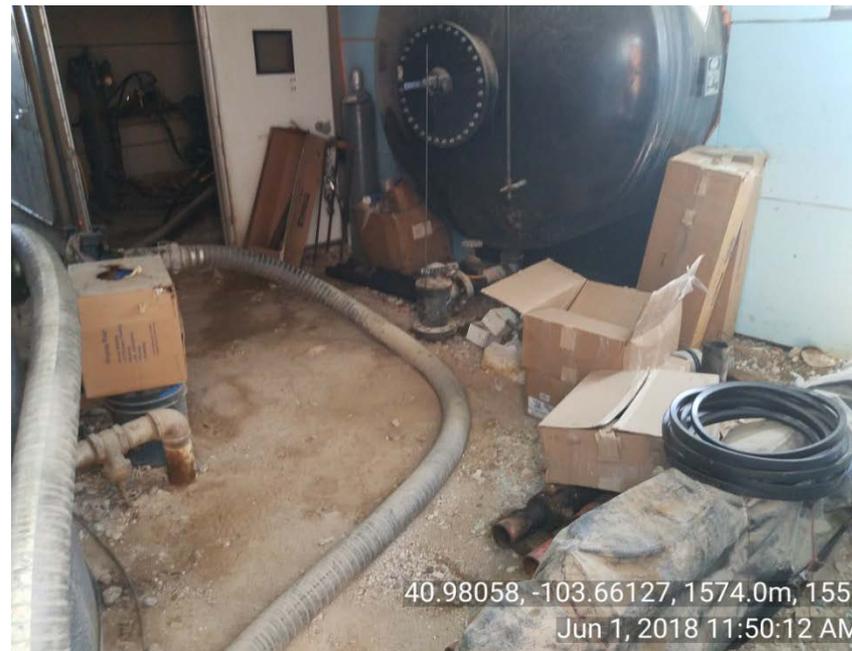
Photo 5: Stained soil, trash in separator house.

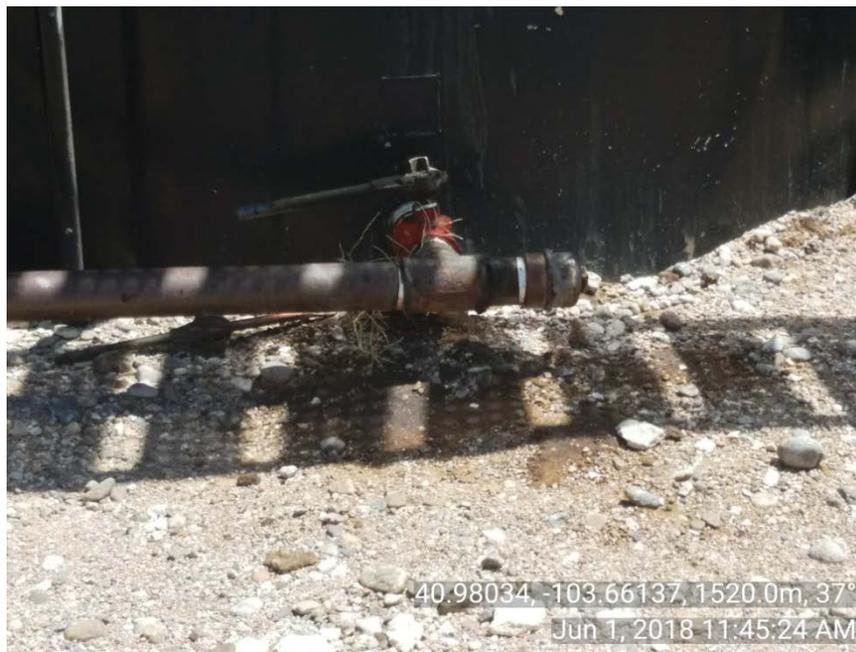
Photo 6: Stained soil at fitting

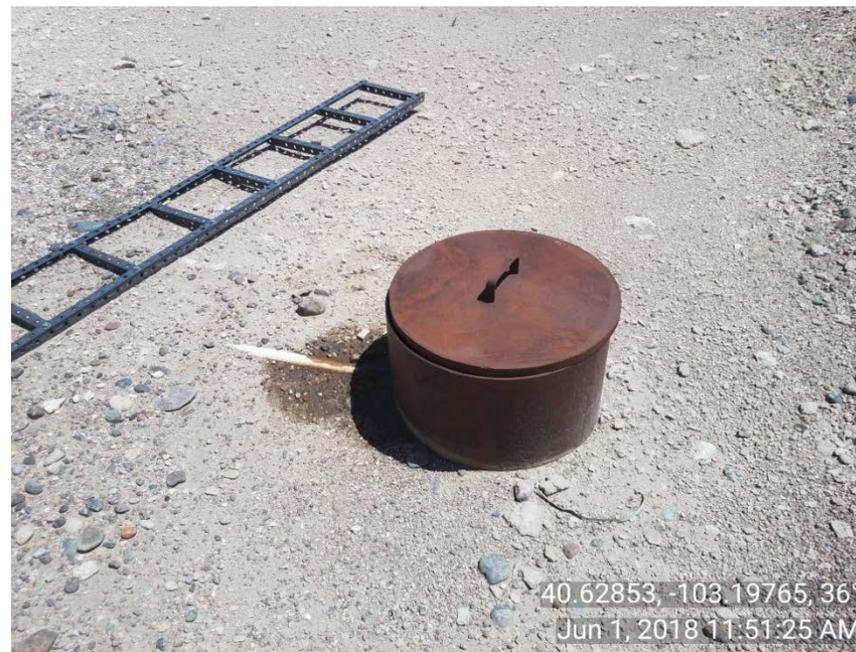
Photo 7: Stained soil at vessel

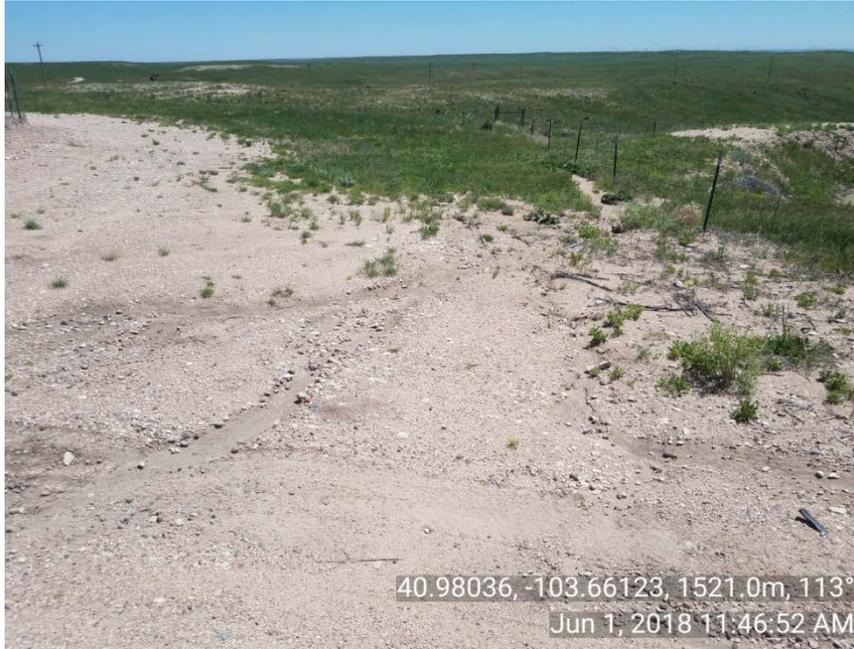
Photo 8: Stormwater erosion S of location.
