Inspection Photos  
Location Name: Mallard 0780 1-15H22  
API: 05-057-06601

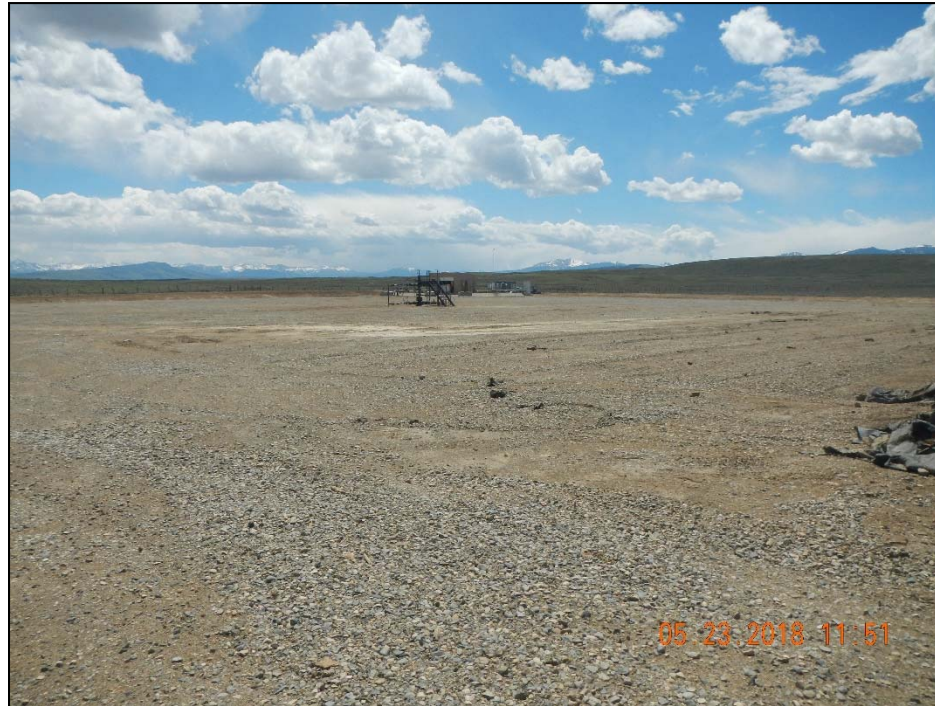
**Photo 1. Overview of location taken at entrance facing east.**

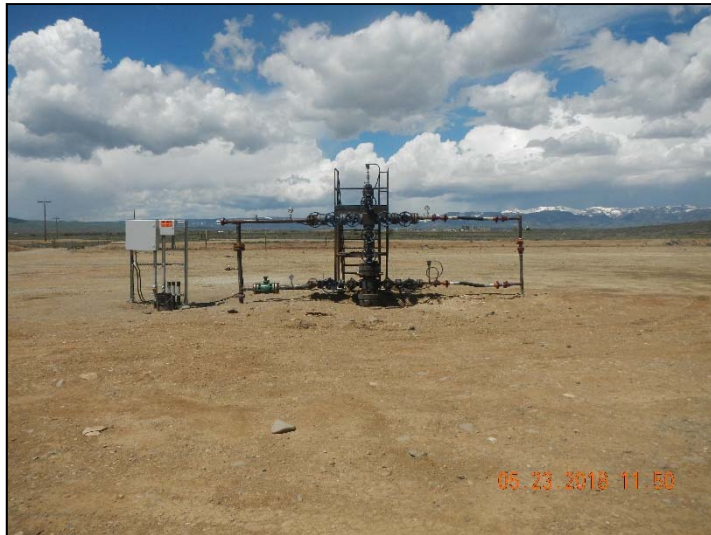
**Photo 2. No wellhead sign.**

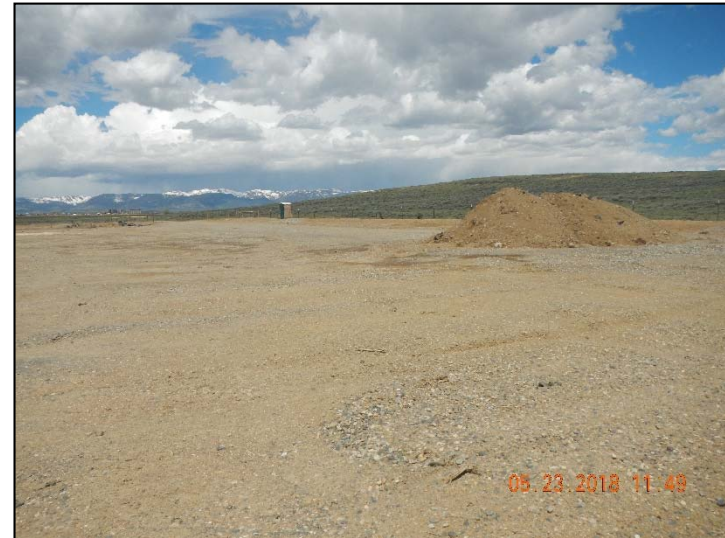
**Photo 3. Drilling and completions debris on location.**

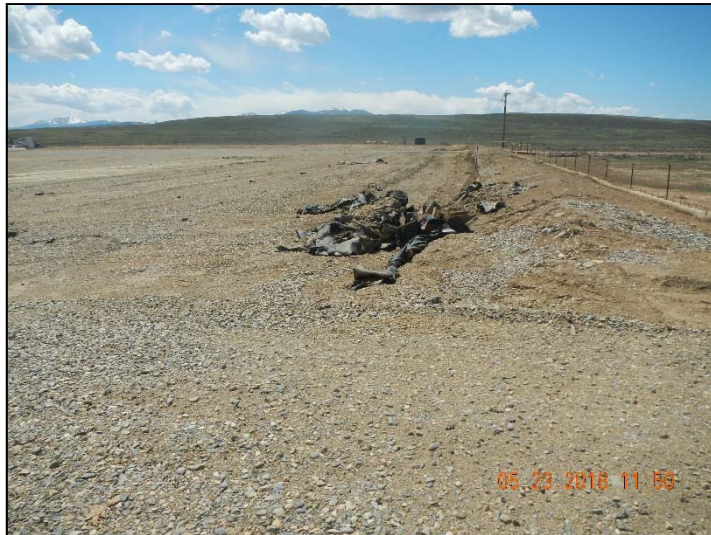
**Photo 4. Drilling and completions debris on location.**

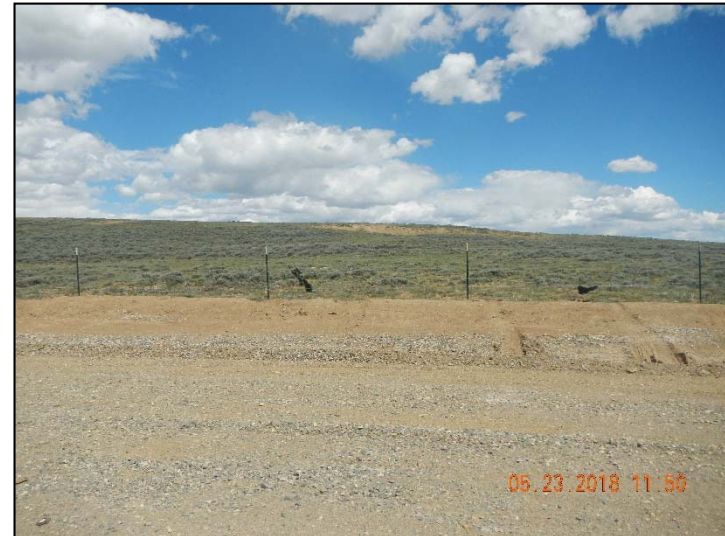
**Photo 5. Debris blowing off location.**
