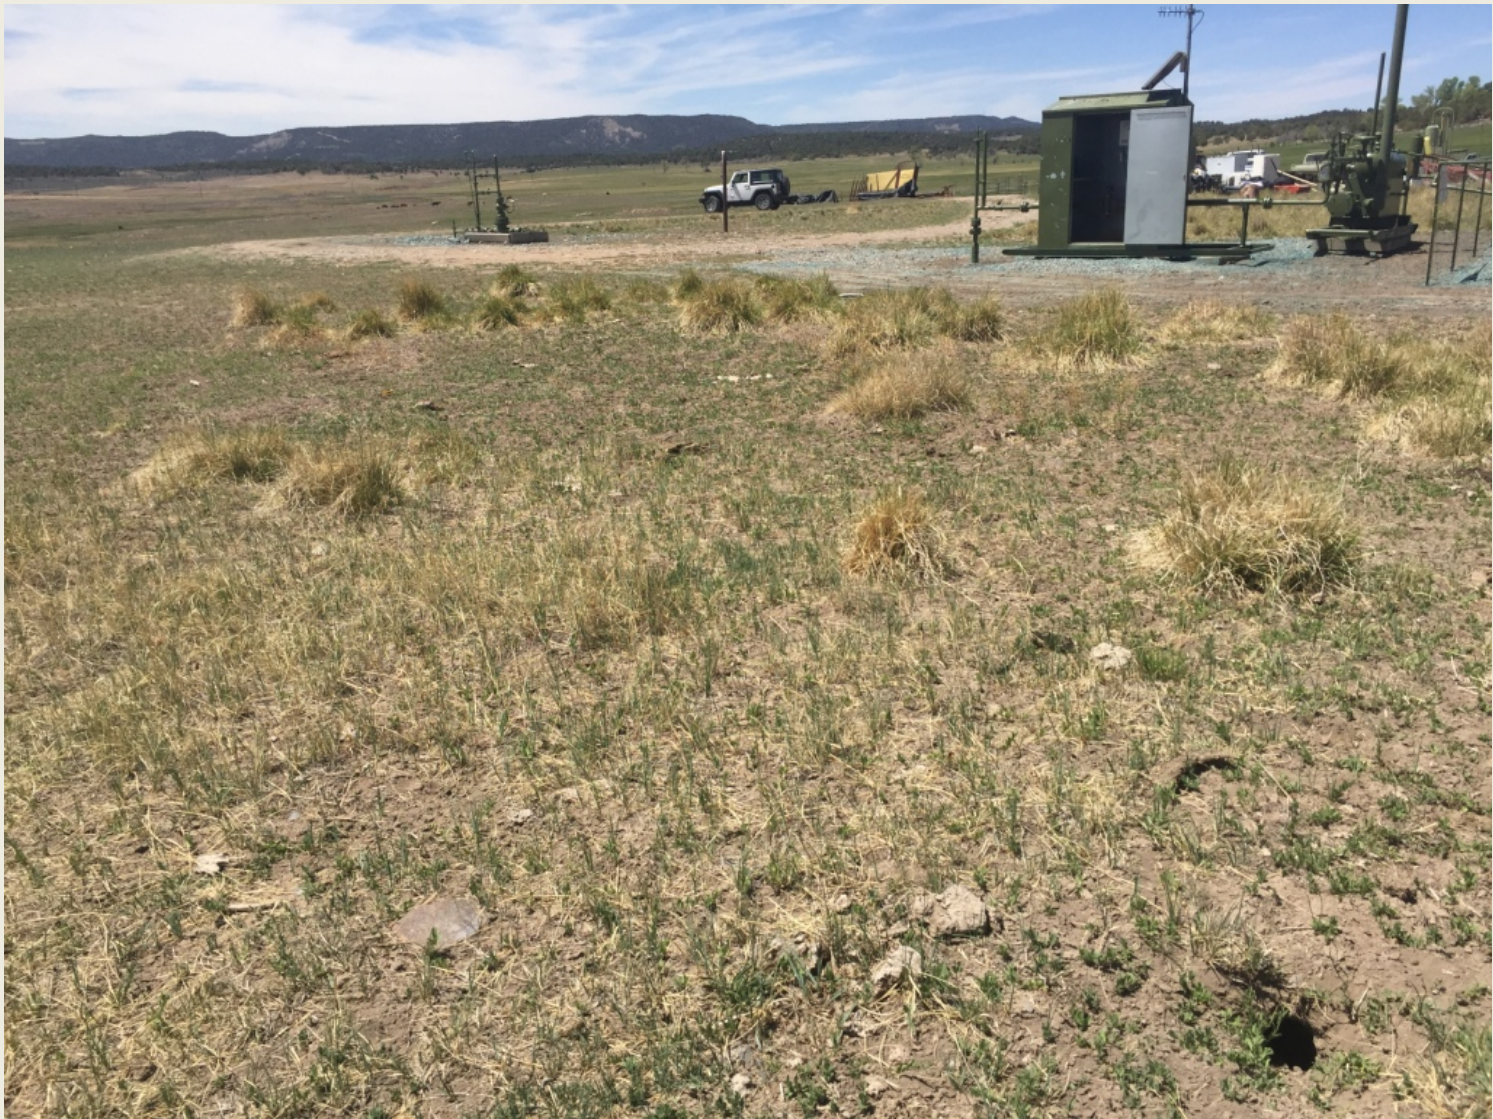
Photo 1. View of the project area from the northeastern corner facing center.

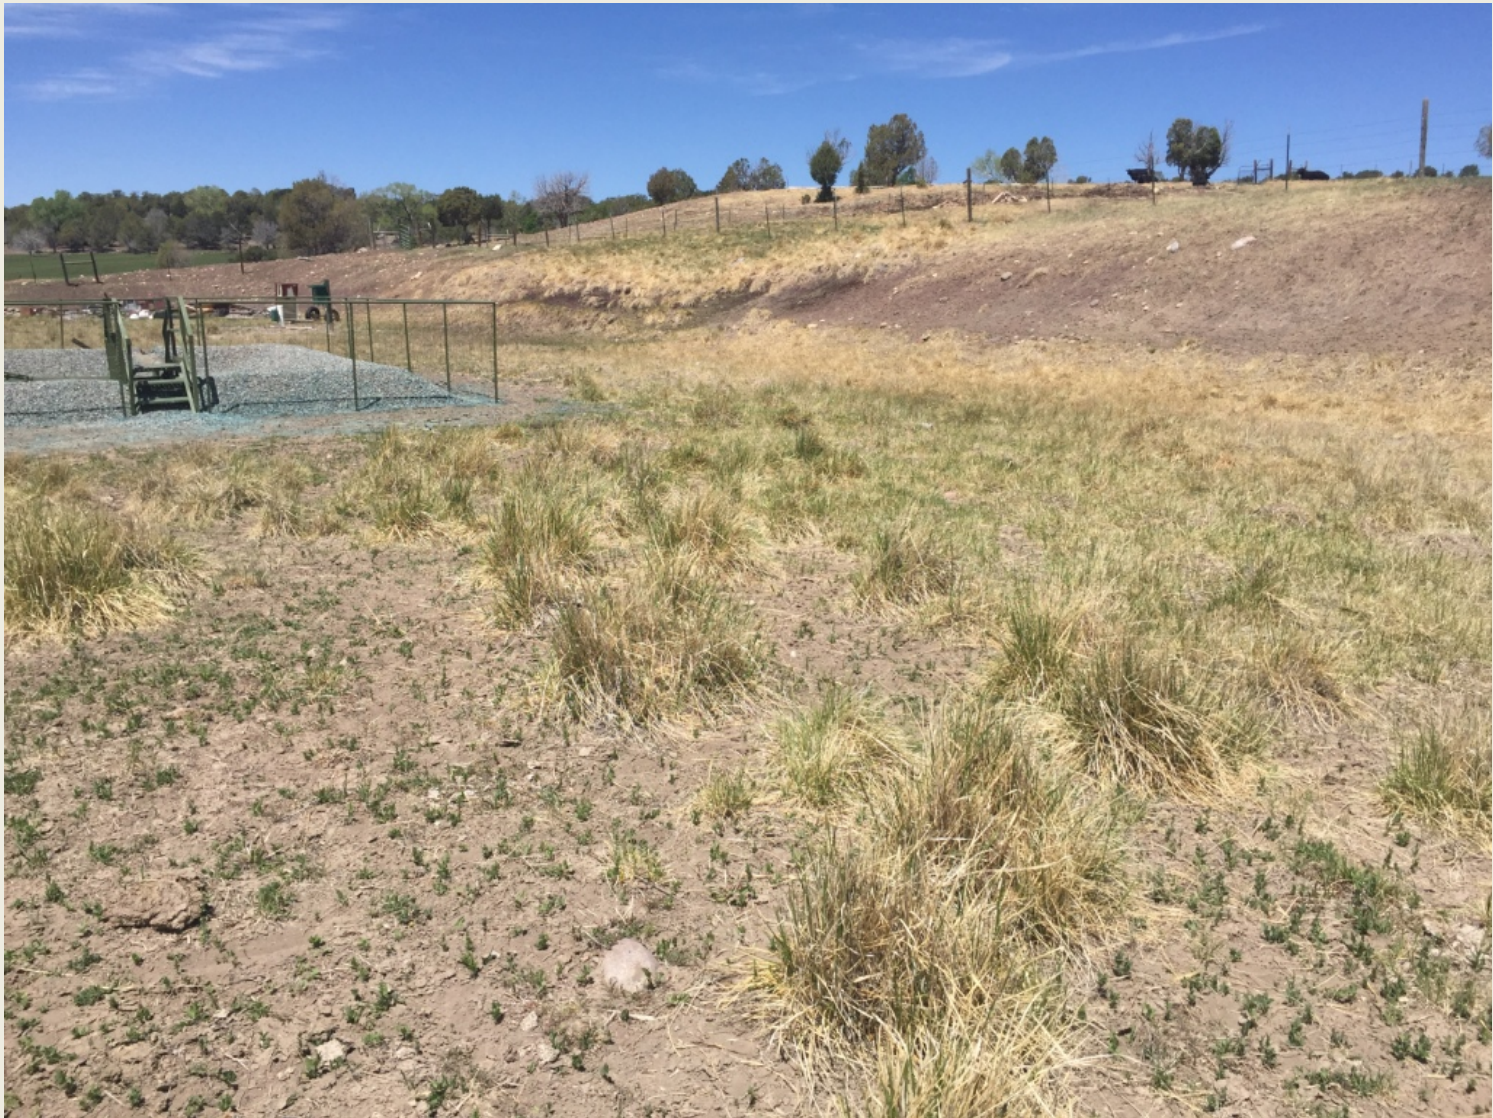
Photo 2. View of the northern portion of the project area from the northeastern corner facing westward. Revegetation is progressing on flat areas, largely with grasses such as western wheatgrass (*Pascopyrum smithii*), intermediate wheatgrass (*Thinopyron intermedium*), and crested wheatgrass (*Agropyron cristatum*). Vegetation on cut-slope is sparse and needs monitoring and revegetation if cover is not increasing.

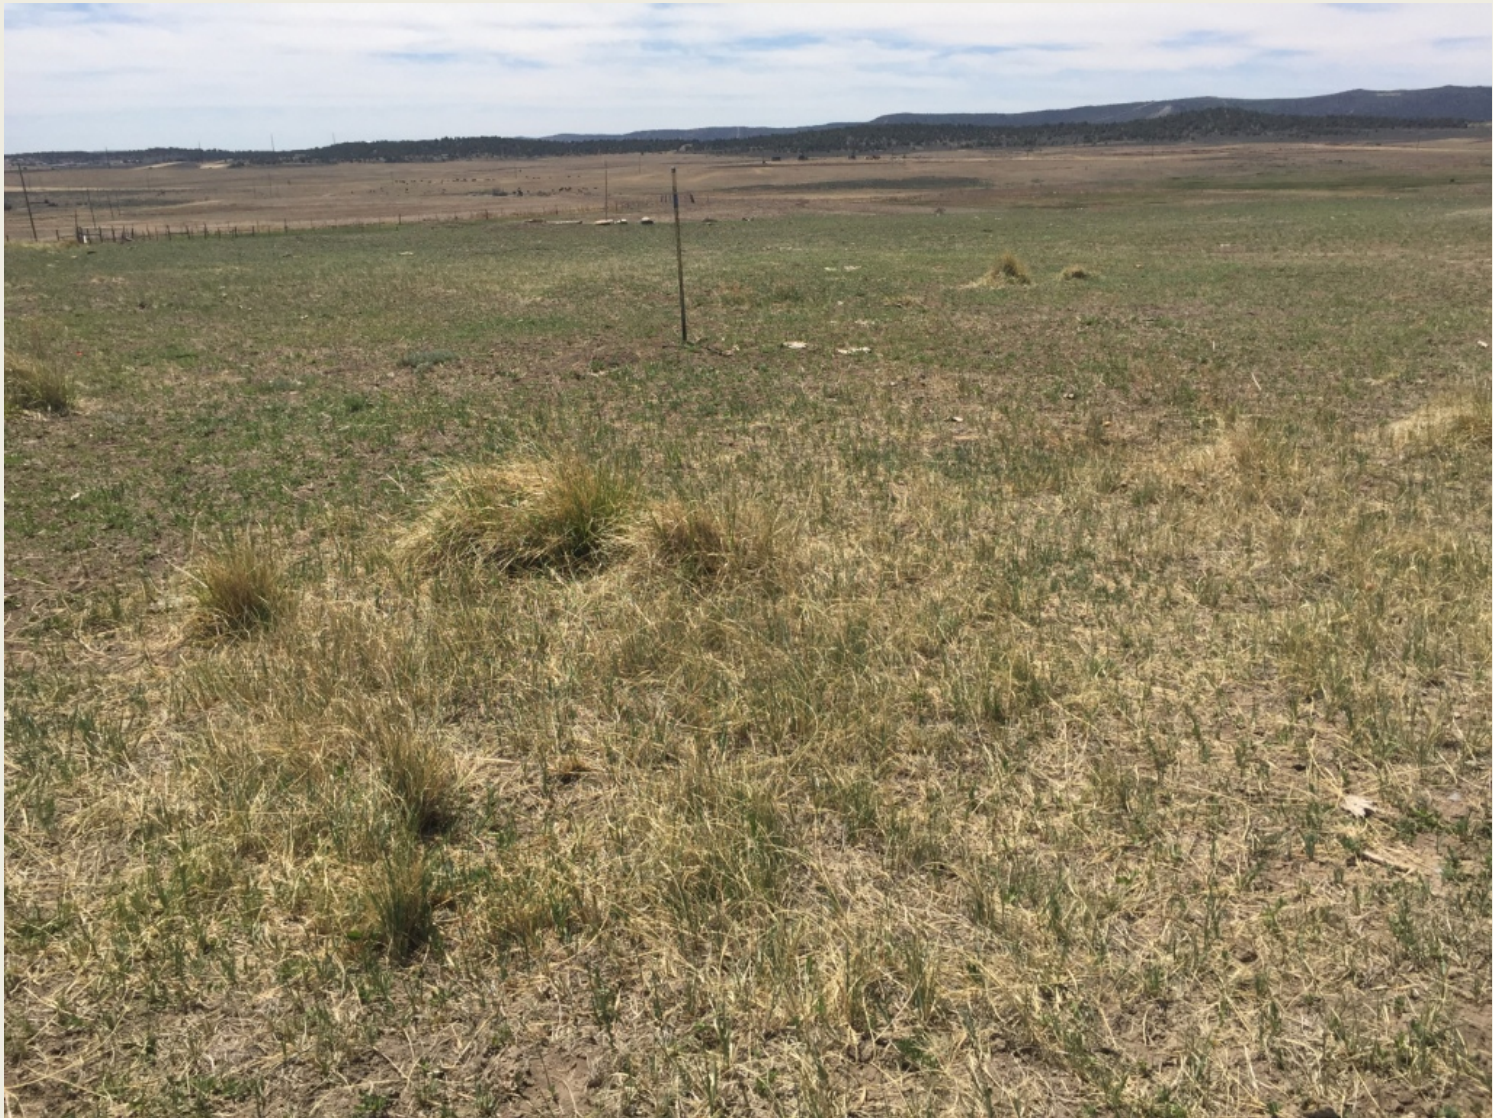
Photo 3. View of the eastern portion of the project area from the northeastern project area facing southward.

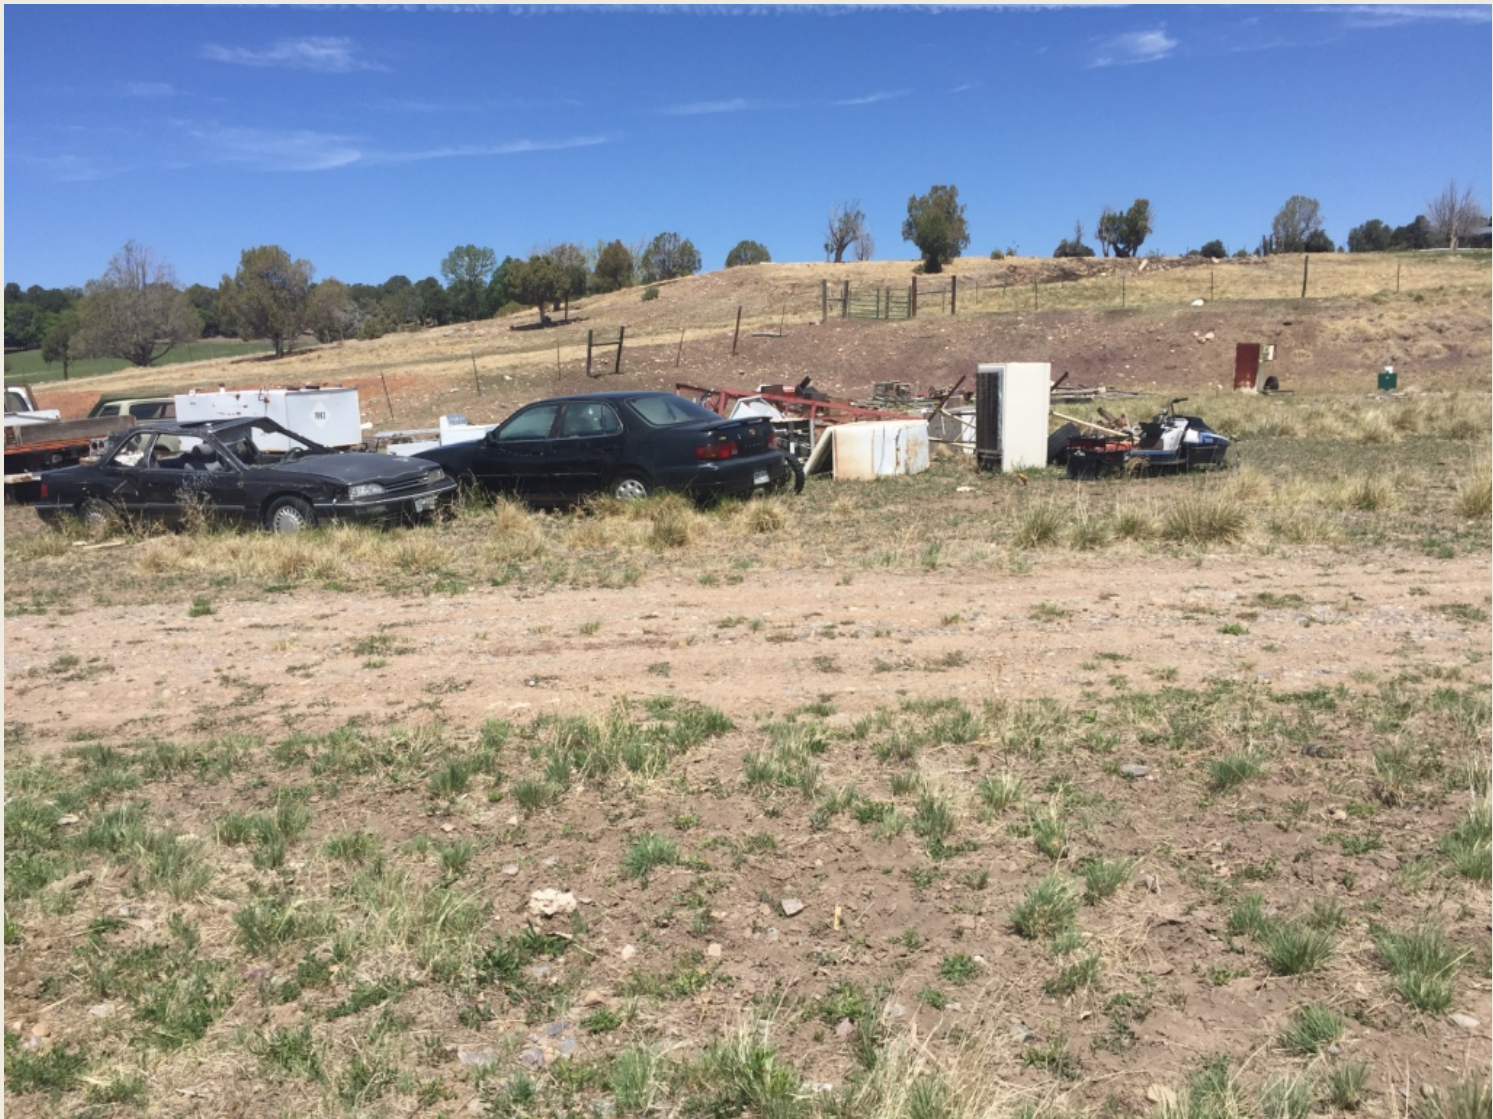
Photo 4. View of the northwestern portion of the project area, facing northward. What appears to be surface owner junk and debris is stored here and needs to be removed.

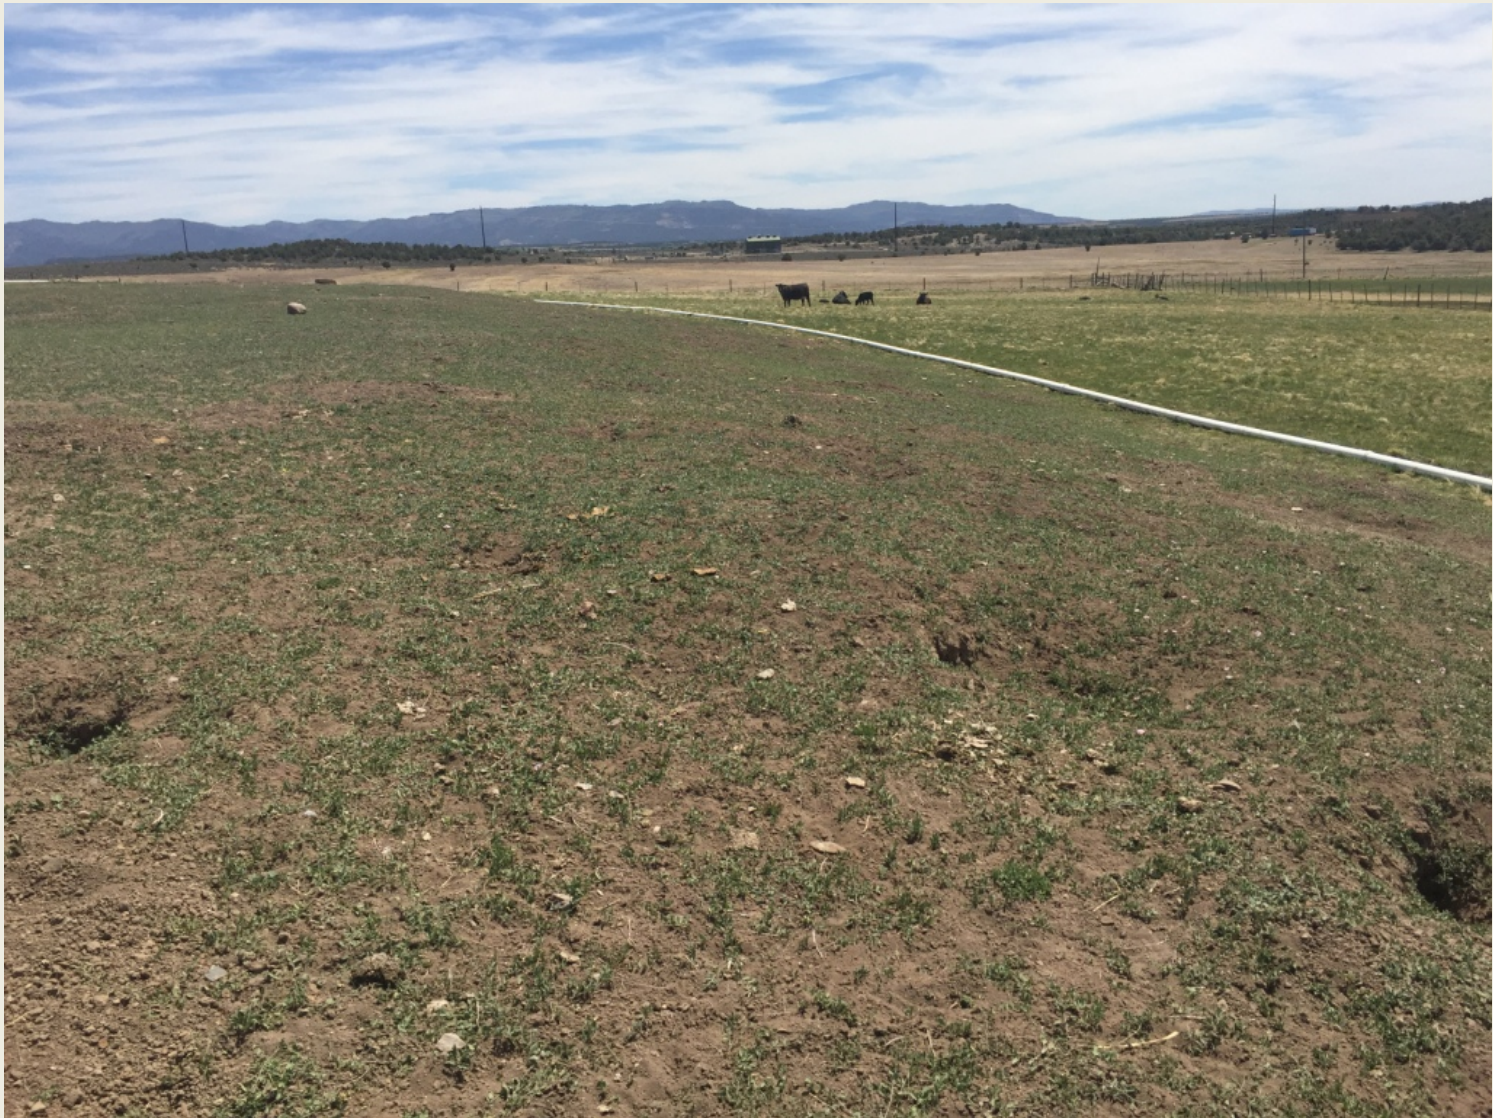
Photo 5. View of the southern portion of the project area from the southwestern edge facing eastward.
