Inspection Photos
Location Name: Javernick 1 DM
API: 05-043-40080
Inspection Number: 685200497

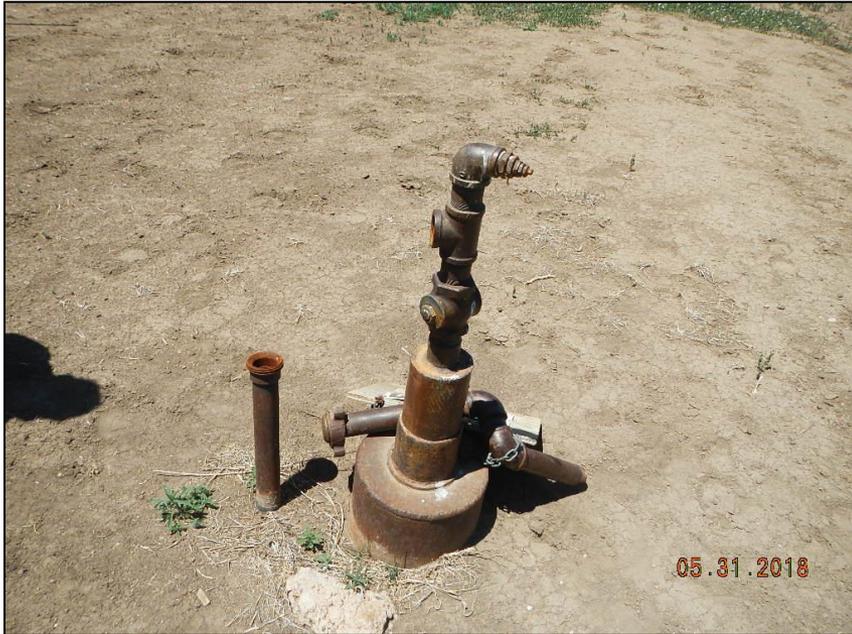
Wellhead and wedge valve with disconnected flowline segment and flowline riser

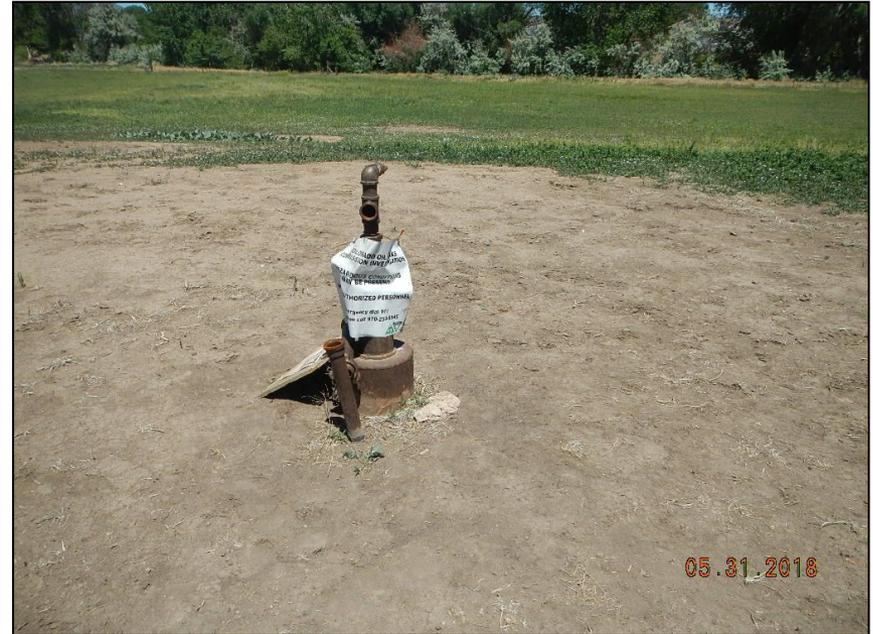
Wellhead with COGCC investigation sign installed, note circular area void of vegetation around well

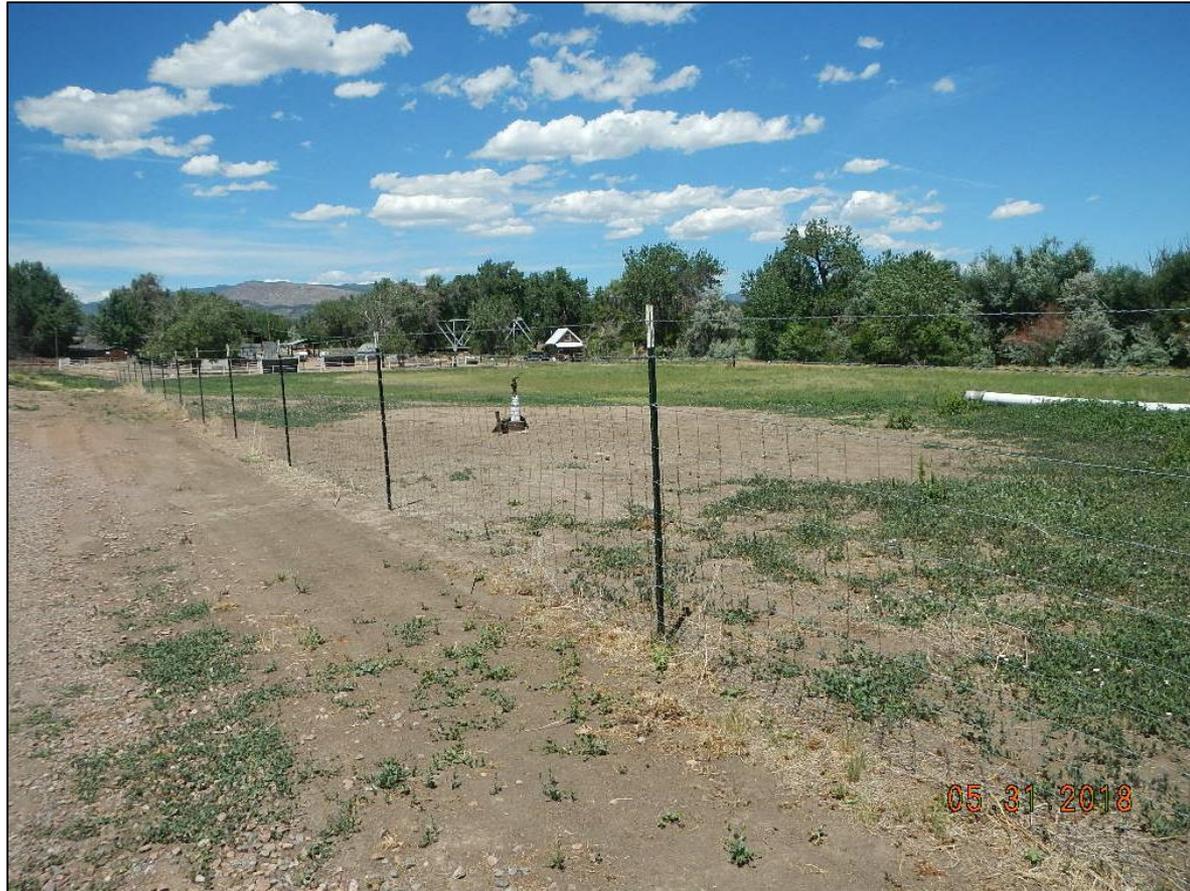
Wellhead and around without vegetation, fence is approximate to Google parcel boundaries.

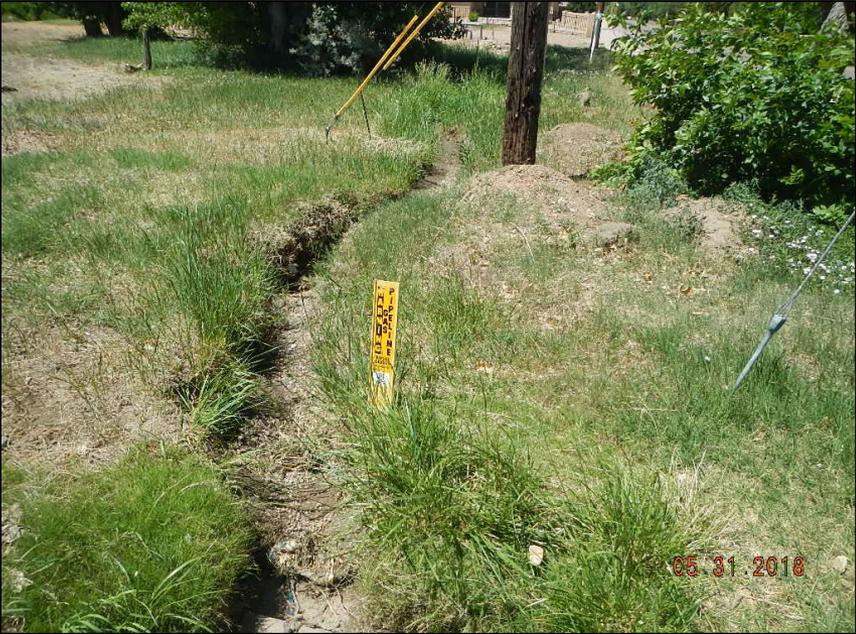
Flwline path going north

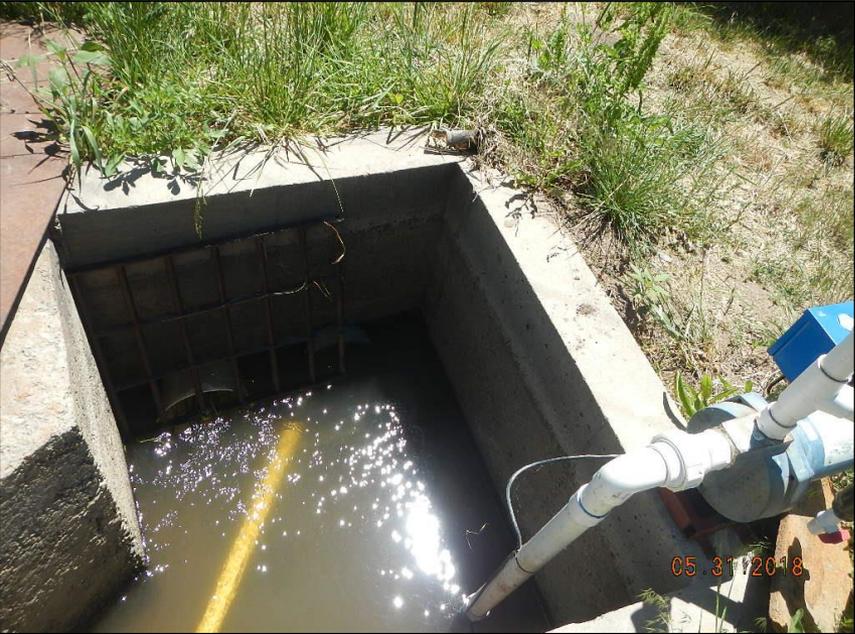
Flwline appears to be routed with irrigation system in places

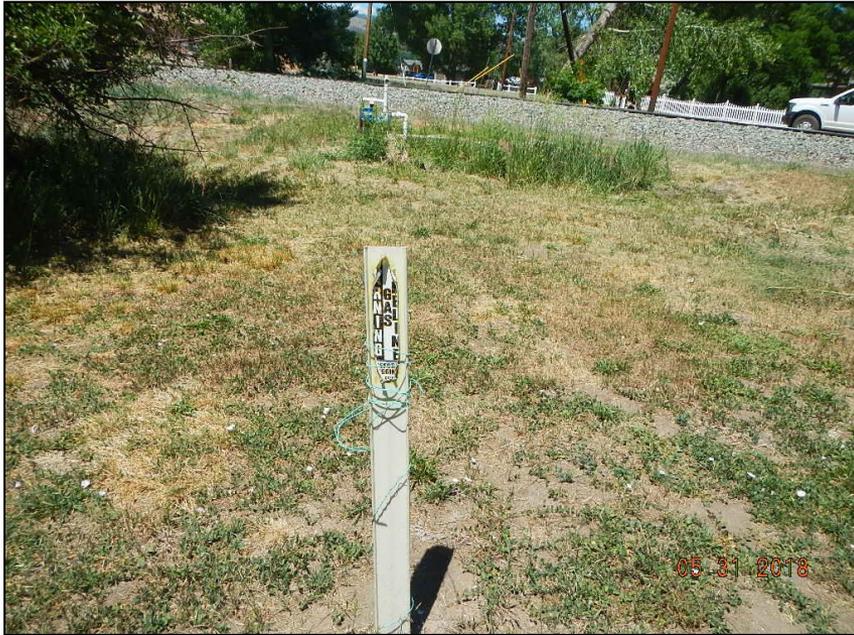
Inadequate flowline marker as line goes north under RR tracks

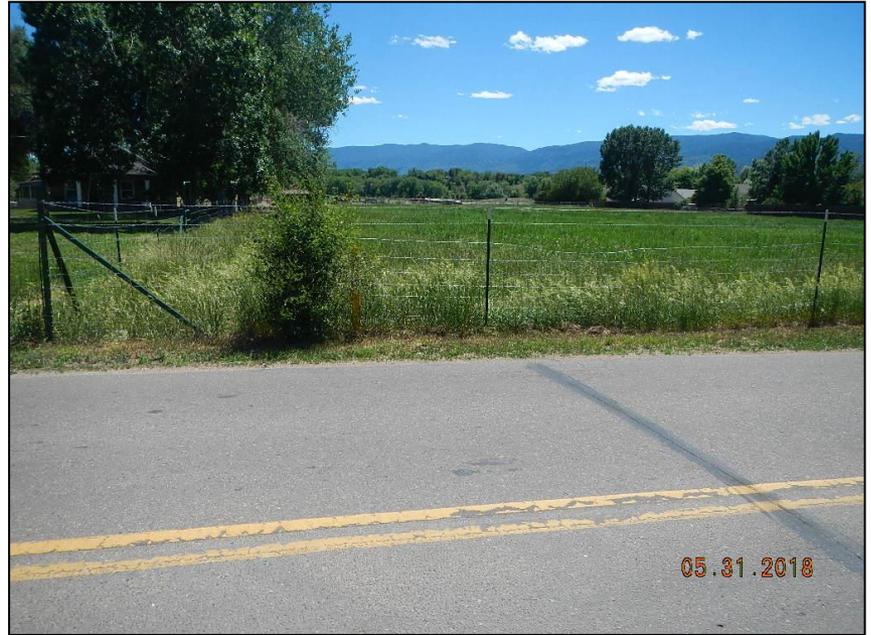
Marker before roadway

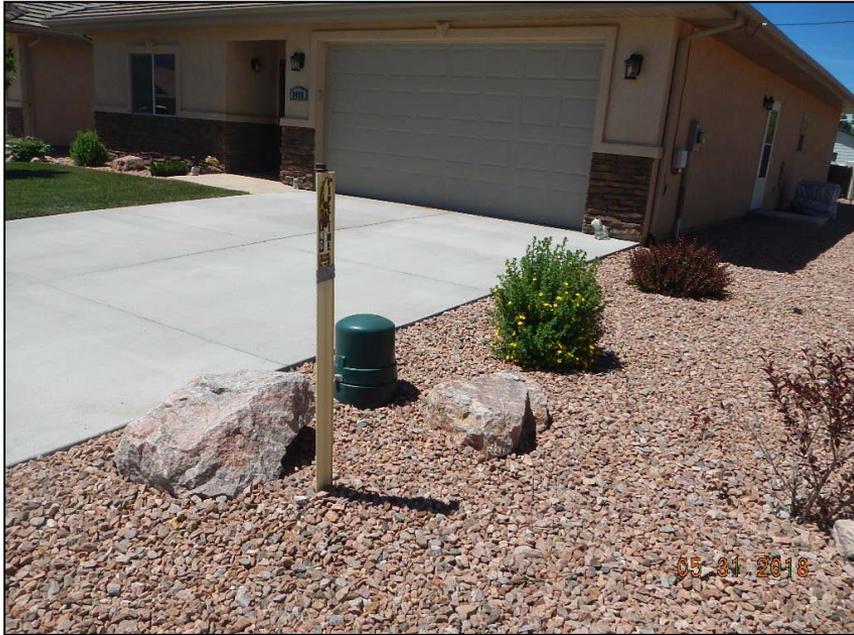
Inadequate flowline marker as line goes through property and near home

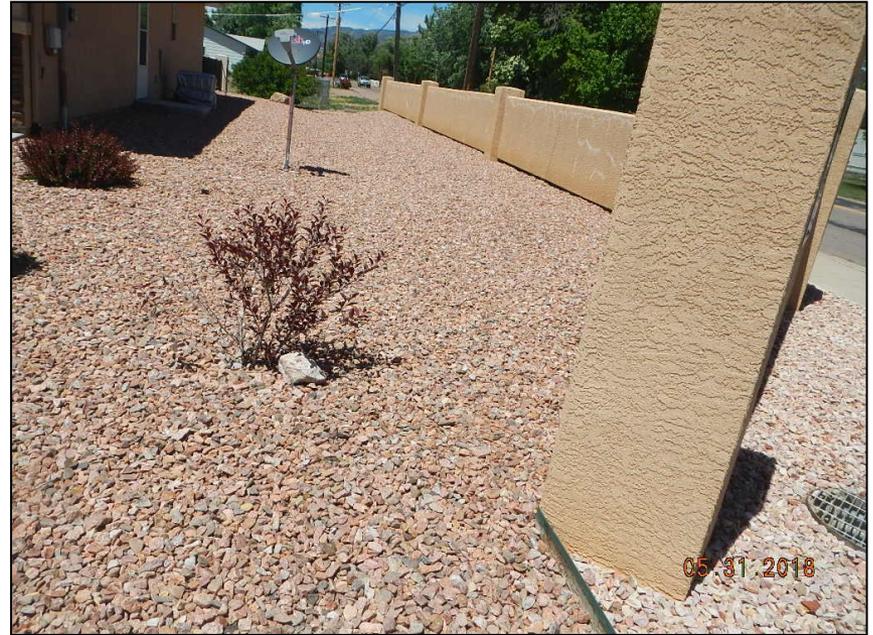
Flowline path

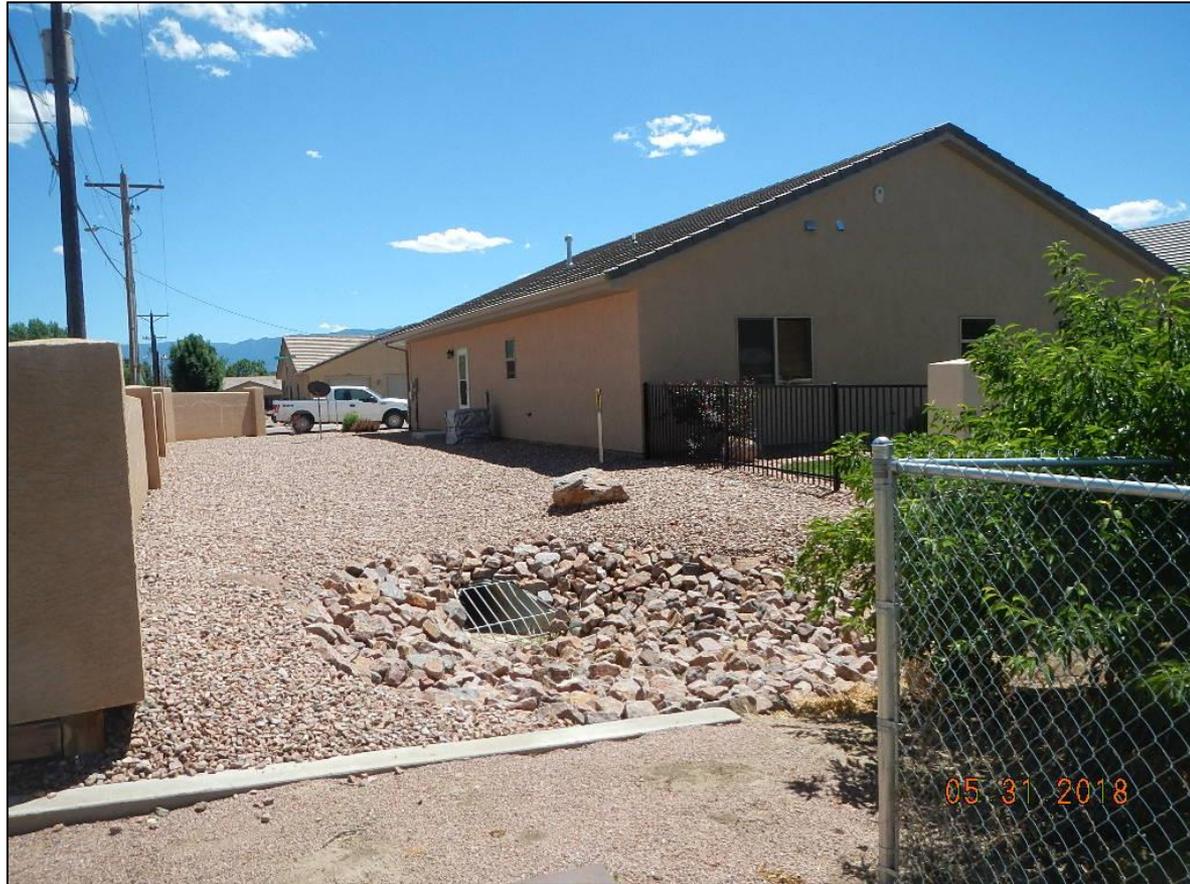
Flowline path coming from south before going across Steinmeier to residence where gas was used in past.
