Well Name : Jacques 2

API # : 067-06292

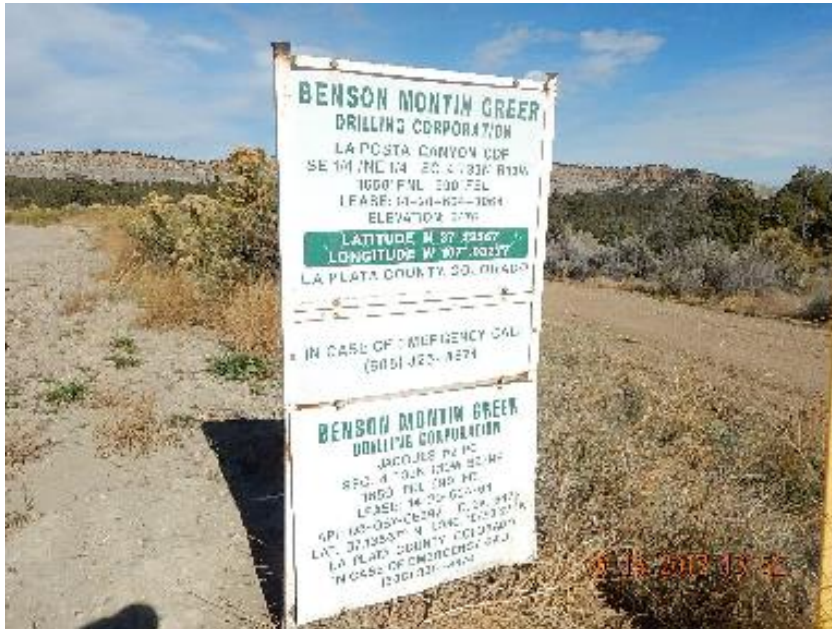
Photo 1: Wellhead sign previous inspection.

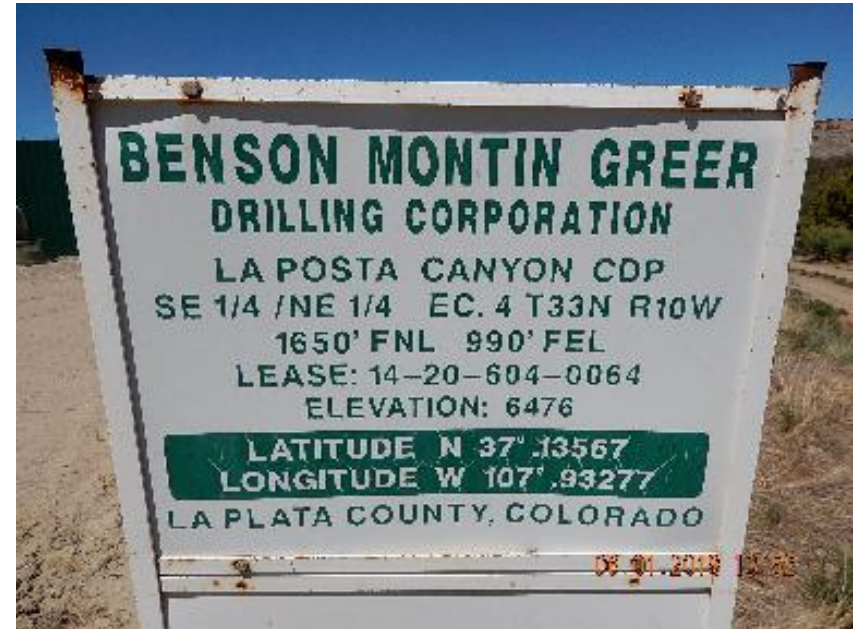
Photo 2: Wellhead sign.

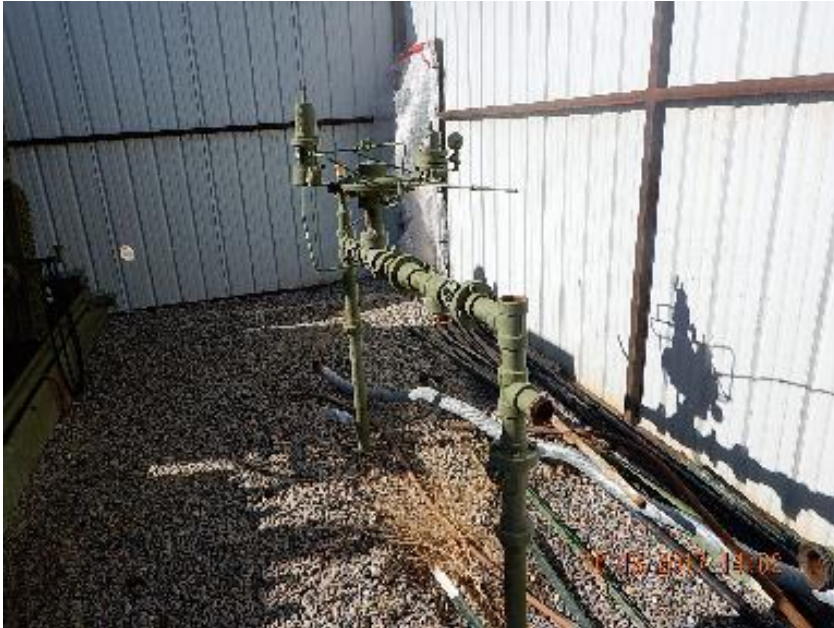
Photo 3: Unused riser with open ended pipe previous inspection.

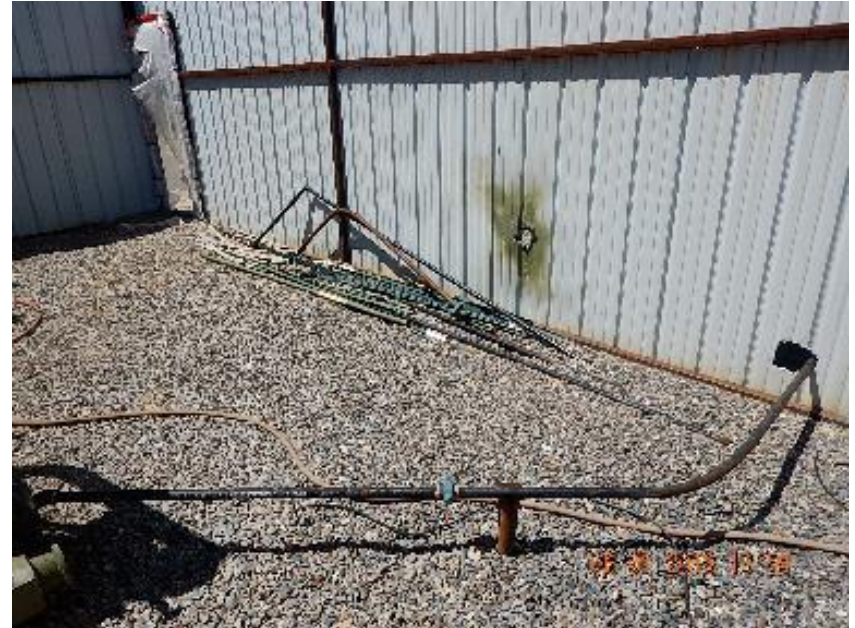
Photo 4: Unused riser removed.

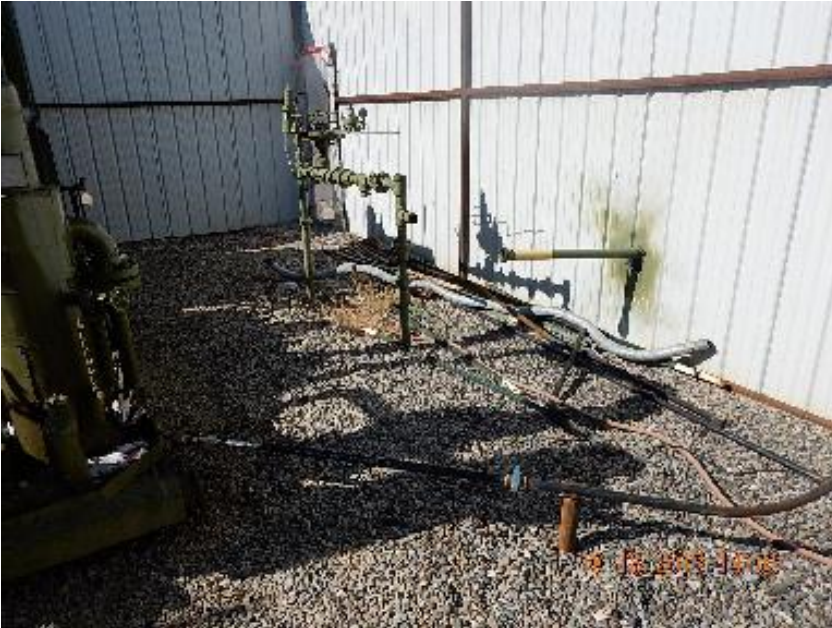
Photo 5: Unused riser, fence post, and hose previous inspection.

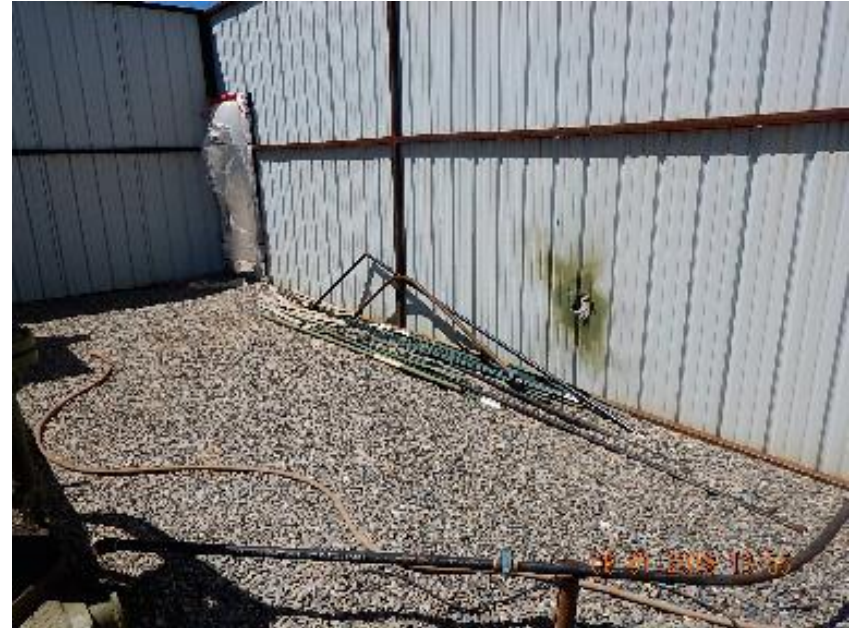
Photo 6: Fence post and pipe.

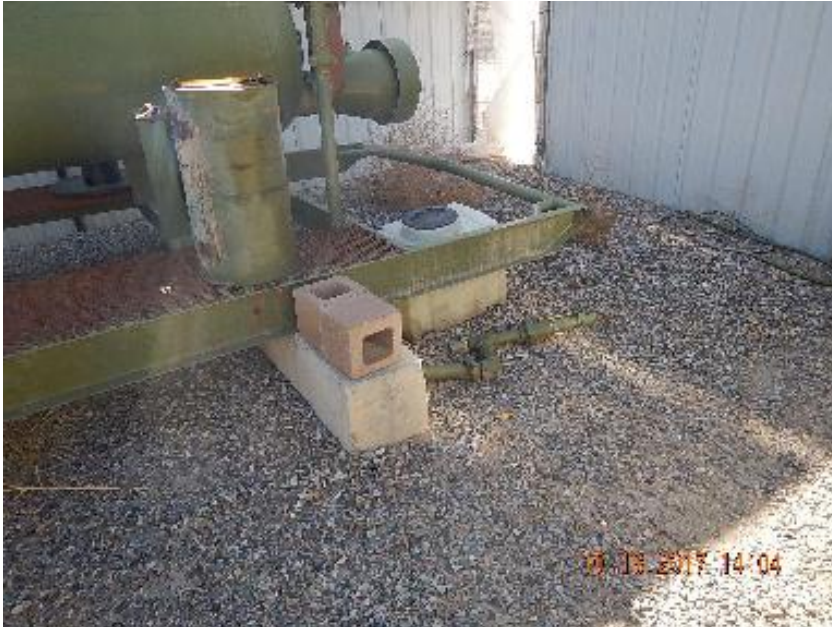
Photo 7: Disconnected pipe and knock out previous inspection.

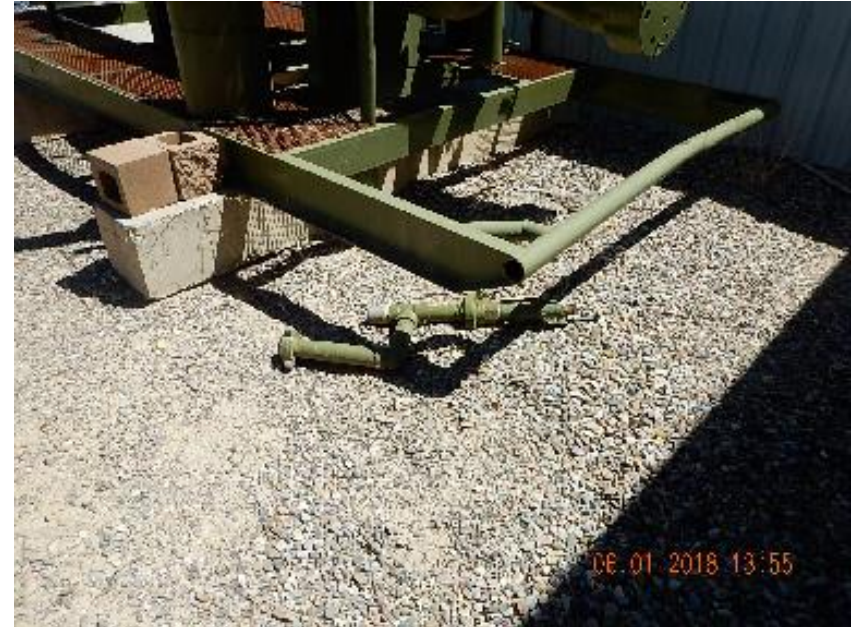
Photo 8: Disconnected pipe, concrete blocks, and knock out.

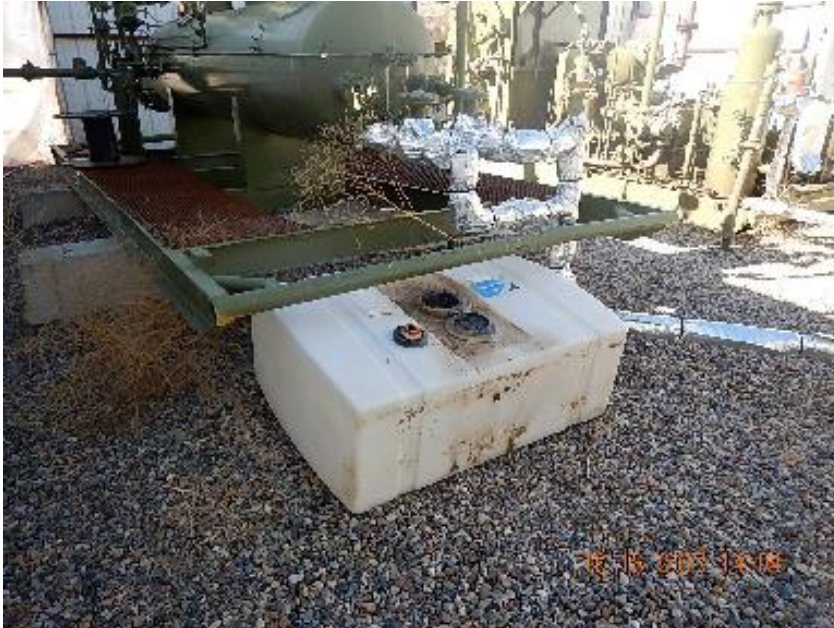
Photo 9: Tank and plastic spool previous inspection.

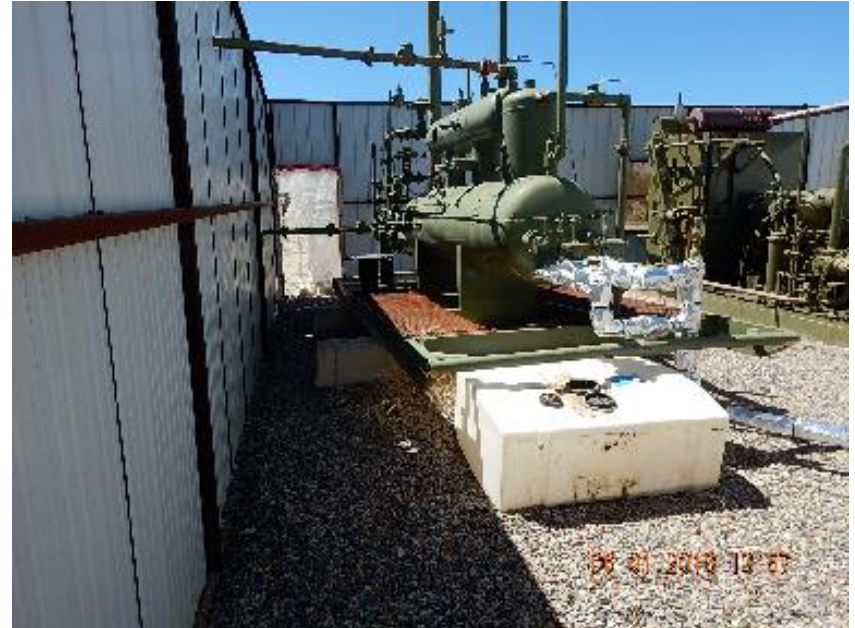
Photo 10: Tank and plastic spool.

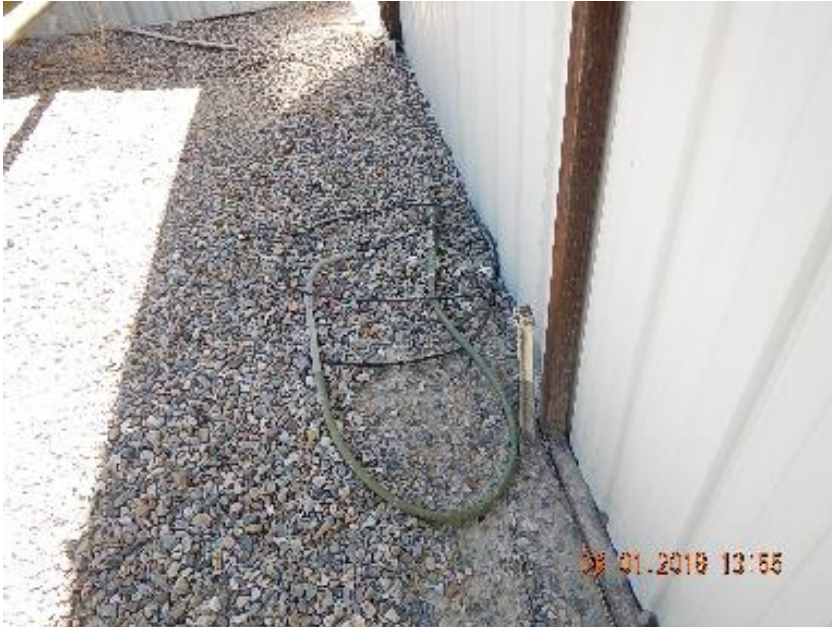
Photo 11: Conduit and wire.

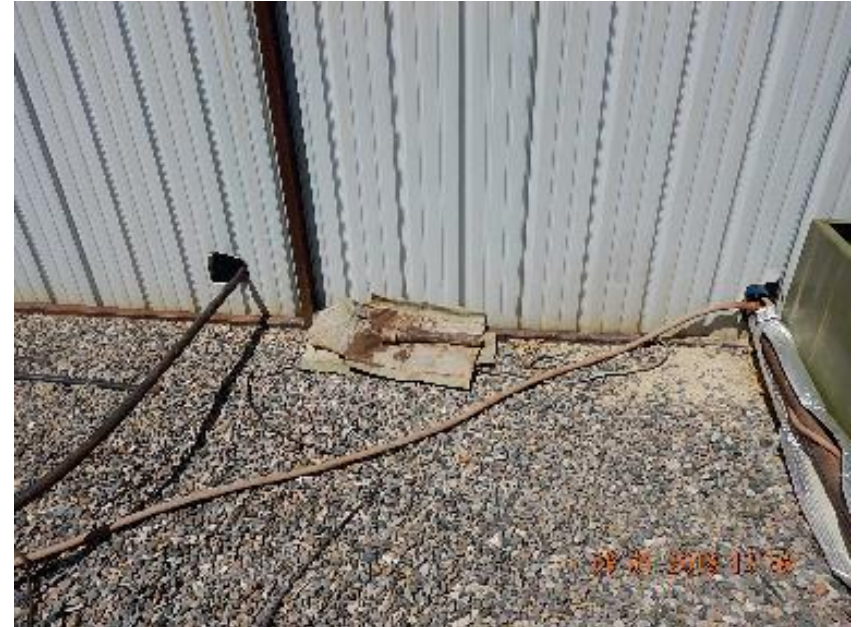
Photo 12: Pipe and debris.

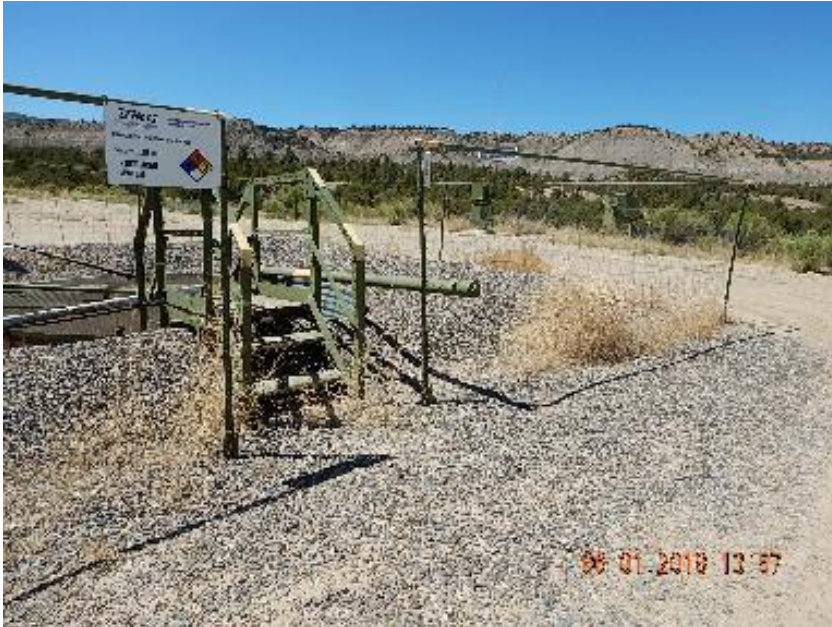
Photo 13: Weed debris in pit fencing.

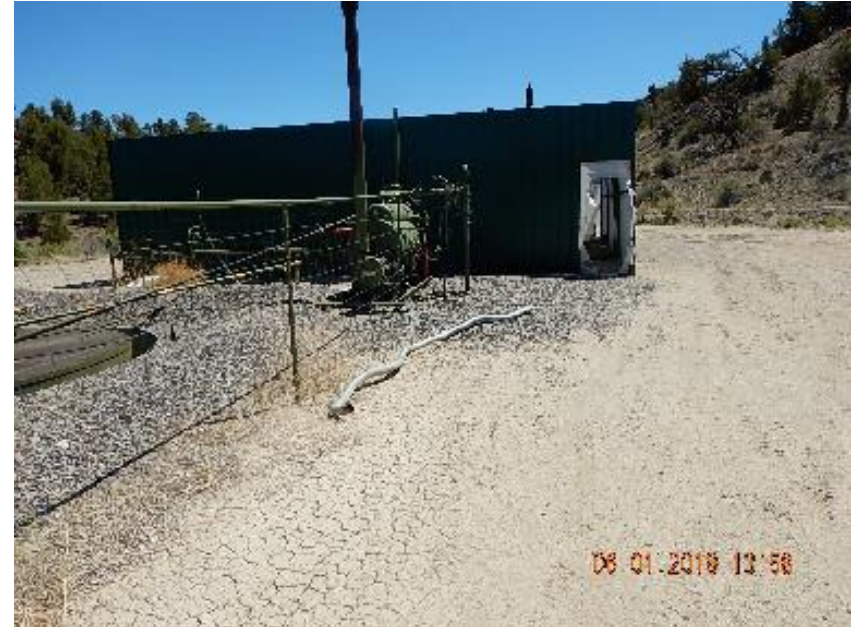
Photo 14: Metal flex hose outside tank fencing.

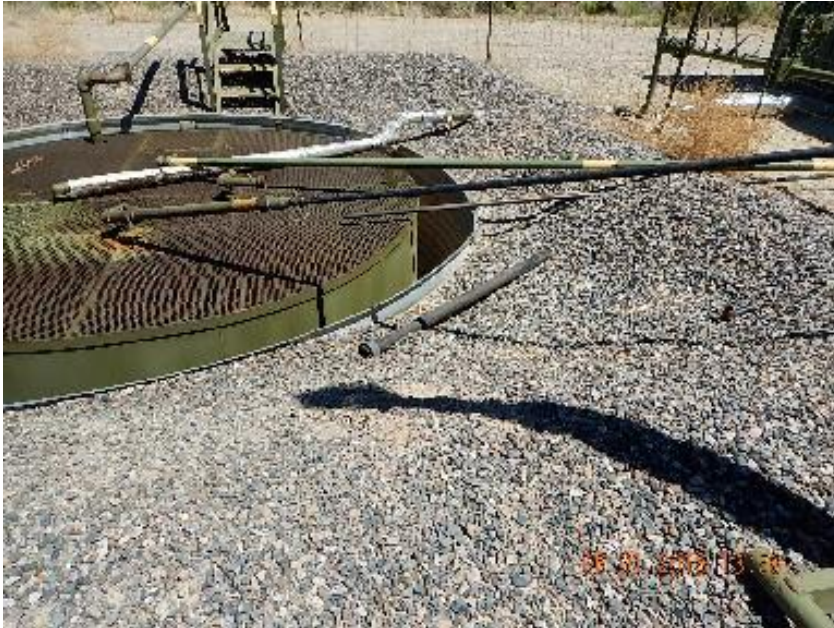
Photo 15: Disconnected pipe inside tank fencing.

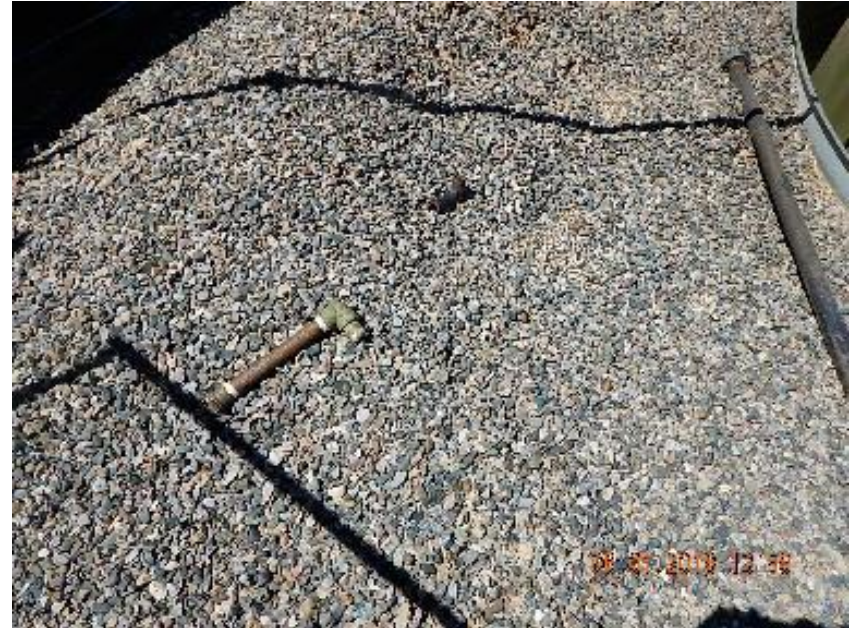
Photo 16: Smaller pipe and fittings inside pit fencing.

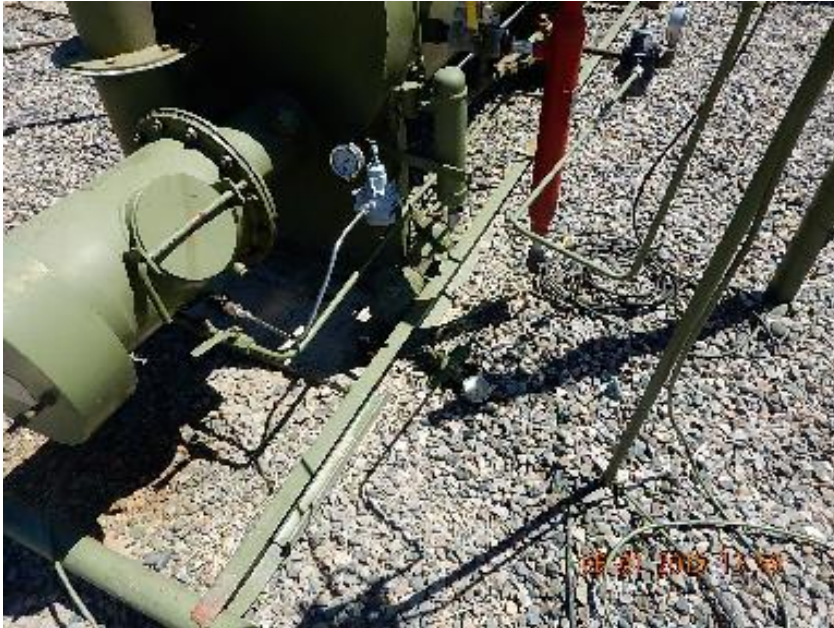
Photo 17: Debris beside separator.

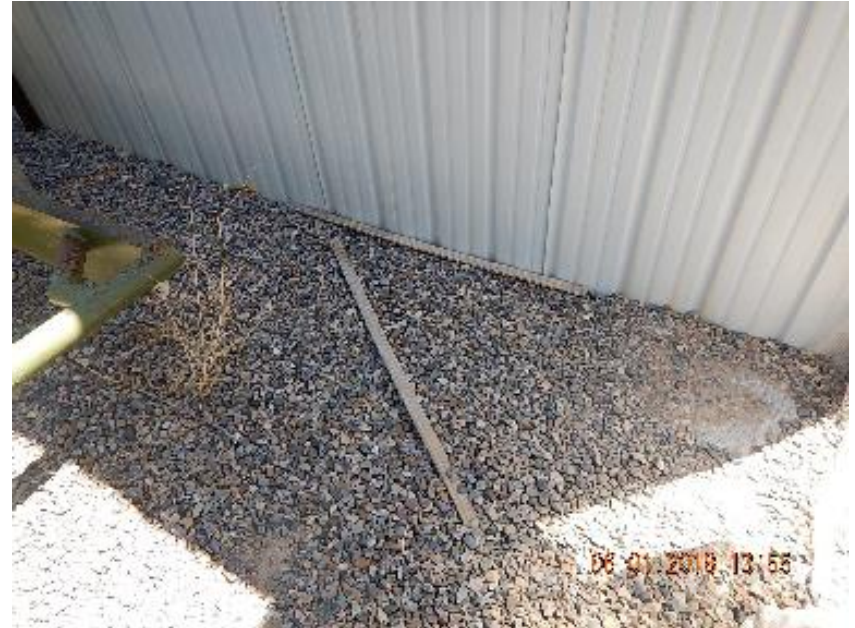
Photo 18: Wood debris inside sound walls.
