# Final Reclamation Inspection

Operator: HOMESTEAD OIL INC - #41050

API: 05-123-10108

Inspection Photos  
Location Name: STATLER #1  
API: 05-123-10108

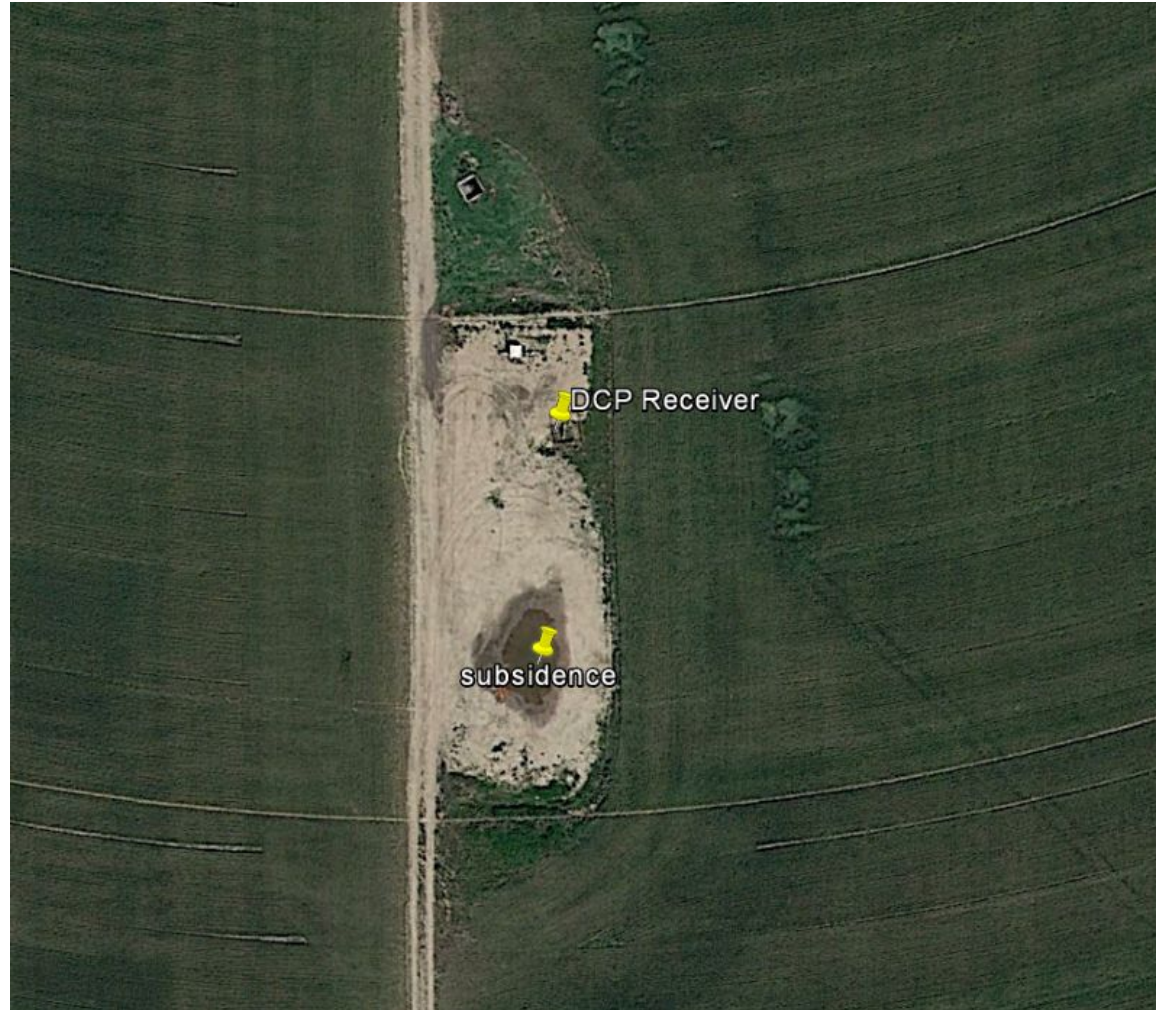
Google Earth aerial imagery taken June 19, 2014 post plugging operations. On June 11, 2018, Staff observed subsidence where a former tank was and a DCP receiver remains at the location.

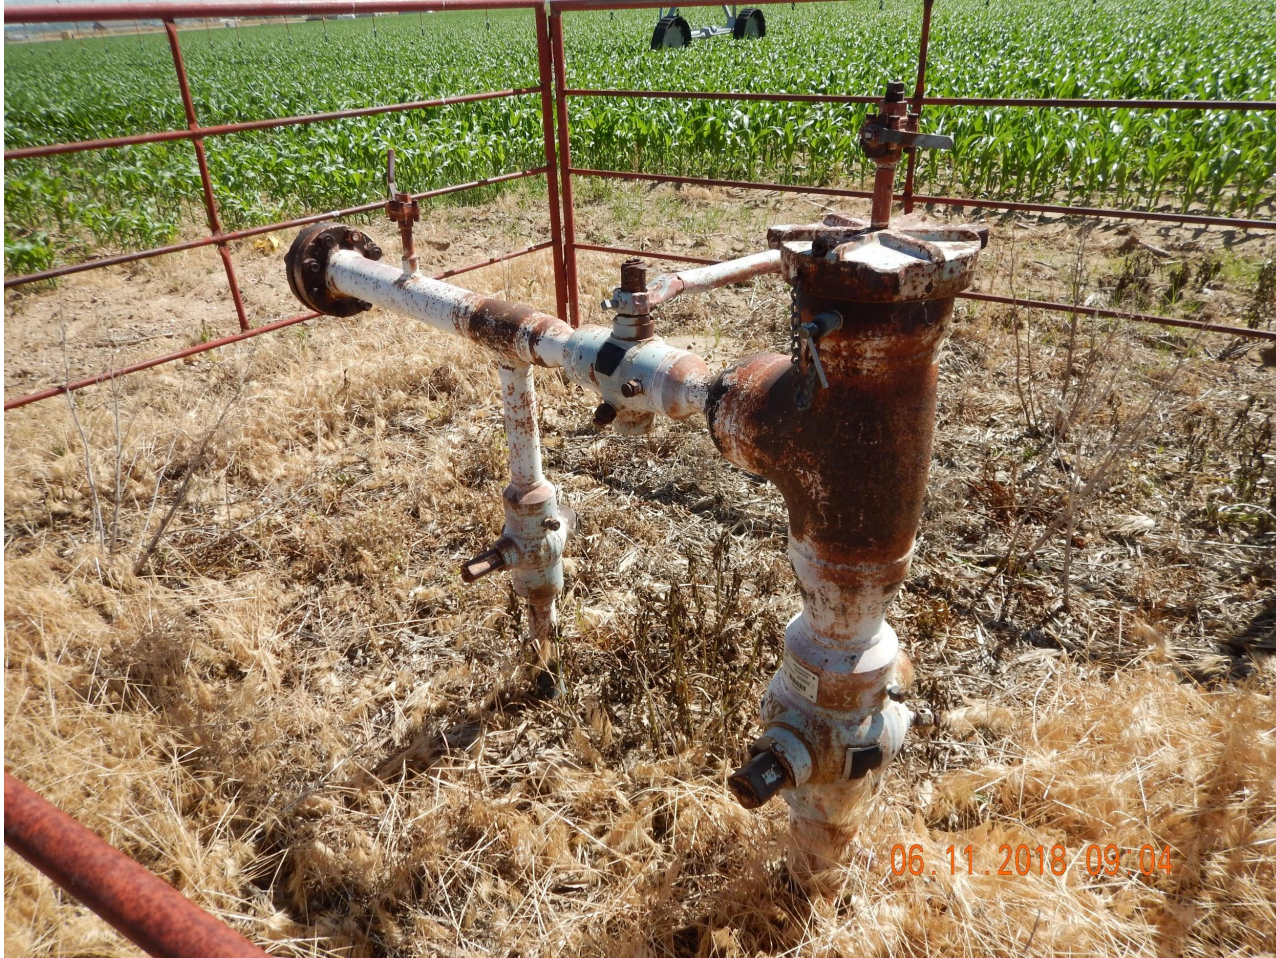
**Photo 1.** Photo taken from the northern battery location. A DCP receiver remains at the location. Operator shall remove all equipment per Rule 1004.a.

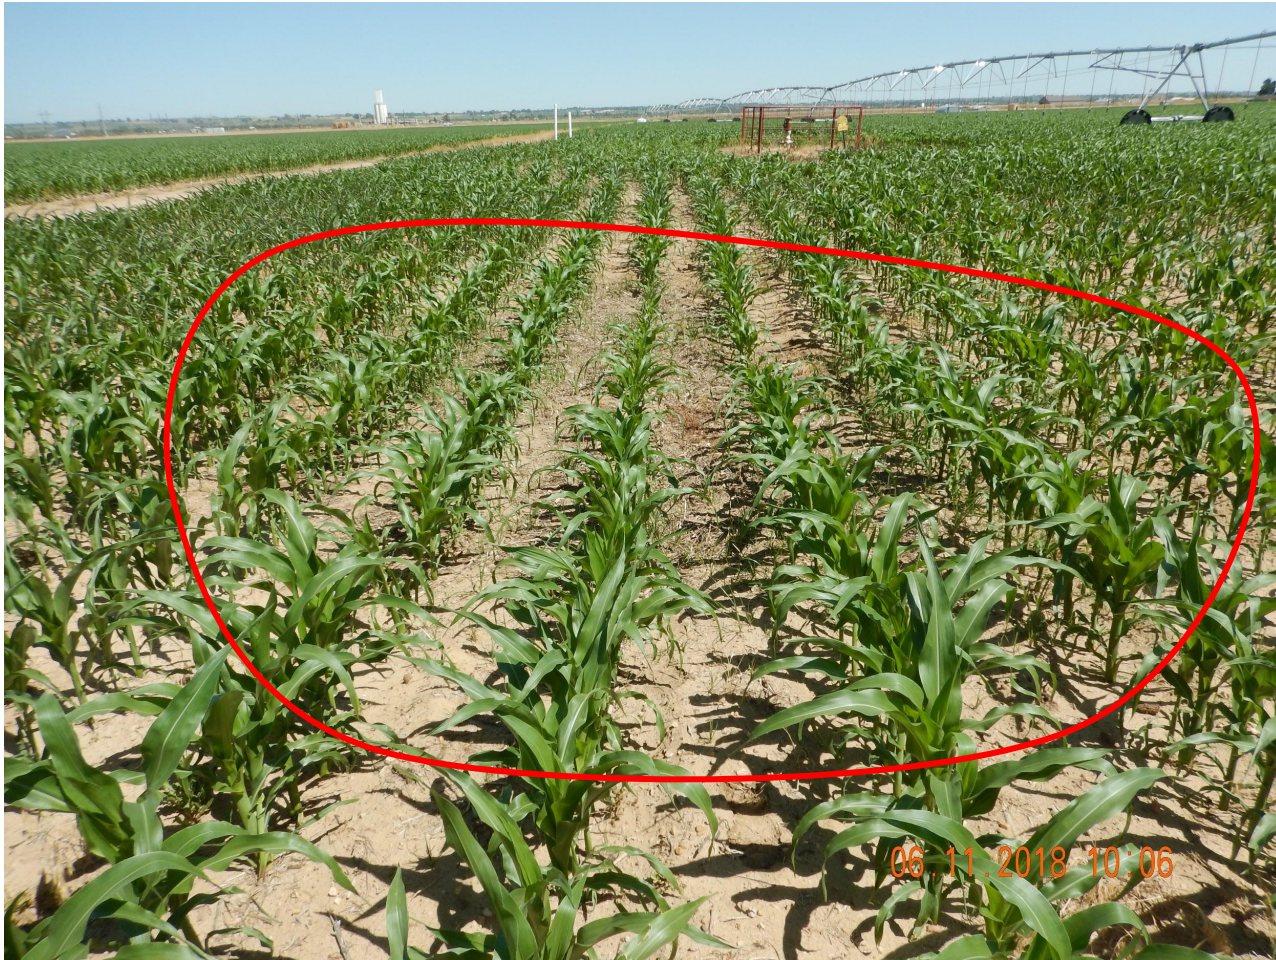
**Photo 2.** Photo taken from the southern battery location. Subsidence was observed where a former tank was located. There shall be no significant unrestored subsidence per Rule 1004.c.(1).

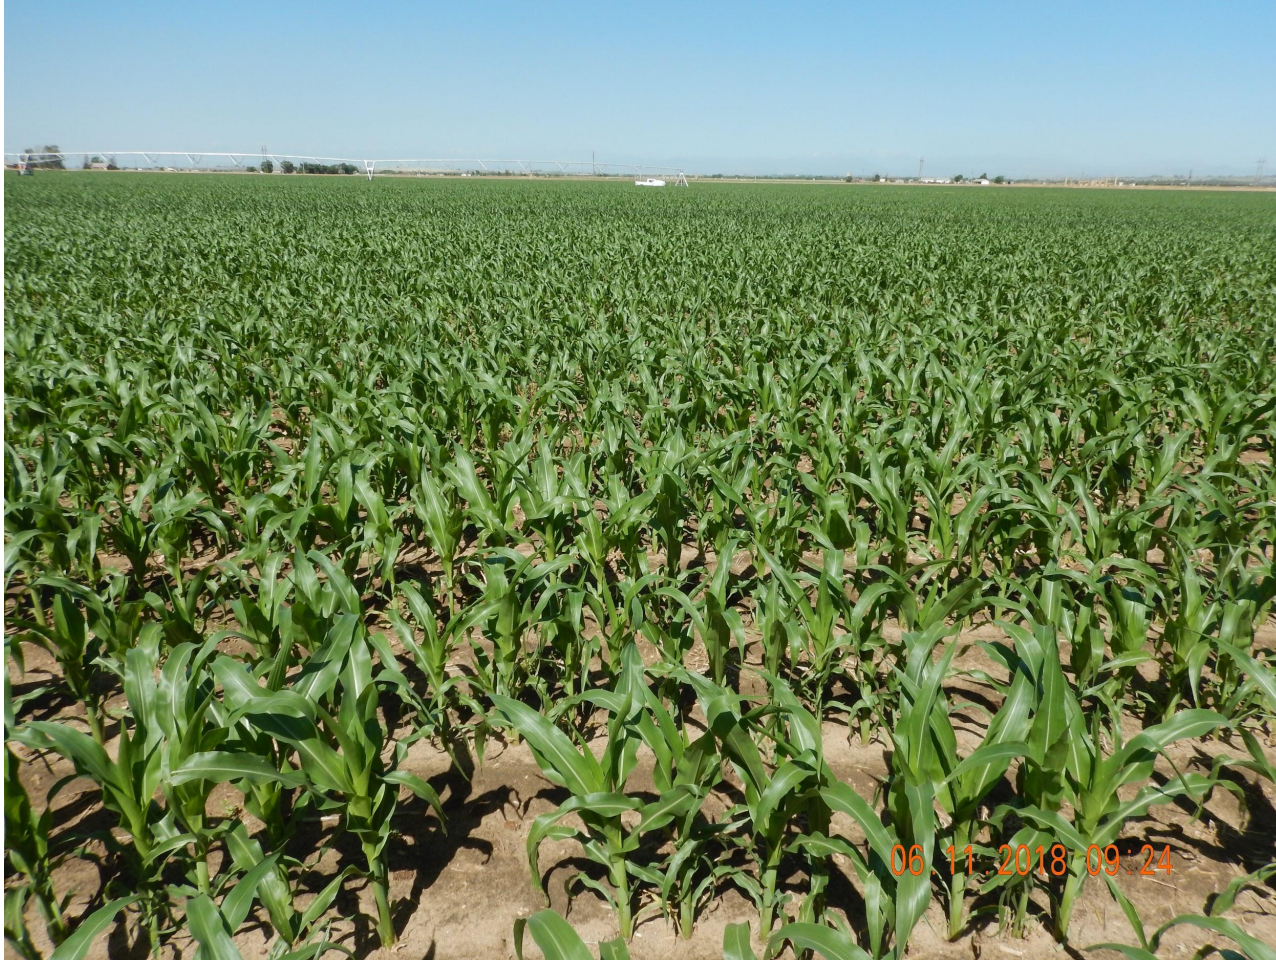
**Photo 3.** Photo taken from the approximate well location, facing West. Well location appears reflective of reference area crop levels.

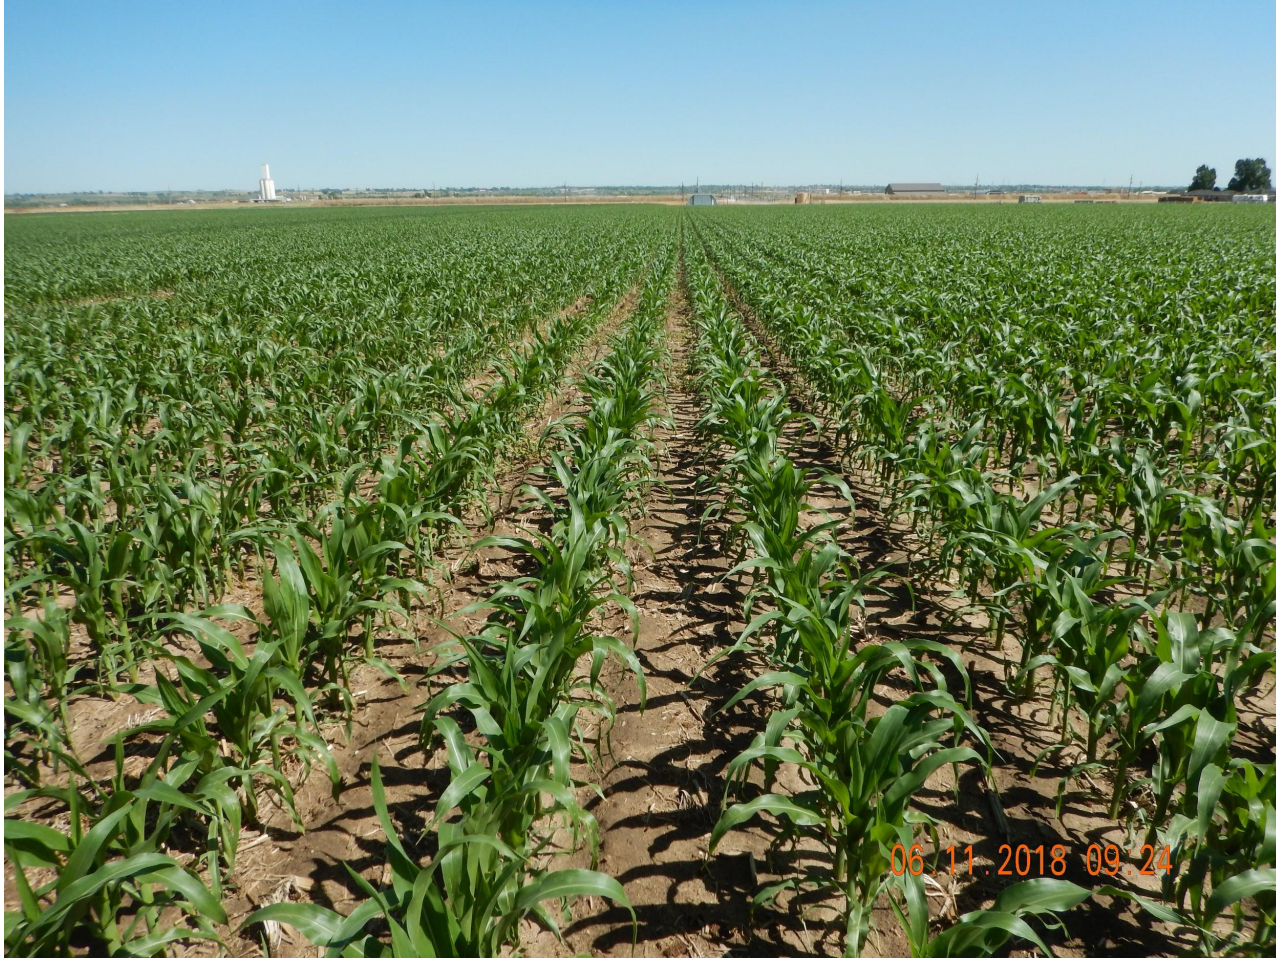
**Photo 4.** Photo taken from the approximate well location, facing North. See comments under Photo 3.

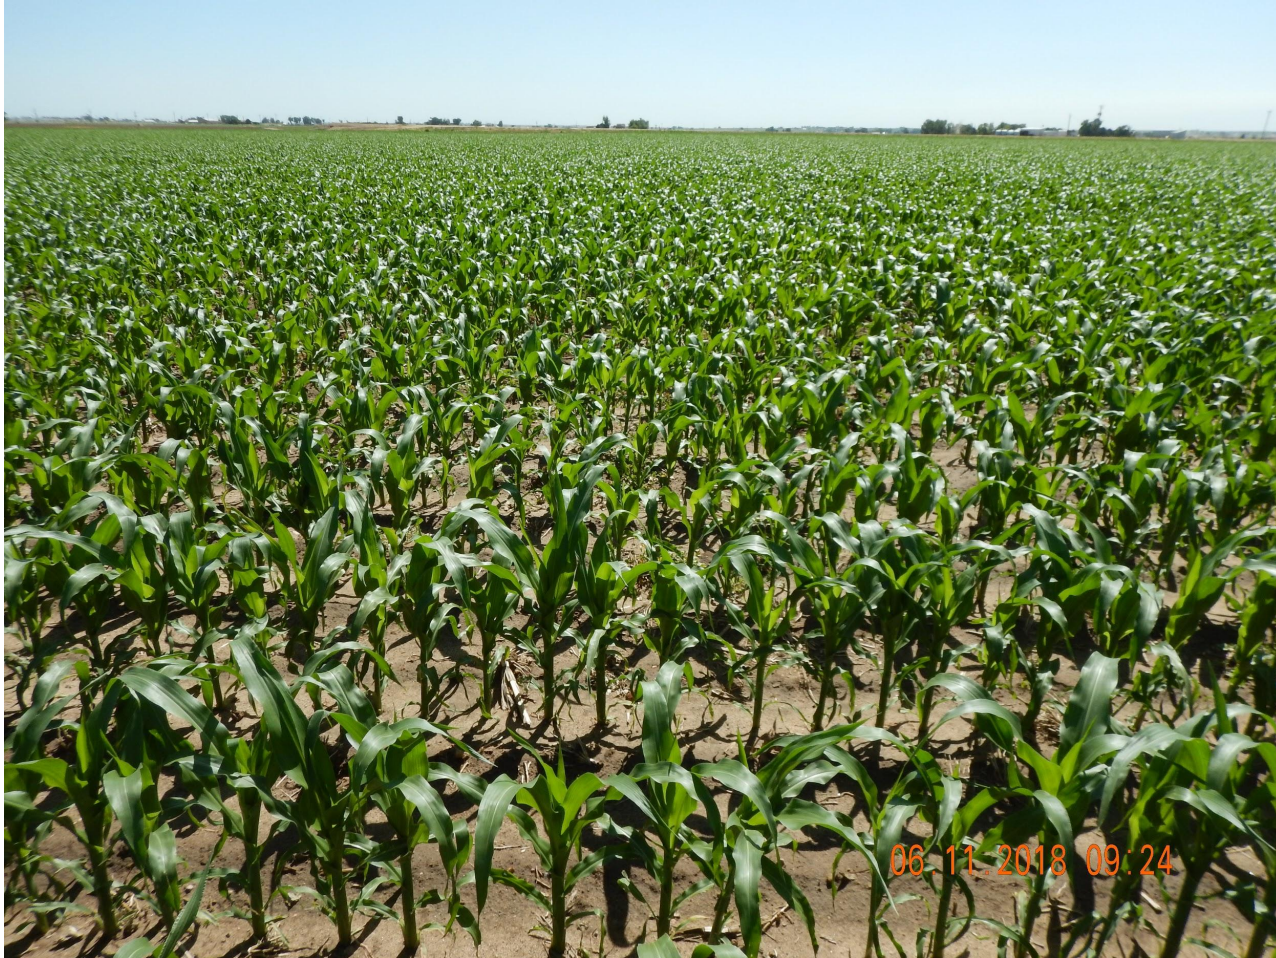
**Photo 5.** Photo taken from the approximate well location, facing East. See comments under Photo 3.

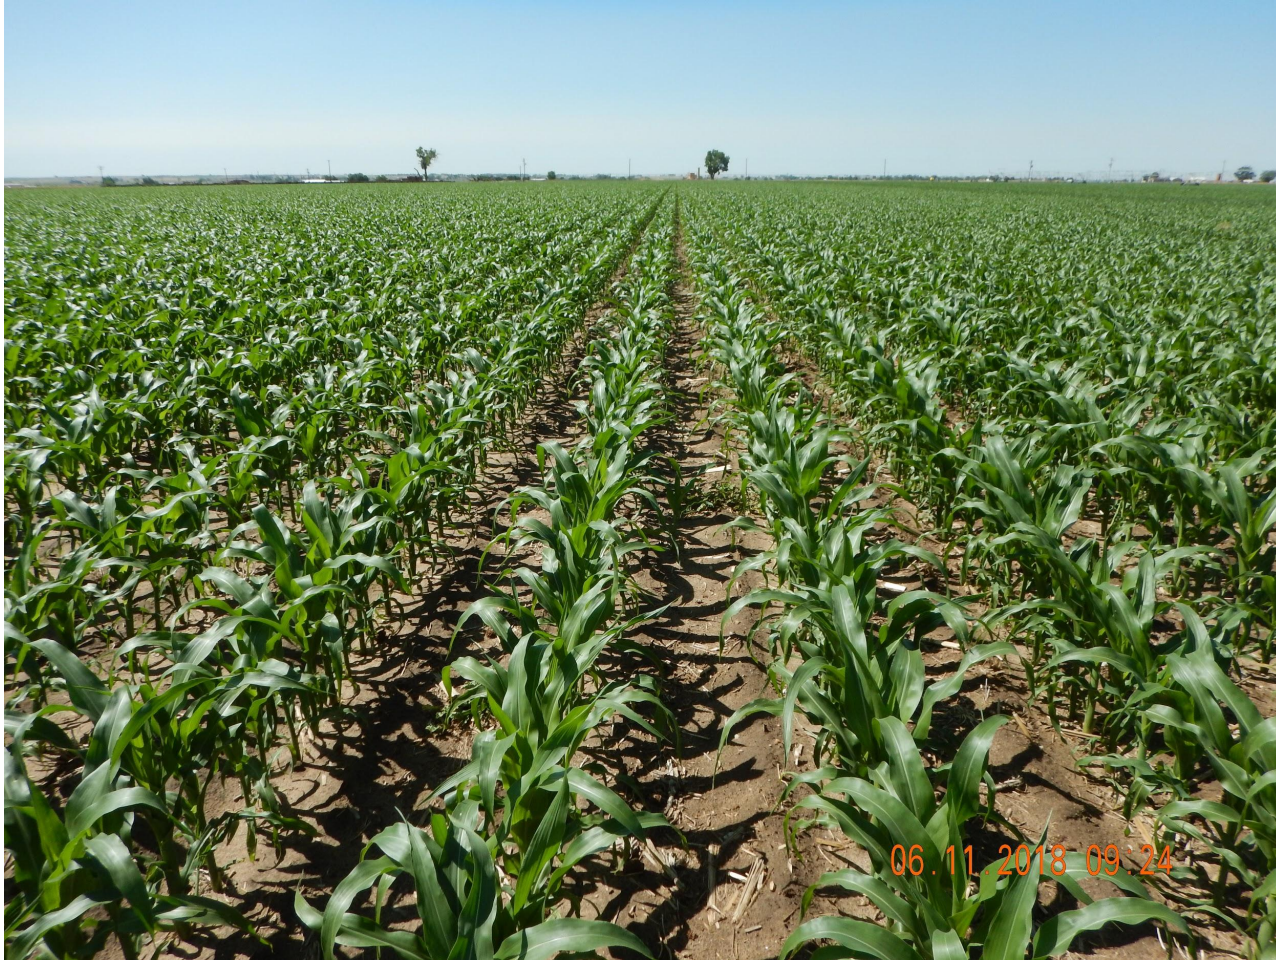
**Photo 6.** Photo taken from the approximate well location, facing South. See comments under Photo 3.

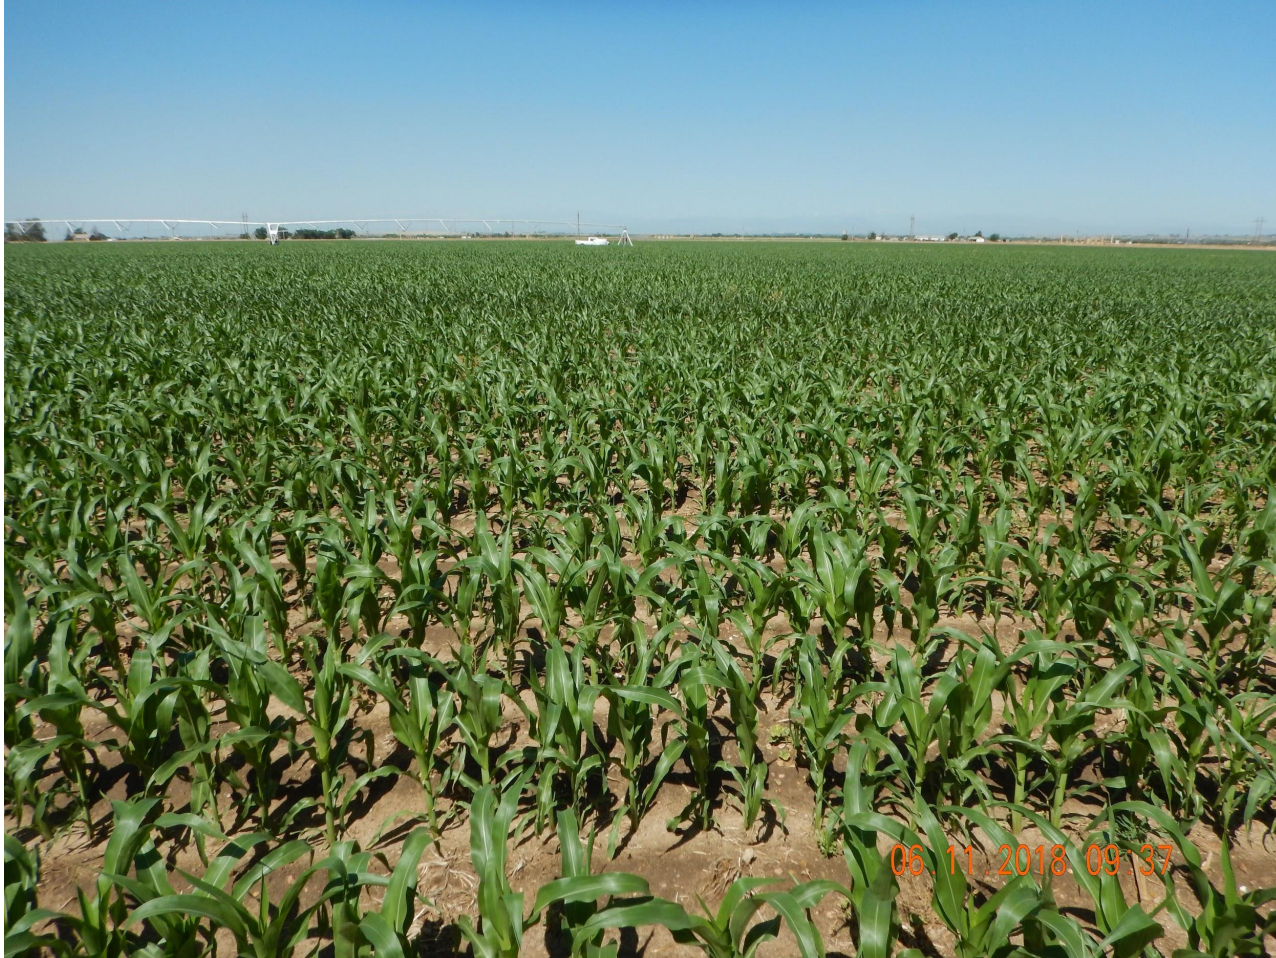
**Photo 7.** Photo taken along a portion of the access road, facing West. See comments under Photo 3.

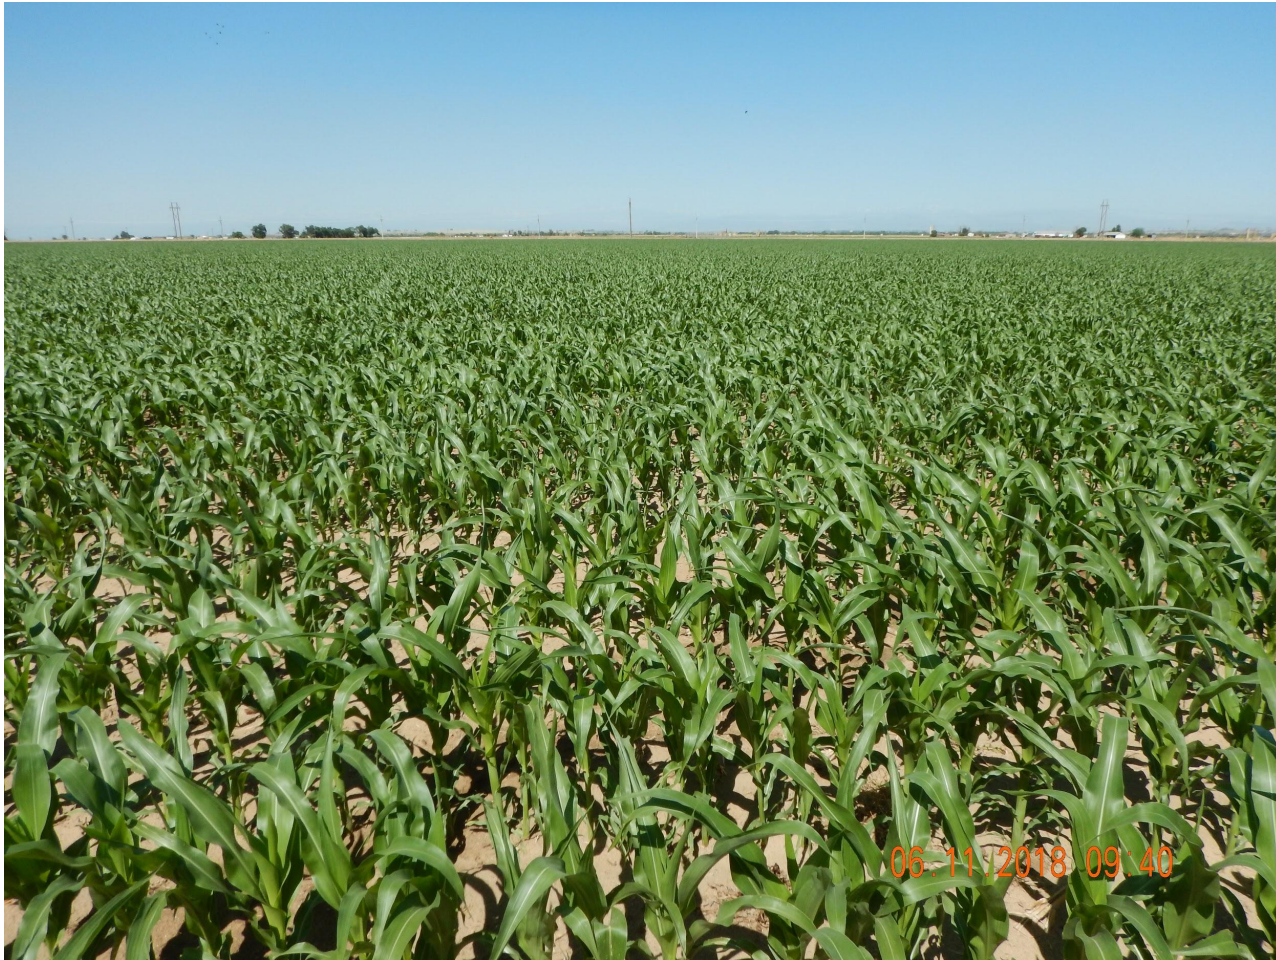
**Photo 8.** Reference photo taken west of the well and access road, facing West. Well location and access road appear reflective of reference area crop levels.
