Inspection Photos
Location Name: Lilli Unit #16-1
Location ID: 326966

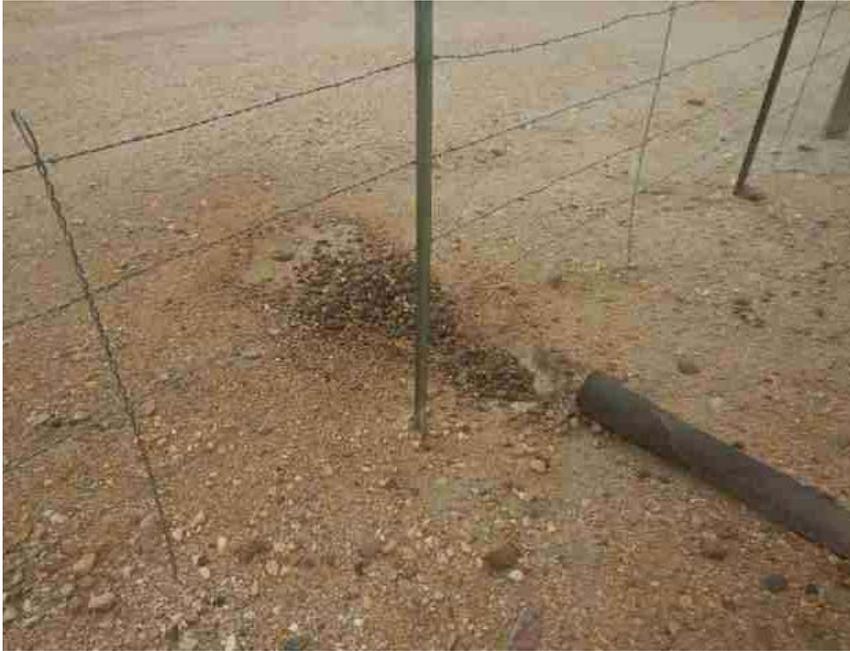
Photo from prior inspection for comparison

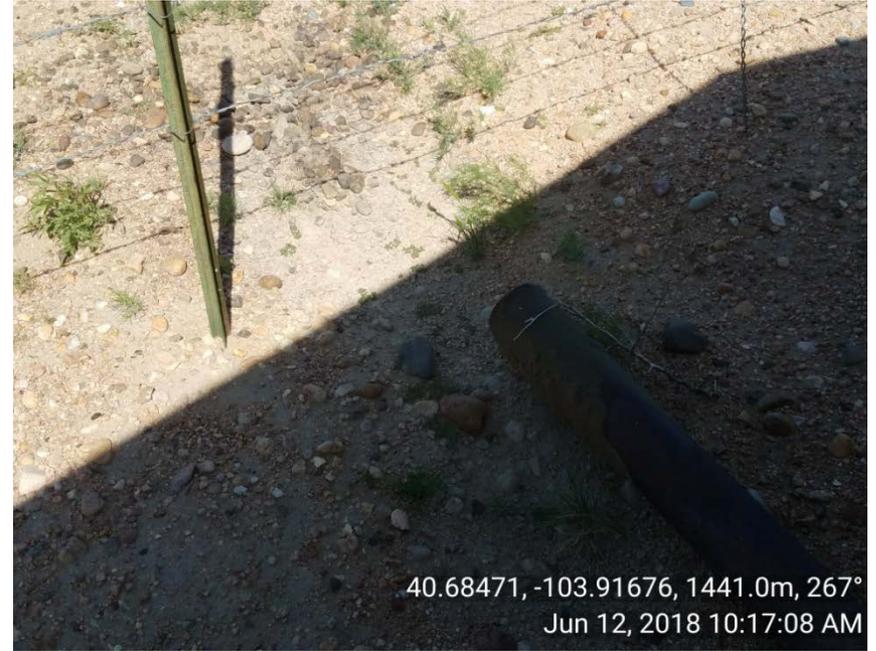
Photo 3: Stained soil at exhaust

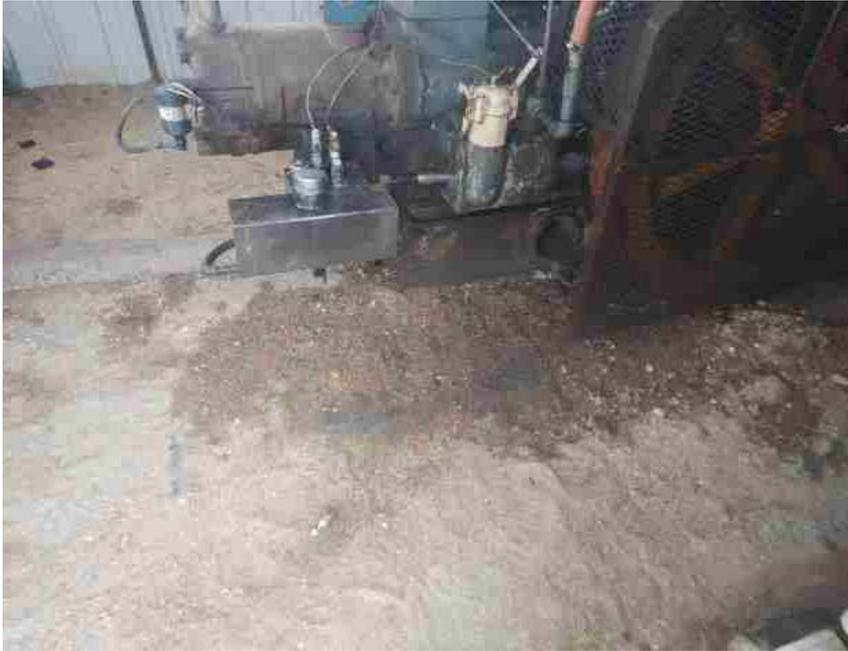
Photo from prior inspection for comparison

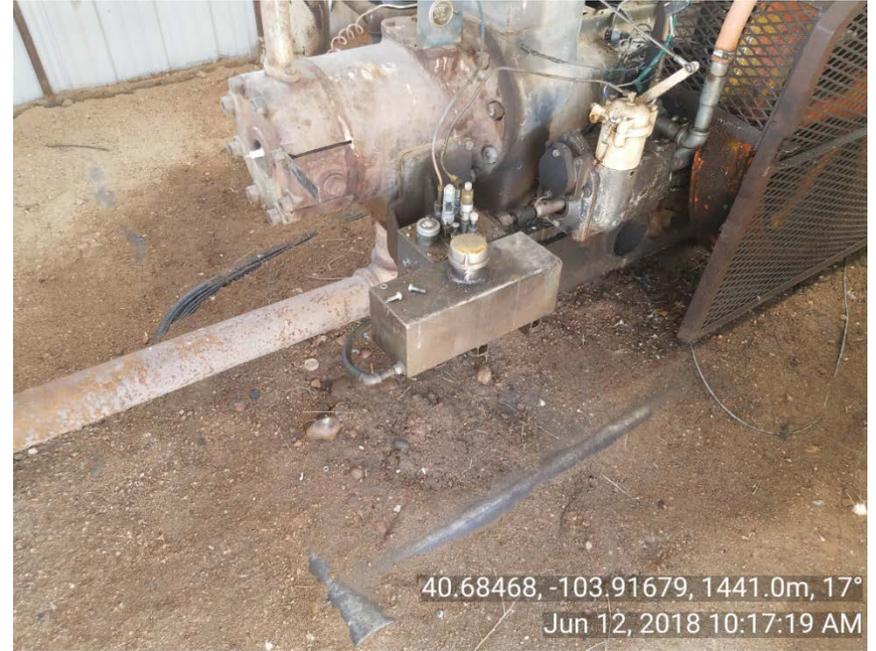
Photo 4: Stained soil at engine

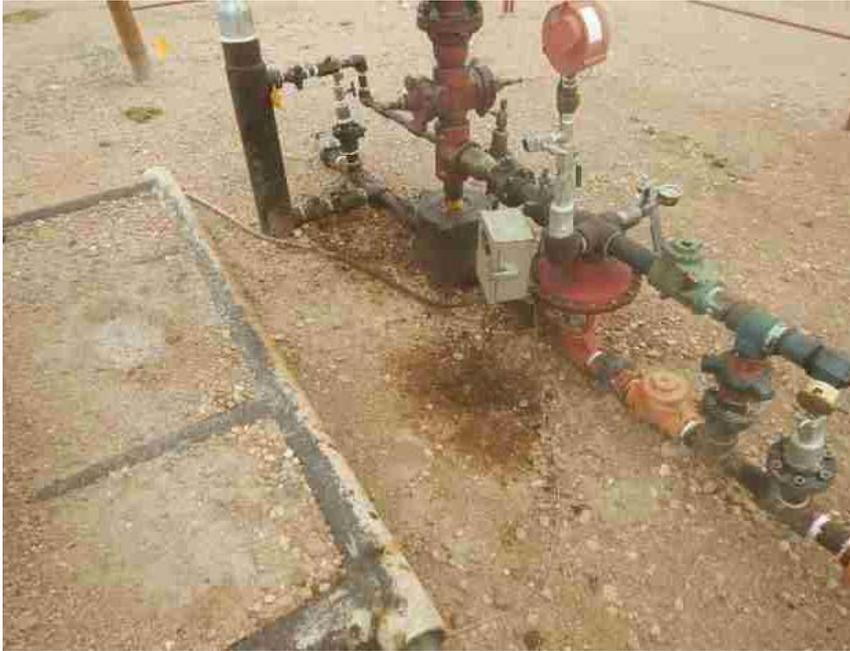
Photo from prior inspection for comparison

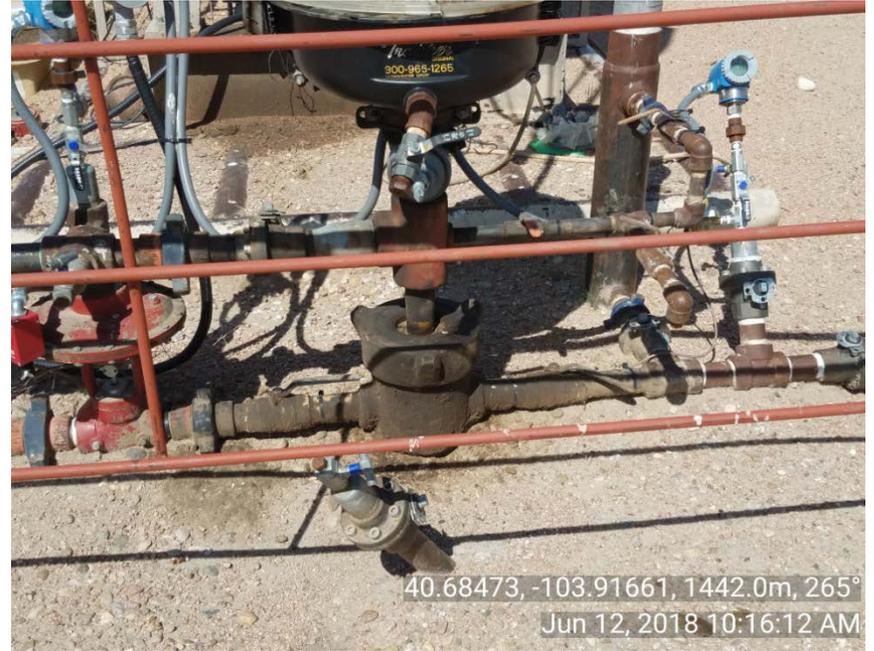
Photo 5: Stained soil at wellhead
