Inspection Photos
Location Name: Lilli Unit #3-10
Location ID: 326974

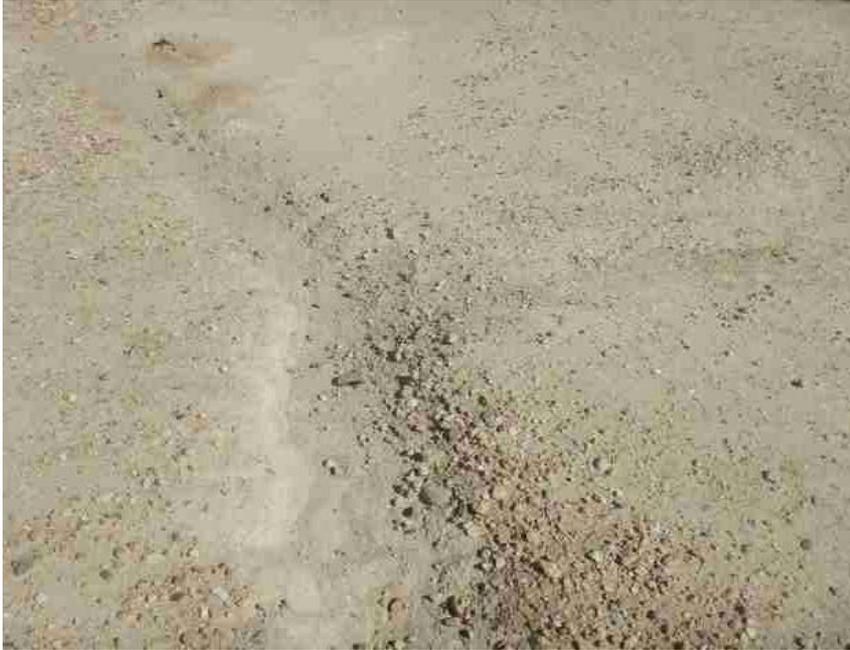
Photo from prior inspection for comparison

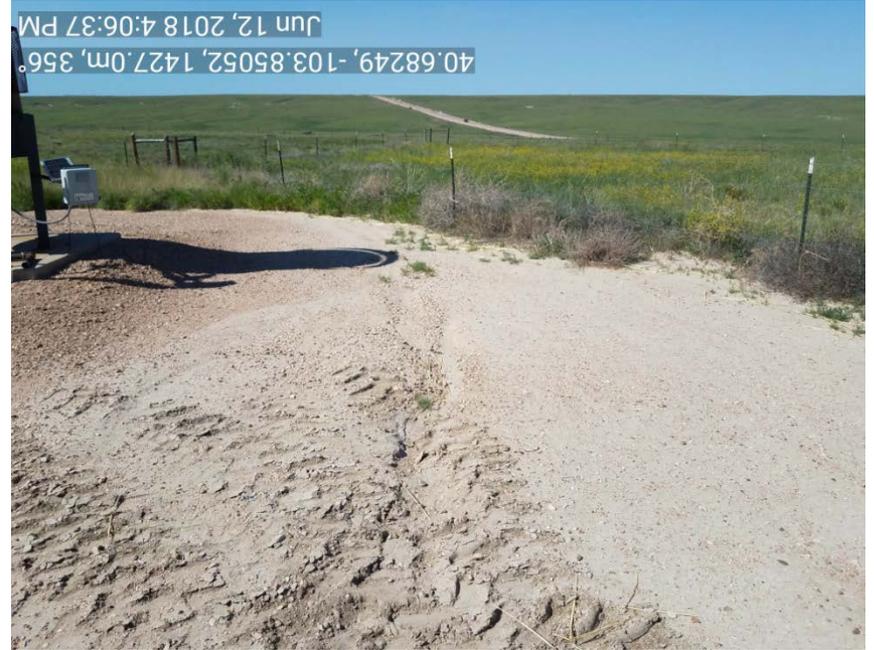
Photo 3: Stormwater erosion on NE corner of location

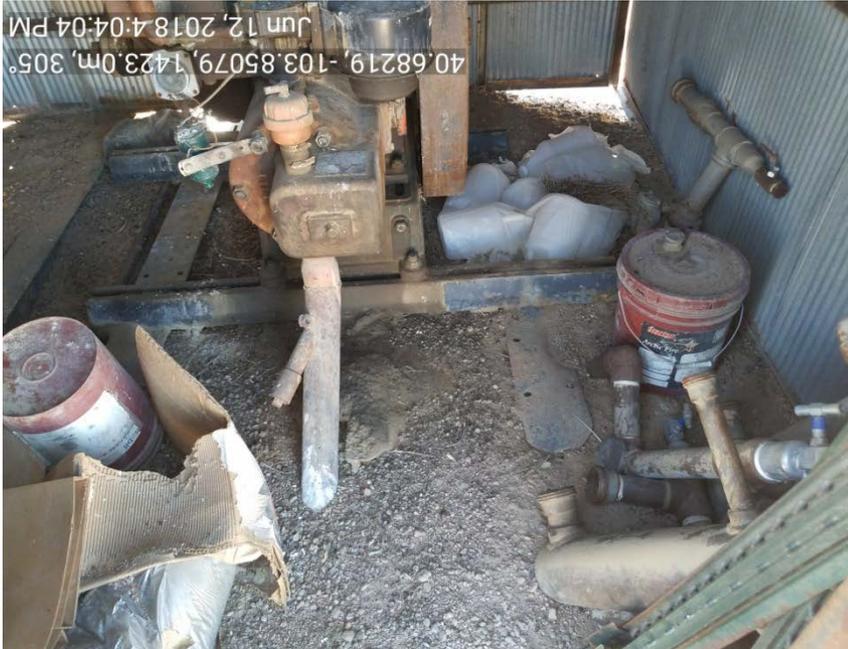
Photo 4: Debris in engine house
