Inspection Photos
Location Name: Lilli Unit #10-2
Location ID: 326778

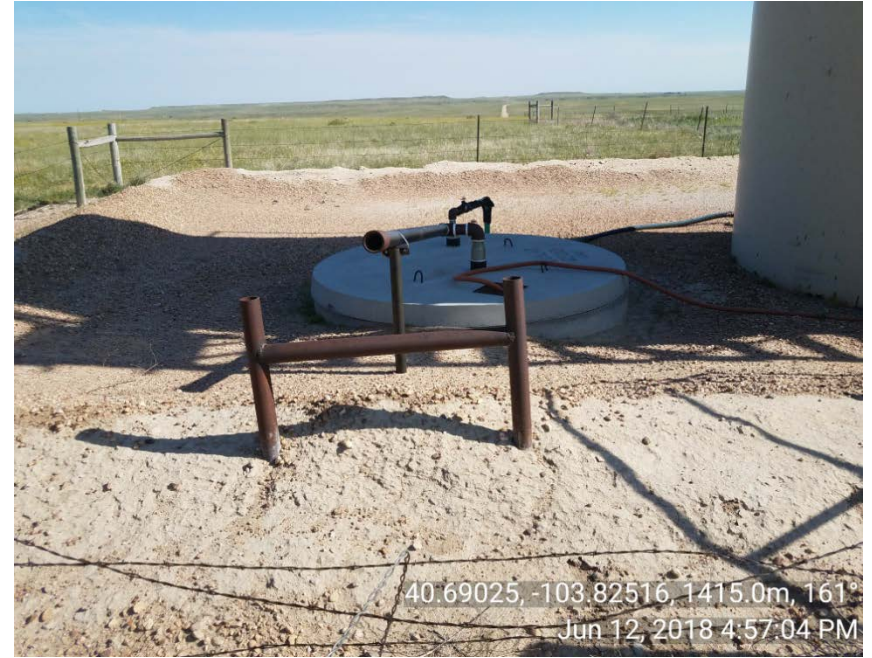
Photo 3: No contents, capacity, NFPA labeling for concrete vault.

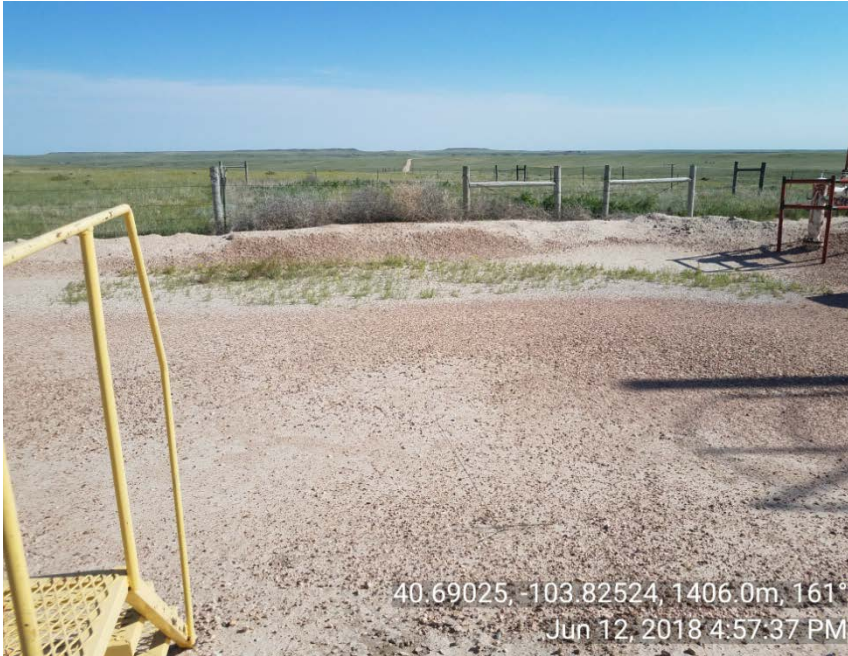
Photo 4: Weeds in tank battery
