Interim Reclamation and Stormwater Inspection

June 11, 2018

Operator: BONANZA CREEK ENERGY OPERATING COMPANY LLC - #8960

Location ID: 436197

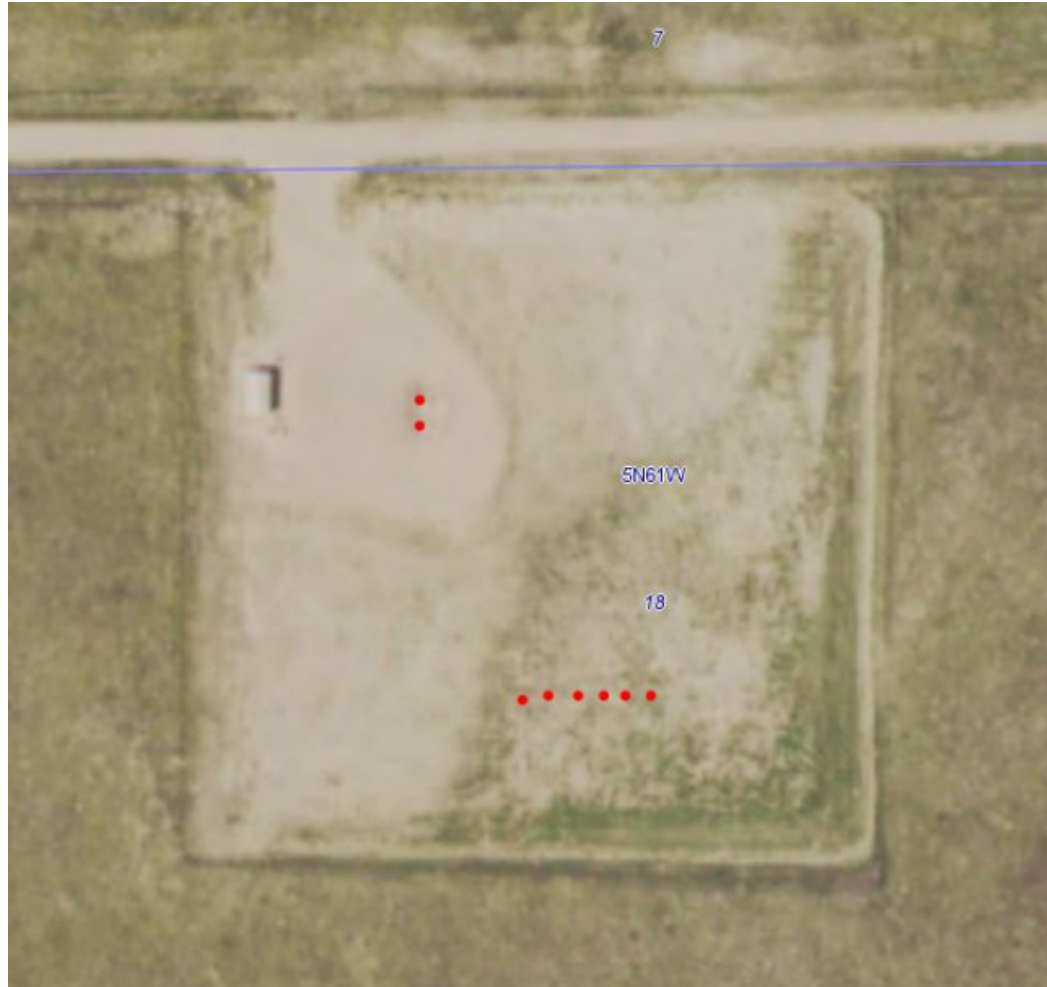
Aerial imagery from 2017, illustrating the total disturbance area of 6.49 acres. The disturbance area was mapped by COGCC Staff on 6/11/2018 using a Trimble Juno 3B handheld device.

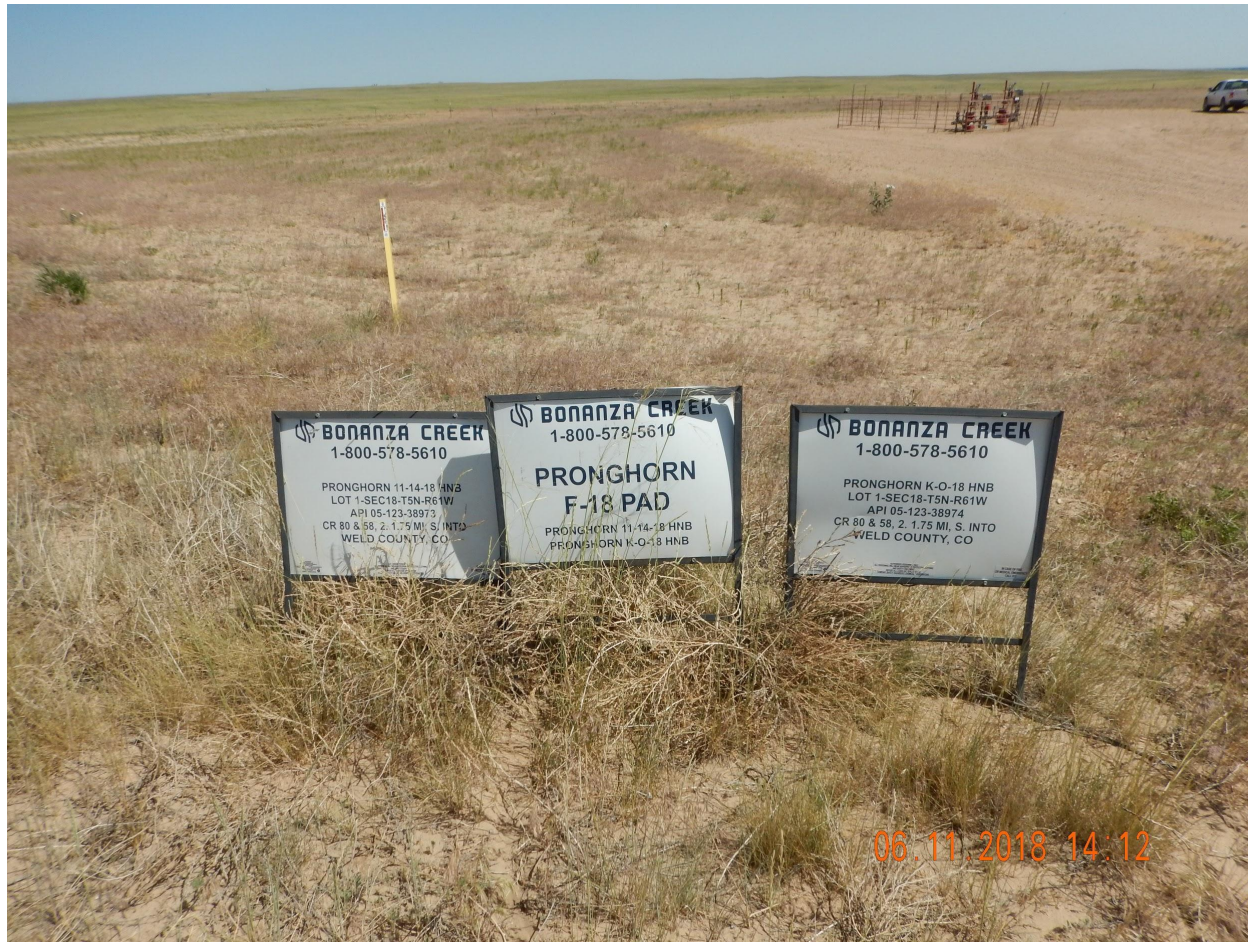
Photo 1. Photo taken from the entrance of the location, facing South.

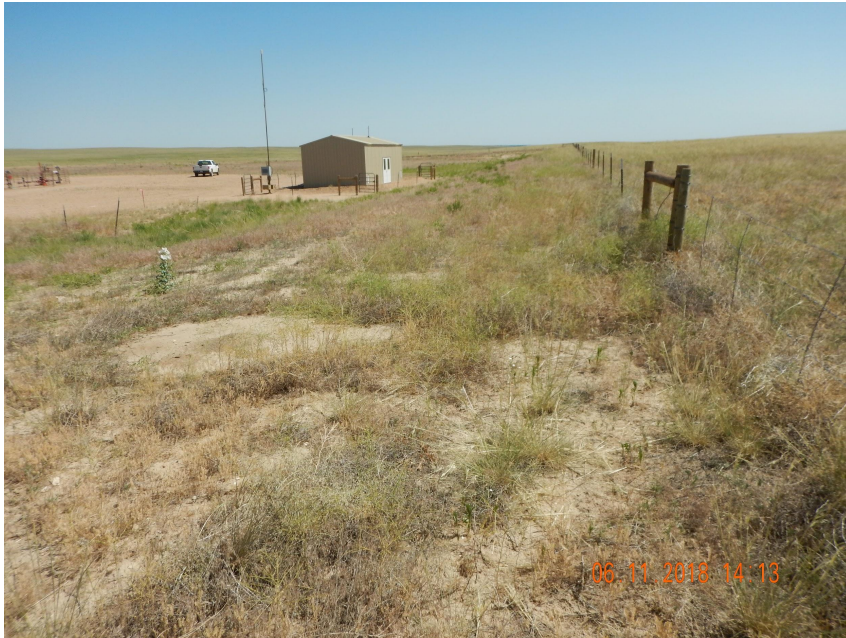
Photo 2. Photo taken from the northwest perimeter of the location, facing South. Some desirable species were observed along the perimeter of the location and along portions of the interim area. However, this location is not in compliance with Rule 1003 vegetation standards.

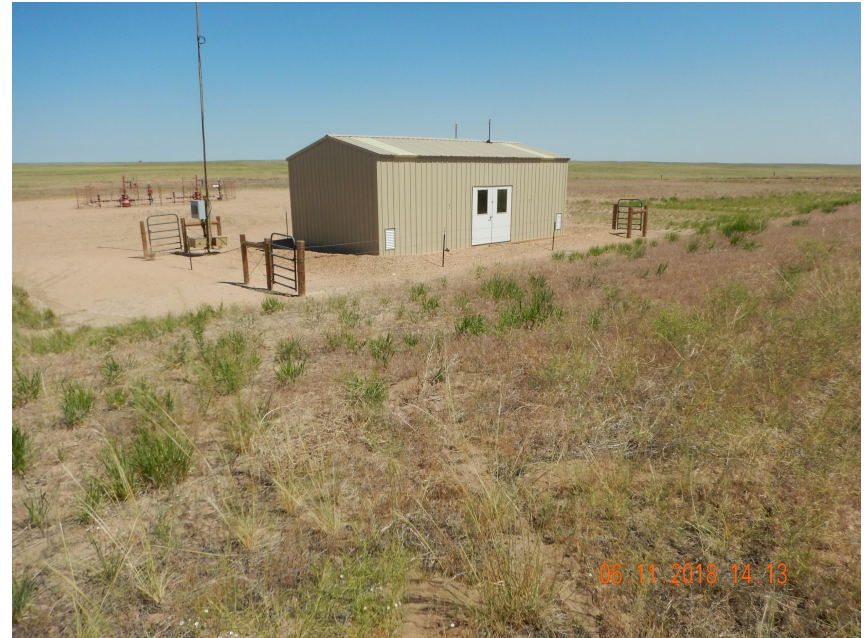
Photo 3. Photo taken from the northwestern perimeter of the location, facing East. Photo illustrates some equipment observed on location.

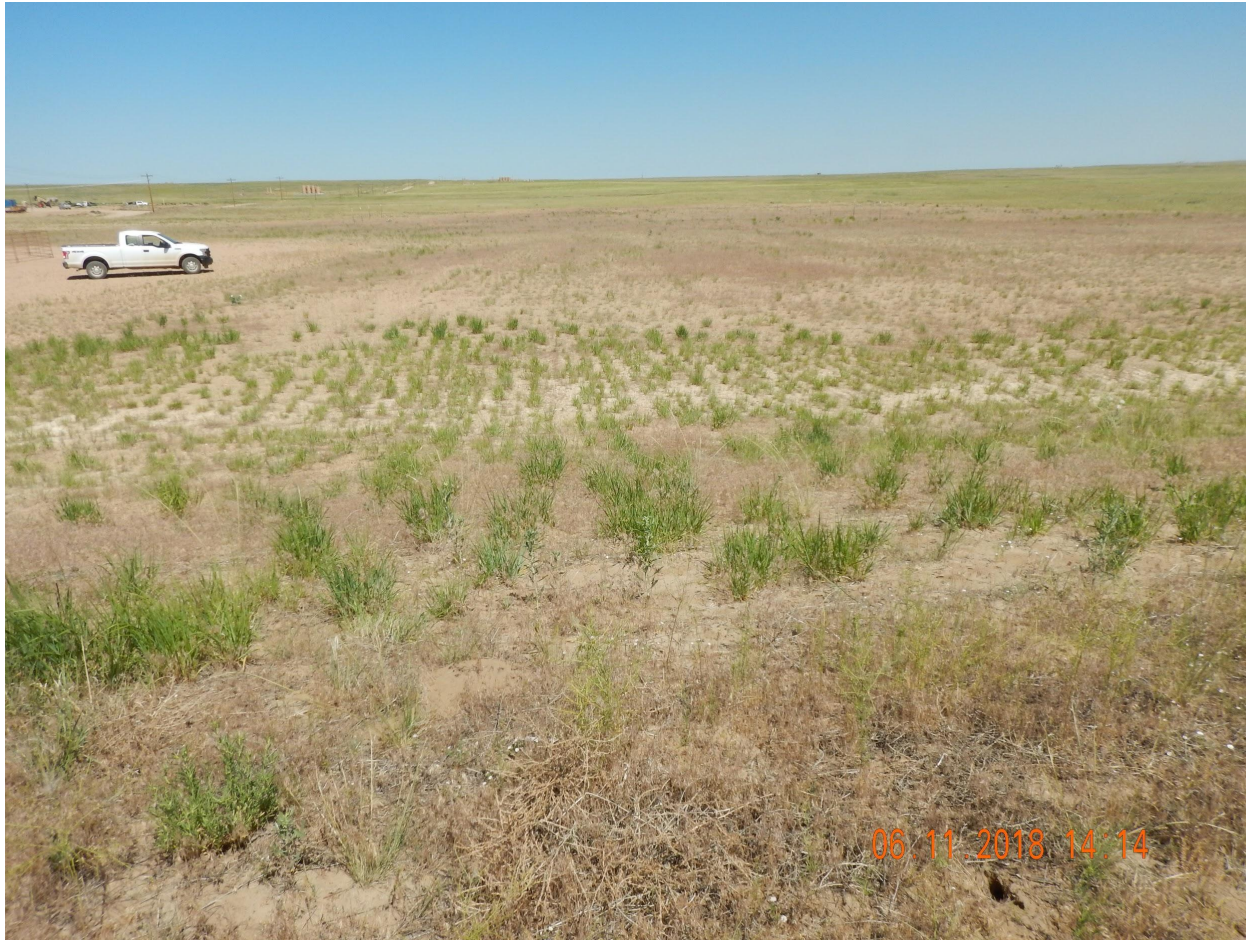
Photo 4. Photo taken from the western perimeter of the location, facing East. Some desirable establishment was observed along the western interim areas but this was not consistent throughout interim area.

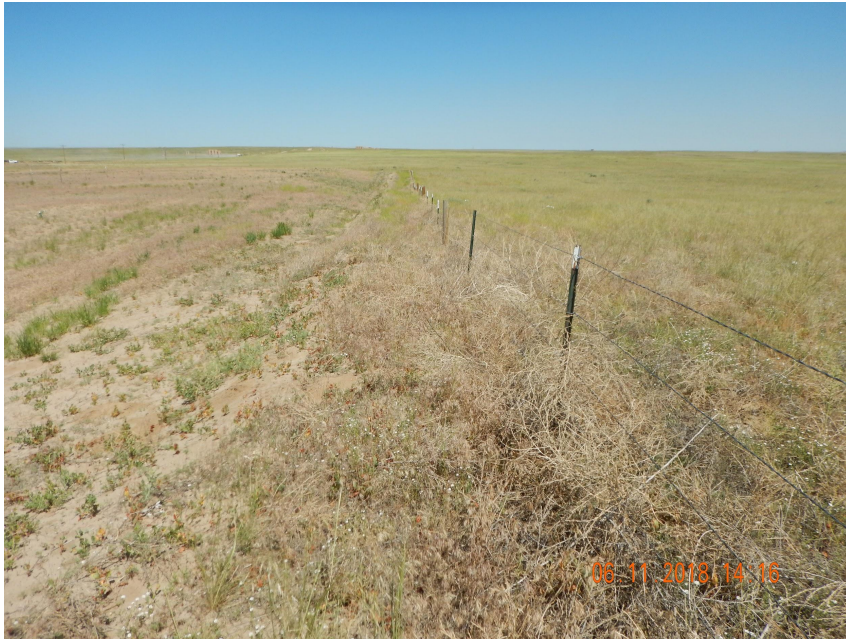
Photo 5. Photo taken from the southwestern perimeter of the location, facing East. Photo illustrates unmanaged Russian thistle weed debris accumulation along the perimeter fence. Russian thistle was not observed in reference areas. Operator shall control weed debris per Rule 603.f.

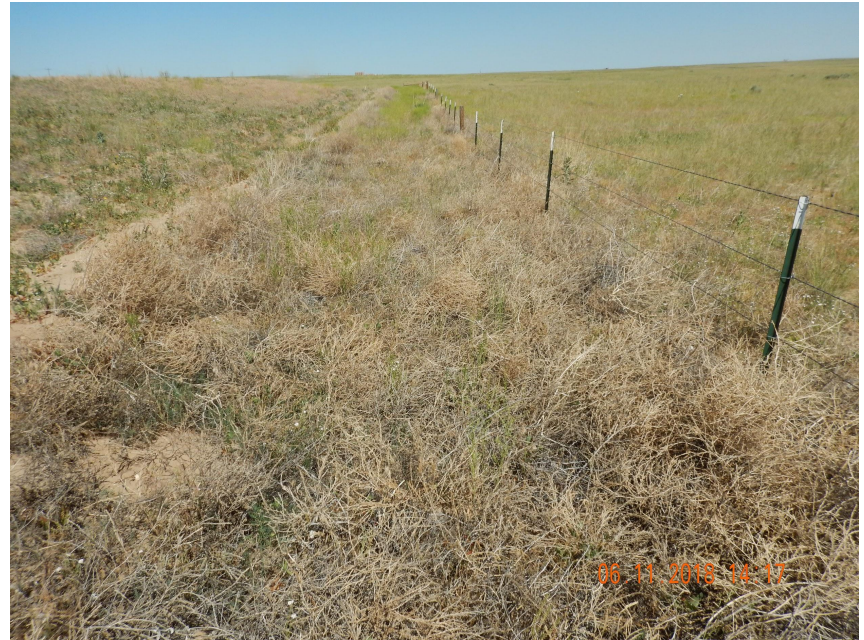
Photo 6. Photo taken from the southern perimeter of the location, facing East. See comments under Photo 5.

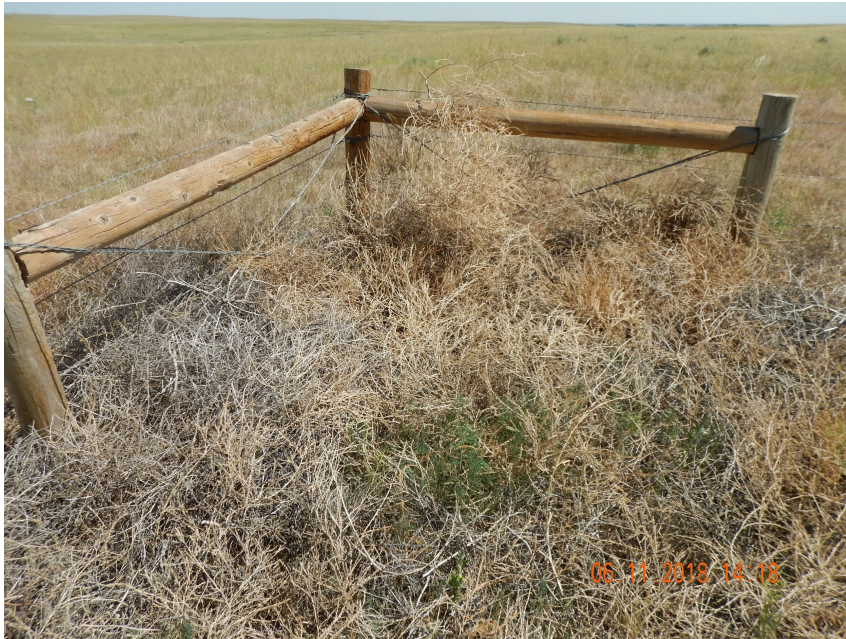
Photo 7. Photo taken from the southeast perimeter of the location, facing South. See comments under Photo 5.

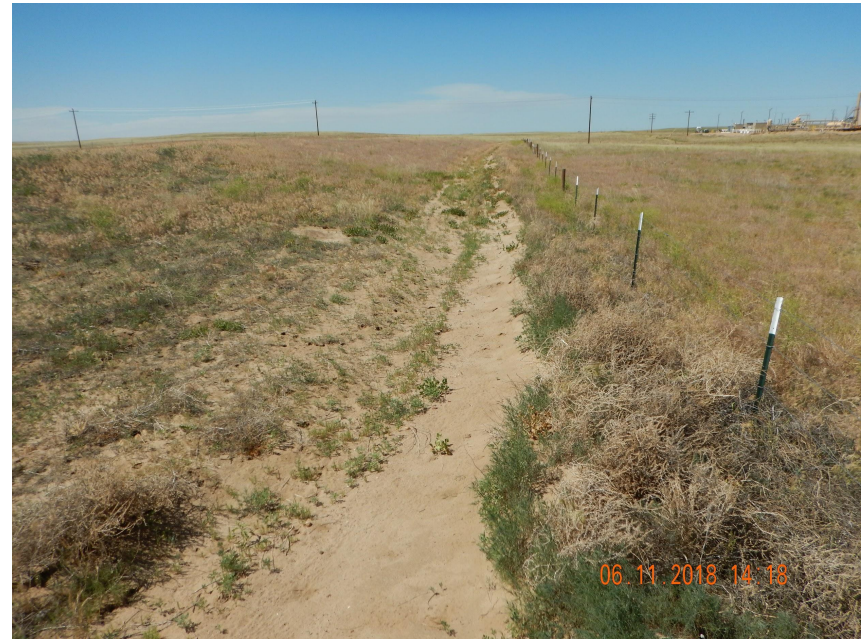
Photo 8. Photo taken from the southeast perimeter of the location, facing North. See comments under Photo 5. Note- a ditch and berm BMP has been installed around the southern and eastern perimeter of the location.

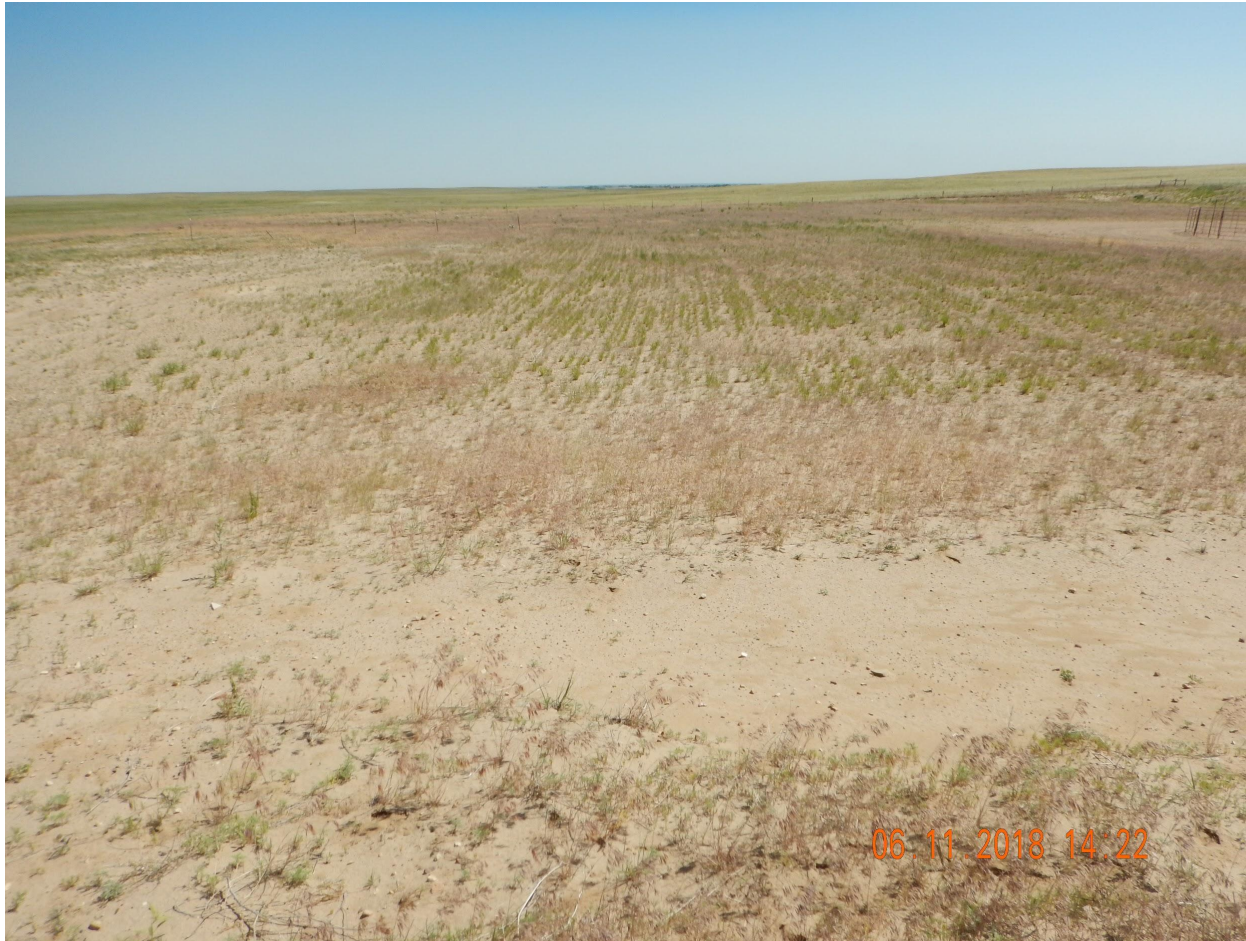
Photo 9. Photo taken from the northern interim area, facing South. Photo illustrates the evidence that the Operator attempted to perform interim reclamation with the presence of desirable vegetation observed in seeding drill row. However, large patches have not established and are bare which are susceptible to wind erosion- see Photos 10-12.

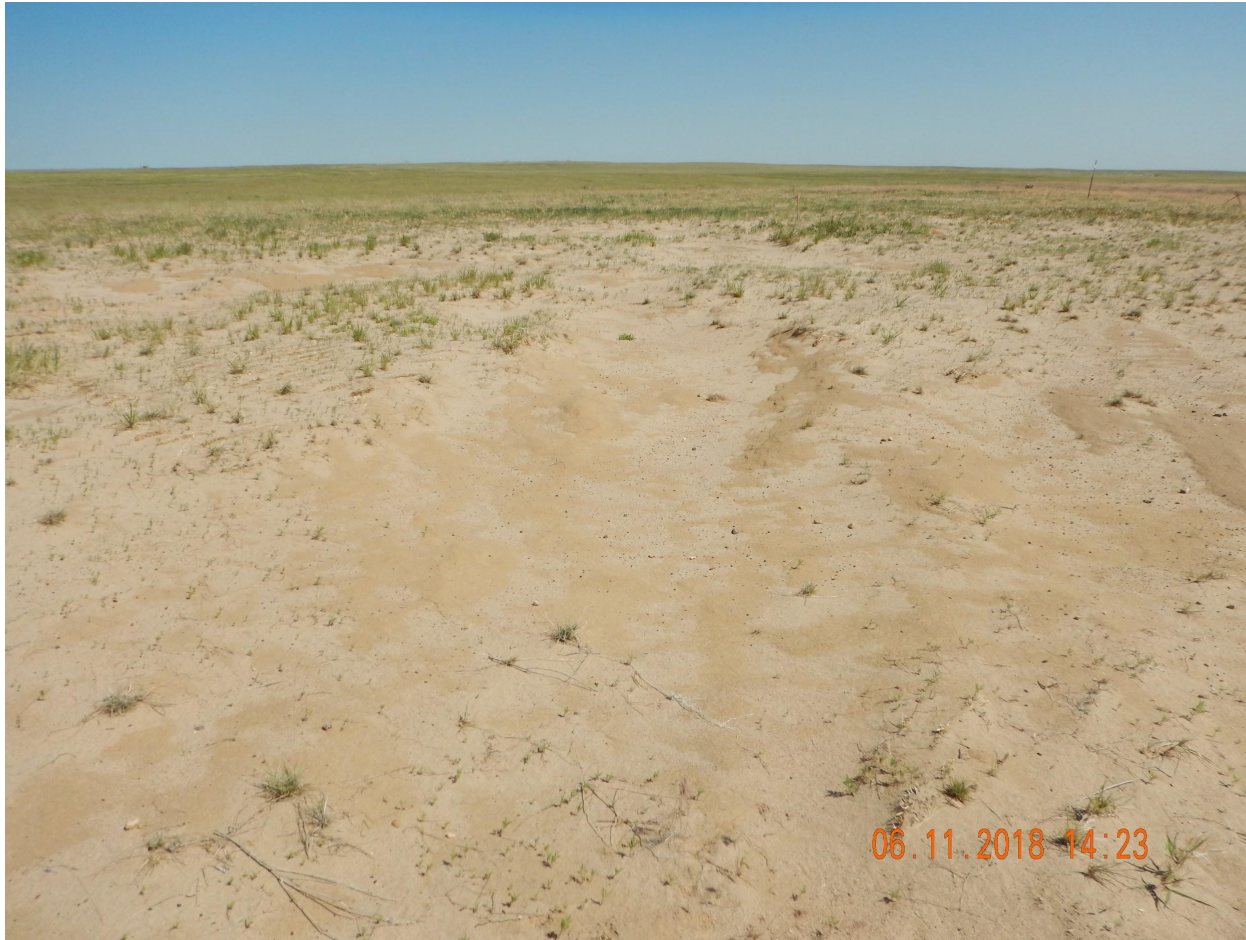
Photo 10. Photo taken from the northeastern interim area, facing East. Photo illustrates an area where wind erosion has scoured an area due to the lack of vegetation establishment.

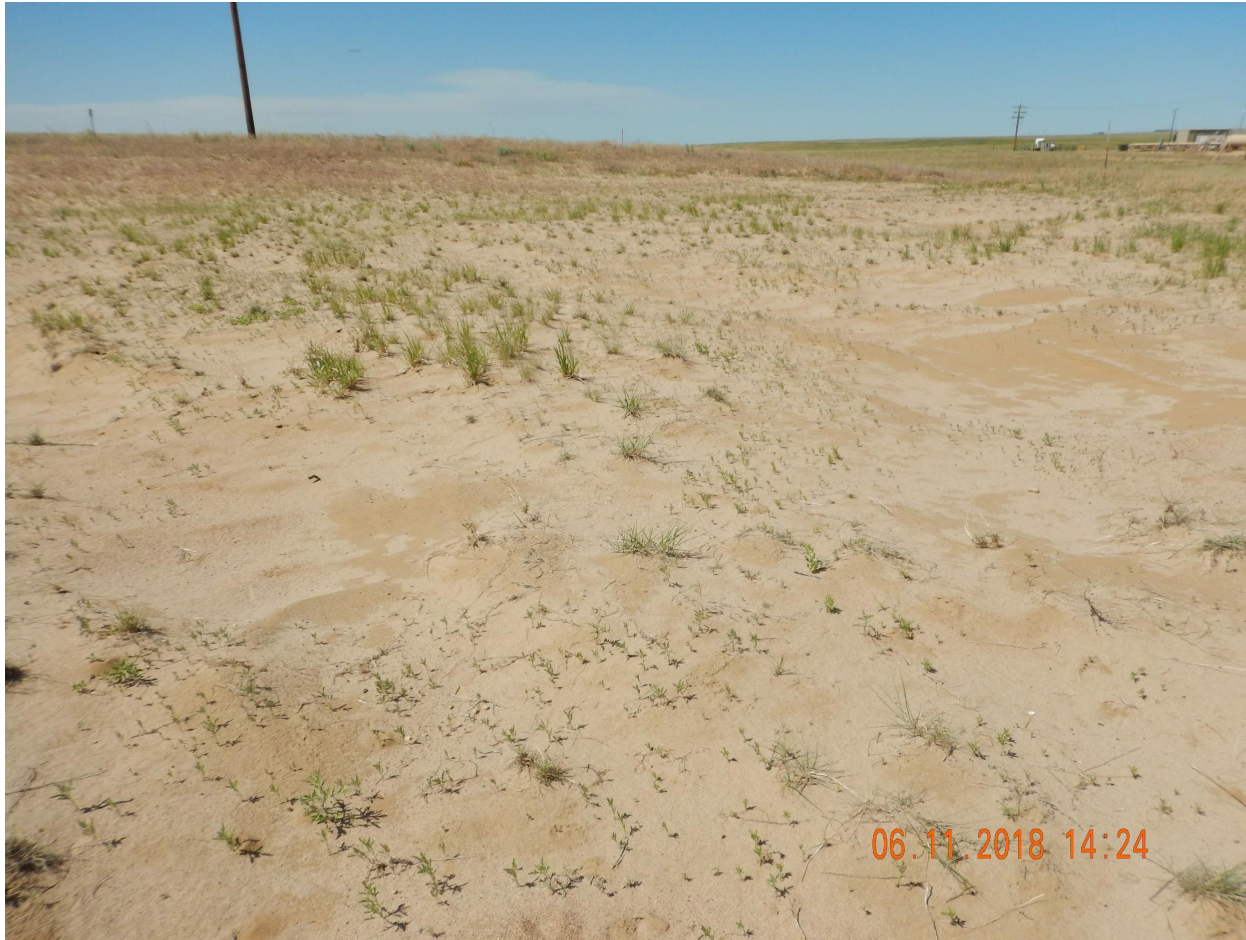
Photo 11. Photo taken from the northeastern interim area, facing Northeast. See comments under Photo 10.

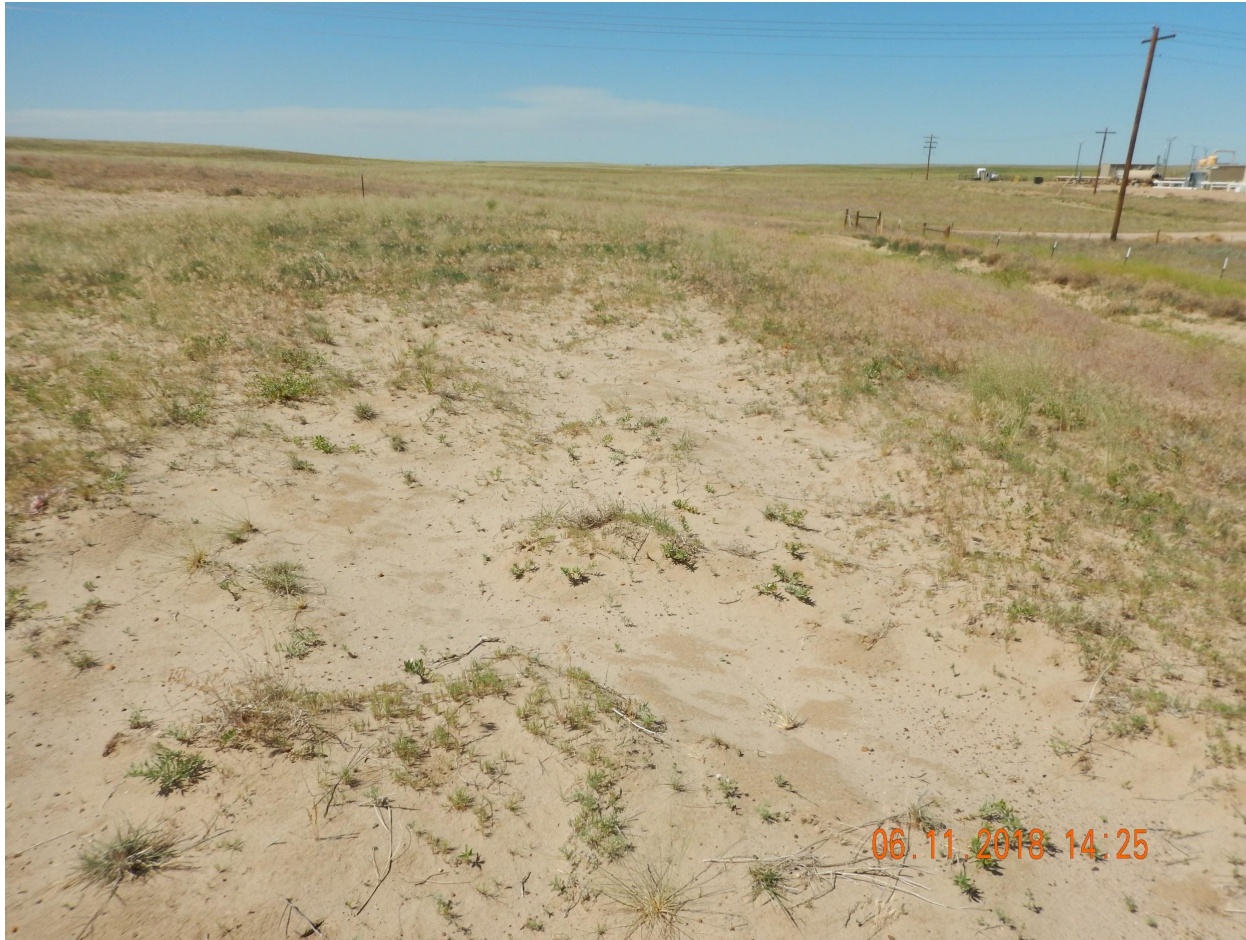
Photo 12. Photo taken from the northeastern interim area, facing North. See comments under Photo 10.
