Construction and Stormwater Inspection

Operator: BONANZA CREEK ENERGY OPERATING COMPANY LLC - #8960

Location ID: 449728

Location Name: State Antelope /41-11 Pad

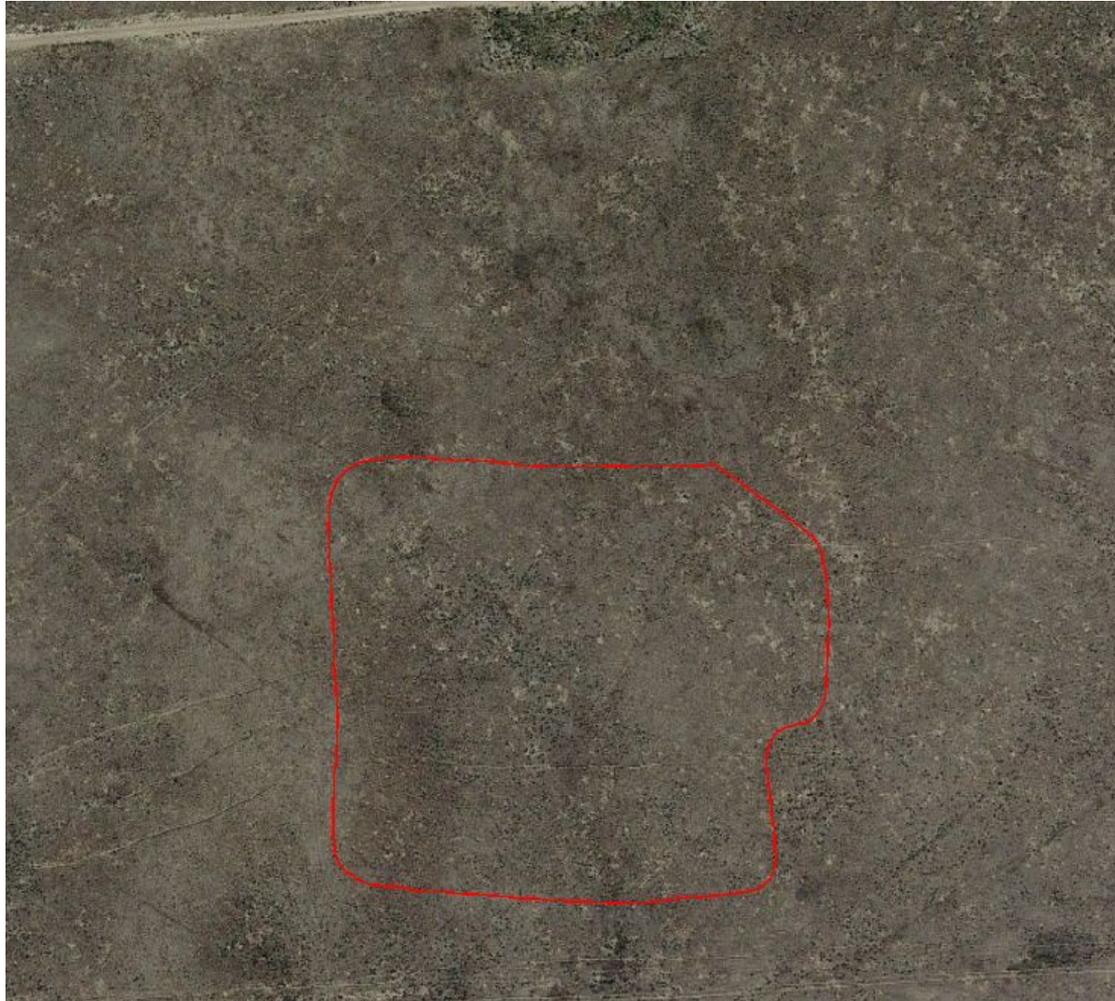
Google Earth imagery taken on September 7, 2013 illustrates the location that was mapped on June 11, 2018 (red line) by COGCC Staff. A Trimble Juno 3B handheld device indicates a total disturbance of 6.23 acres. This does not appear to be in compliance with the approved Form 2A.

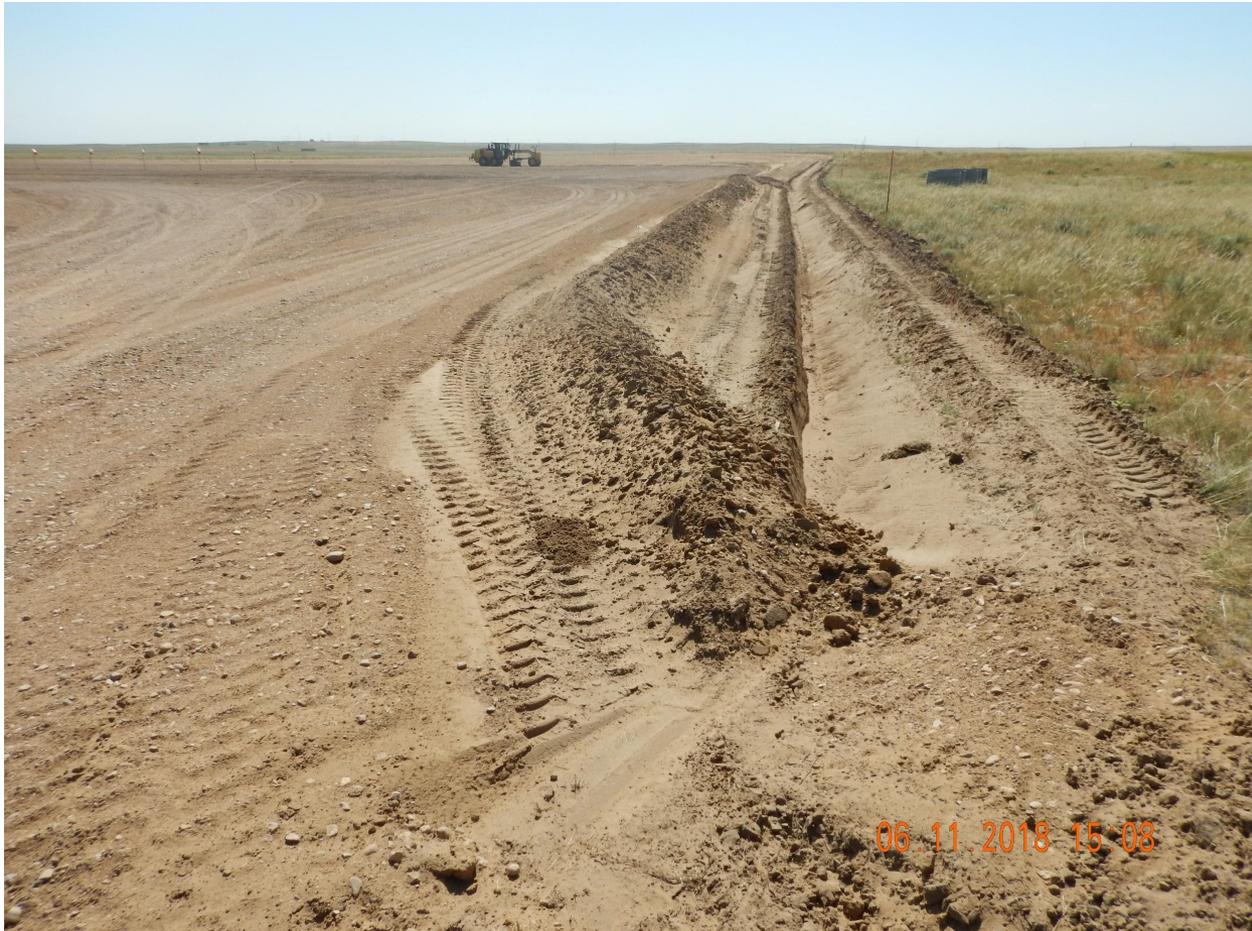
Photo 1. Photo taken from the entrance of the location, facing West. Ditch and berm BMP has been installed. The berm BMP has not been stabilized and left unconsolidated. An unconsolidated berm BMP is not a proper functioning BMP, as the unconsolidated material becomes a source of potential pollution itself and susceptible to wind and water erosion. The well location has been graveled throughout the area.

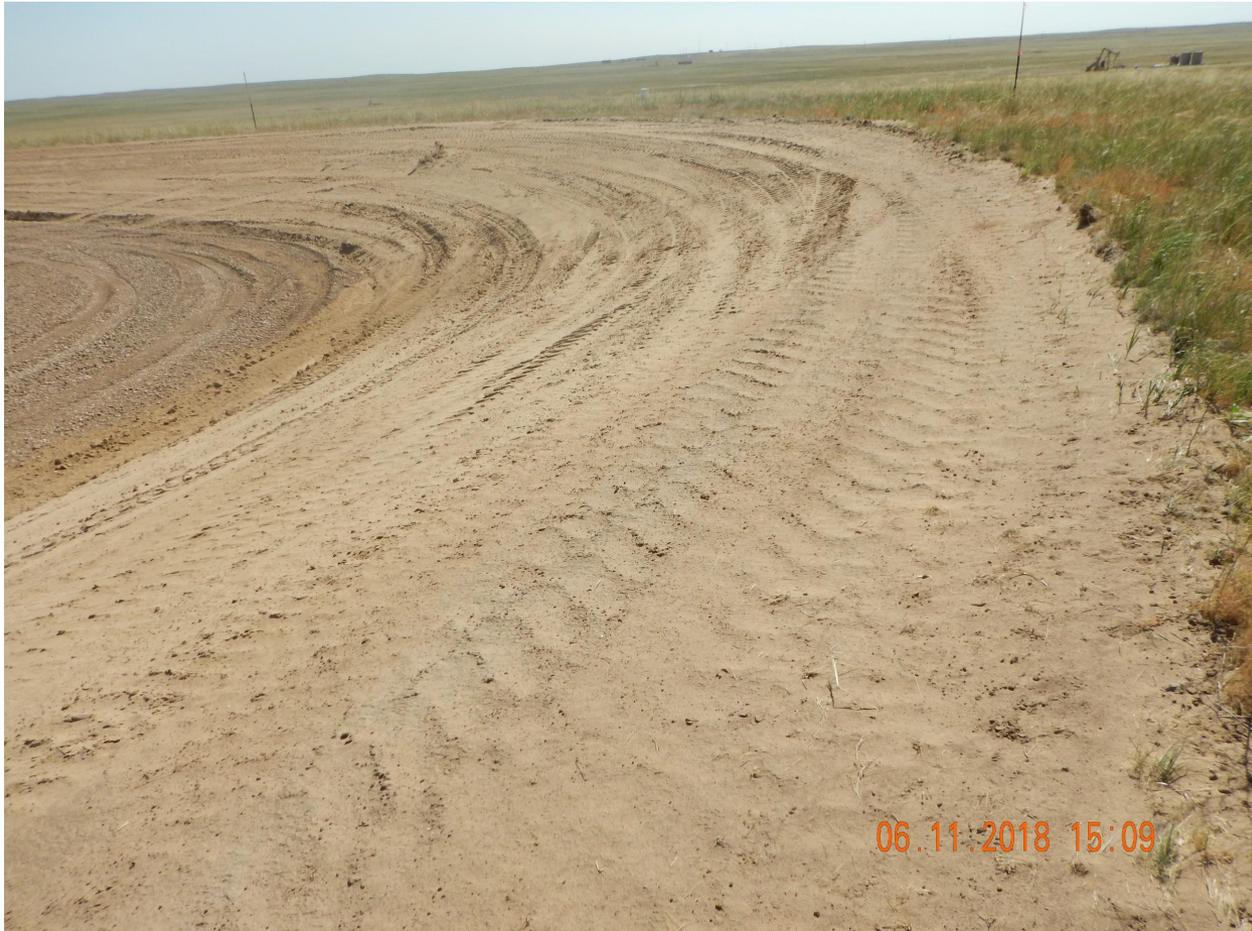
Photo 2. Photo taken from the northwest perimeter of the location, facing Southwest. See comments under Photo 1.

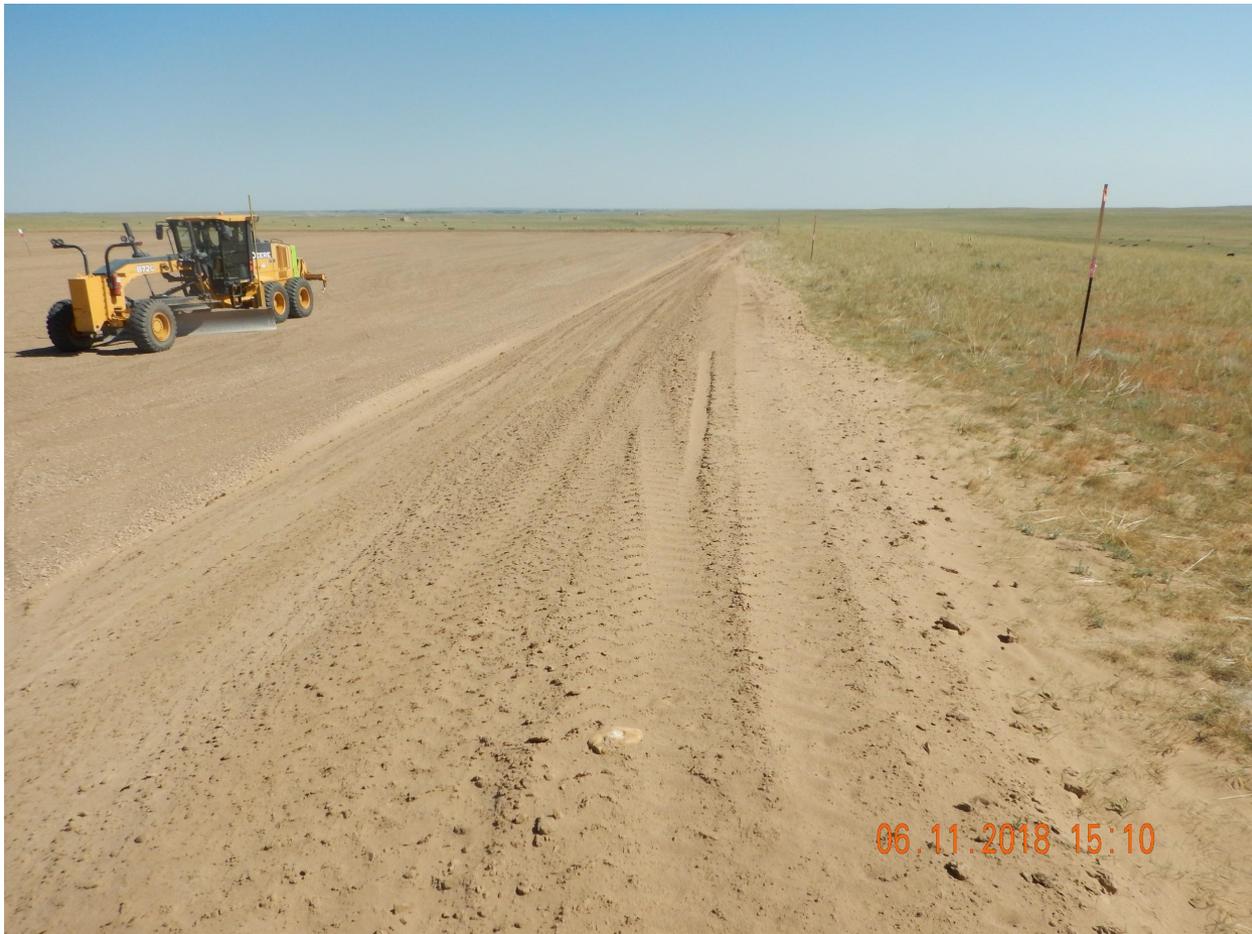
Photo 3. Photo taken from the northwestern perimeter of the location, facing South. Operator shall stabilize all cut and fill slopes from wind and water erosion.

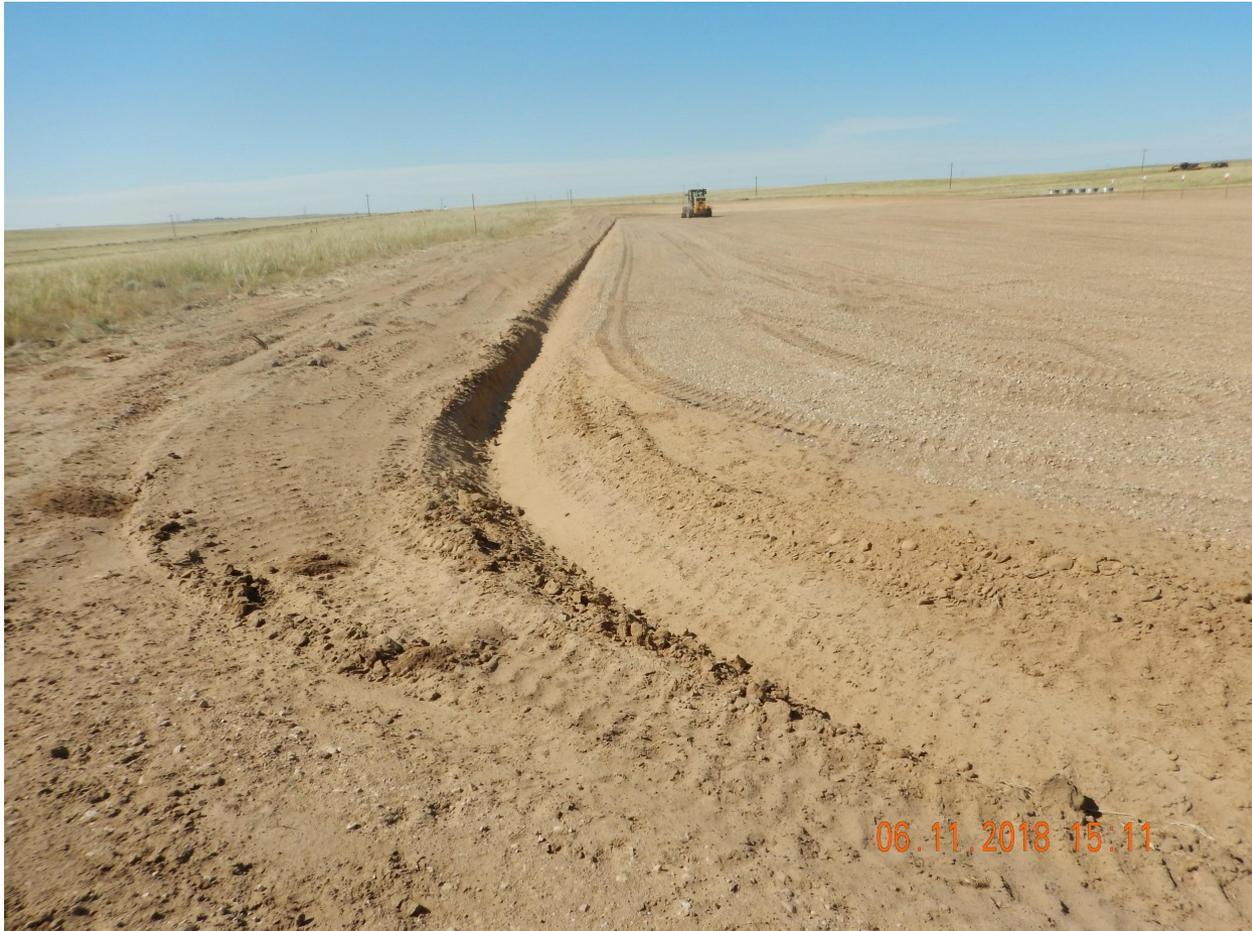
Photo 4. Photo taken from the southwest perimeter of the location, facing North. See comments under Photo 1.

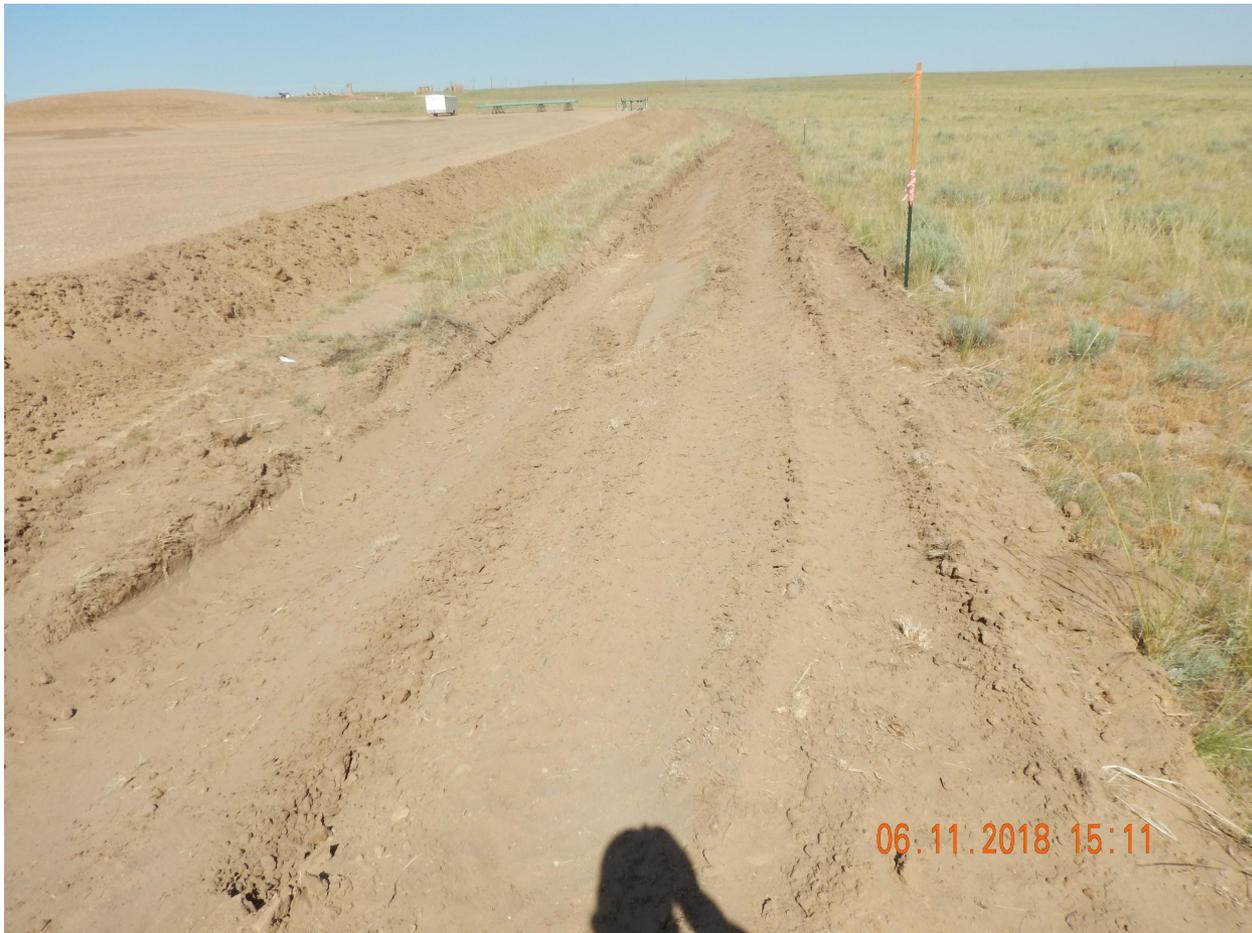
Photo 5. Photo taken from the southwest perimeter of the location, facing East. See comments under Photo 1.

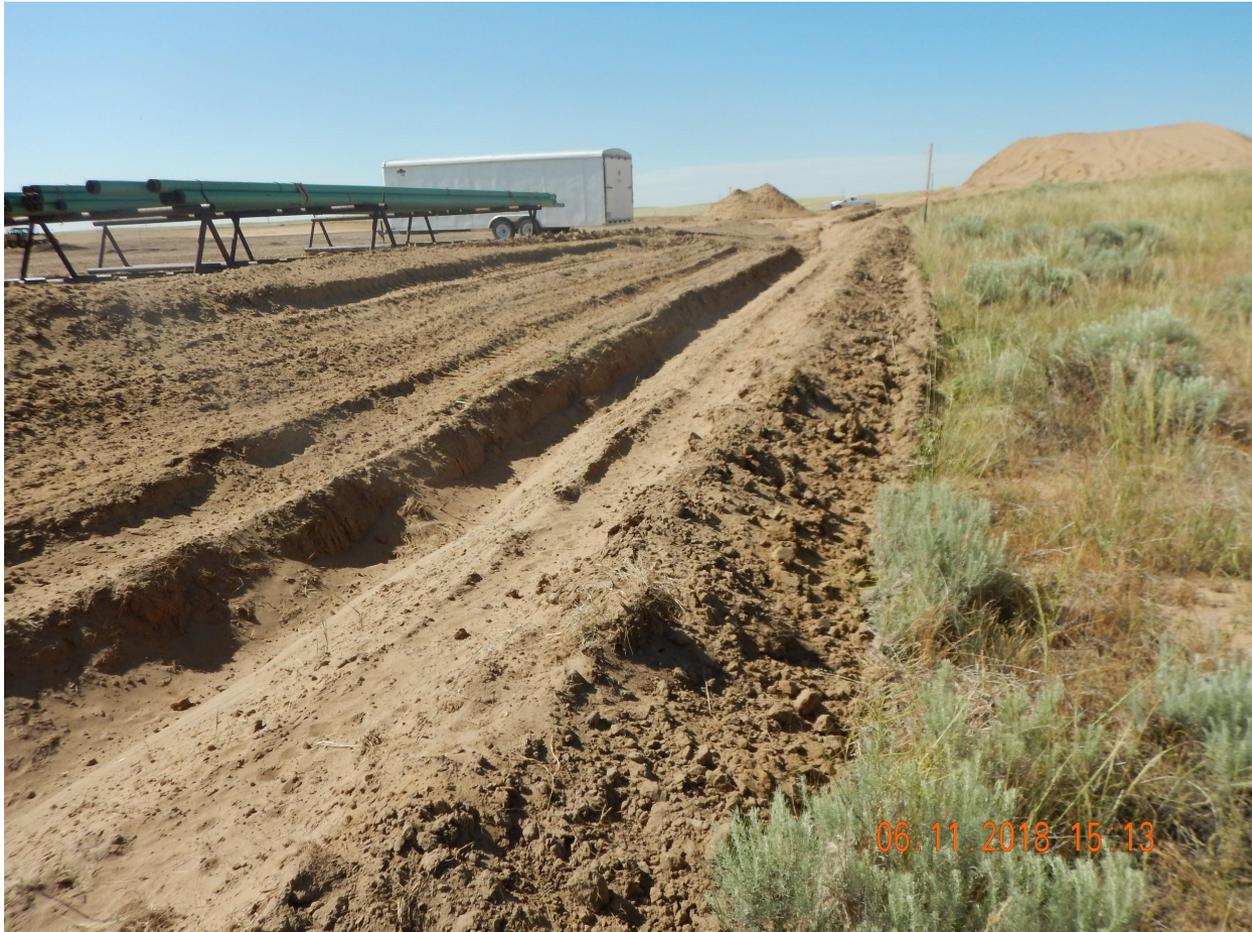
Photo 6. Photo taken from the southeastern perimeter of the location, facing North. See comments under Photo 1. Portions of the ditch BMP appear to be filling in from unconsolidated material.

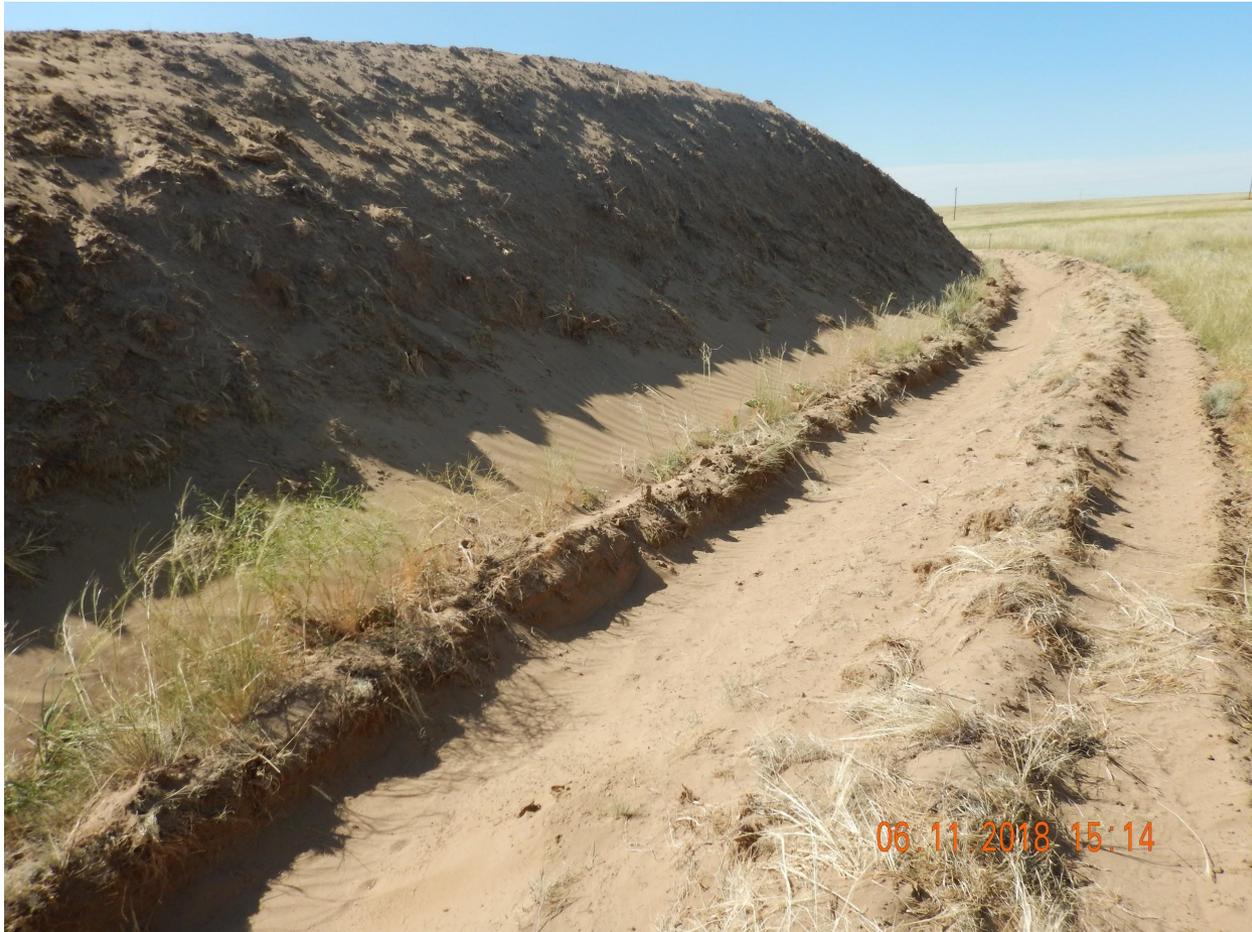
Photo 7. Photo taken from the northeastern perimeter of the location, facing North. Topsoil has been salvaged and stored along the northeastern location but has not been properly stabilized. The ditch BMP is filling in from unconsolidated material.
