Inspection Photos

06/12/2018

Operator: ST CROIX OPERATING INC - 81490

Location ID: 454146

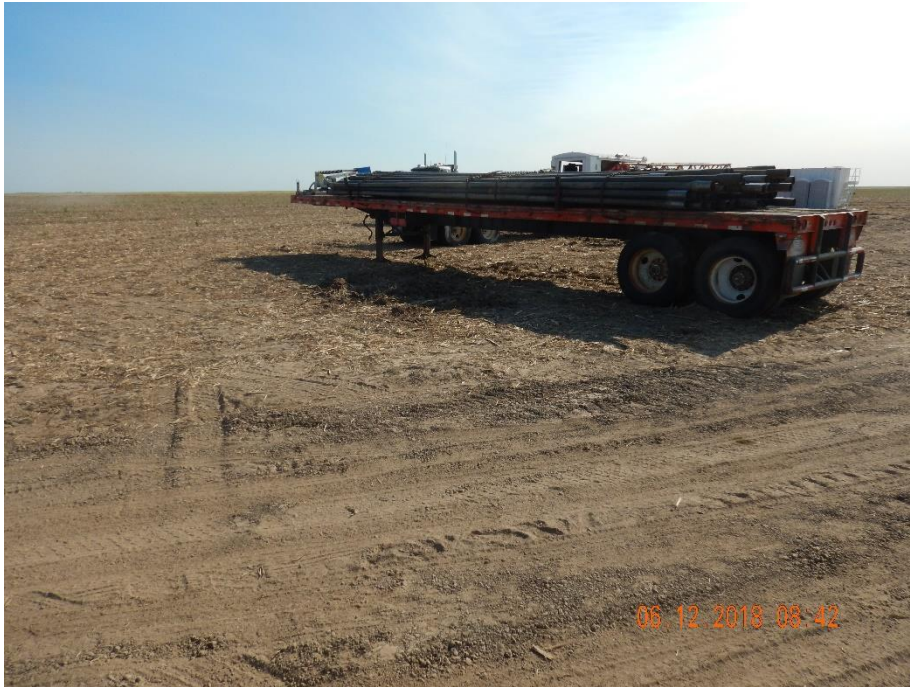
Photo 1: Photo taken from the west end of the location, facing northeast. Photos 1-3 provide an overview of the location from northeast, east, to south. Photos show that the pit on the south end of the location appears to be the only area of the location where topsoil has been salvaged. Photos show operator has not salvaged topsoil from the remaining Oil and Gas location during construction operations; various equipment, including the drilling rig, have been set up, and have operated directly upon the surface of the topsoil.

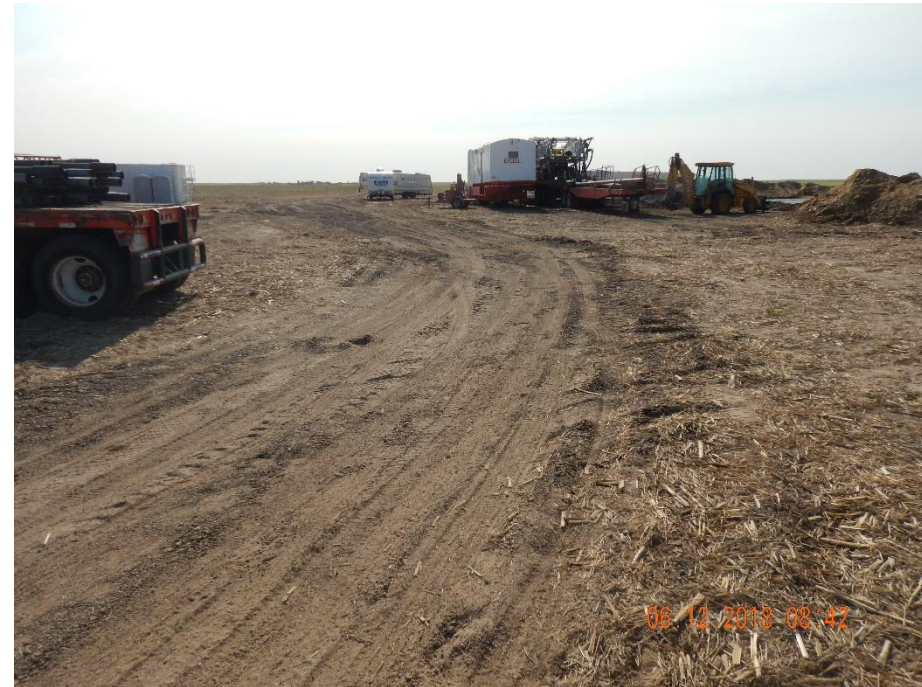
Photo 2: Photo taken from the west end of the location, facing east. See comments under photo 1.

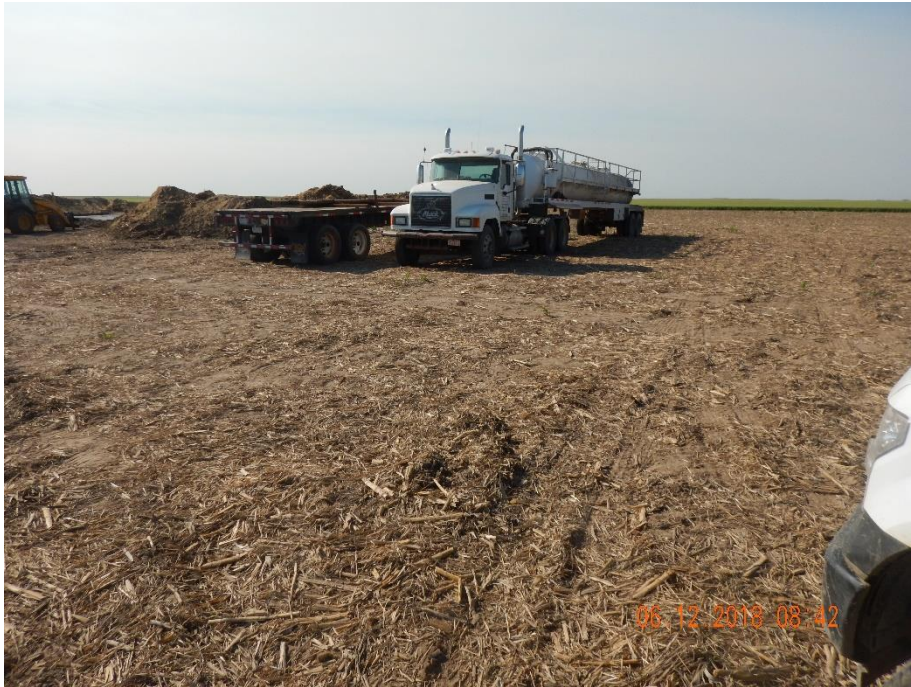
Photo 3: Photo taken from the west end of the location, facing south. See comments under photo 1.

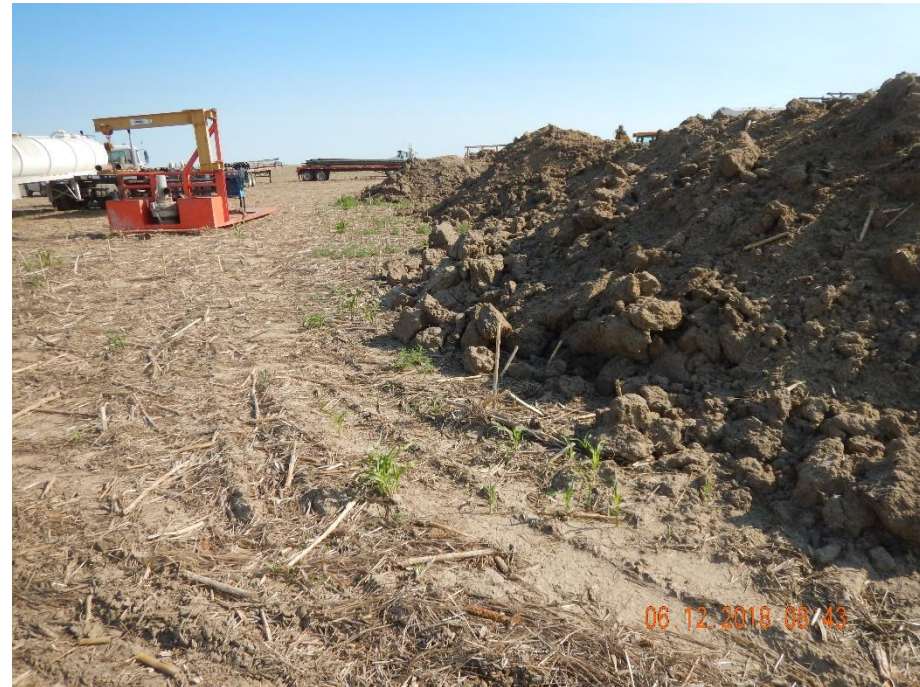
Photo 4: Photo taken from the southwest end of the location, facing north. Photo shows no perimeter stormwater controls have been installed. A tackifier appears to have been applied to the berms at the pit.

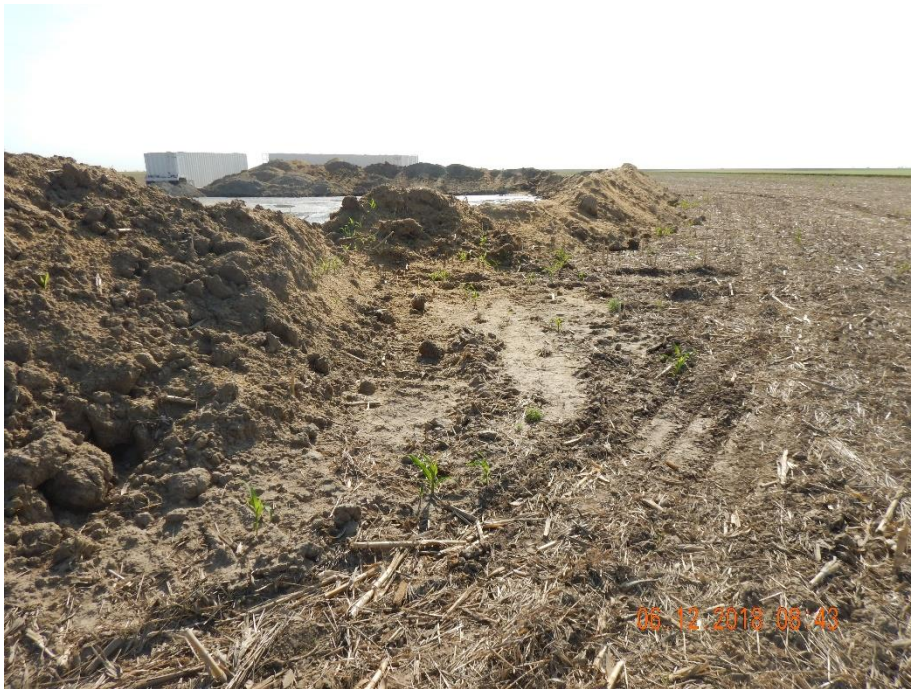
Photo 5: Photo taken from the southwest end of the location, facing east. See comments under photo 4.

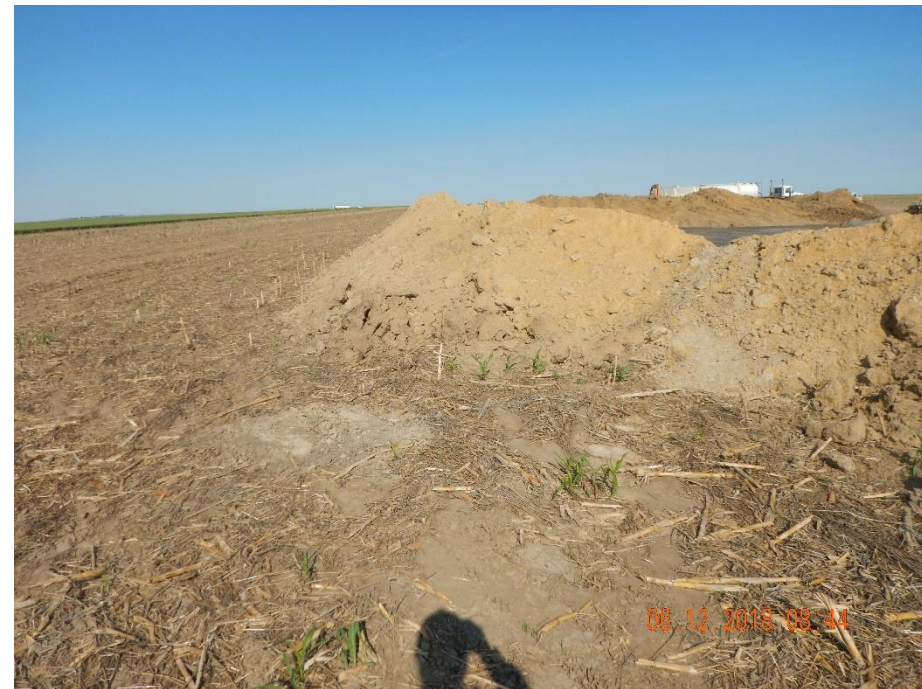
Photo 6: Photo taken from the southeast end of the location, facing west. See comments under photo 4.

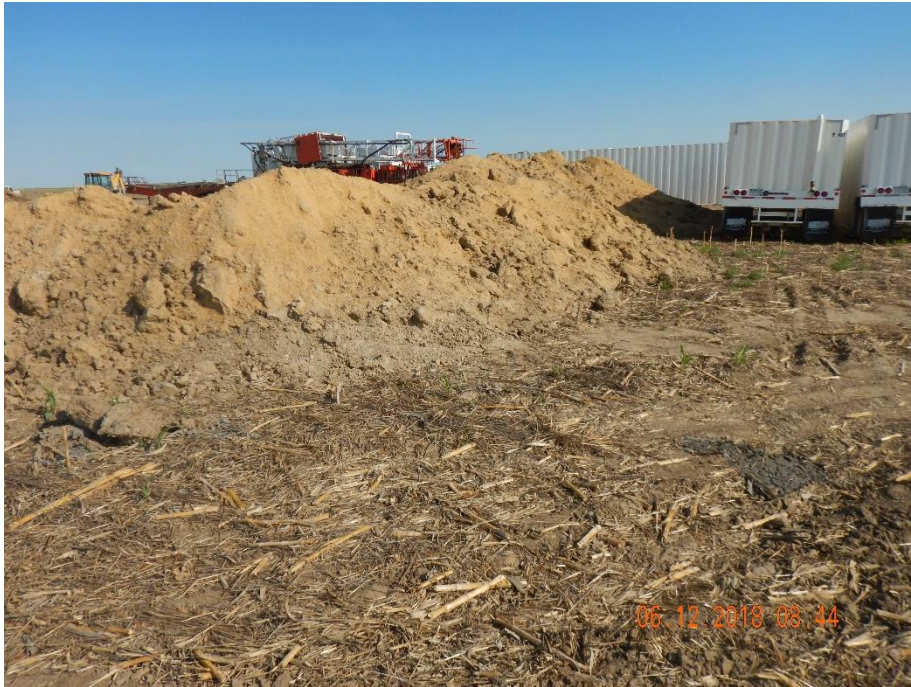
Photo 7: Photo taken from the southeast end of the location, facing north. See comments under photo 4.

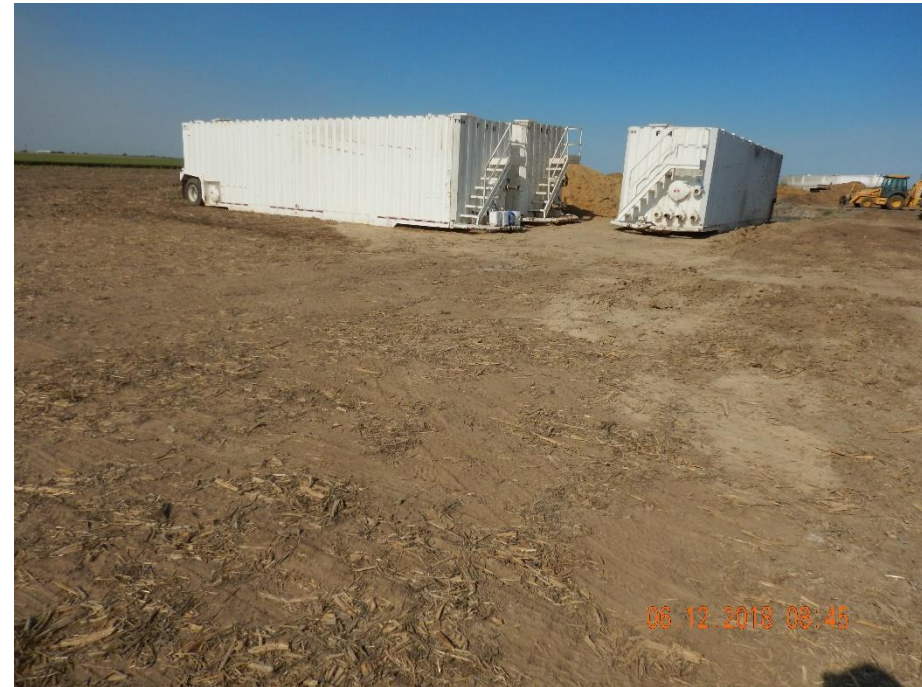
Photo 8: Photo taken from the east end of the location, facing southwest. Photos 8-10 provide an overview of the location from southwest, west, to north. Photos show that the pit on the south end of the location appears to be the only area of the location where topsoil has been salvaged. Photos show operator has not salvaged topsoil from the remaining Oil and Gas location during construction operations; various equipment, including the drilling rig, have been set up, and have operated directly upon the surface of the topsoil.

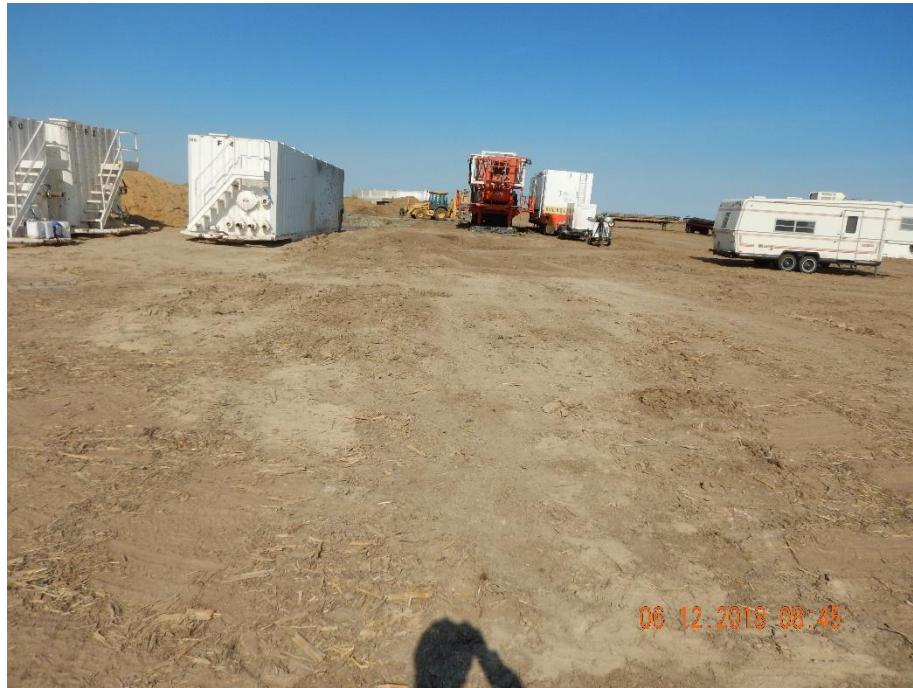
Photo 9: Photo taken from the east end of the location, facing west. See comments under photo 1.

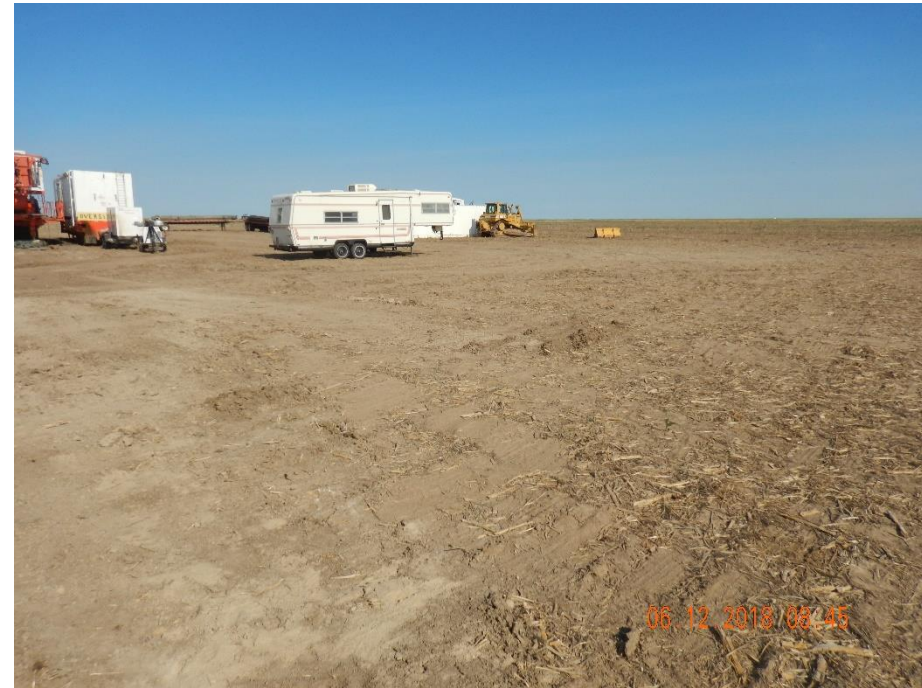
Photo 10: P Photo taken from the east end of the location, facing north. See comments under photo 1.

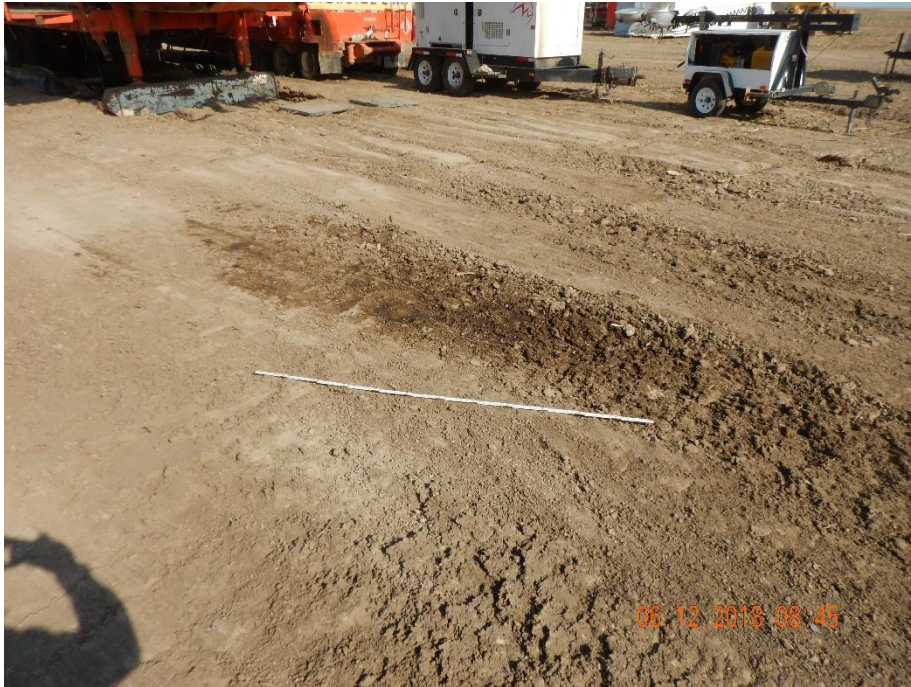
Photo 11: Photo taken from the eastern side of where the drill rig sits. Photo shows areas where stained and/or contaminated soil from various spills or drips were observed on the topsoil of the location. 6 foot measuring stick for reference. This is not protective of topsoil in accordance to 1001.a

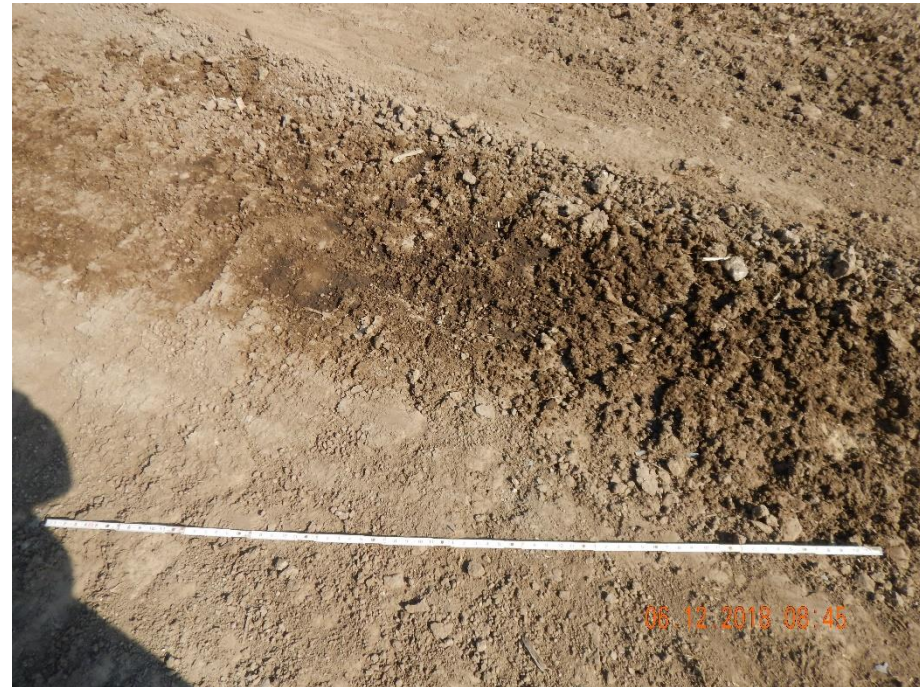
Photo 12: See comments under photo 11.

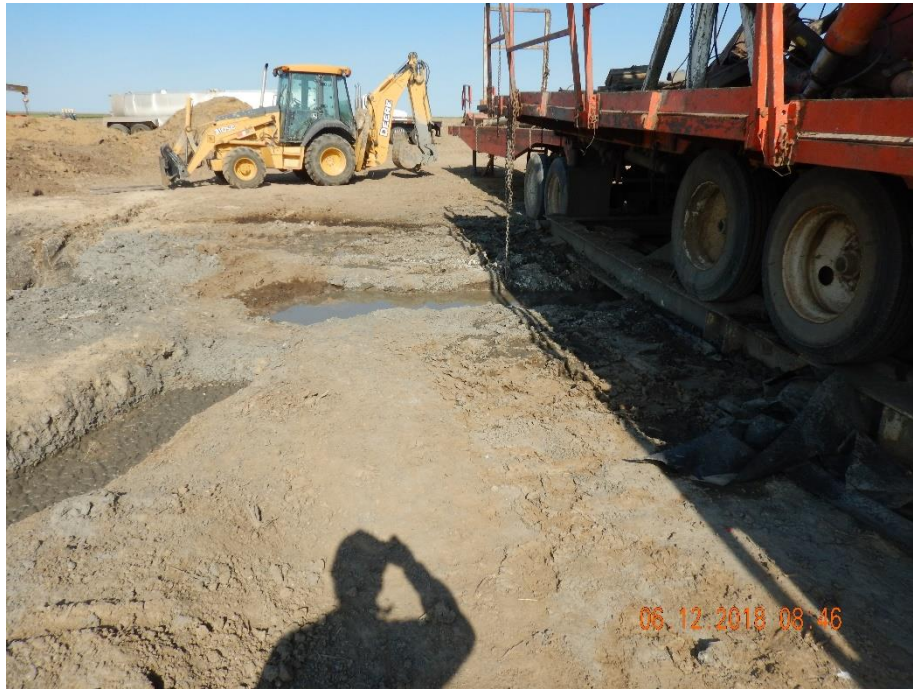
Photo 13: Photo taken at from the southern side of the drill rig. Photo shows areas where what appears to be drilling mud and various other chemical contaminants have spilled on the topsoil of the location.

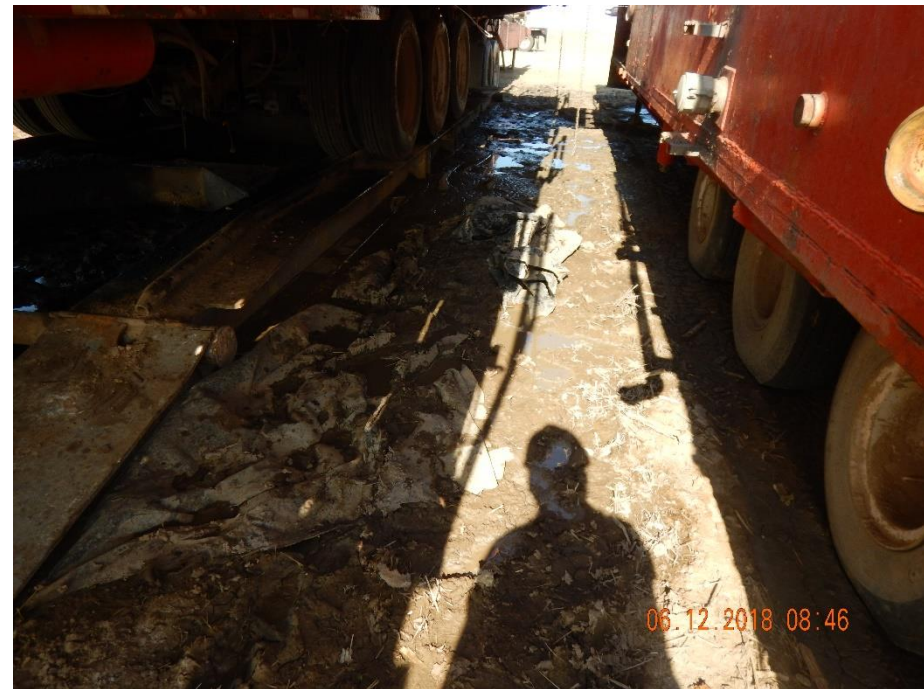
Photo 14: Photo taken at from the northern side of the drill rig. Photo shows areas where what appears to be drilling mud and various other chemical contaminants have spilled on the topsoil of the location.

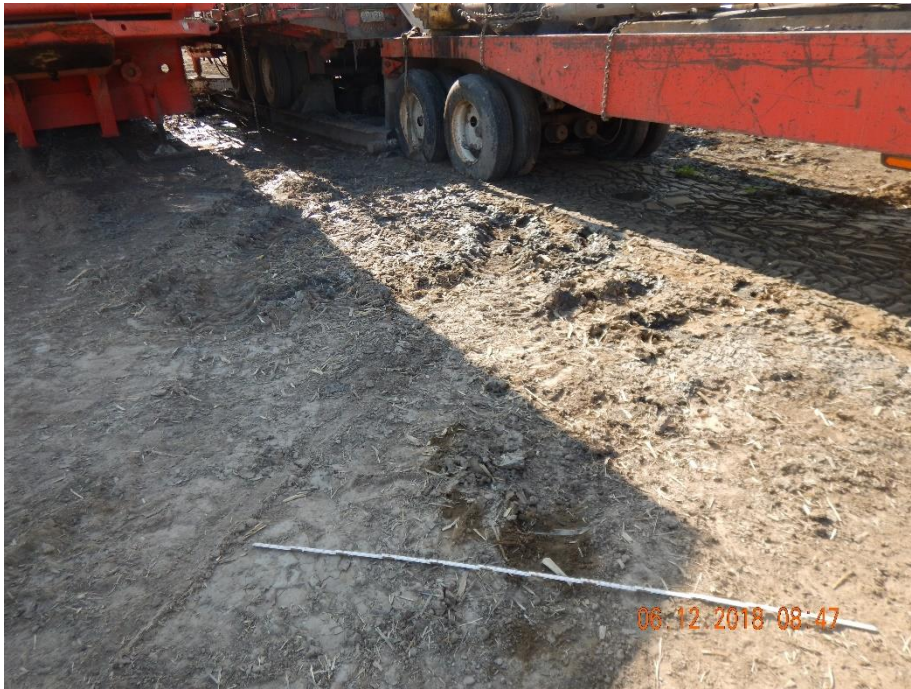
Photo 15: Photo taken from the west end of the drill rig. Photo shows areas where what appears to be drilling mud and various other chemical contaminants have spilled on the topsoil of the location.

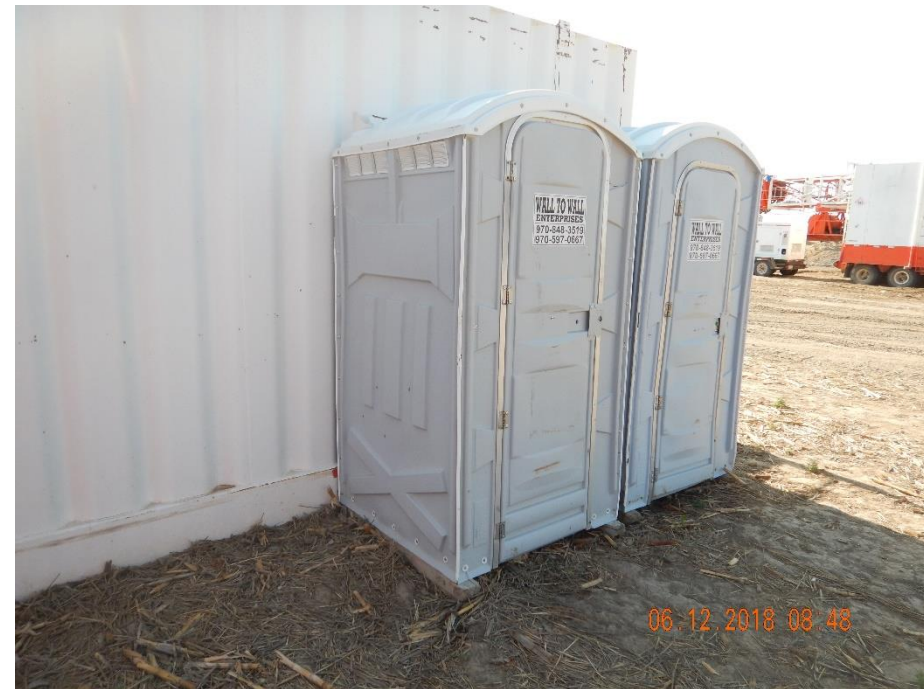
Photo 16: Photo taken from the northern end of the location. Photo of two (2) portable toilets on location. Photo shows portable toilets have not been staked down, or secured in accordance to best management practices.

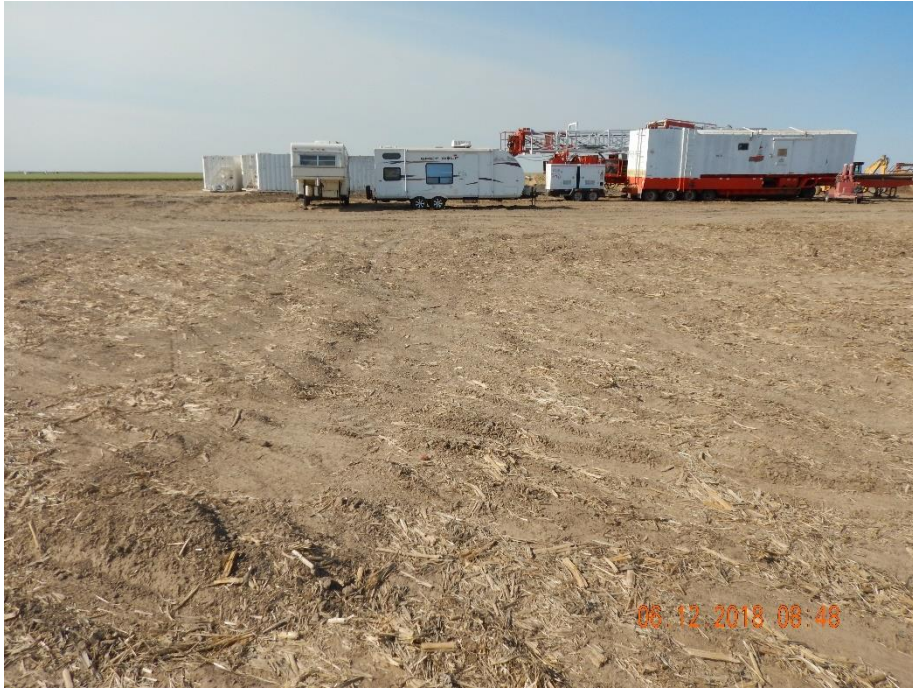
Photo 17: Photo taken from the north end of the location, facing south. See comments under photo 8.

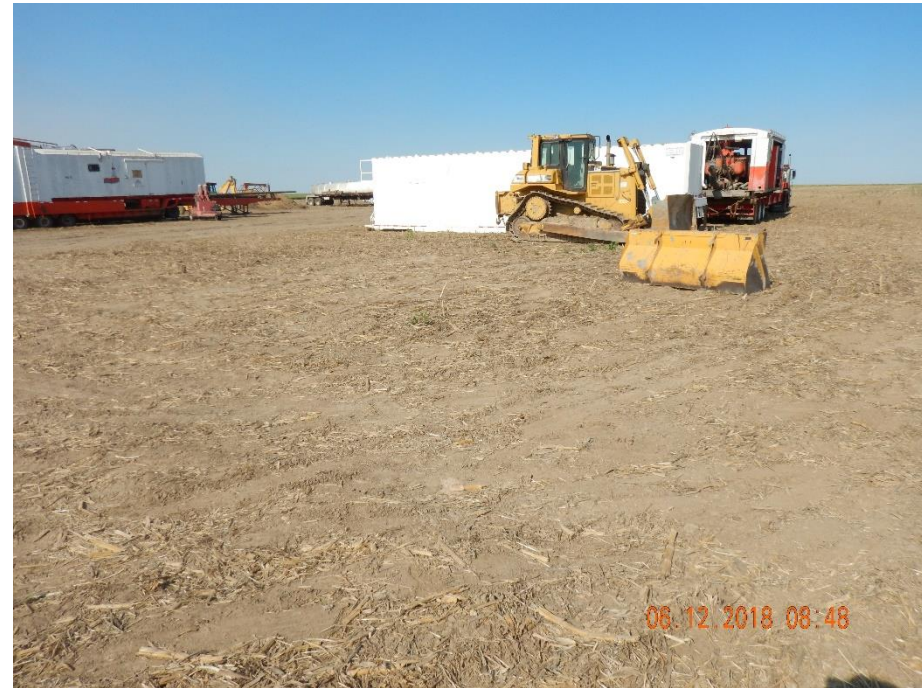
Photo 18: Photo taken from the north end of the location, facing southwest. See comments under photo 8.

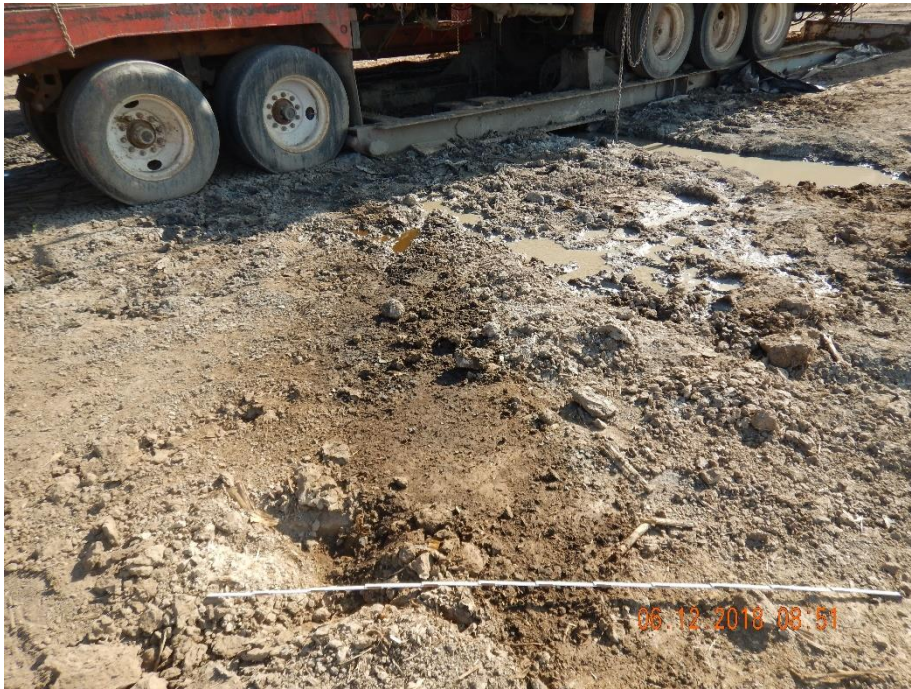
Photo 19: Photo taken at from the southwest end of the drill rig. Photo shows areas where what appears to be drilling mud and various other chemical contaminants have spilled on the topsoil of the location. 6 foot measuring stick for reference.

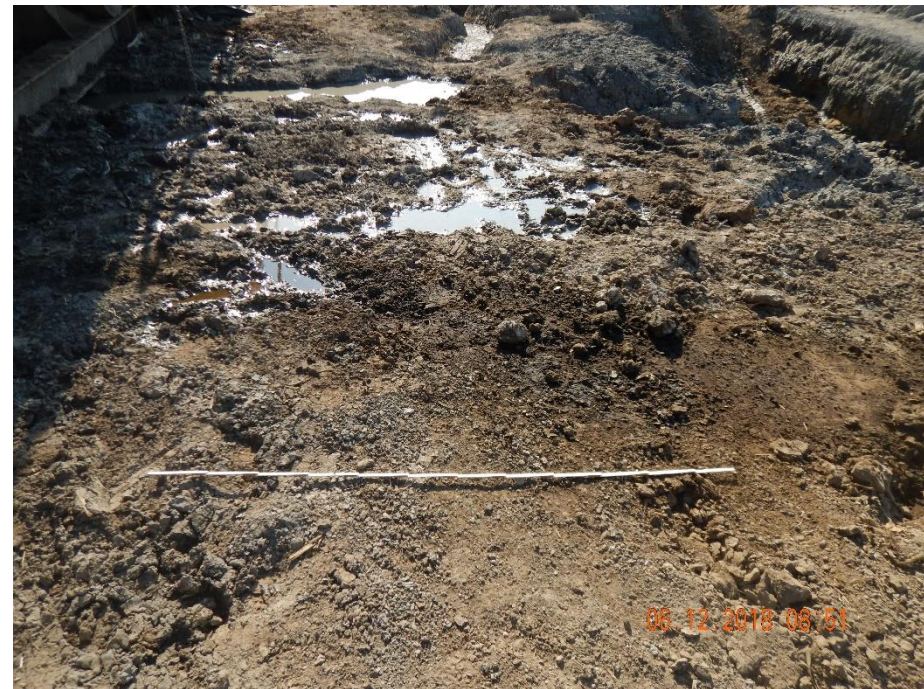
Photo 20: See comments under photo 19.

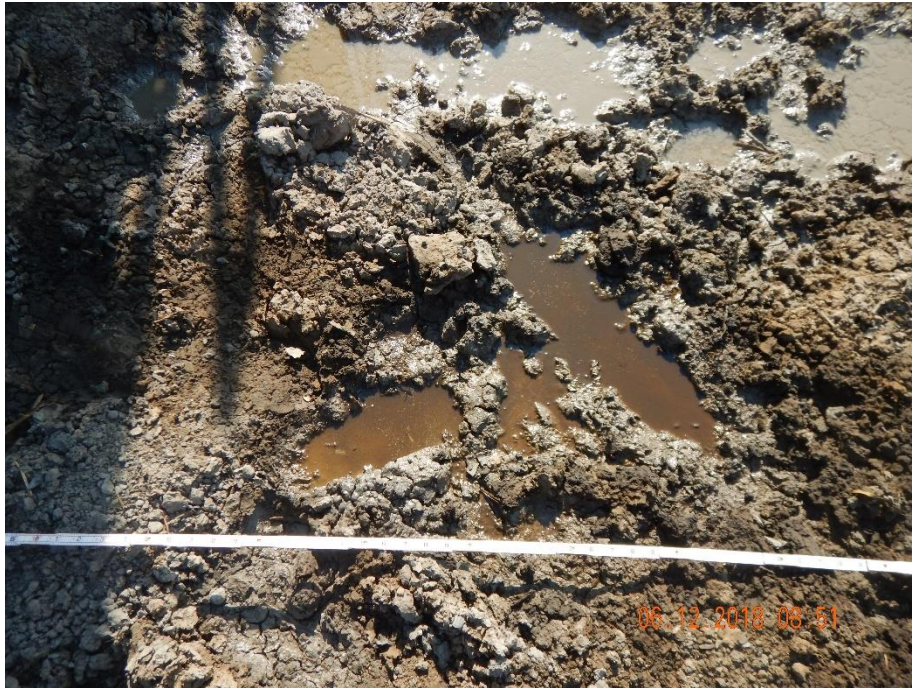
Photo 21: See comments under photo 19.

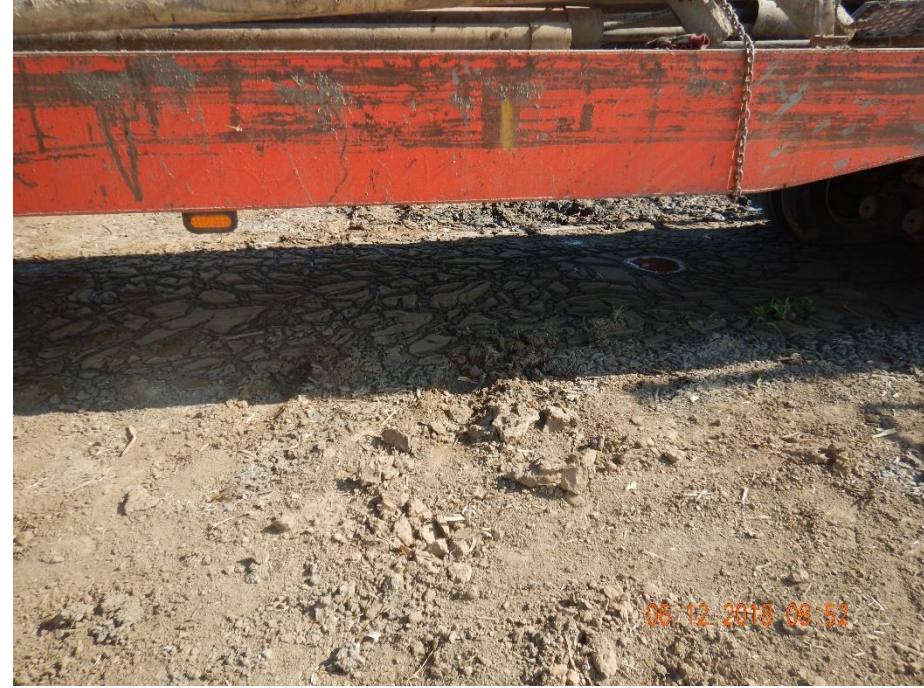
Photo 22: See comments under photo 19.

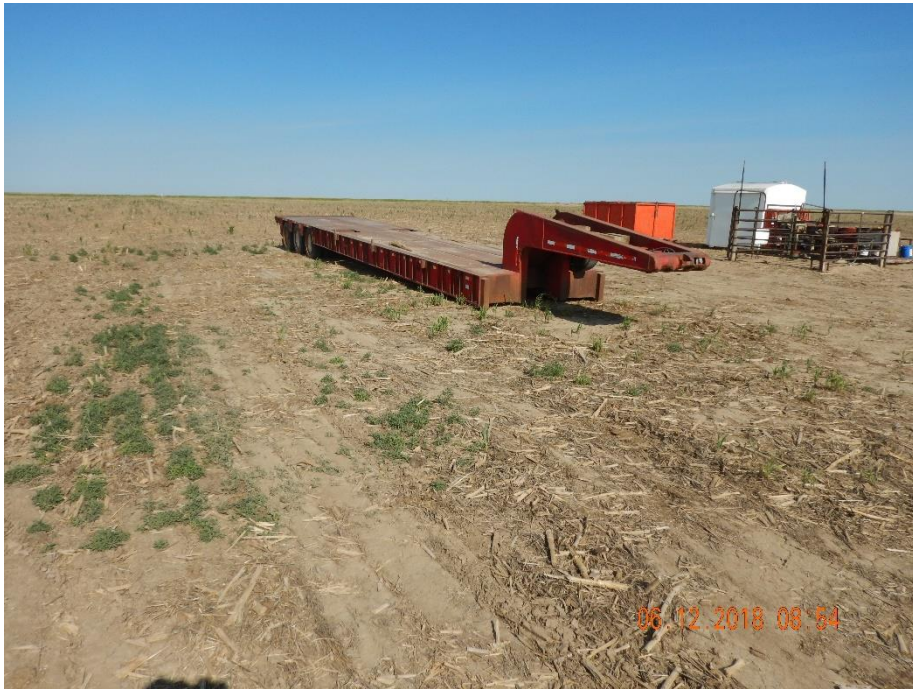
Photo 23: Photo taken from the southeast end of the State 11-16 well (121-10990). Photo shows operator has stored various equipment for the location being constructed at this site. Disturbances created at this location will need to be reclaimed.

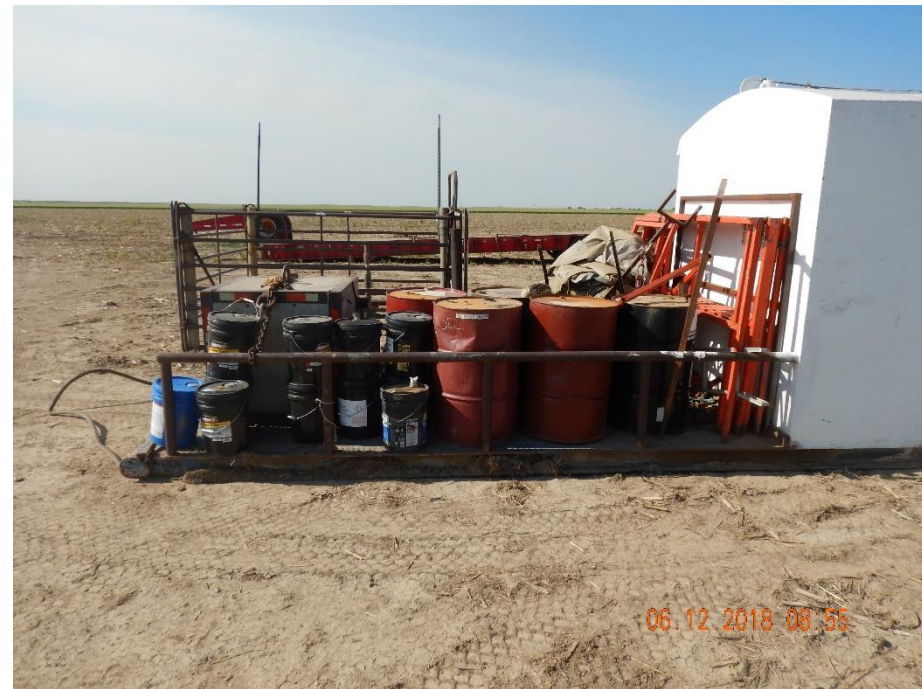
Photo 24: Photo taken from the northern end of the State 11-16 well (121-10990). Photo shows operator has stored various equipment for the location being constructed at this site. Disturbances created at this location will need to be reclaimed.
