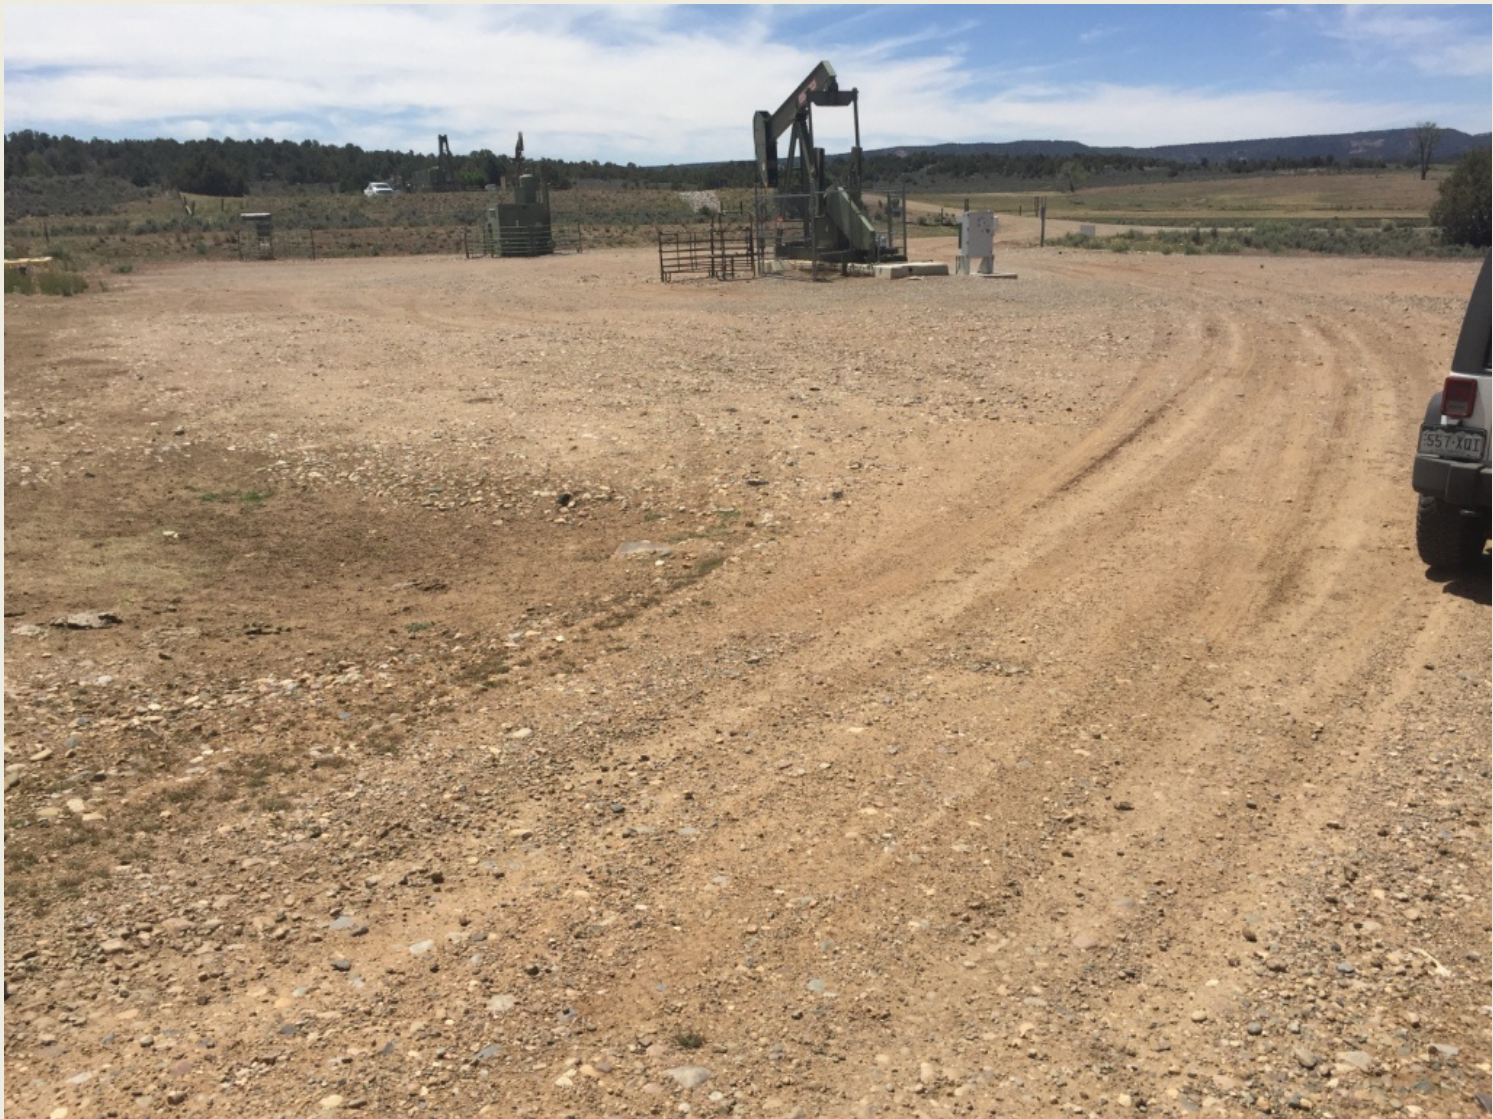
Photo 1. View of the project area from the northeastern corner facing center.

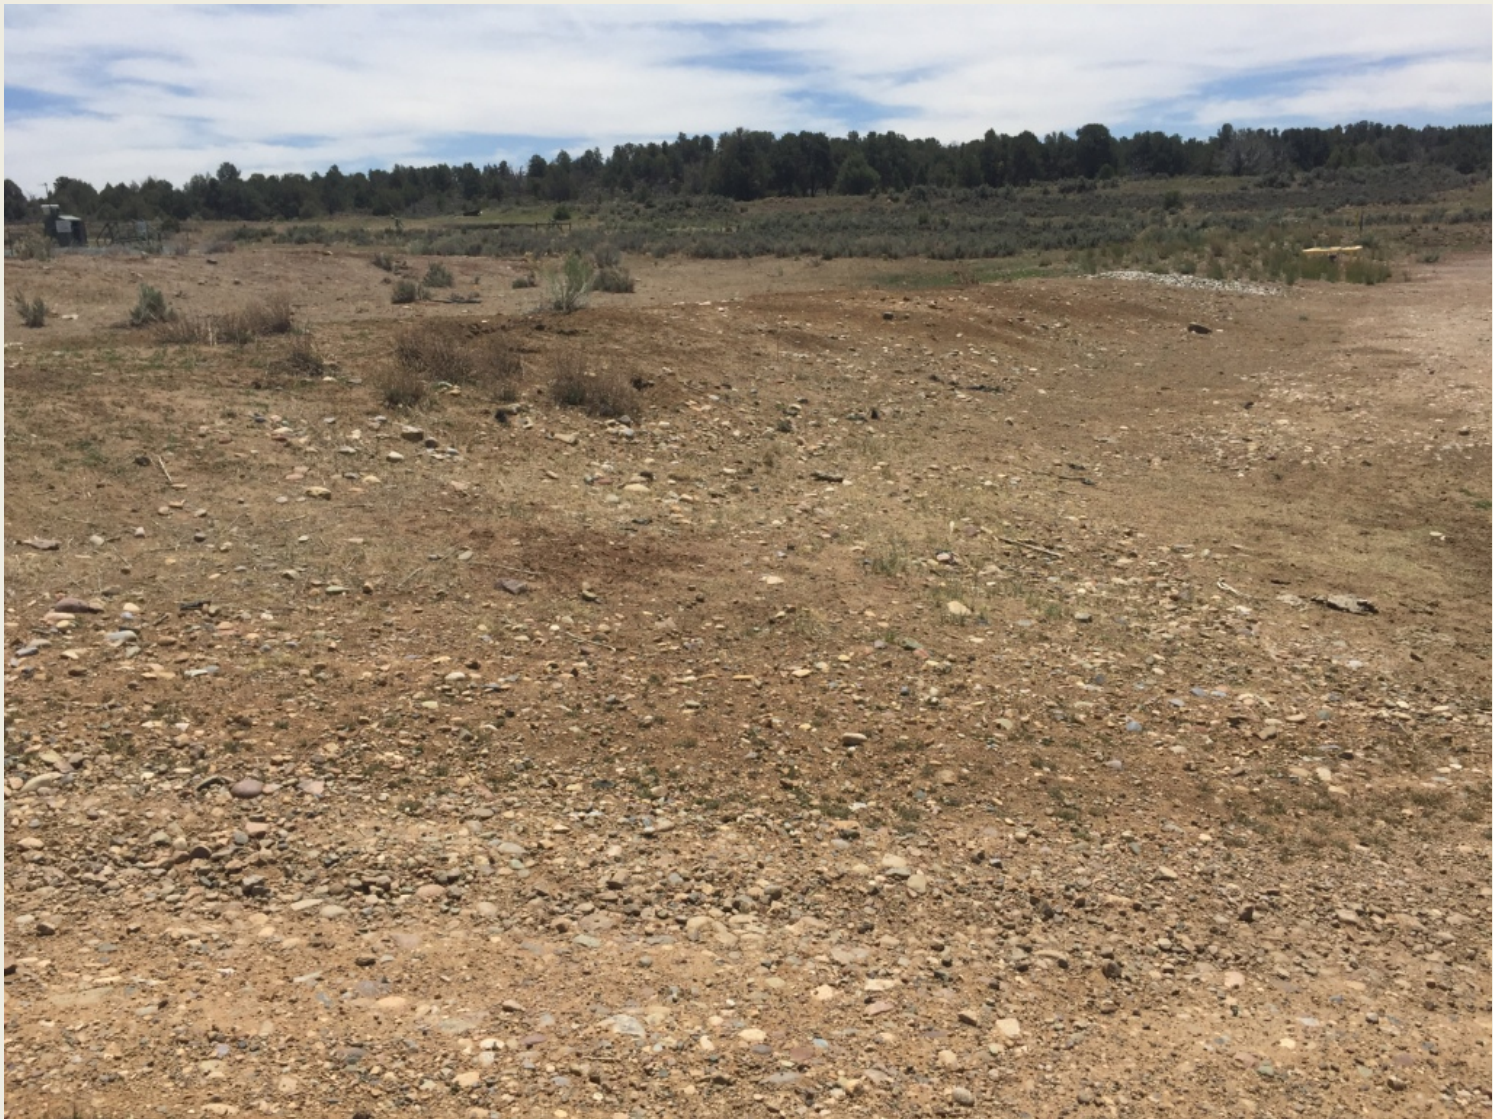
Photo 2. View of the eastern portion of the project area from the northeastern edge facing southward. Poor revegetation and rilling observed in the northeastern interim reclamation area. This needs to be monitored and stormwater controls installed if erosion worsens, and re-seeding if revegetation is not increasing.

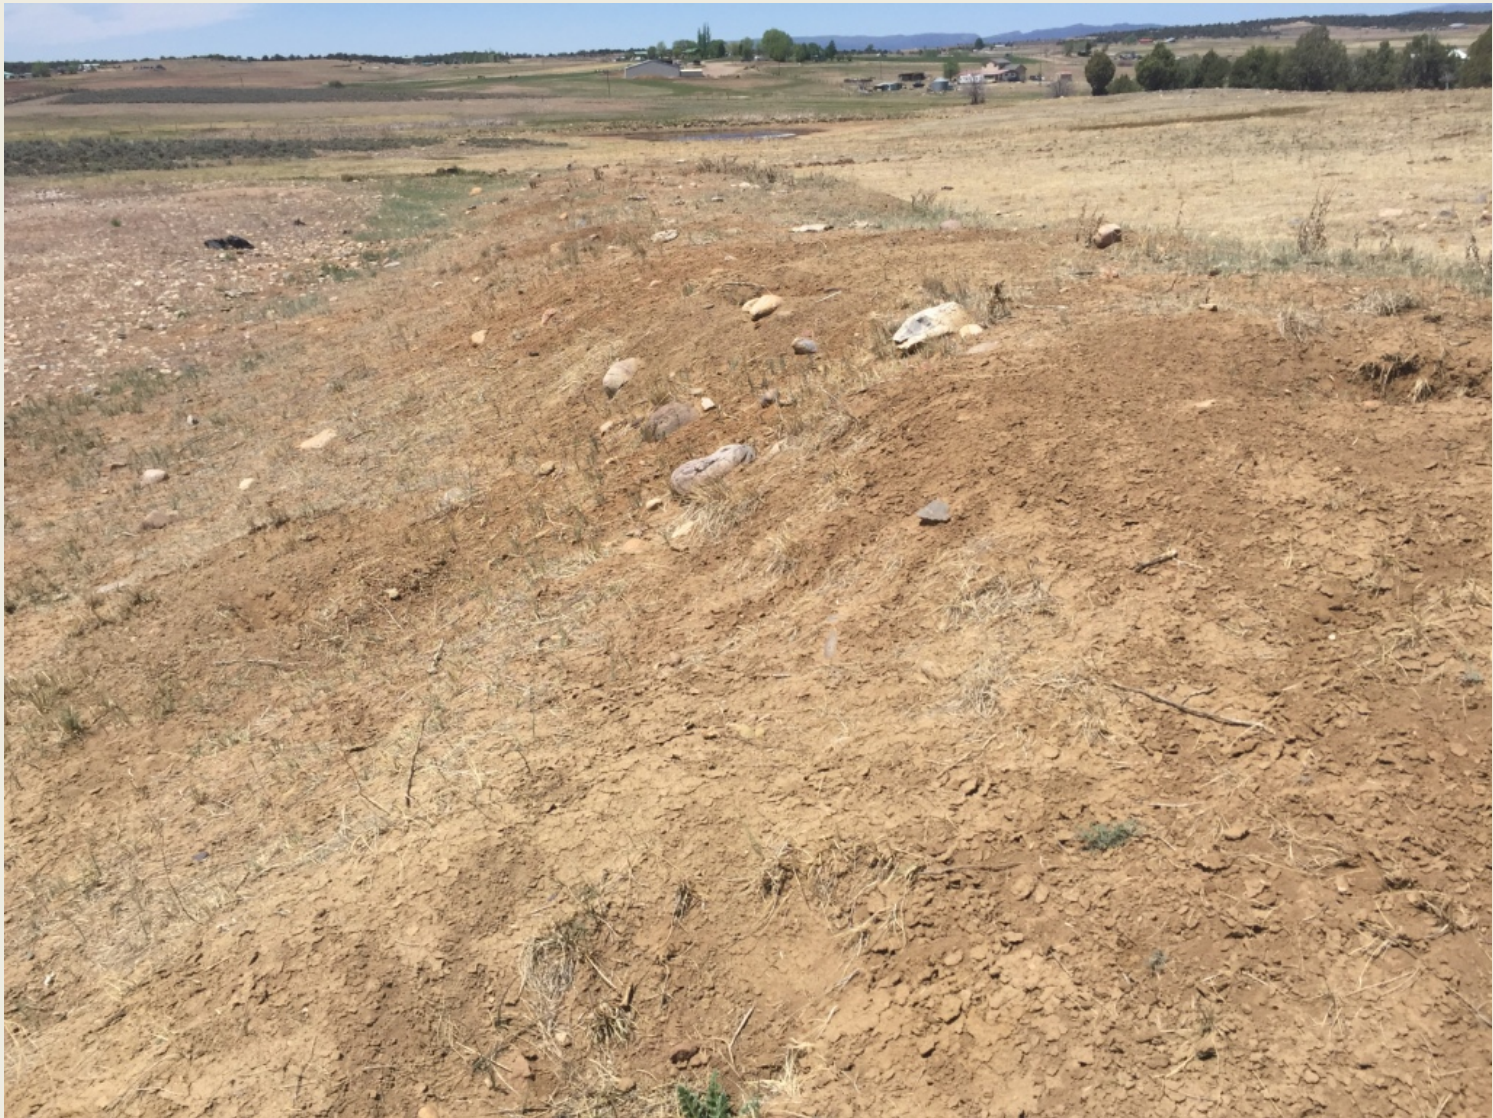
Photo 3. View of the northern portion of the project area from the northeastern corner facing westward.

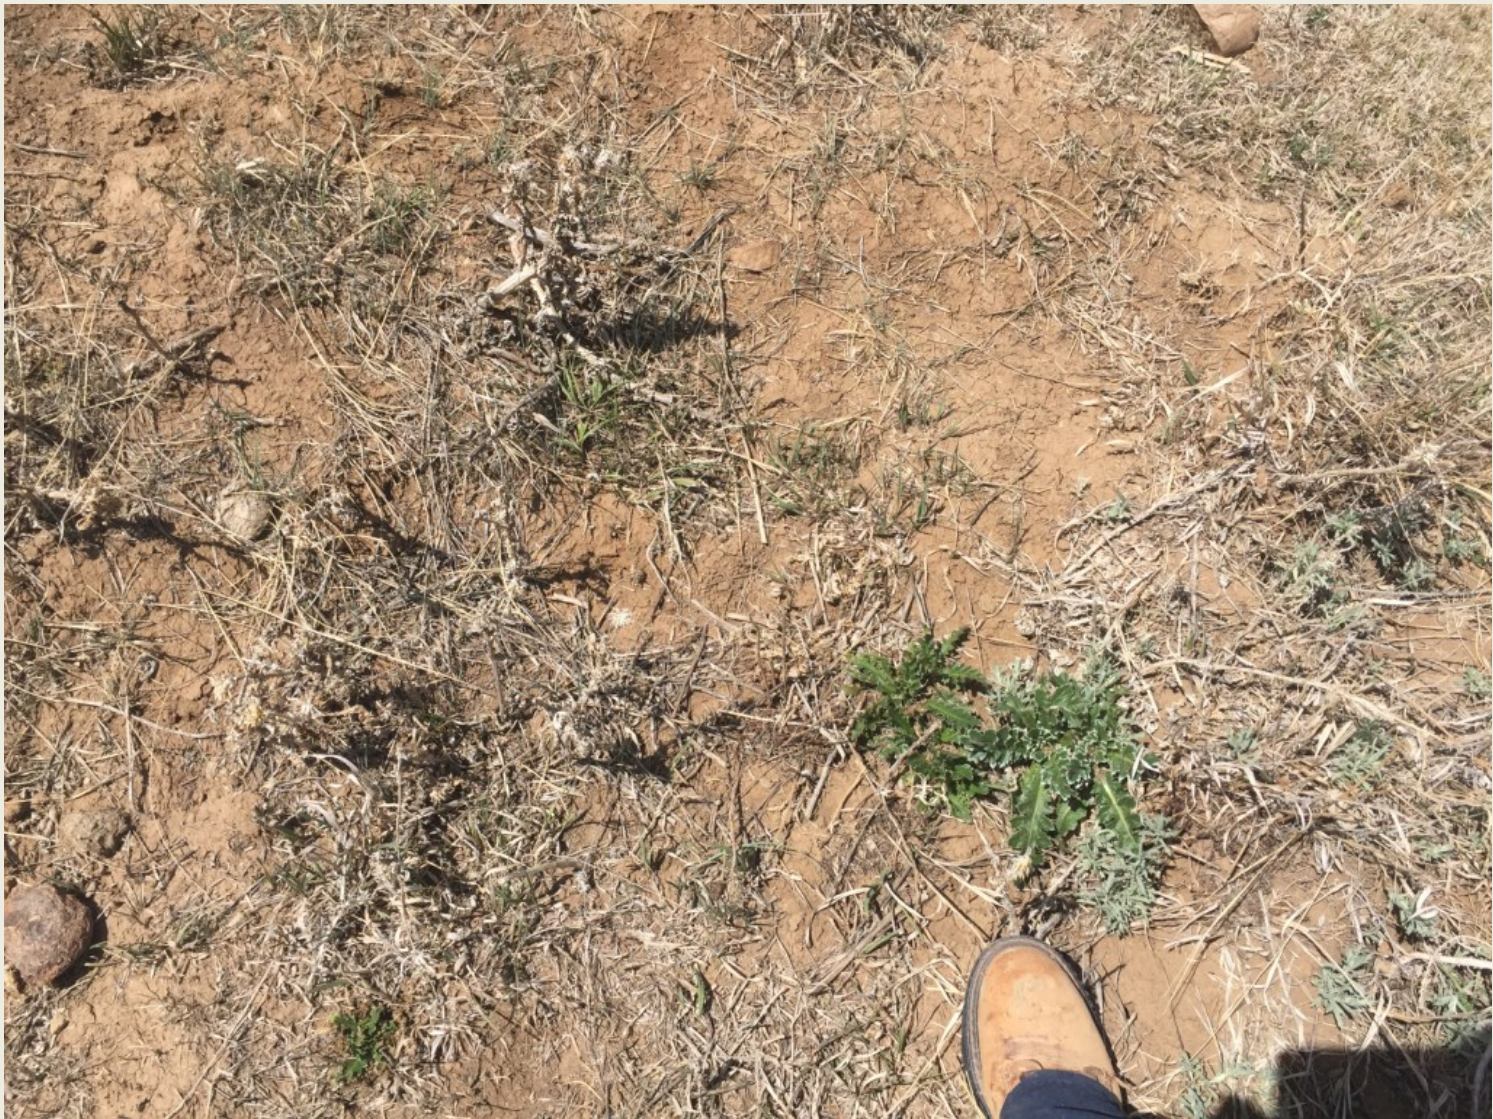
Photo 4. View of musk thistles (*Carduus nutans*) within the project area.
