# *Inspection Photos*

*API#081-07364*

*Operator: Tatonka O&G*

*Inspection Number: 6741*

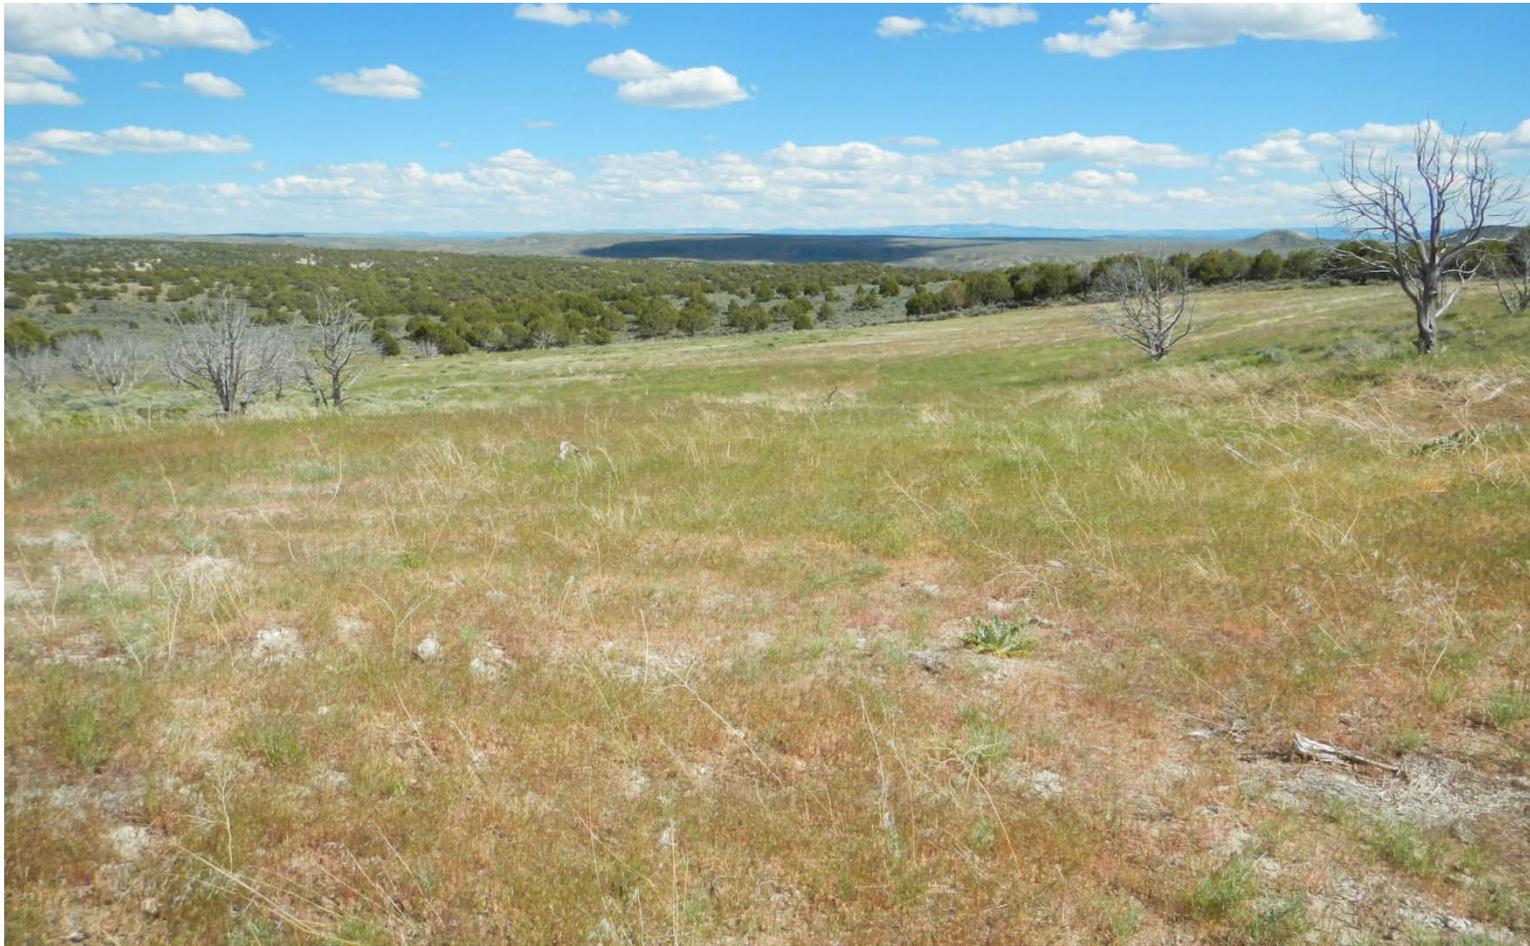
Photo#1:  
Overview of Location from Entry to Southeast.

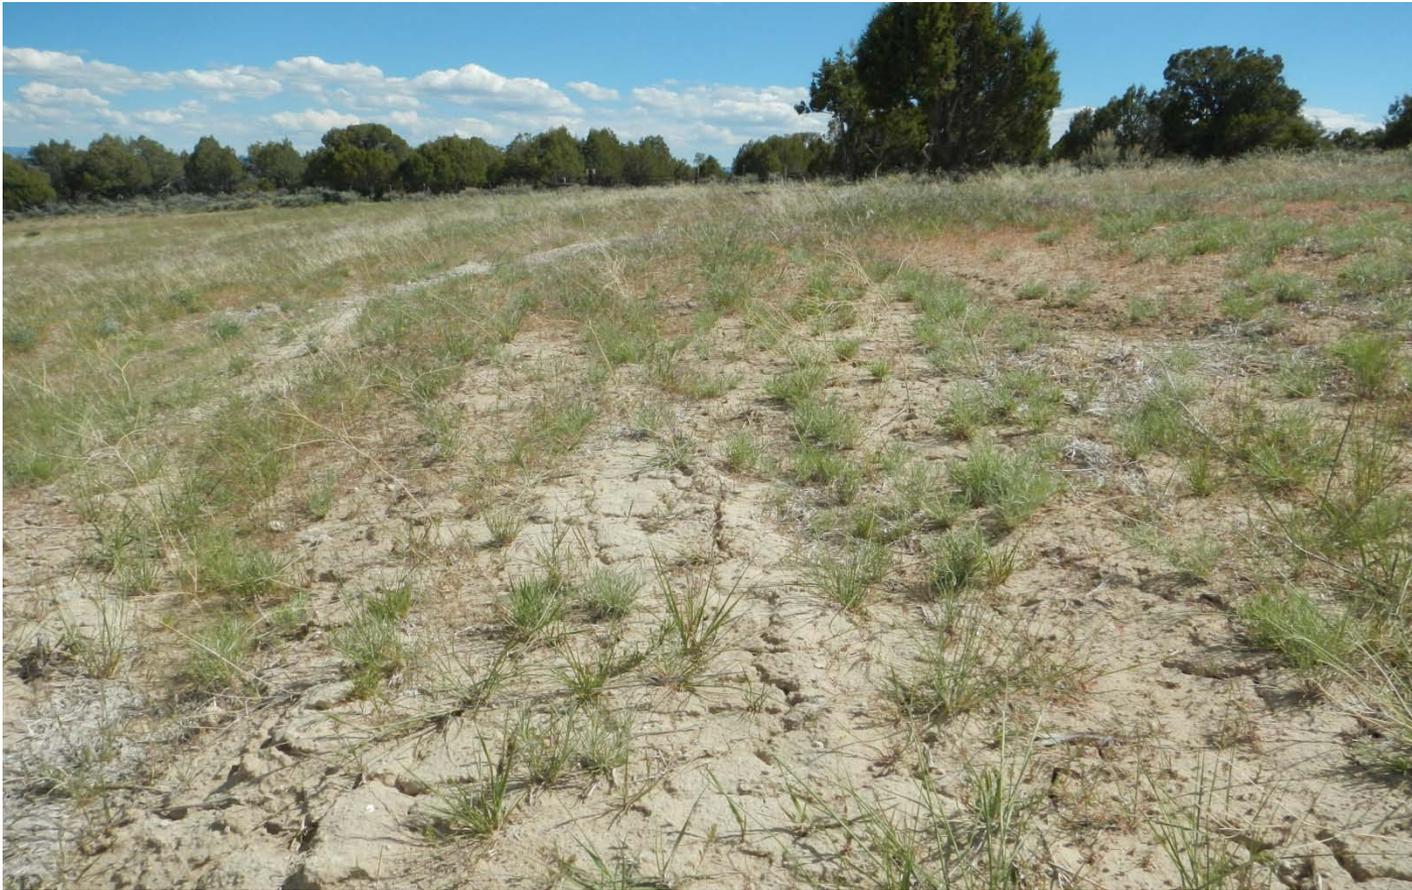
Photo#2:  
Top of what was Cut slope at West side of Location looking South

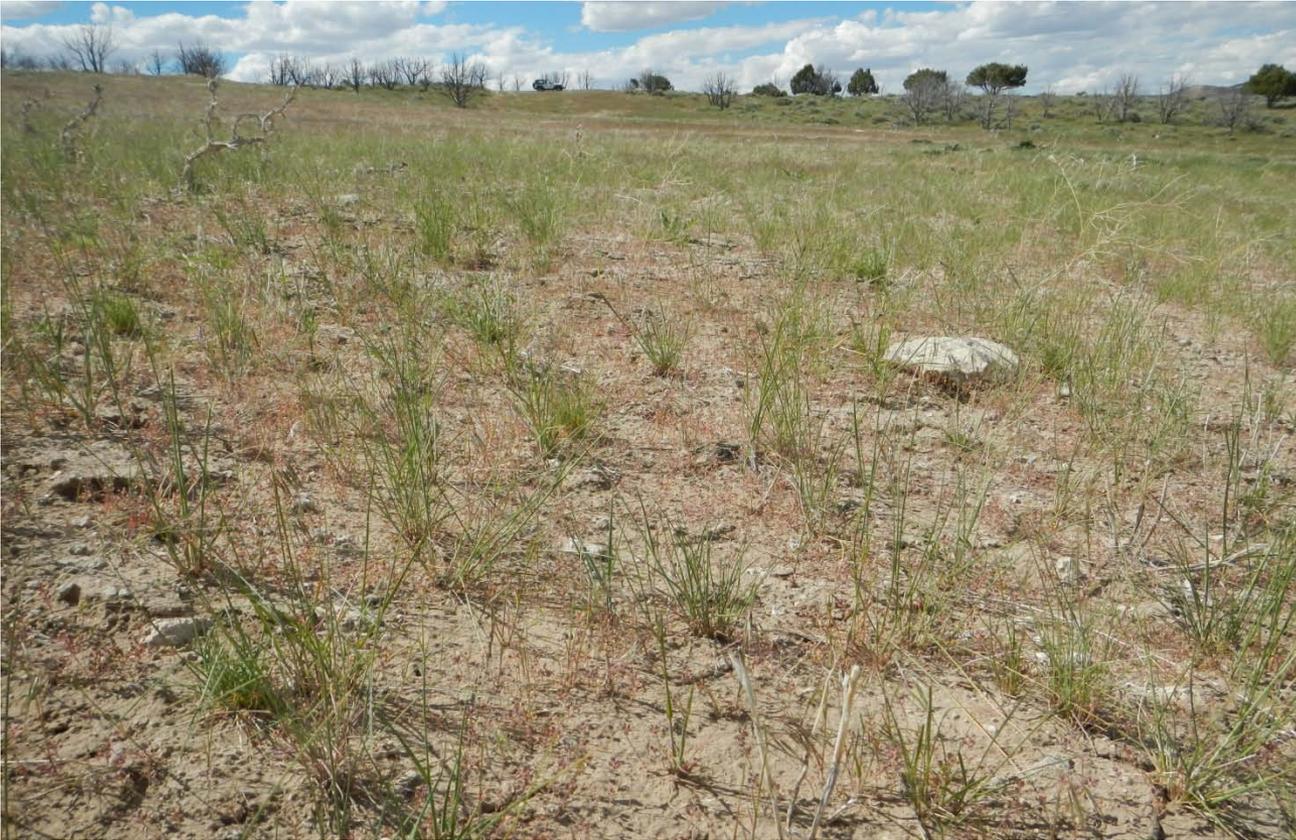
Photo#3:  
View to Northwest .

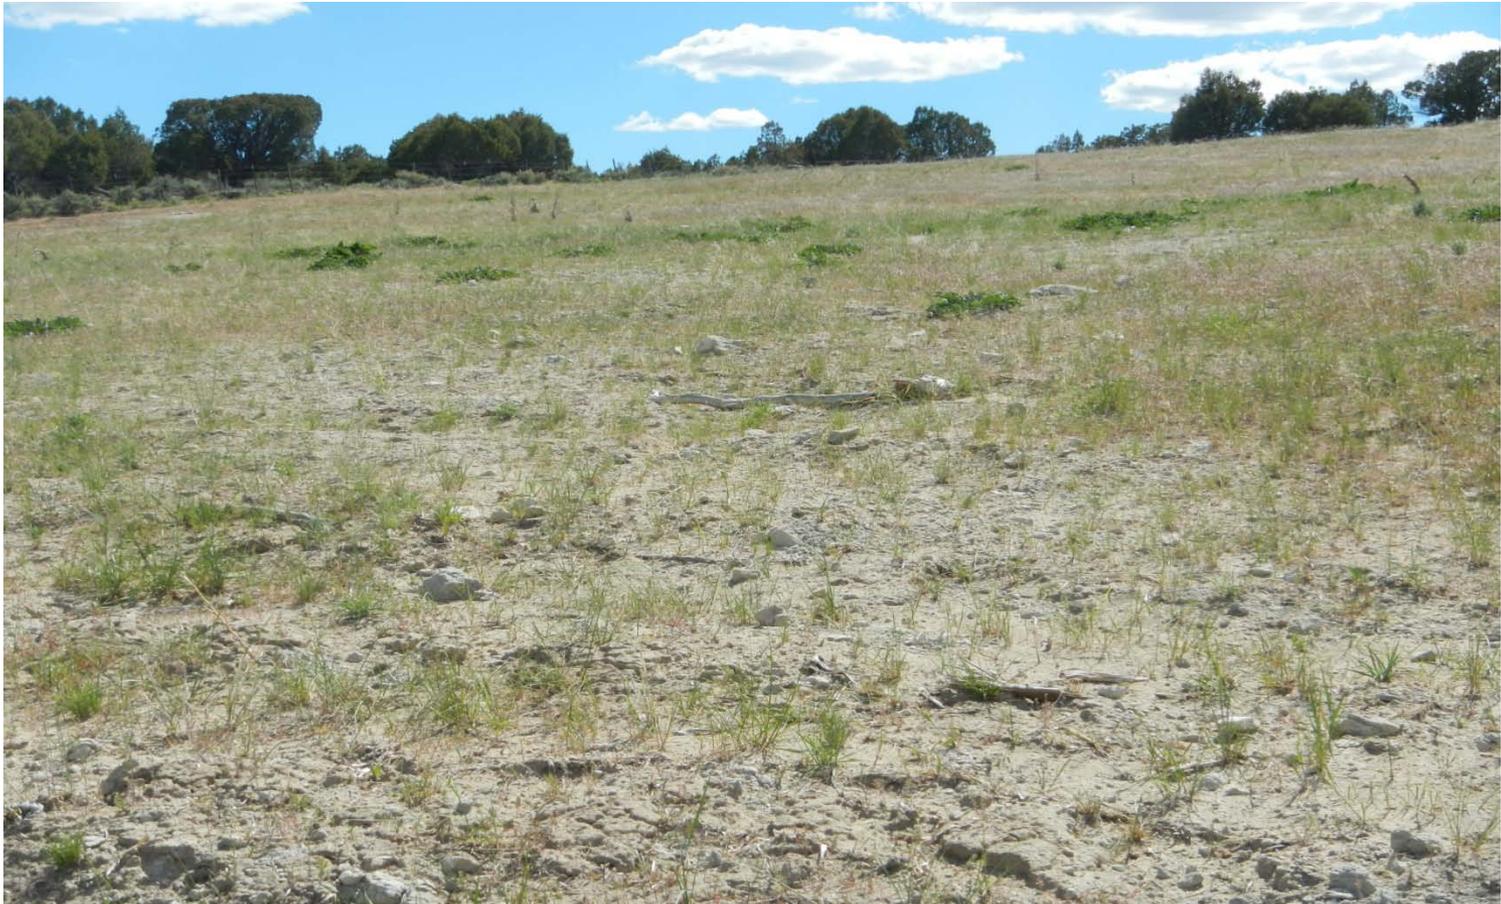
Photo#4:  
View from center of Location to Southwest.

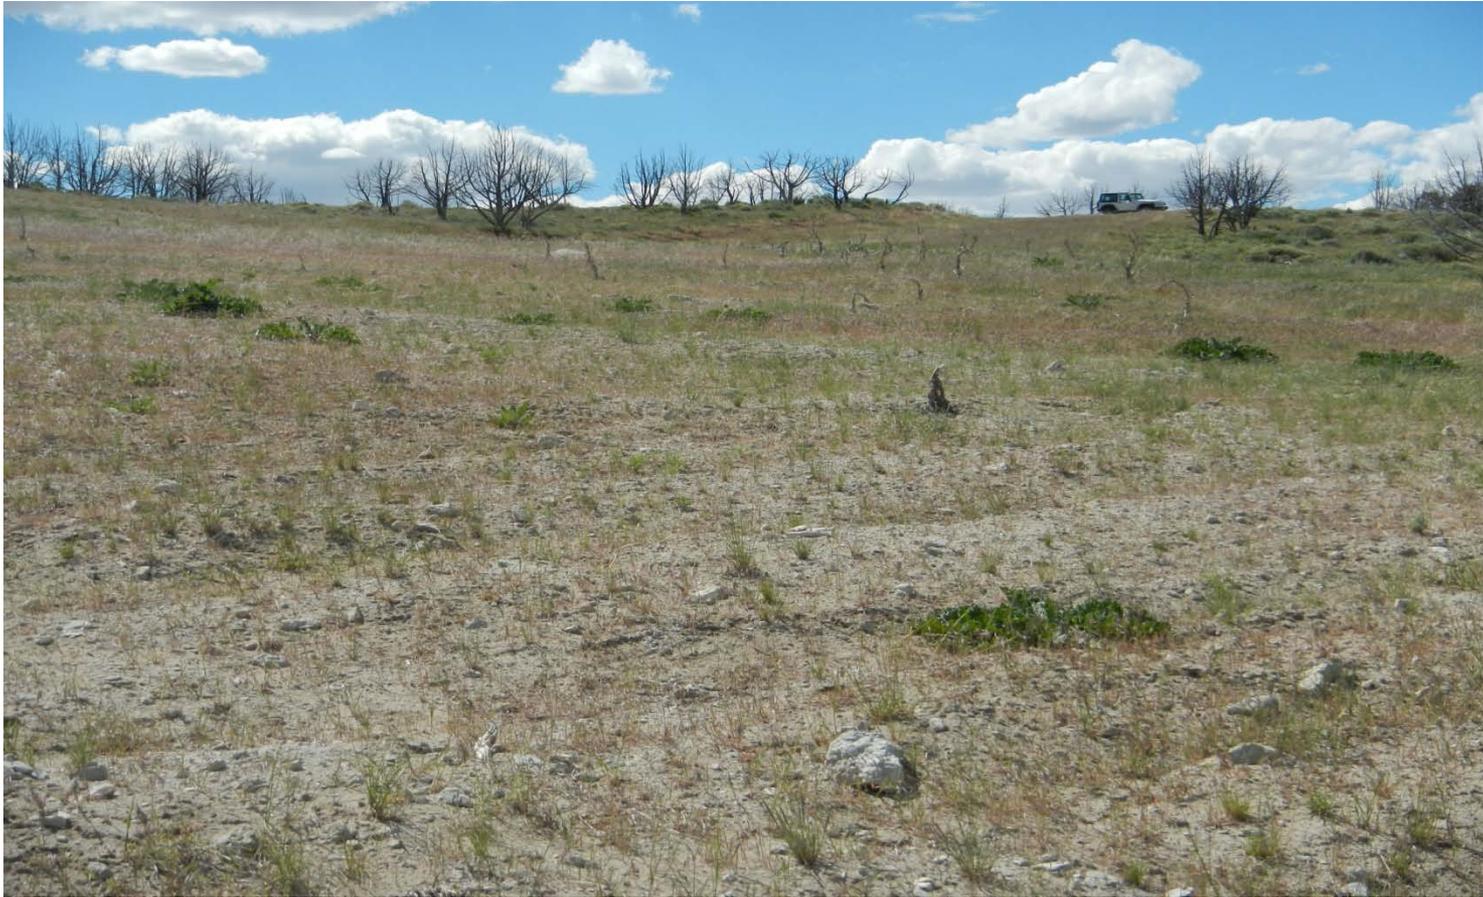
Photo#5:

View from center of Location to Northwest.

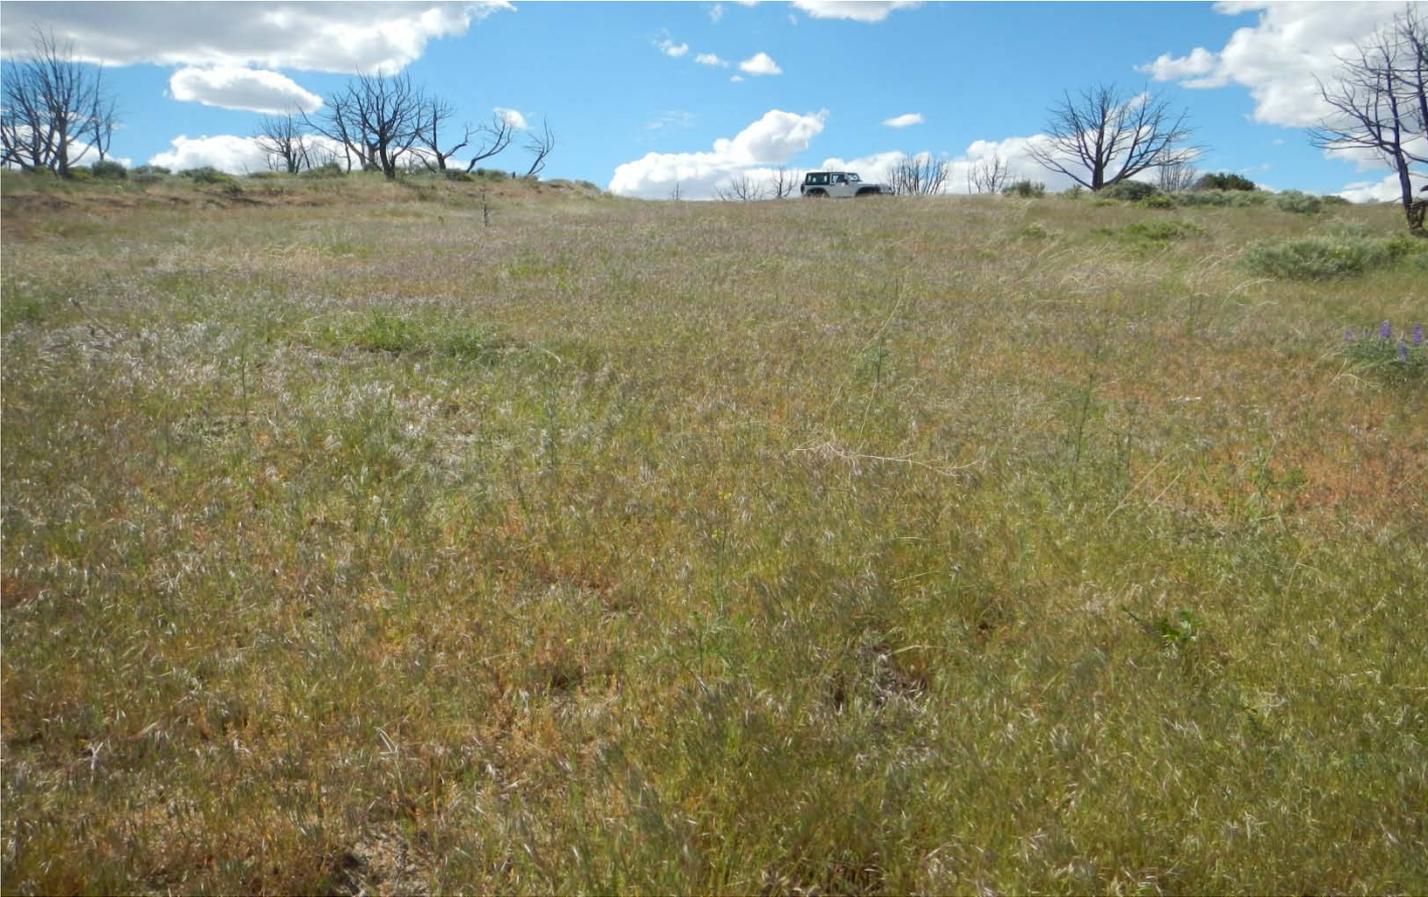
Photo#6:  
View Northwest to Entry.

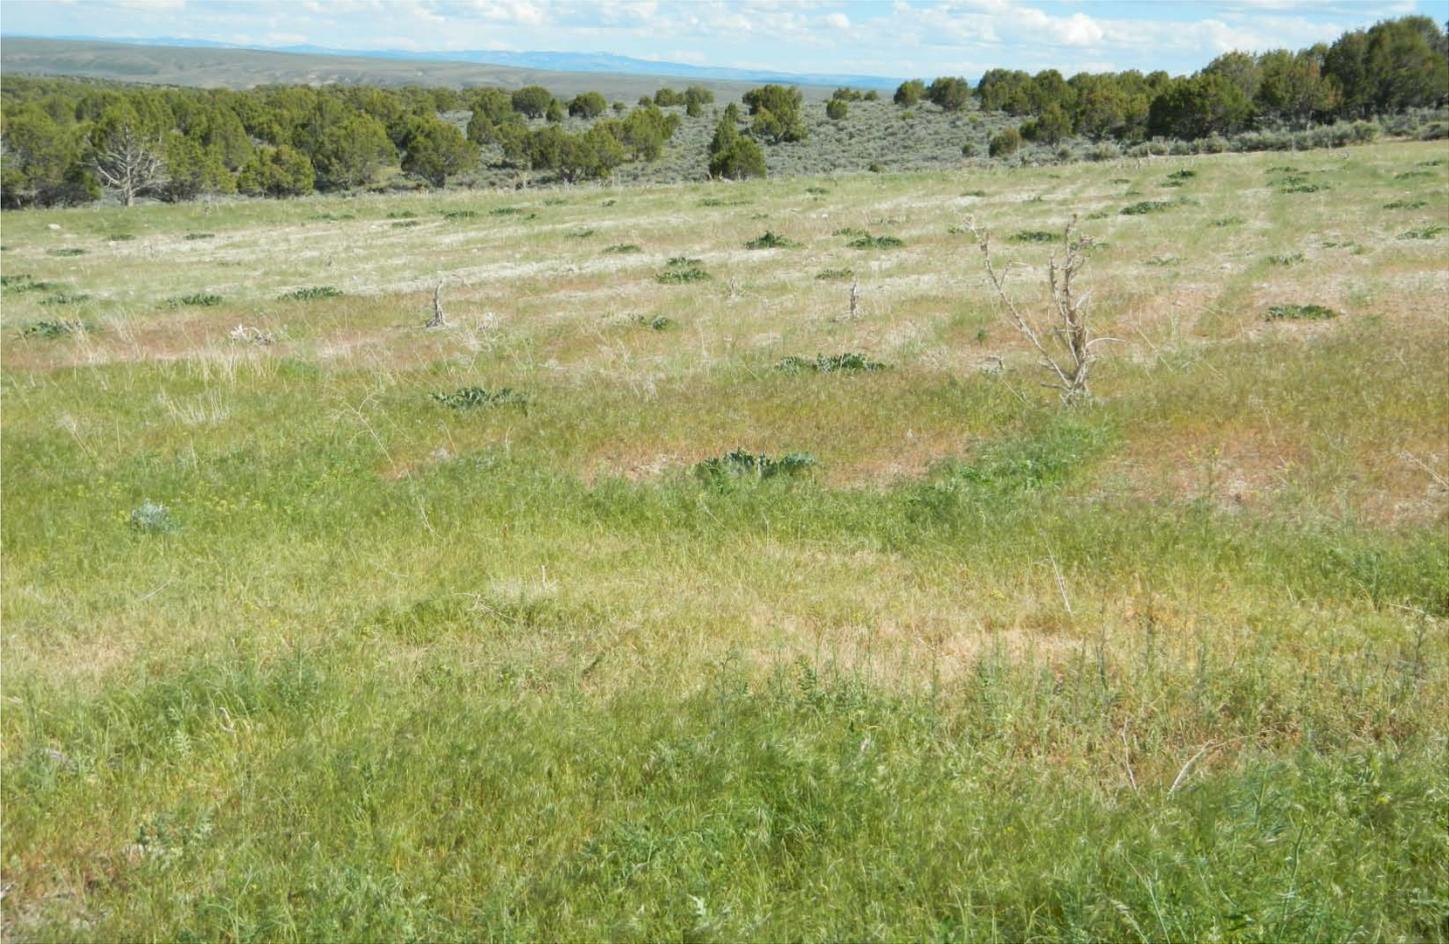
Photo#7:

View from North side of Location to South. Dark green vegetation mounds are Scotch thistle.

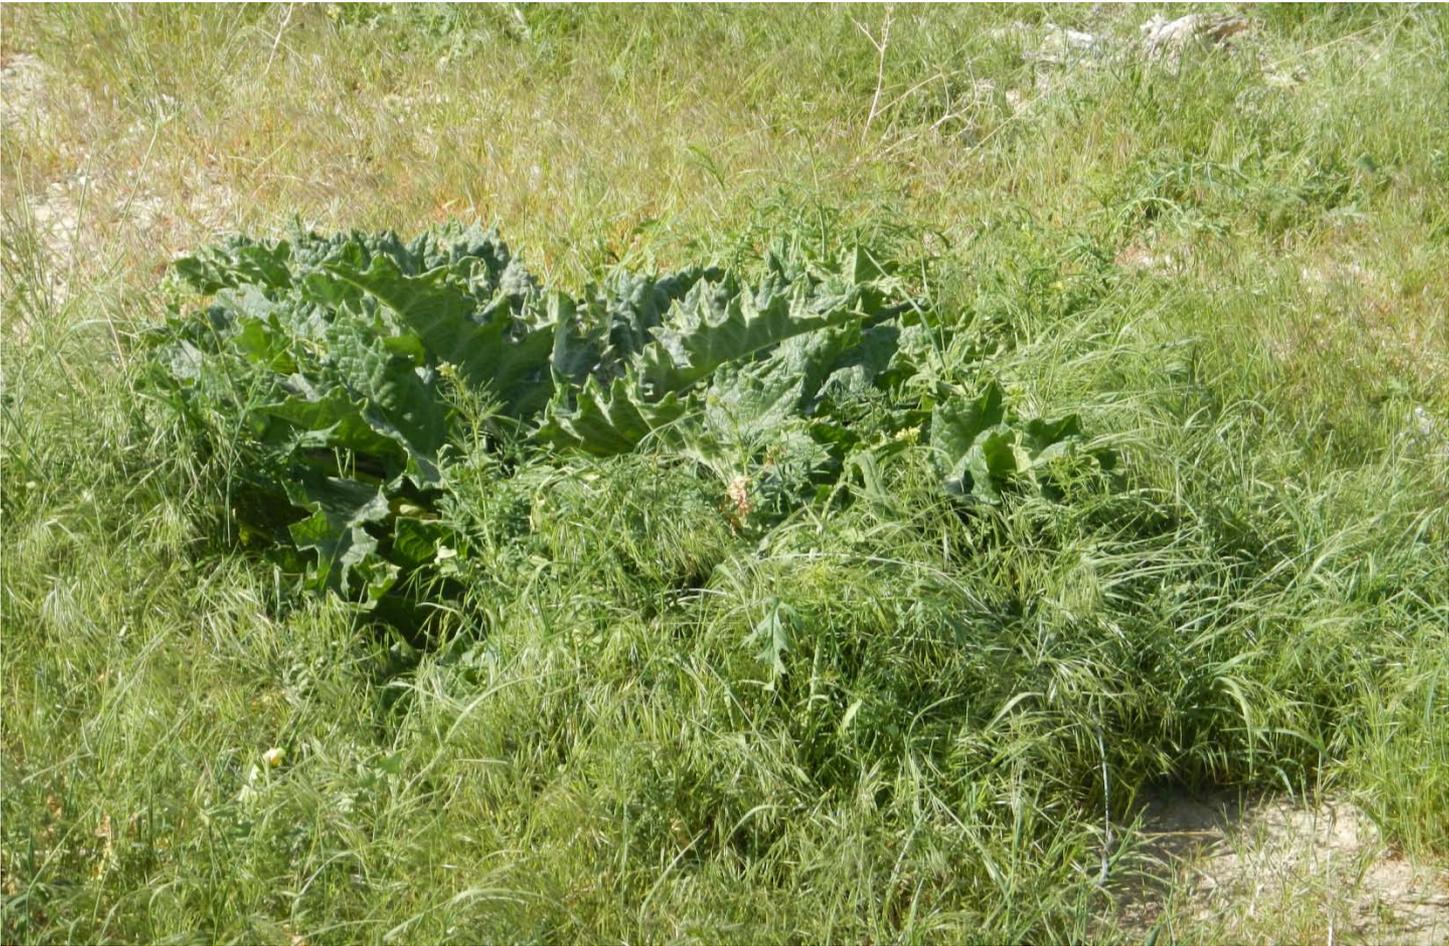
Photo#8:  
Scotch thistle on Location.
