# Inspection Photos

06/15/2018

Operator: FOUNDATION ENERGY  
MANAGEMENT LLC - 10112

Inspection Doc. Number: 682503493  
Weld County, CO

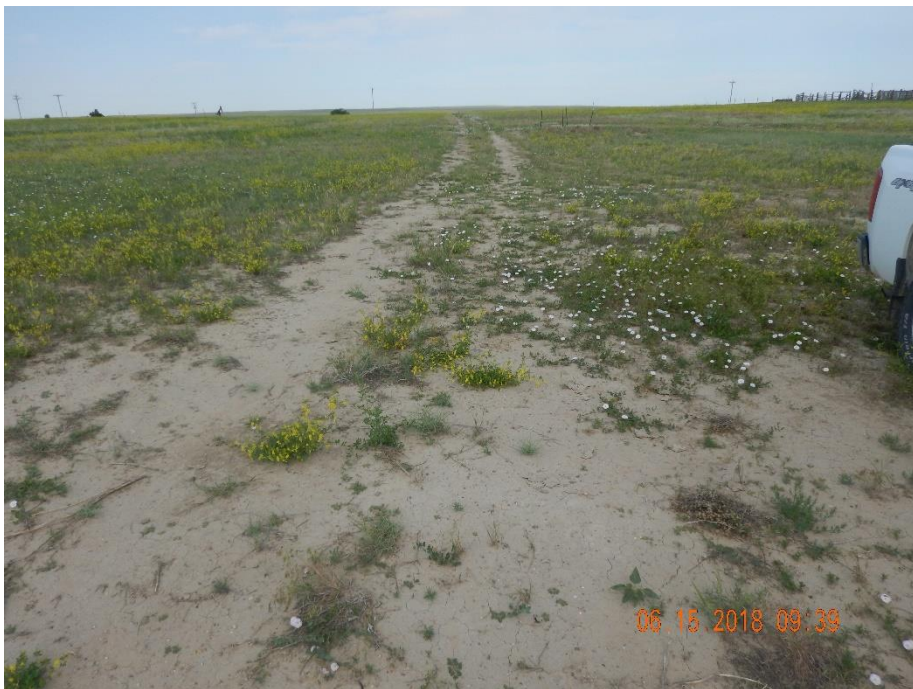
**Photo 1:** Photo taken from the well location, facing west. Photo shows access road has not been reclaimed.

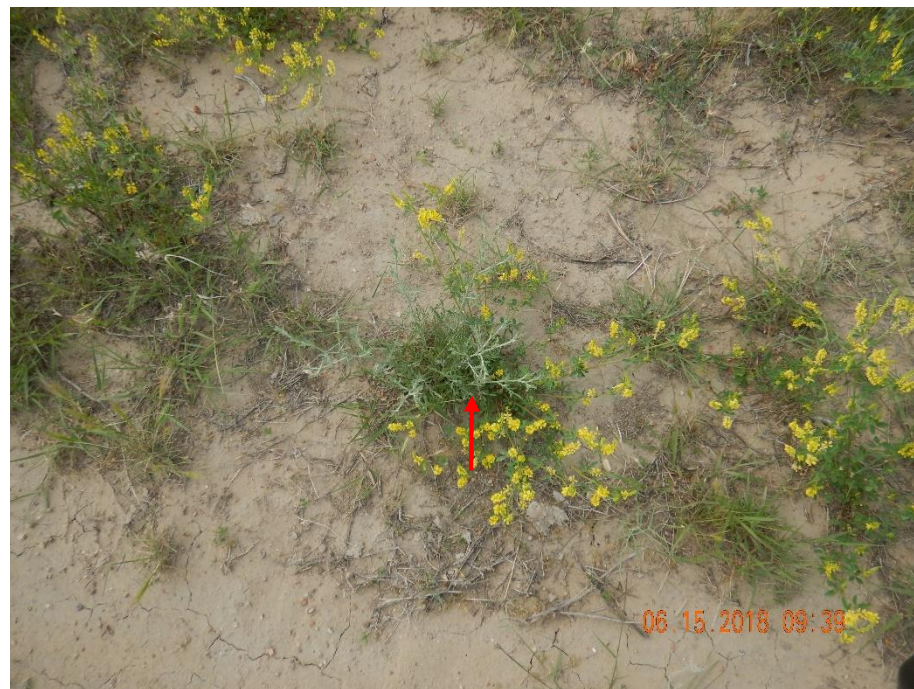
**Photo 2:** Photo taken from the south end of the well location. Photo of Diffuse Knapweed (lighter green plant in photo, red arrow) found on location.

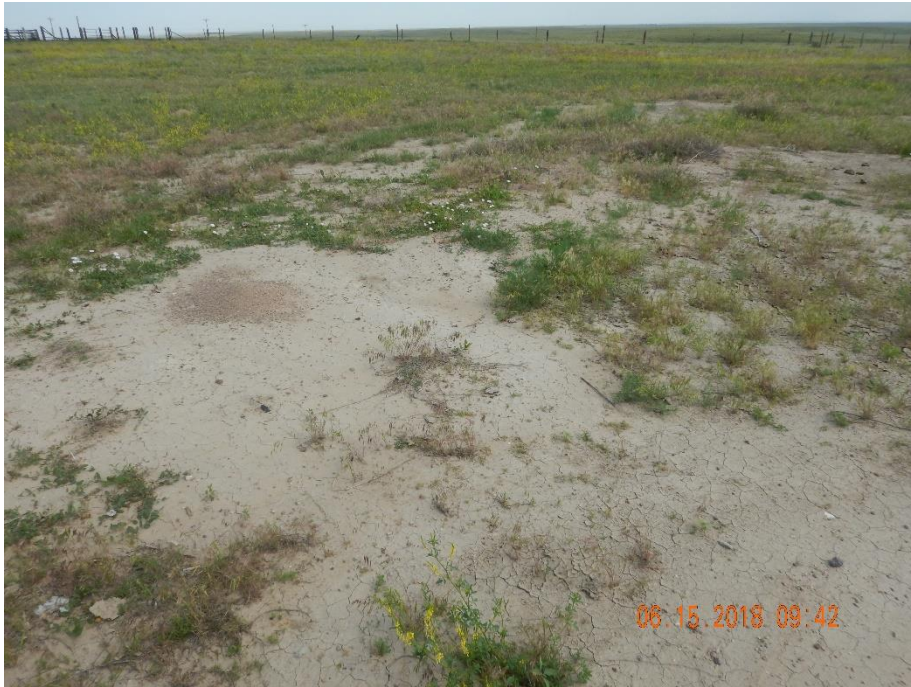
**Photo 3:** Photo taken from the south end of the well location, facing northwest. Photo shows well location remains bare and exposed soil, or predominantly undesirable weedy plant species

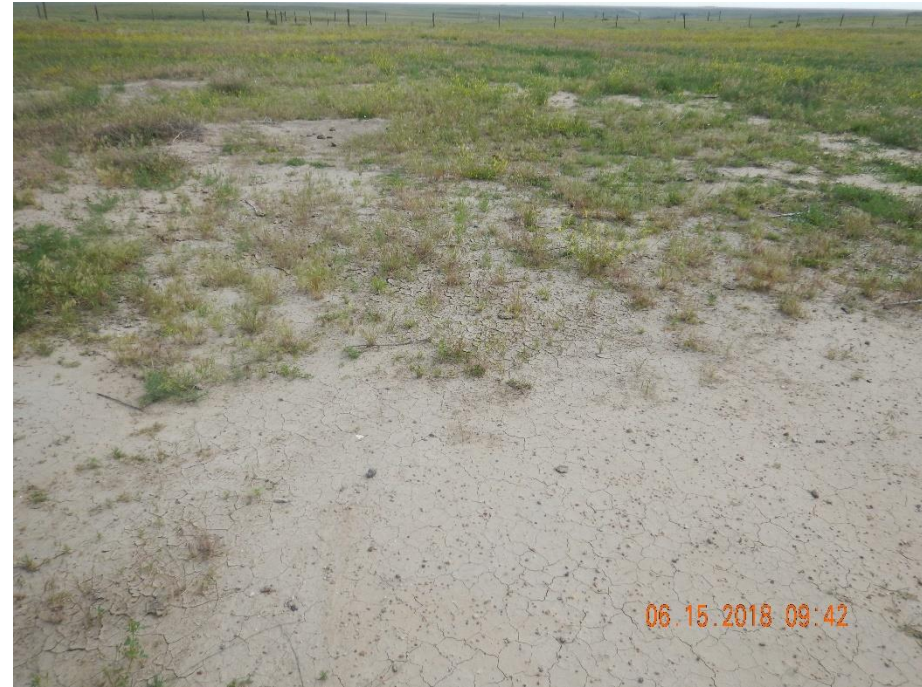
**Photo 4:** Photo taken from the south end of the well location, facing northeast. Photo shows well location remains bare and exposed soil, or predominantly undesirable weedy plant species

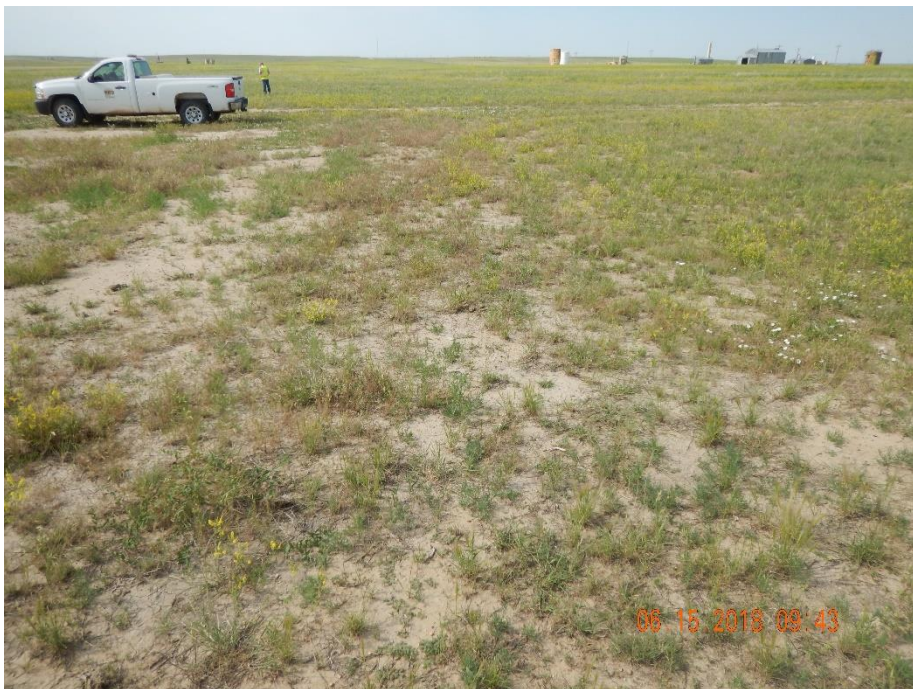
**Photo 5:** Photo taken from the north end of the well location, facing south. Photo shows portion of the access road “loop” that remains evident.

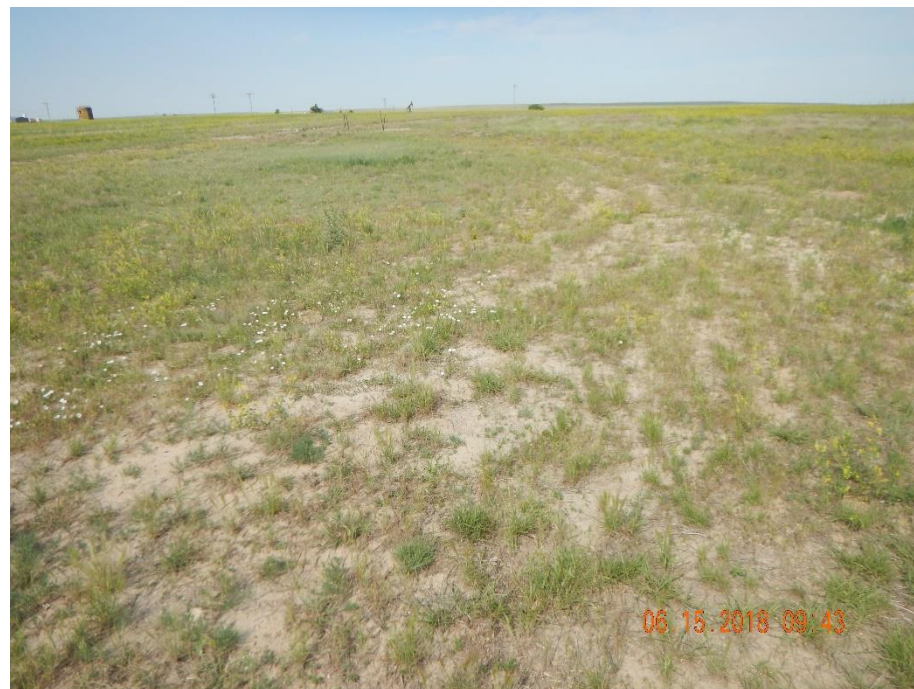
**Photo 6:** Photo taken from the north end of the well location, facing west. Photo shows portion of the access road “loop” that remains evident.

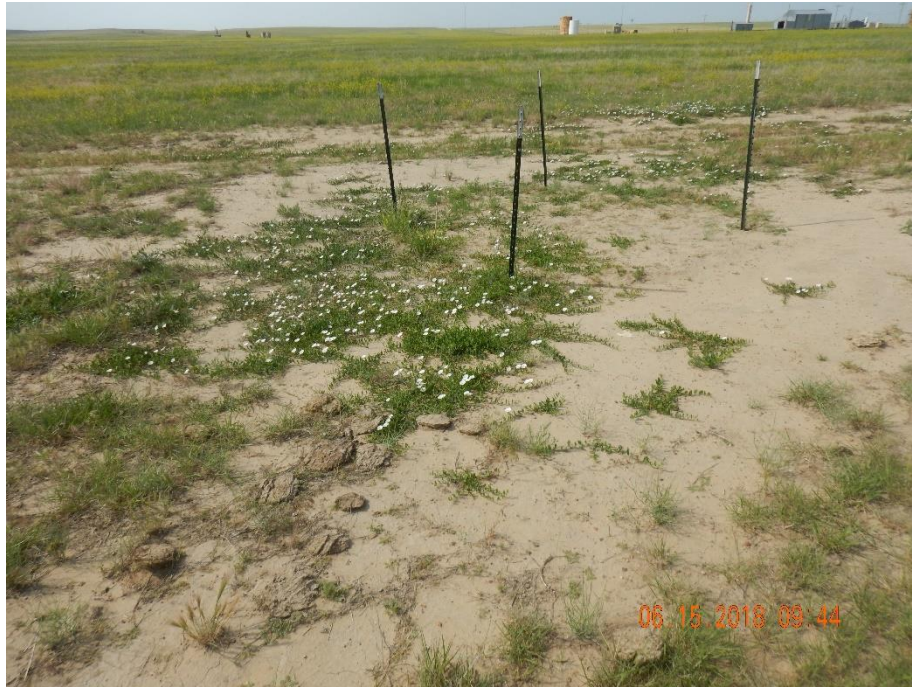
**Photo 7:** Photo taken from the west of the well, facing south. Photo shows areas of the location where reclamation activities do not appear to have been conducted.

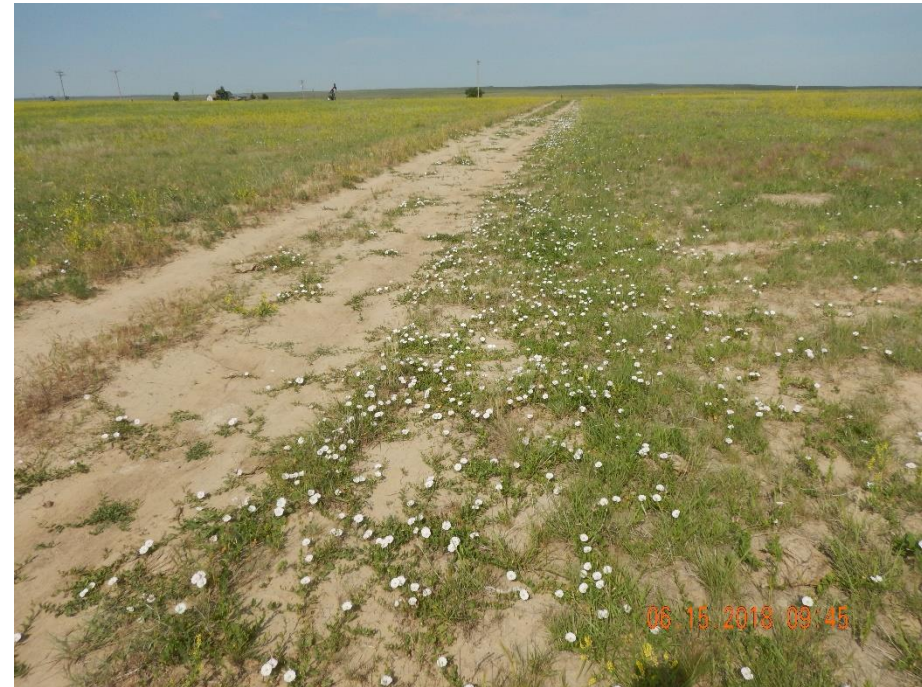
**Photo 8:** Photo taken from the well location, facing west. Photo shows access road has not been reclaimed. Photo also shows Field Bindweed along access road.

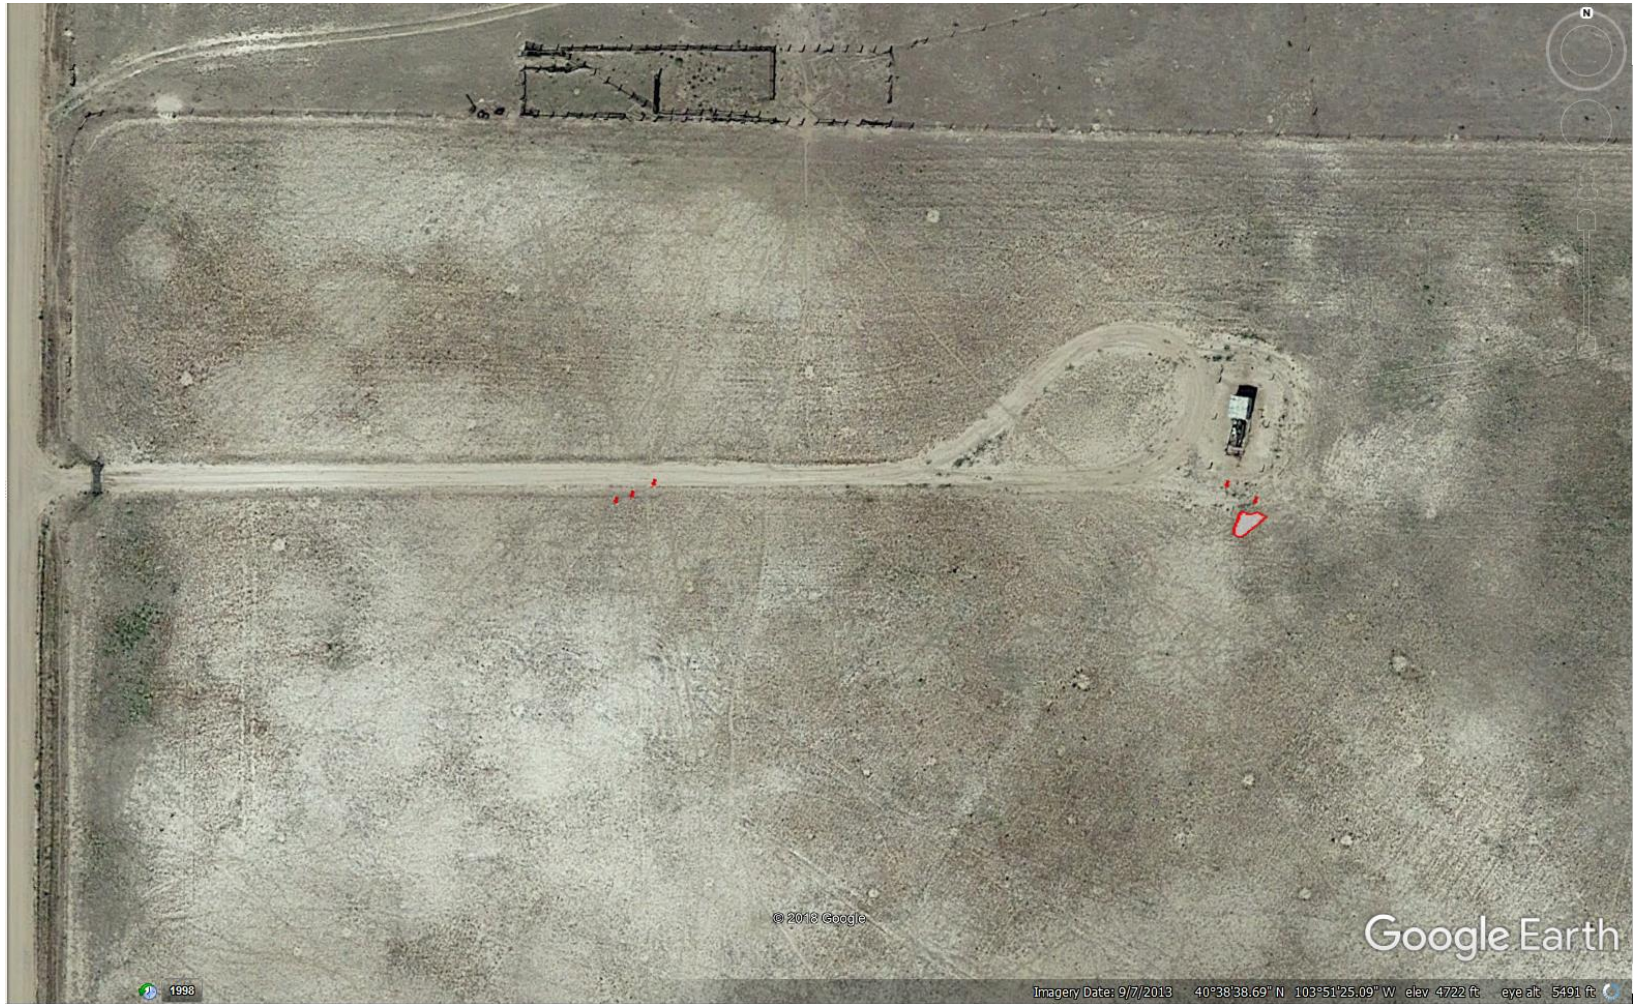
**Photo 9:** 2013 Aerial imagery. Photo shows areas (red polygon) where Noxious Weeds (Diffuse Knapweed) were observed on location and access road, and mapped using a GPS.
