Inspection Photos
Location Name: Ptasynski 1X
API: 05-081-06614

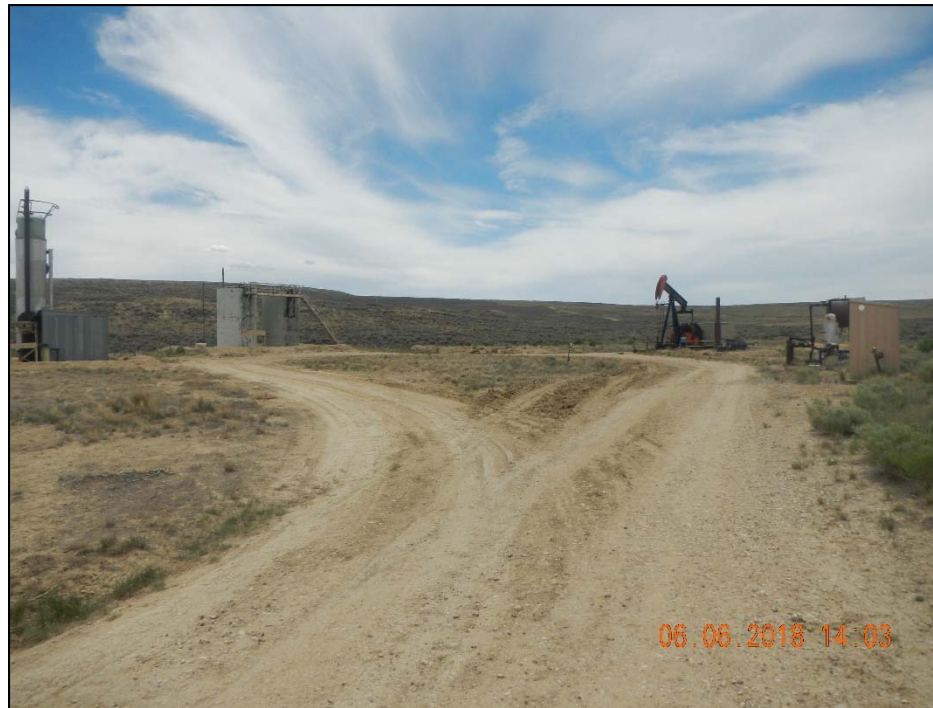
Photo 1. Overview of location taken at entrance facing southwest.

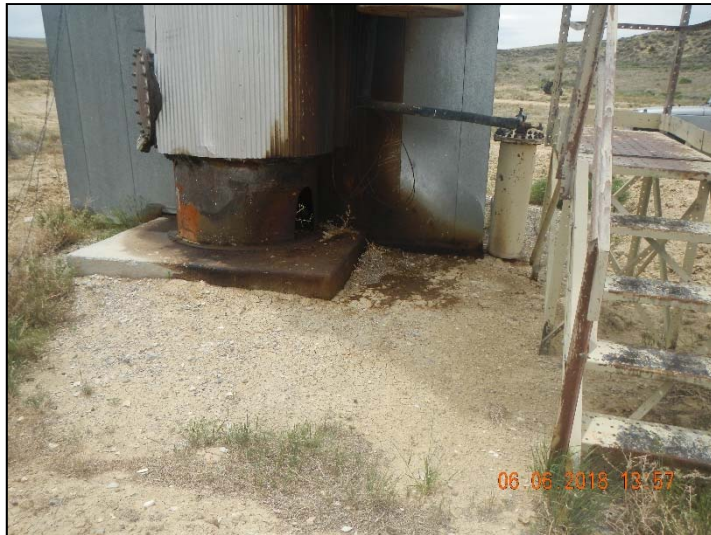
Photo 2. Stained soil at vertical separator.

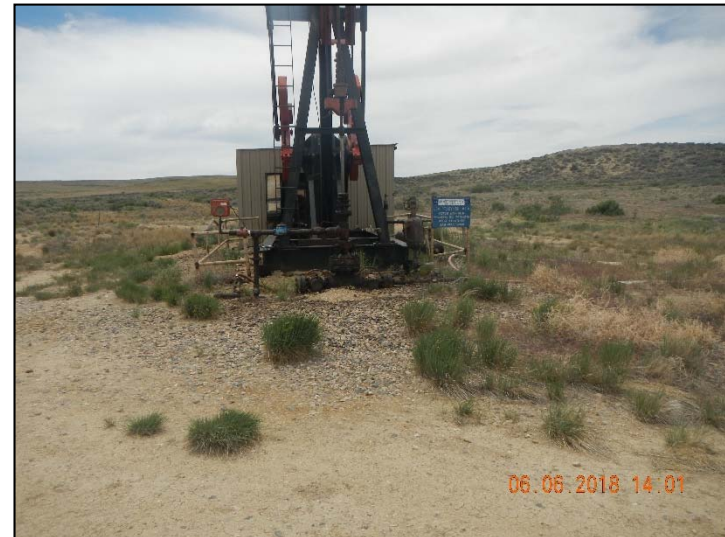
Photo 3. Fresh gravel at wellhead.

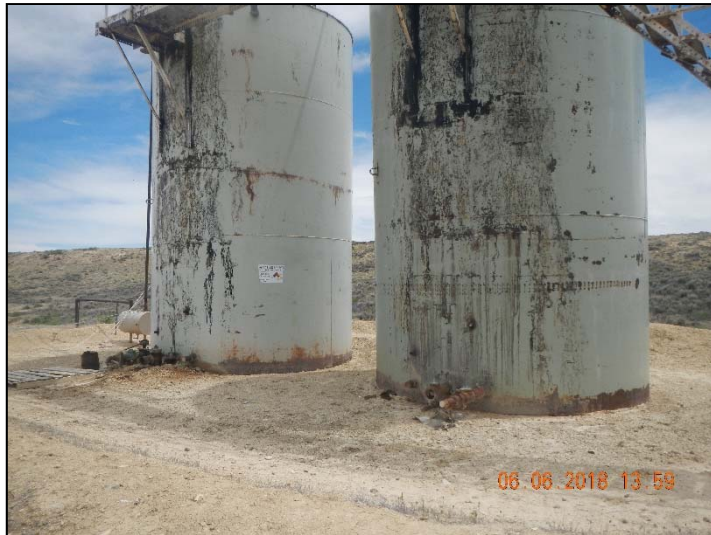
Photo 4. Only one tank labeled.

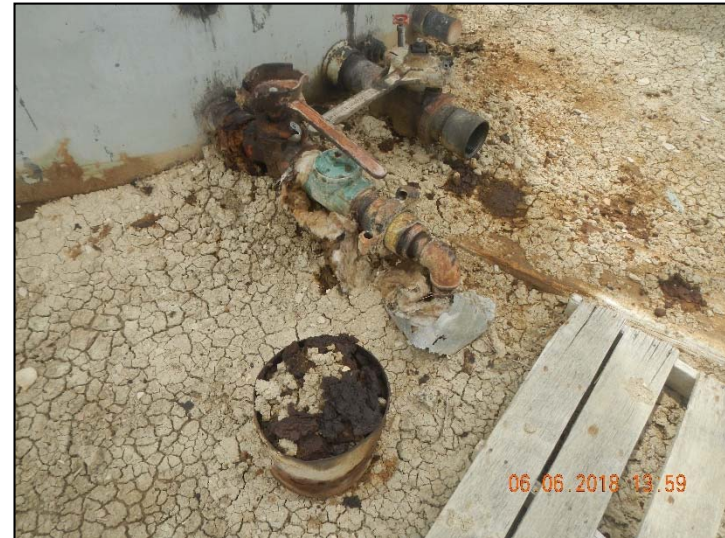
Photo 5. Stained soil at tank loadout.

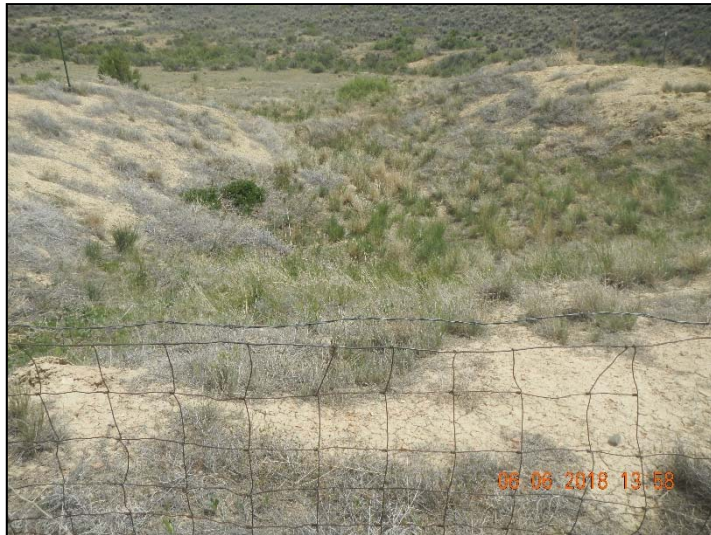
Photo 6. Pit with weeds and poor fencing.

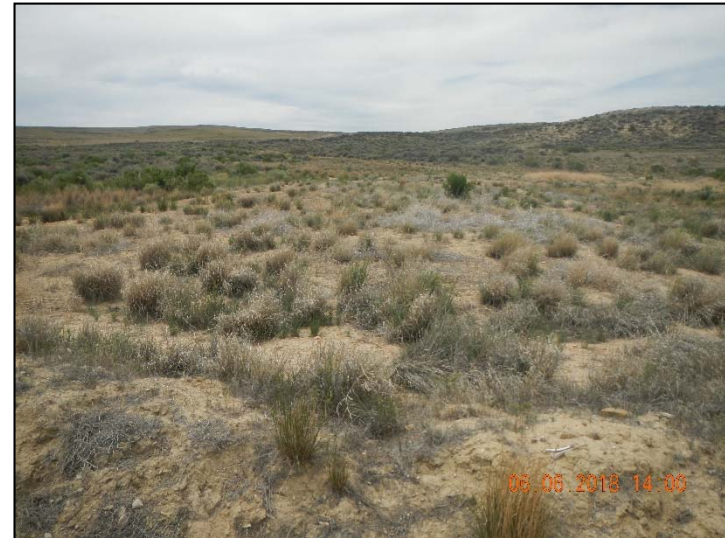
Photo 7. Land farm area.
