McPherson A
Inspection # 689301178

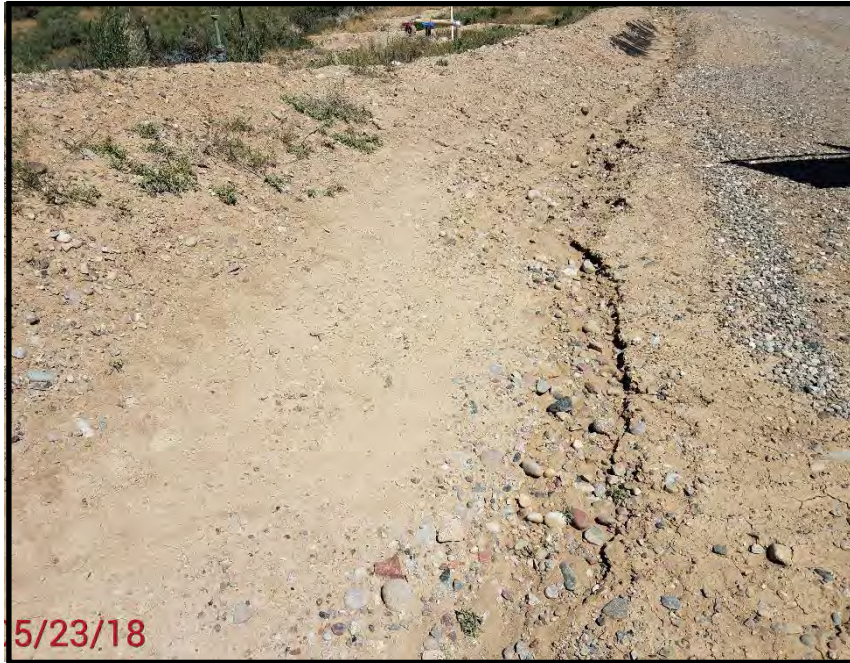
Before:

Erosion along West side of access road

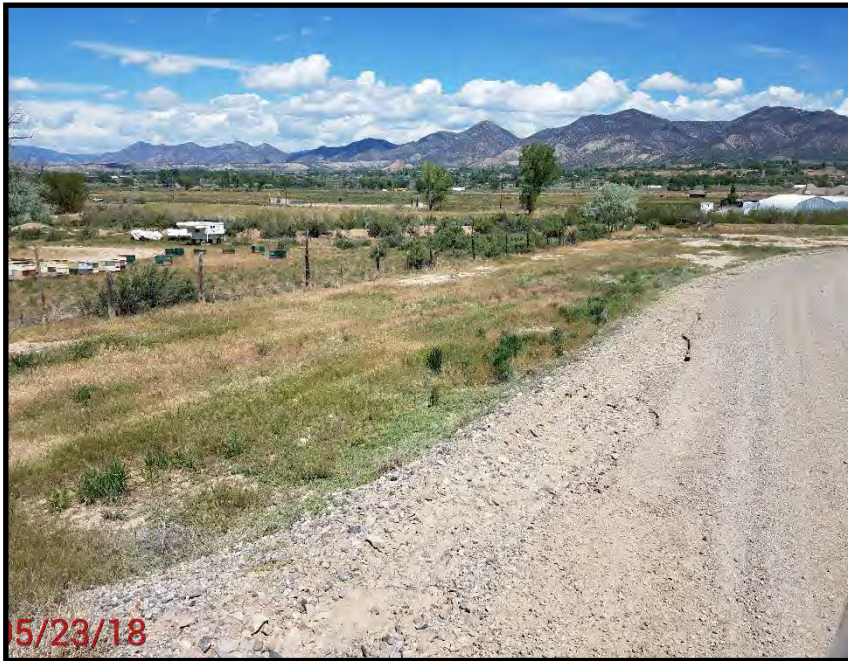
Before:

Erosion along West side of access road

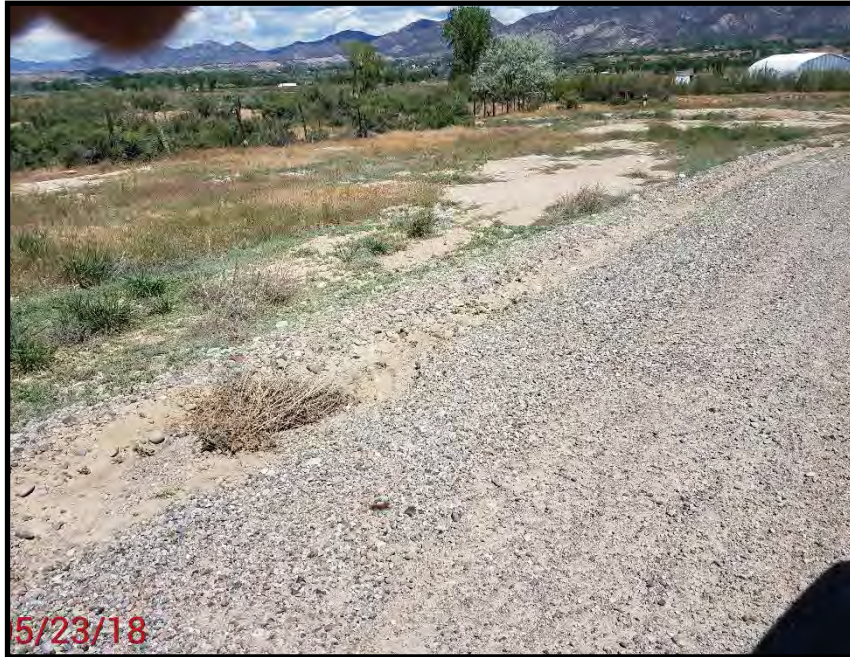
Before:

Erosion along West side of access road
