O'toole A

Inspection # 689301172

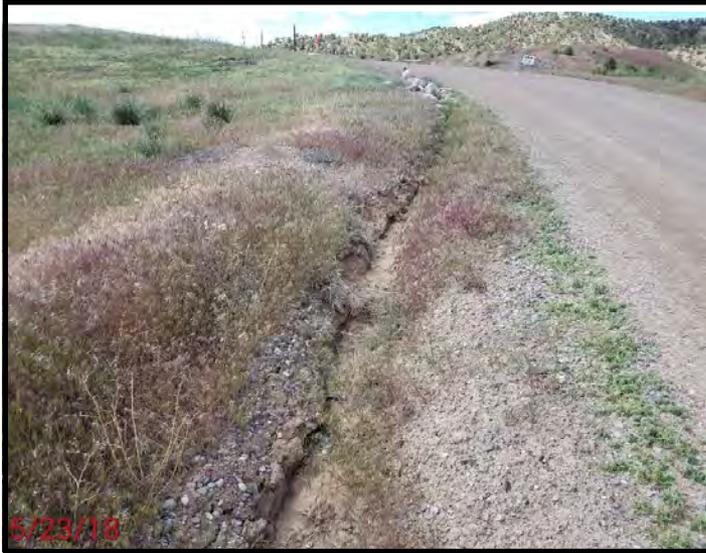
Ditch erosion along side of road on east side

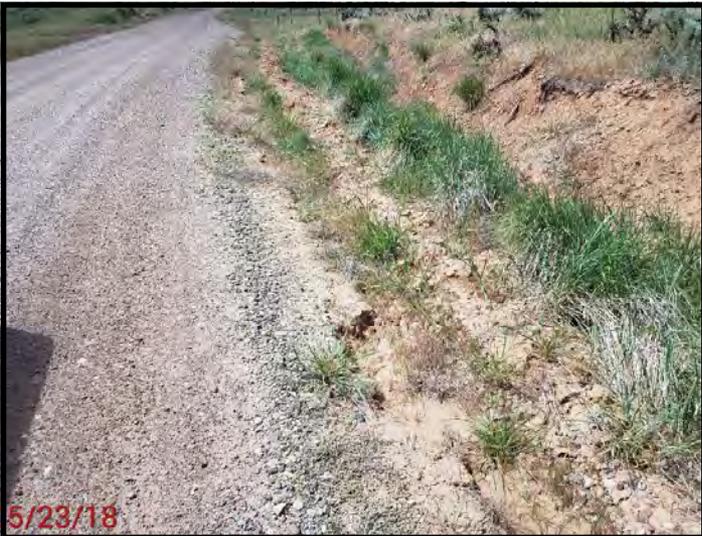
Ditch erosion along side of road on east side. Looking down hill

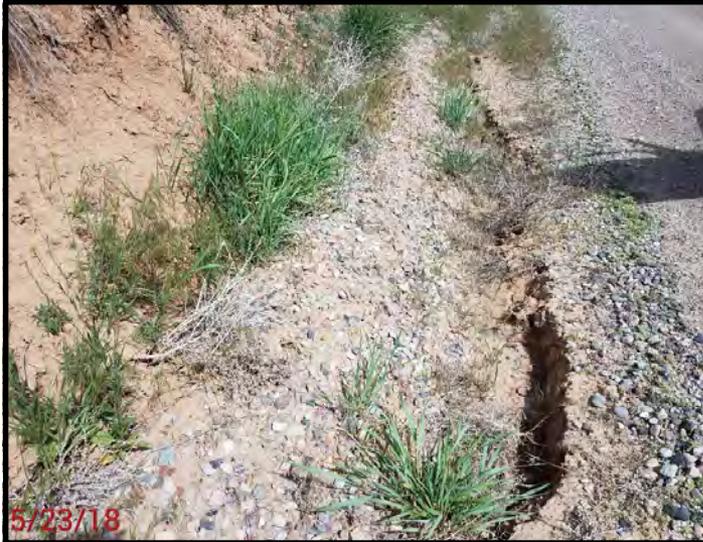
Ditch erosion along side of road on West side. Looking down hill

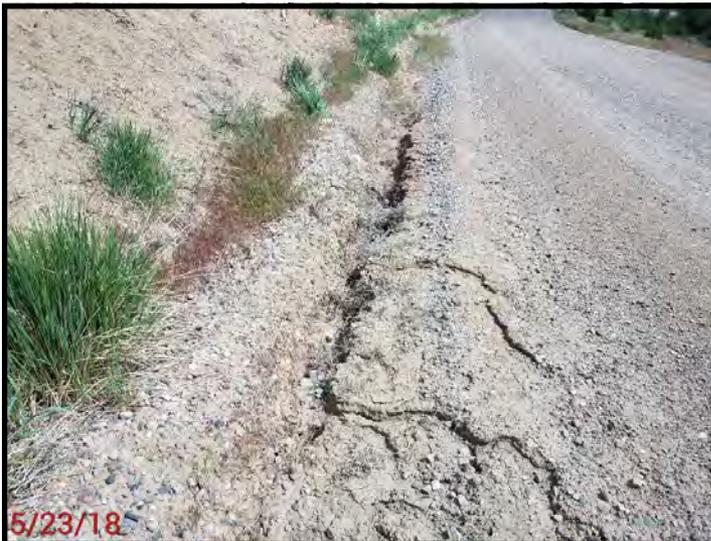
Ditch erosion along side of road on West side. Looking downhill

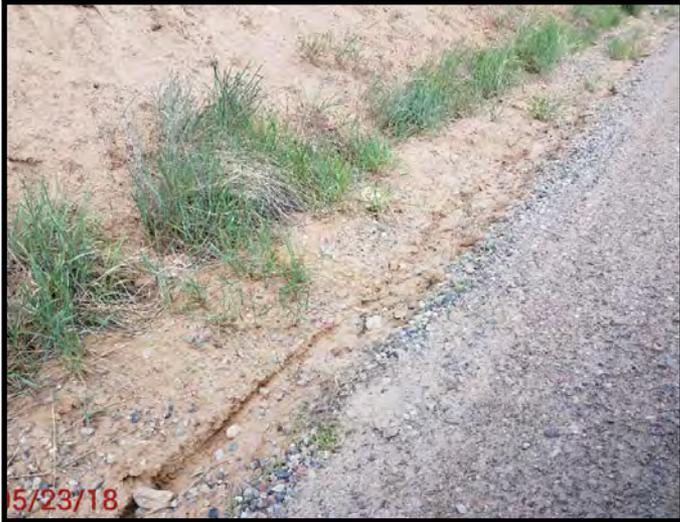
Ditch erosion along side of road on east side near curve

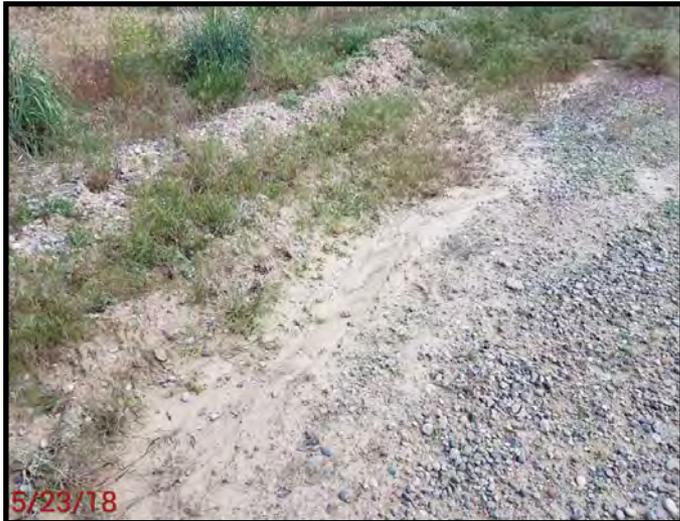
Ditch erosion along side of road on east side near curve
