# Inspection Photos

06/19/2018

Operator: WIEPKING-FULLERTON ENERGY LLC -  
96340

Inspection Doc. Number: 682503514  
Lincoln County, CO

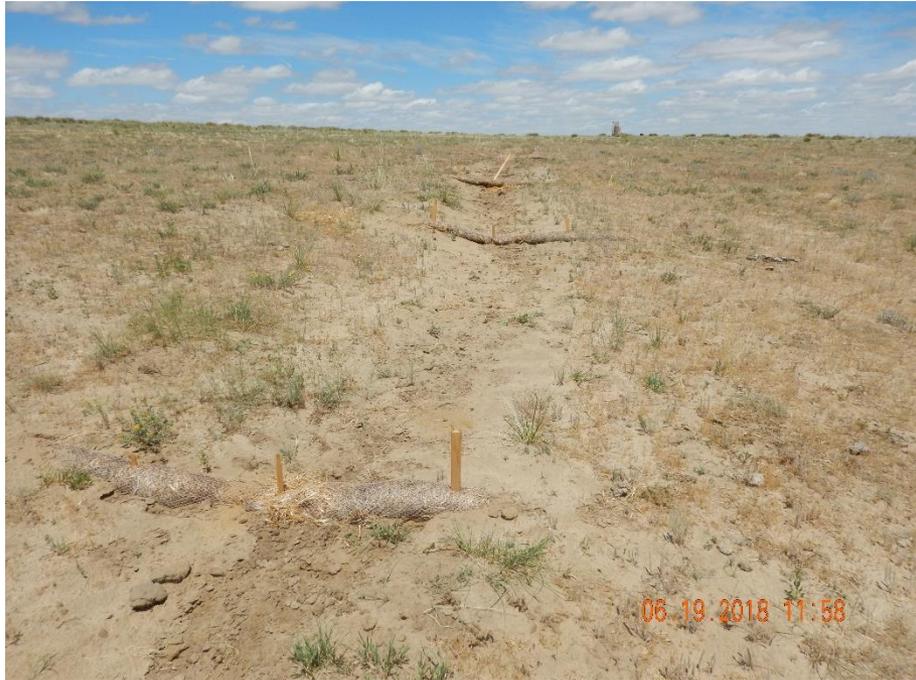
**Photo 1:** Photo taken from the northwest end of the location, facing north. Photo shows straw wattles have been installed on the north end. Wattles do not appear to be in proper functioning conduction, or have filled with sediment.

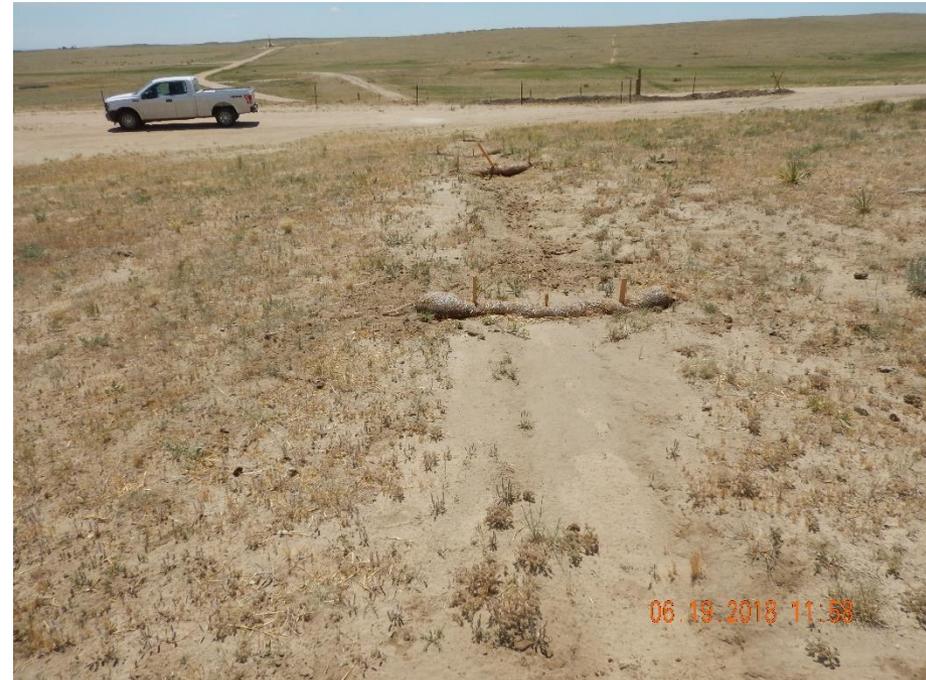
**Photo 2:** Photo taken from the northwest end of the location, facing south. Photo shows straw wattles have been installed on the north end. Wattles do not appear to be in proper functioning conduction, or have filled with sediment.

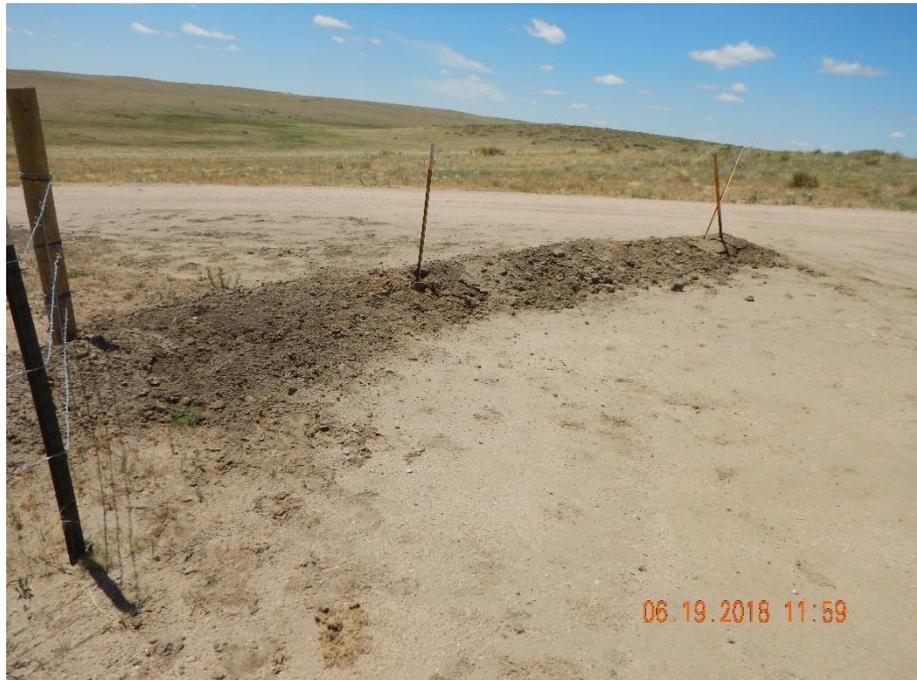
**Photo 3:** Photo taken from the west end of the location. Photo shows water bar. BMP does not appear to have been installed in accordance to good engineering practices; water bar has not been consolidated or in proper functioning conduction, and is considered a sediment source.

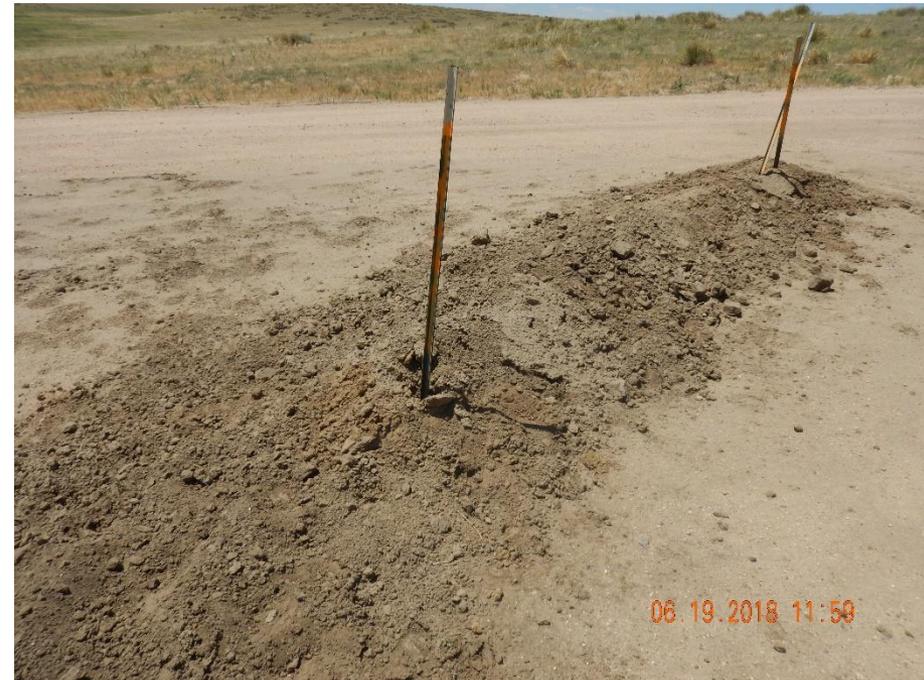
**Photo 4:** Continued from photo 3.

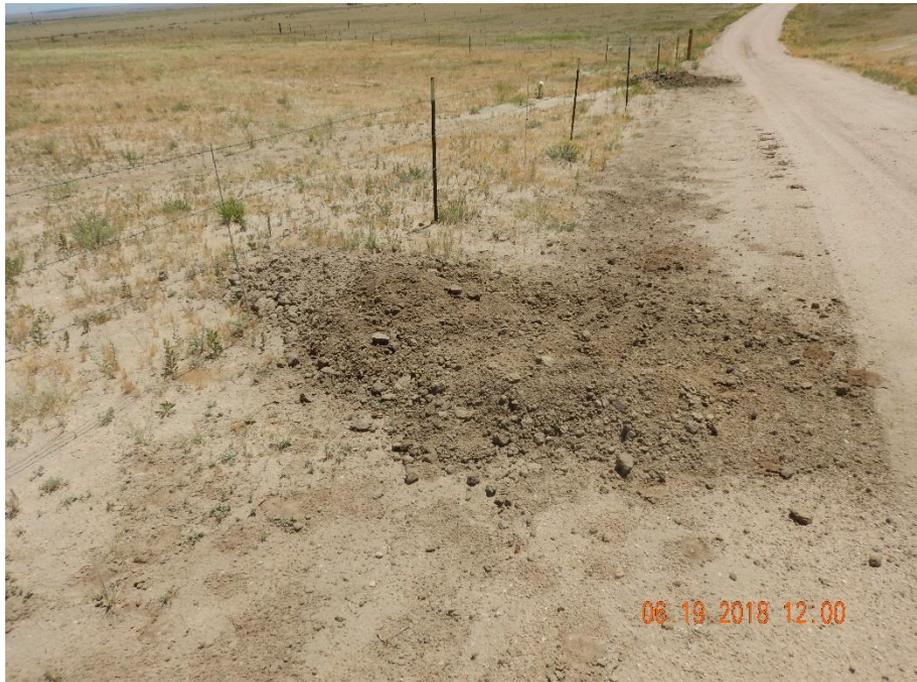
**Photo 5:** Photo taken from access road, west of the location, facing south. See comments under photo 4.

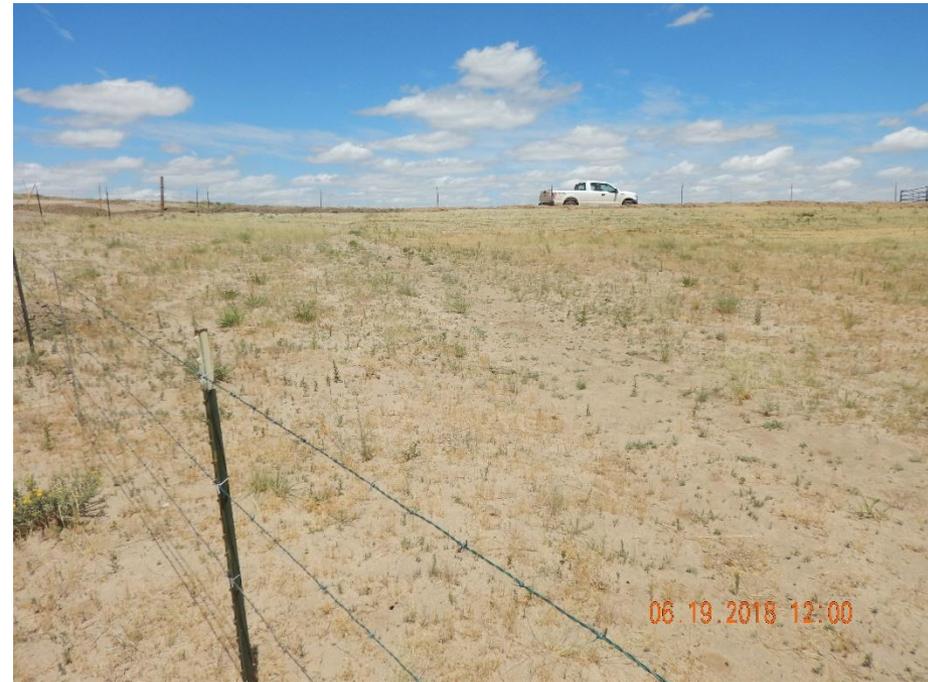
**Photo 6:** Photo taken from the south end of the location, facing north. Photo shows interim area has been fenced and slope has been repaired and stabilized with straw blankets.
