Inspection Photos

API: 05-067-09814

Operator: RIM OPERATING INC

Inspection Date: 06/05/2018

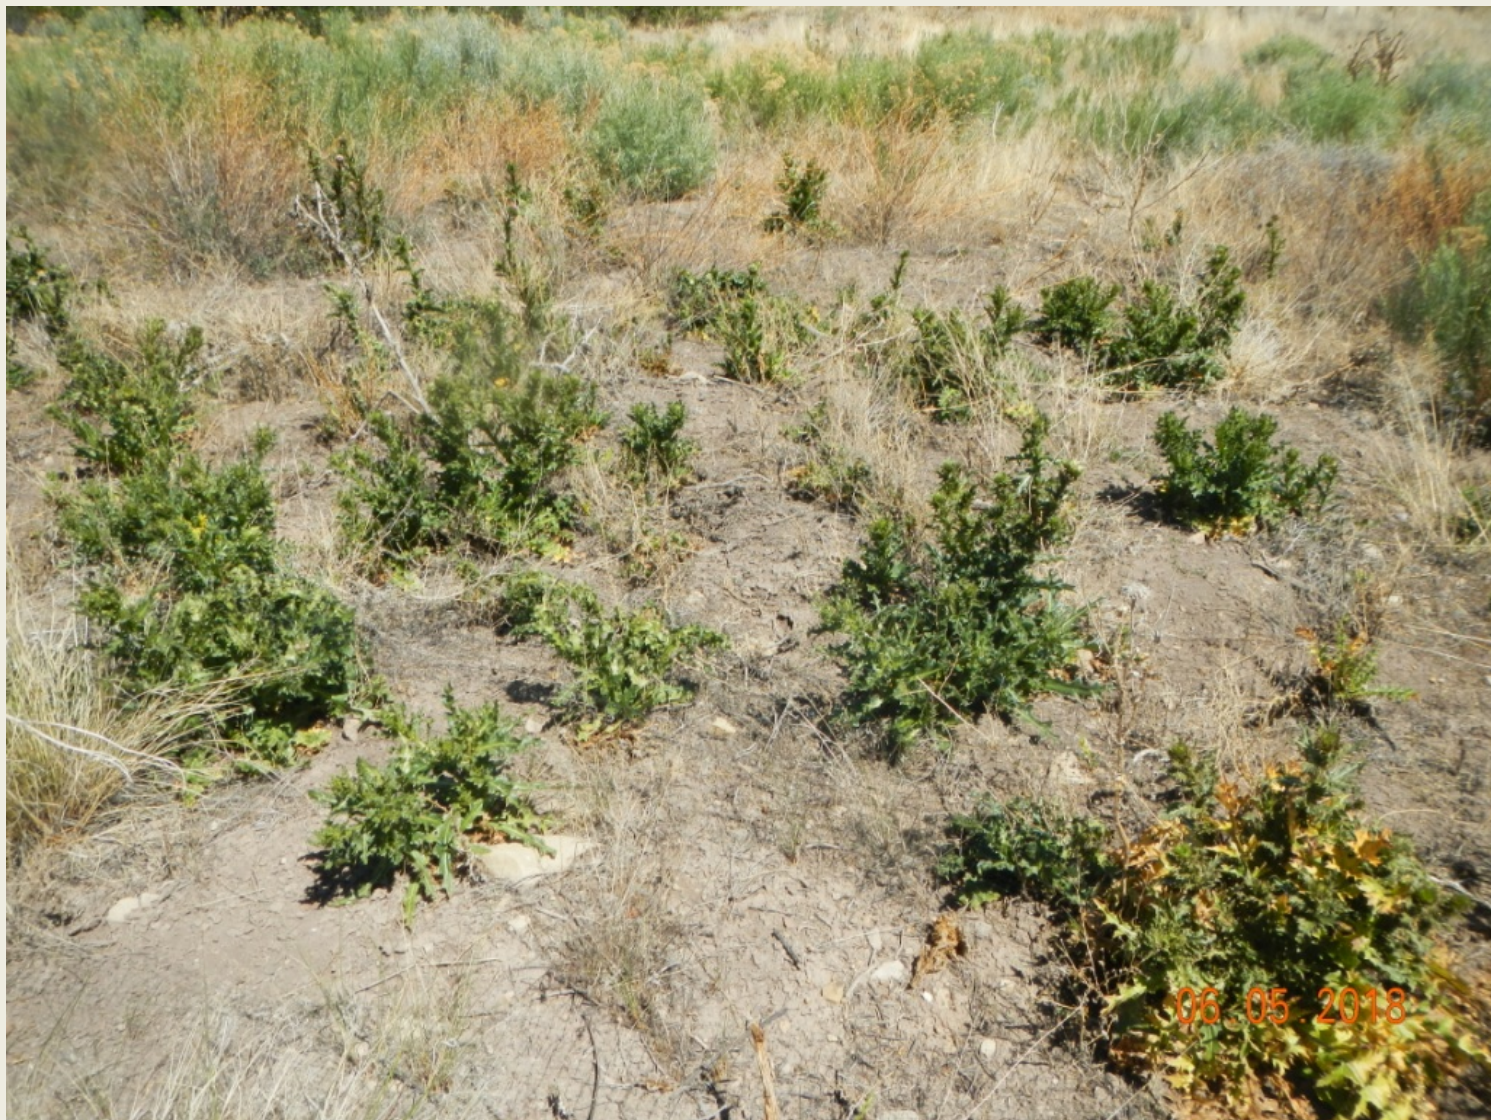
Photo 1. View of musk thistles (*Carduus nutans*) within the northern interim reclamation area.

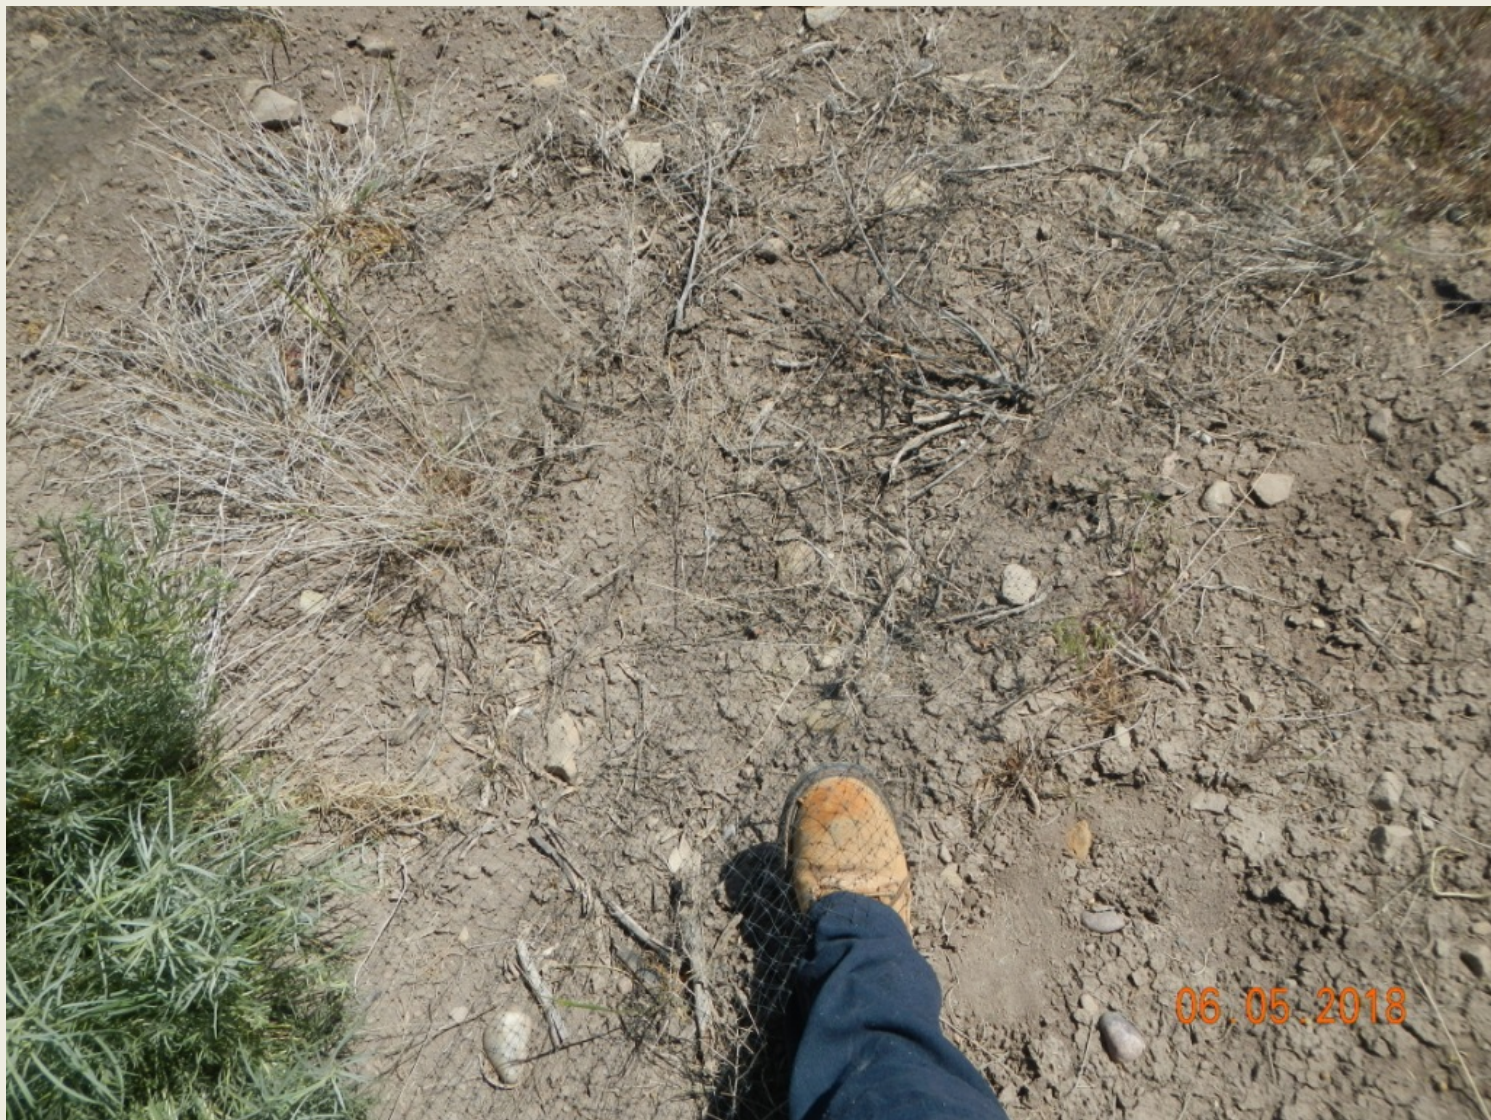
Photo 2. View of black plastic netting debris within the northern interim reclamation area.

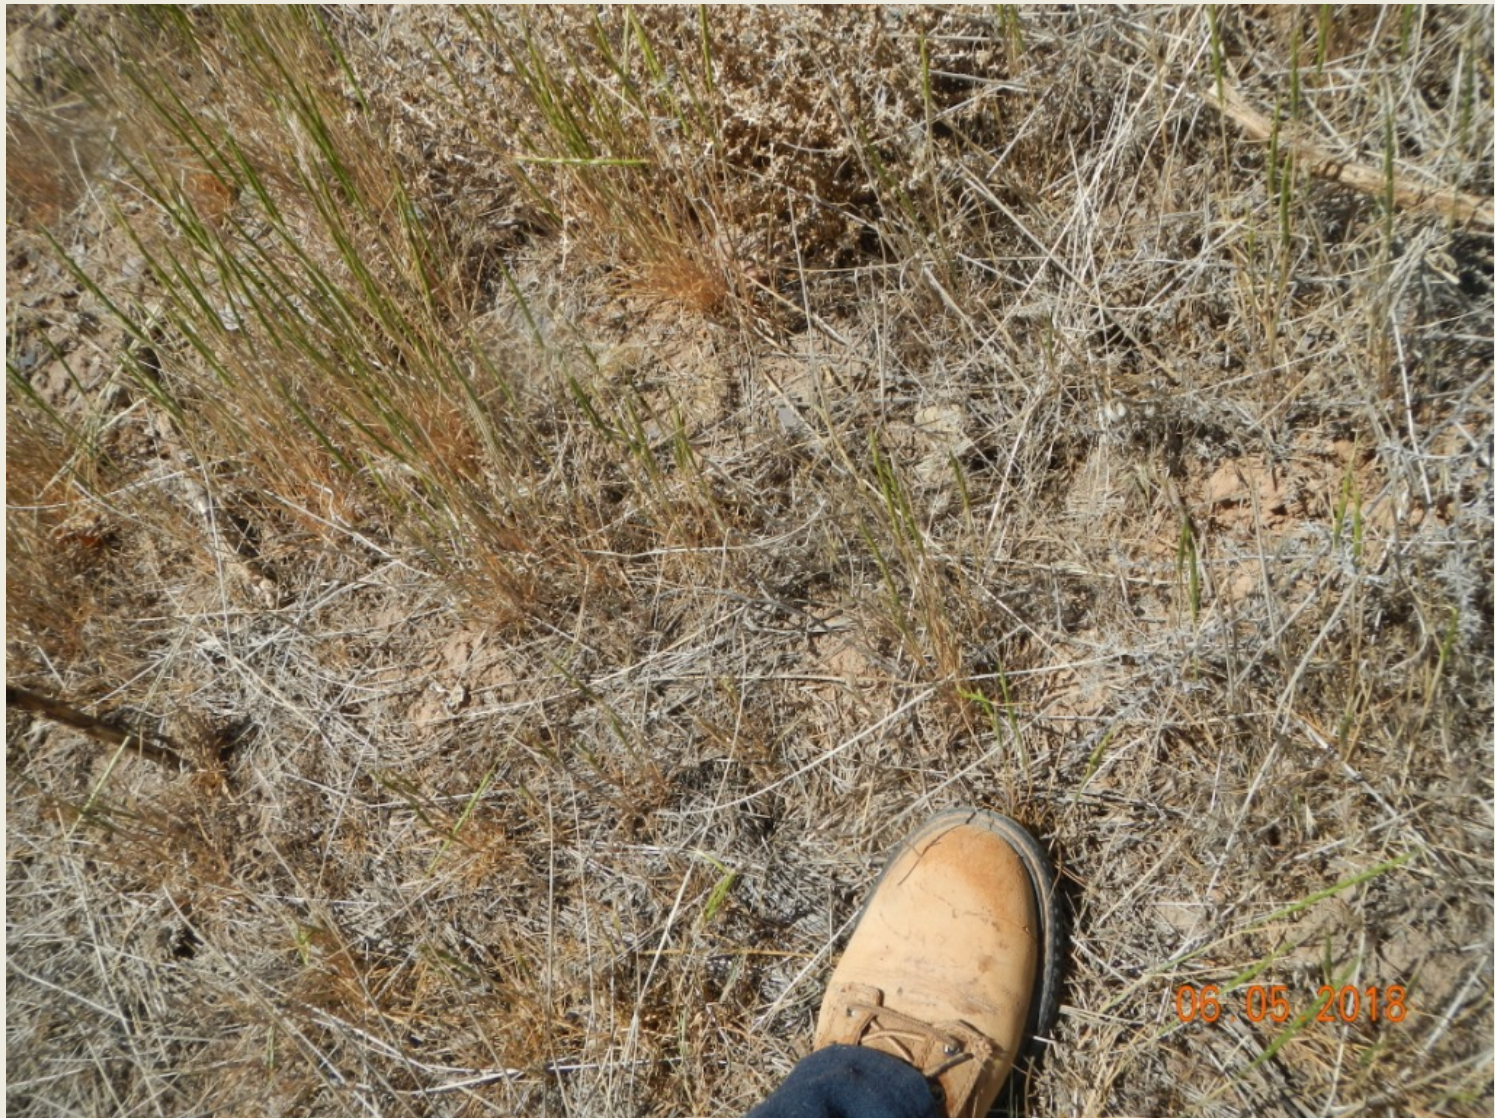
Photo 3. View of jointed goatgrass (*Aegilops cylindrica*). Approximately 1000 individuals observed within the project area.

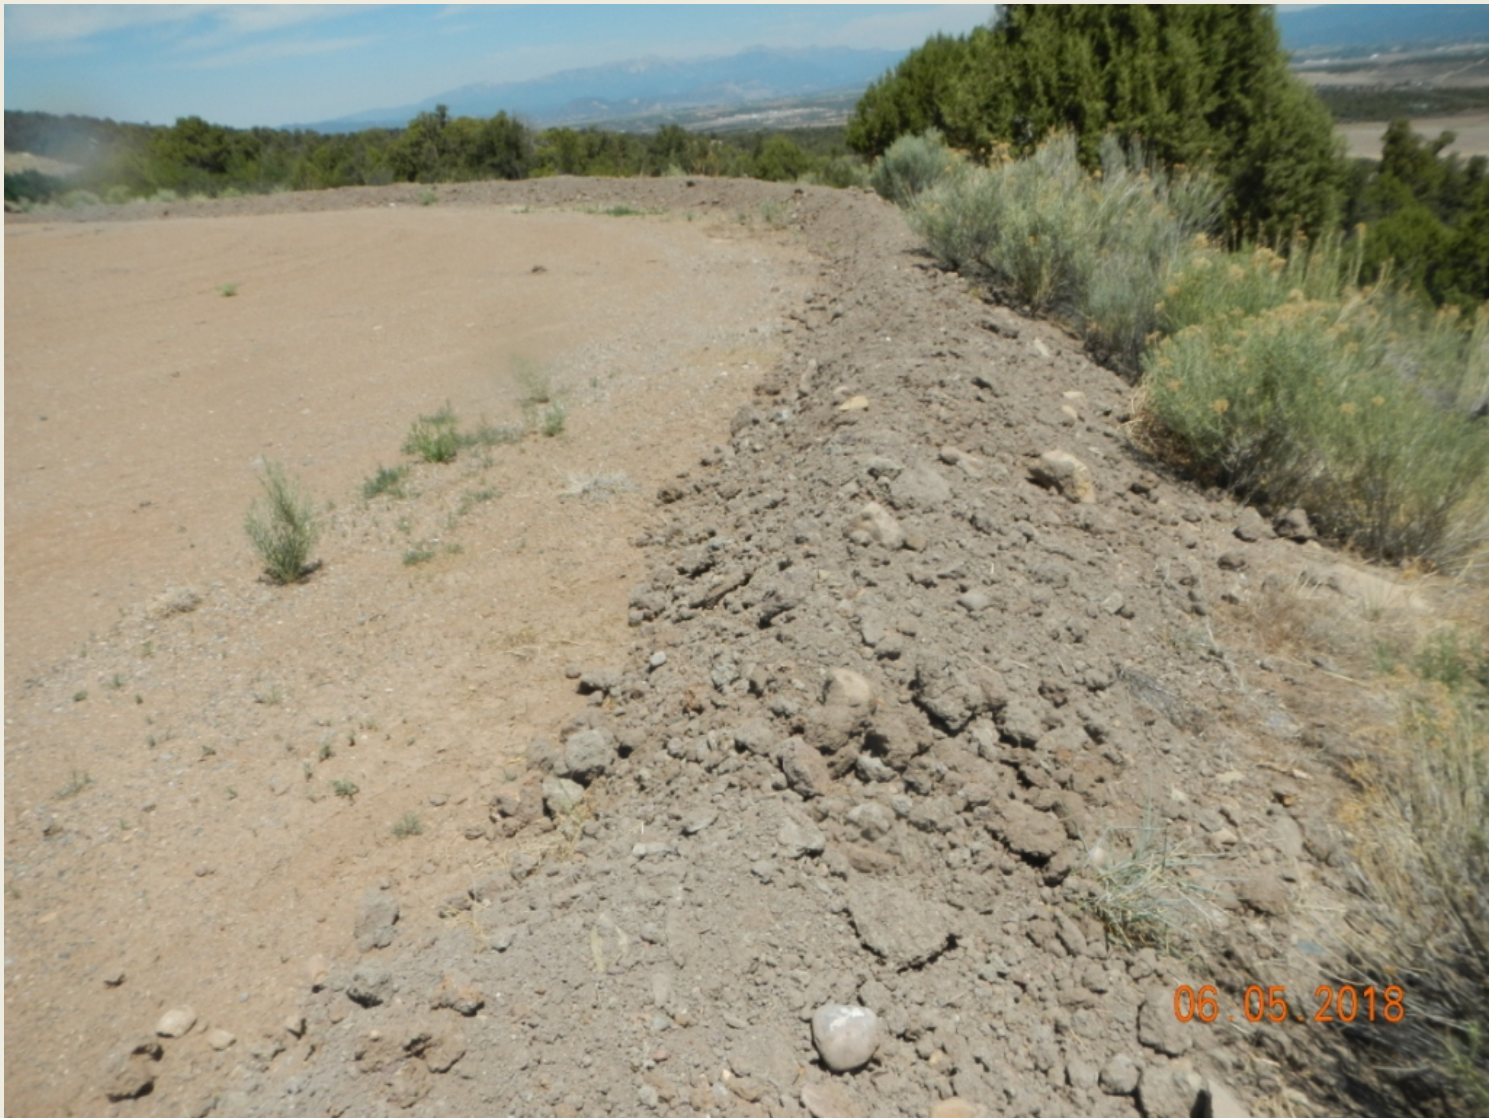
Photo 4. View of berm along the northern edge of the working area. Berms are not properly stabilized and need stabilization measures such as revegetation, or proper compaction and stormwater controls. Wattles are not appear sufficient.

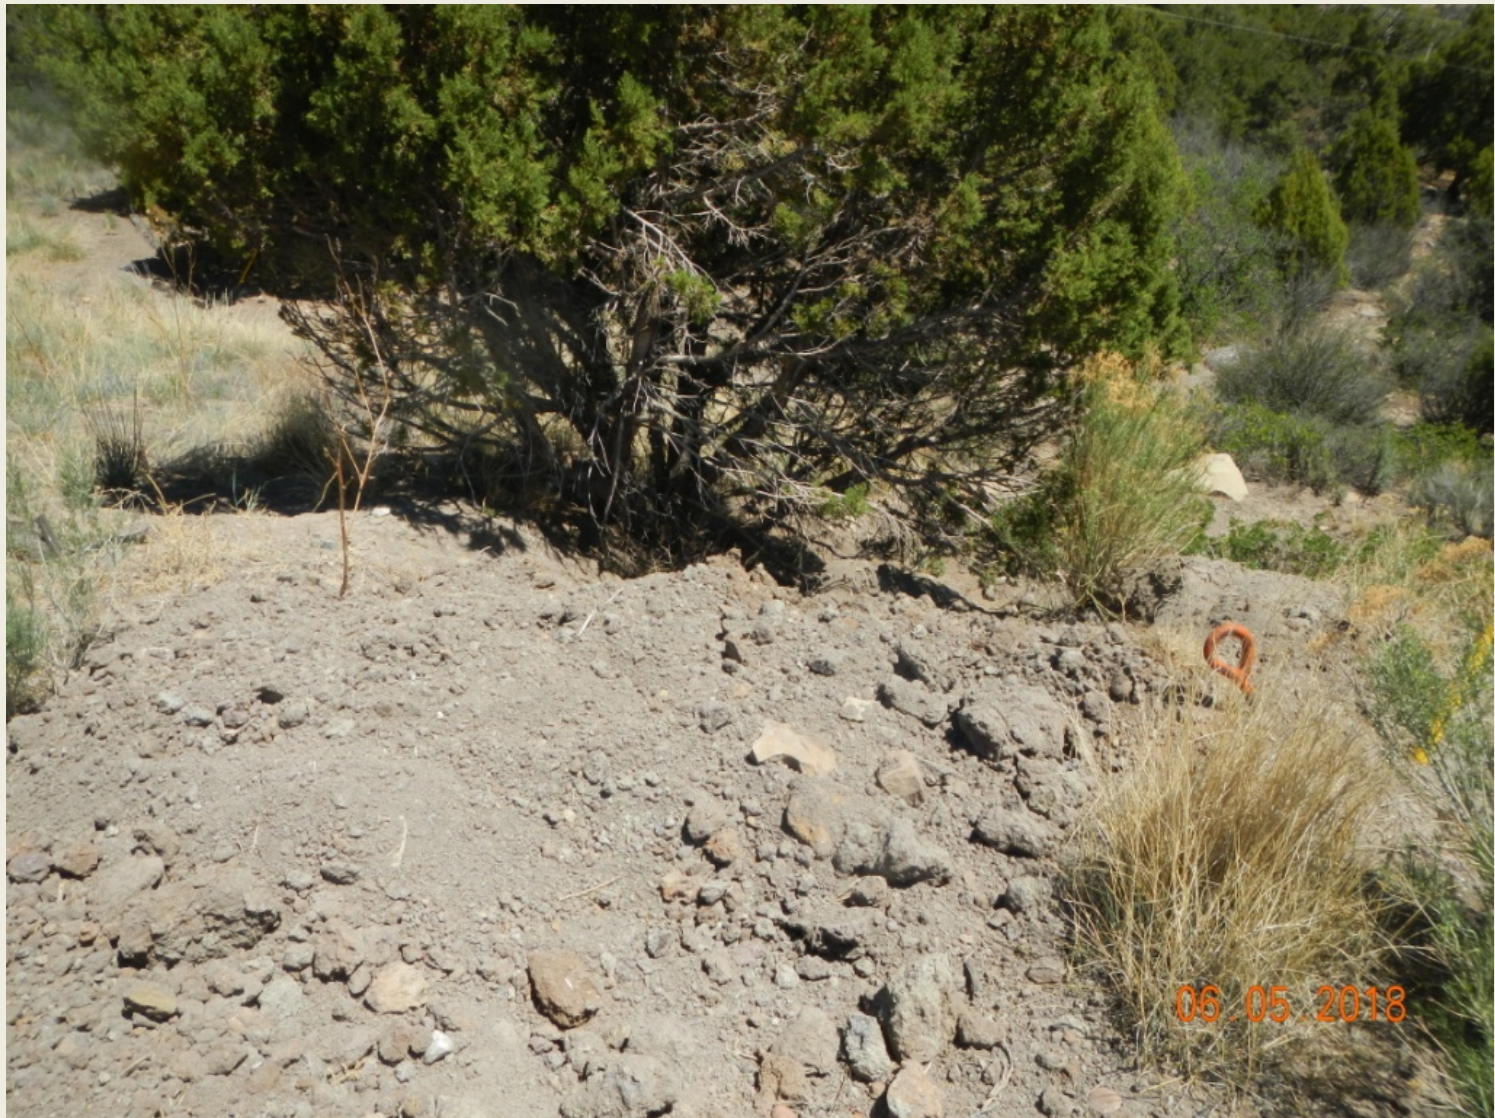
Photo 5. View of bare soil on northeastern fill slope needing revegetation measures and stormwater controls to prevent soil from eroding off of slope.

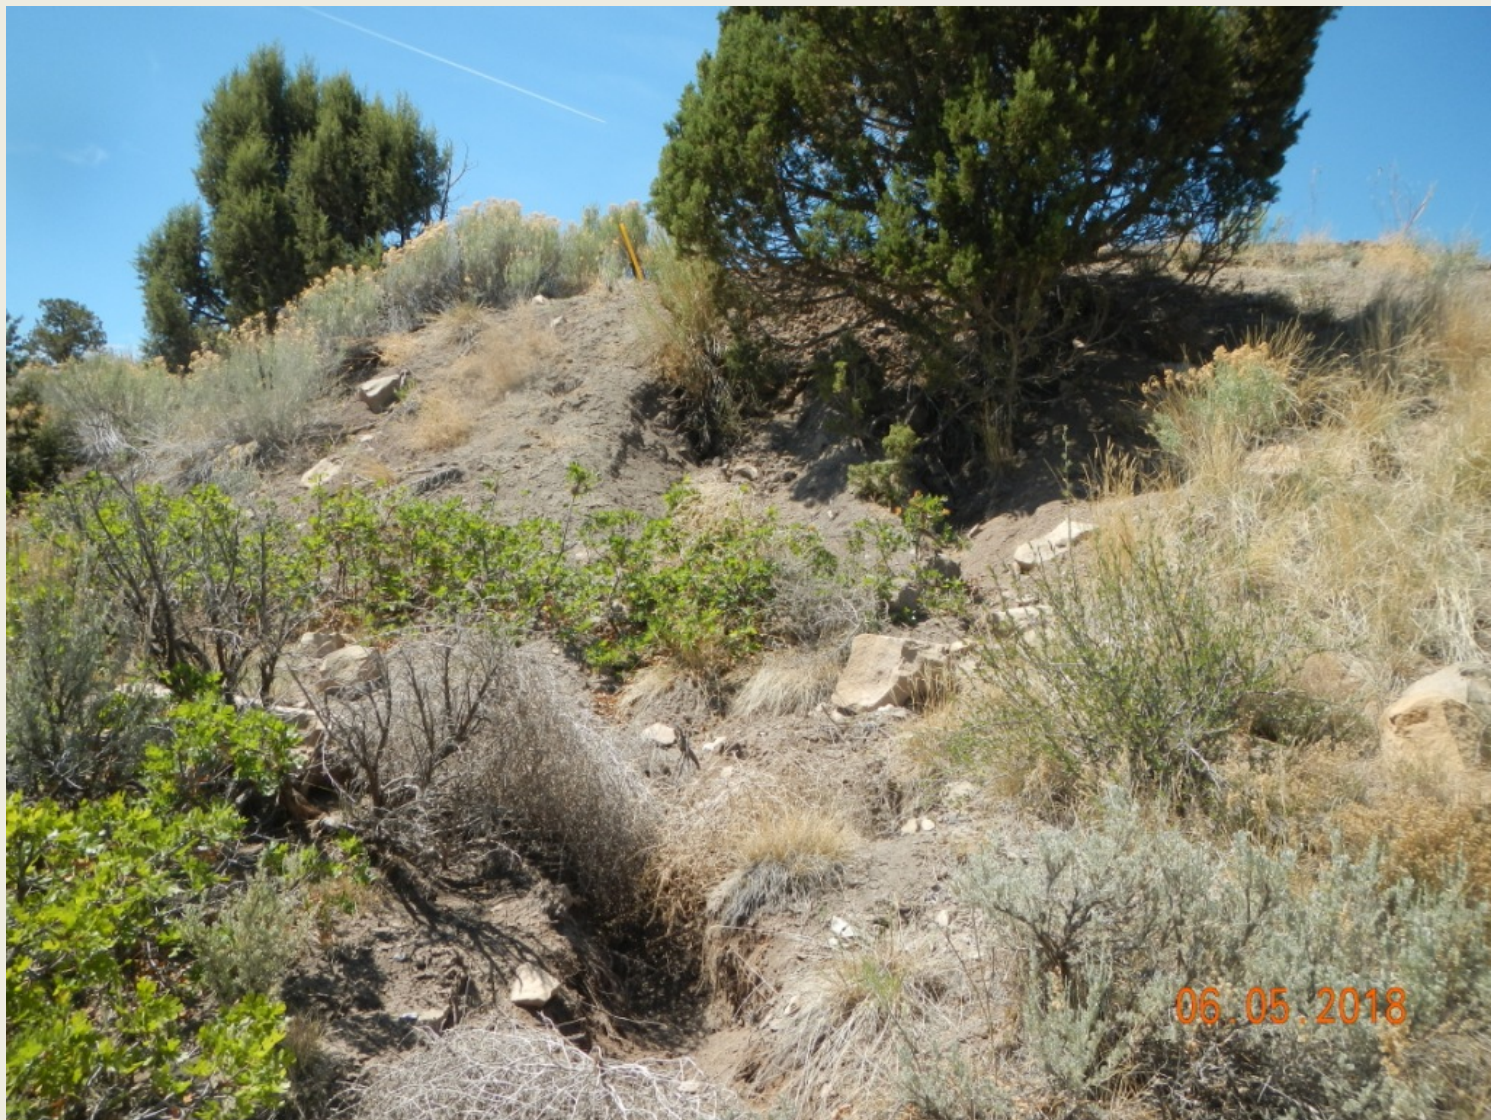
Photo 6. View of erosional channel in the northeastern fill slope facing up-slope. Top of channel is filled with bare soil.

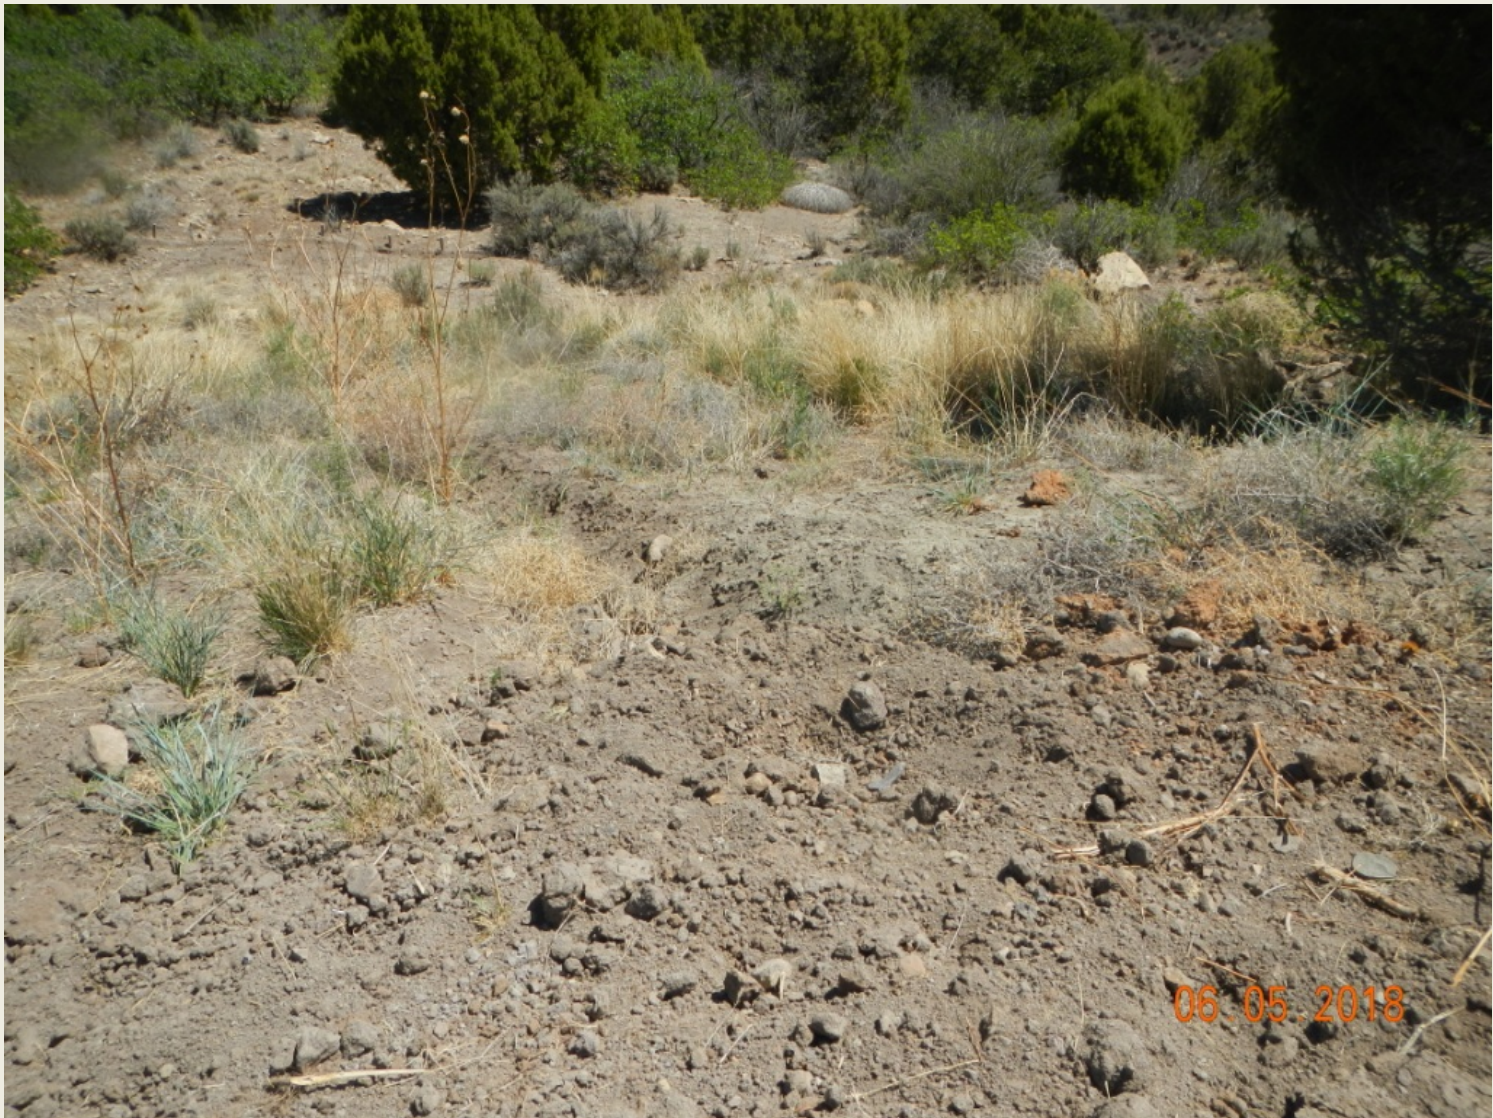
Photo 7. View of another area of bare soils, in the northern interim reclamation area. It appears bare soils are placed in erosional channels. This practice does not stabilize erosion and results in the introduction of a new pollutant source. Bare soils need stabilization.

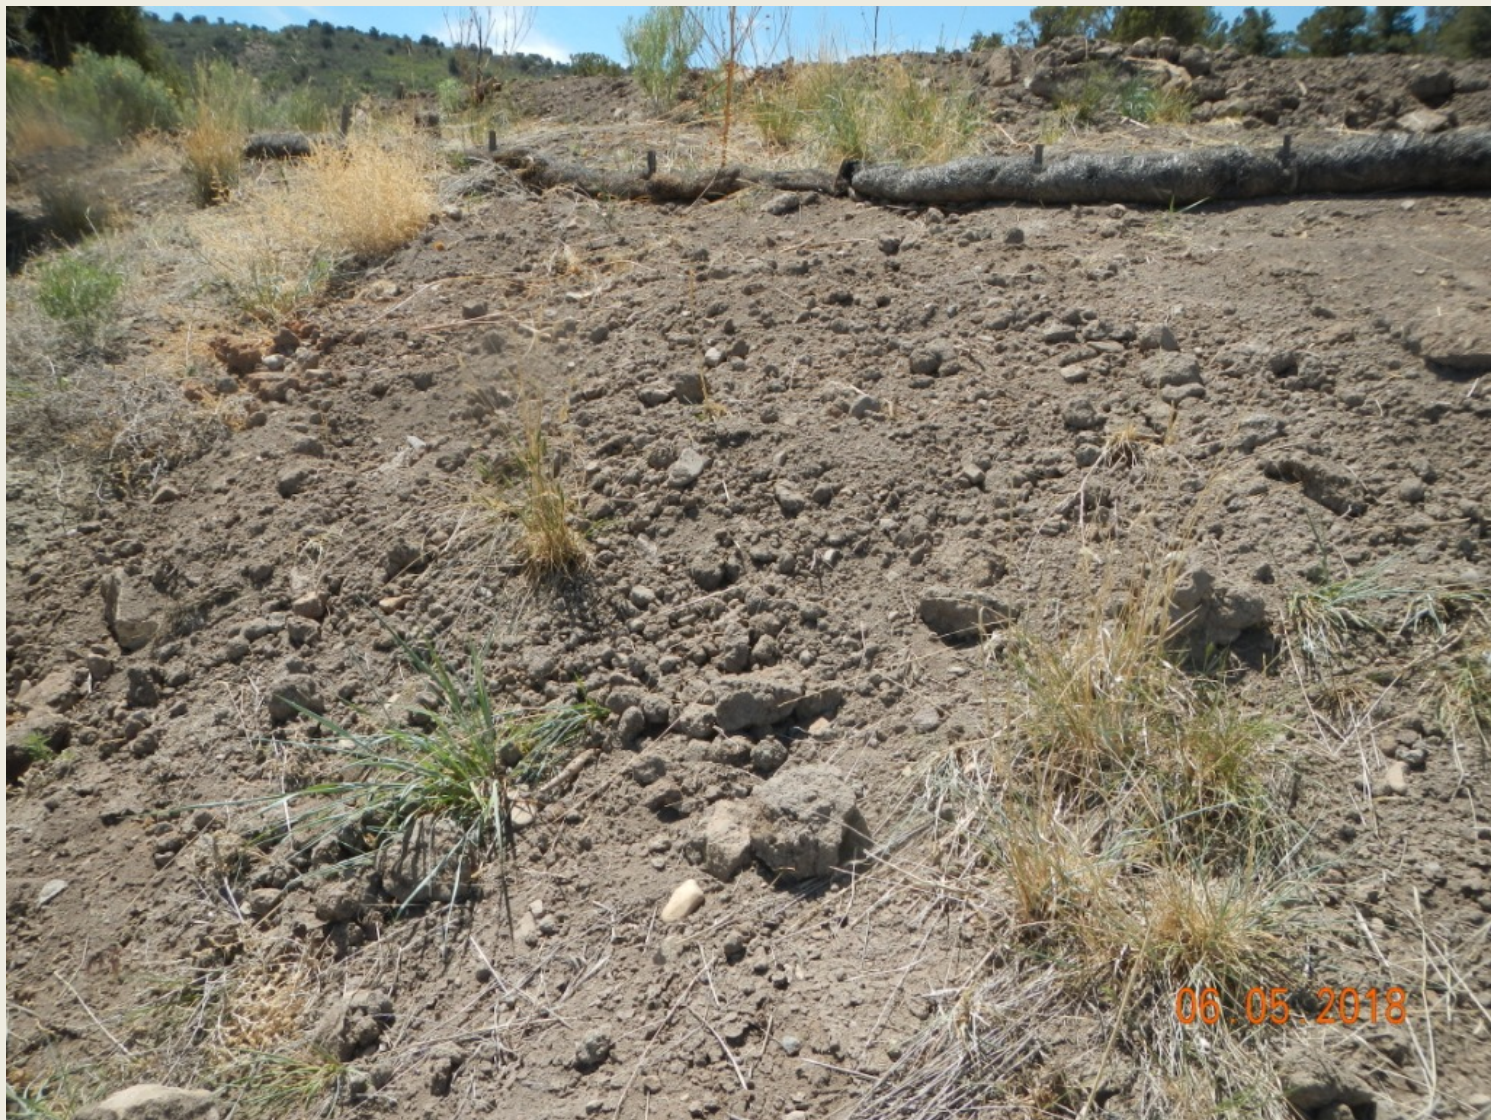
Photo 8. View of bare soils placed in fill slope facing up-slope. Wattle is up-slope from bare soils.

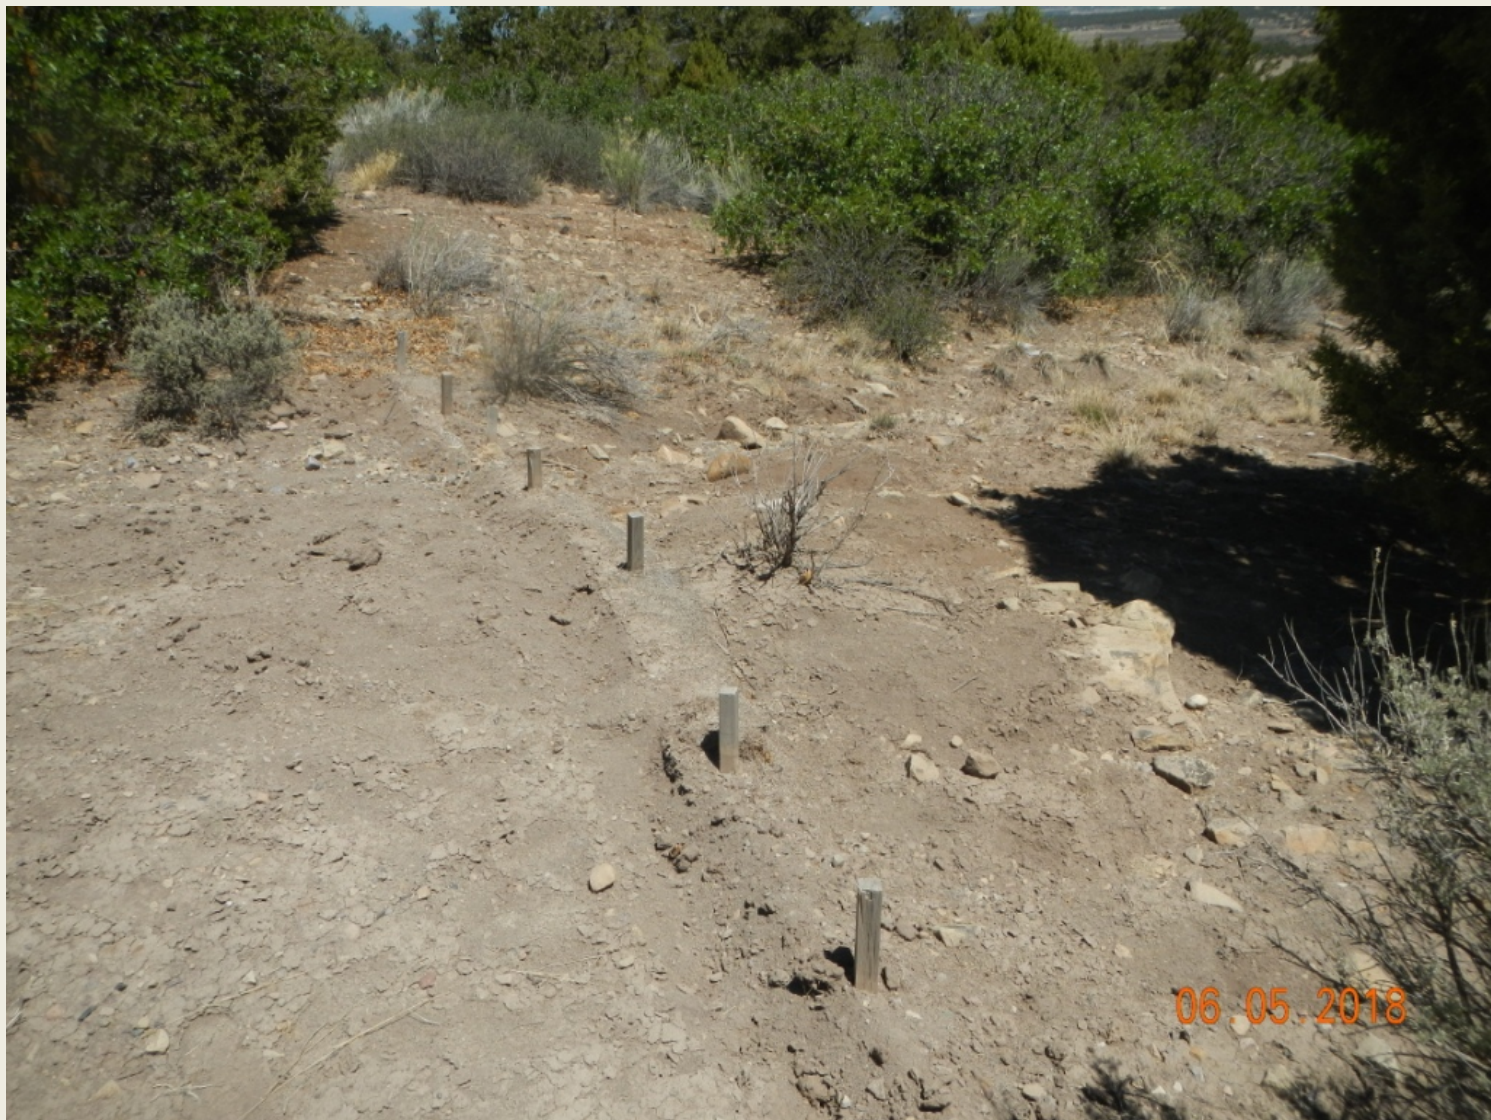
Photo 9. View of area along the northeastern edge of the project area where wattles are removed. Long-term stormwater controls are needed in this area as it is where stormwater flows exit the outer project area.

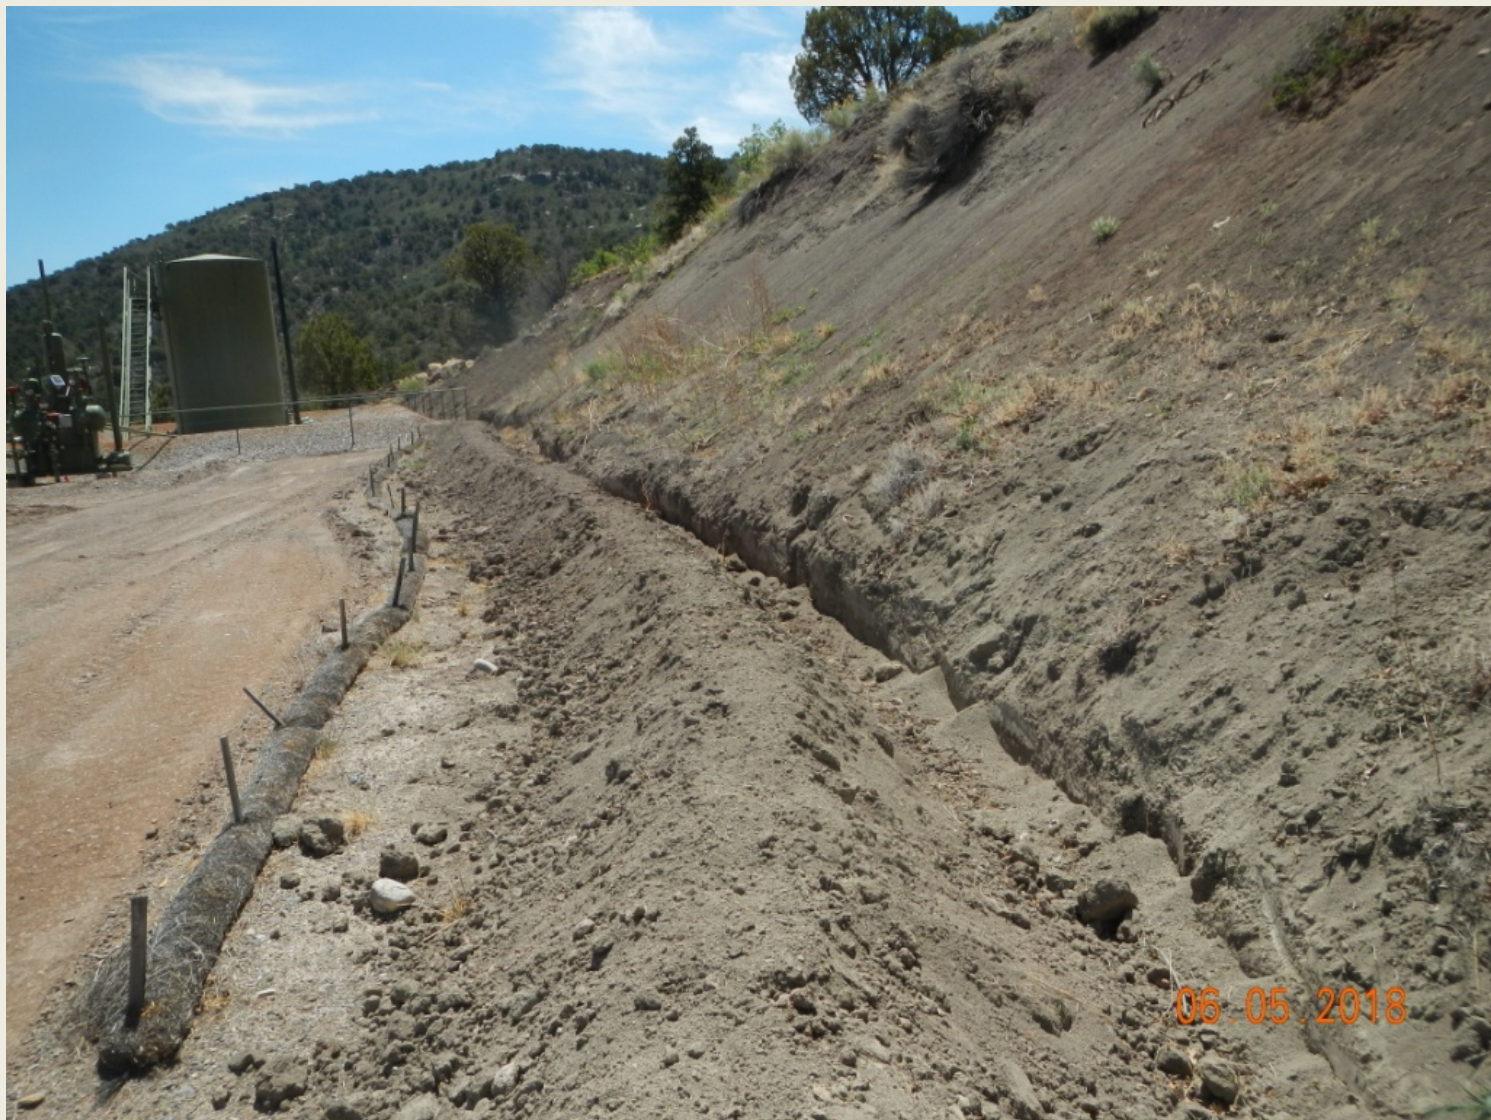
Photo 10. View of well pad cut-slope and diversion. Long-term erosion control measures are needed to stabilize cut-slope.

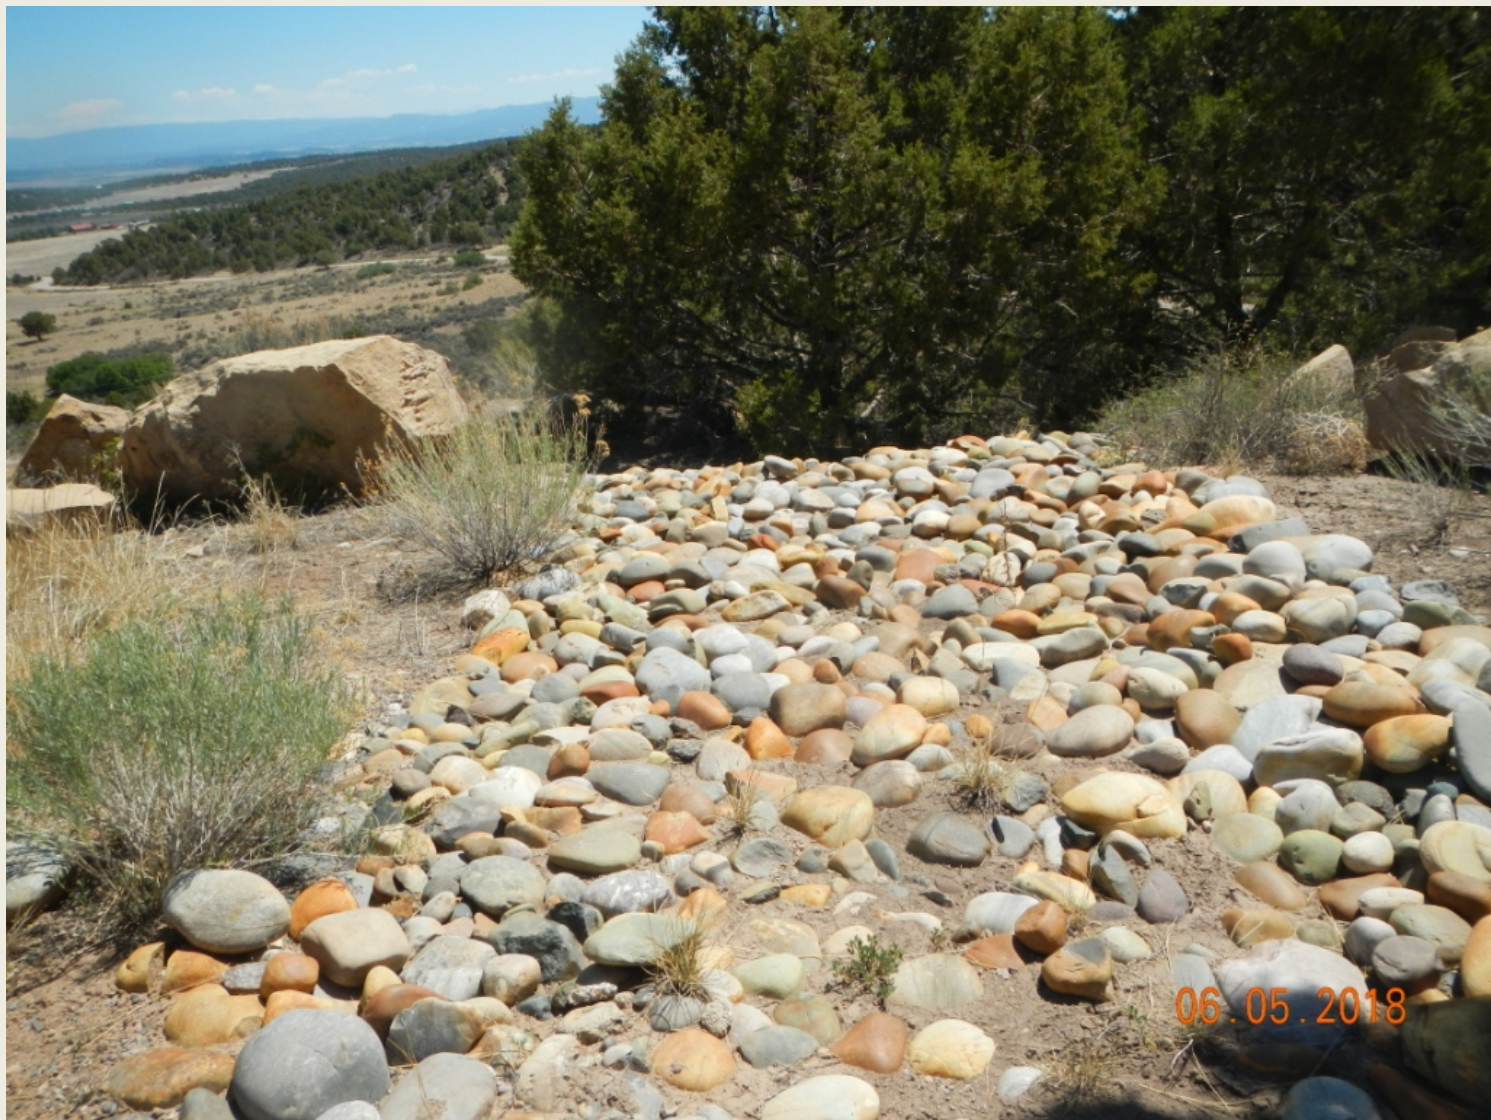
Photo 11. View of cobble run-down in southeastern project area. Appears to be functioning at this time, but will likely need re-shaping as channel is not in place and if significant stormwater flows toward the area erosion will likely occur along the outer edges of the cobble.
