Inspection Photos
Location Name: Iles Investment CO 1-23
API: 05-081-05136

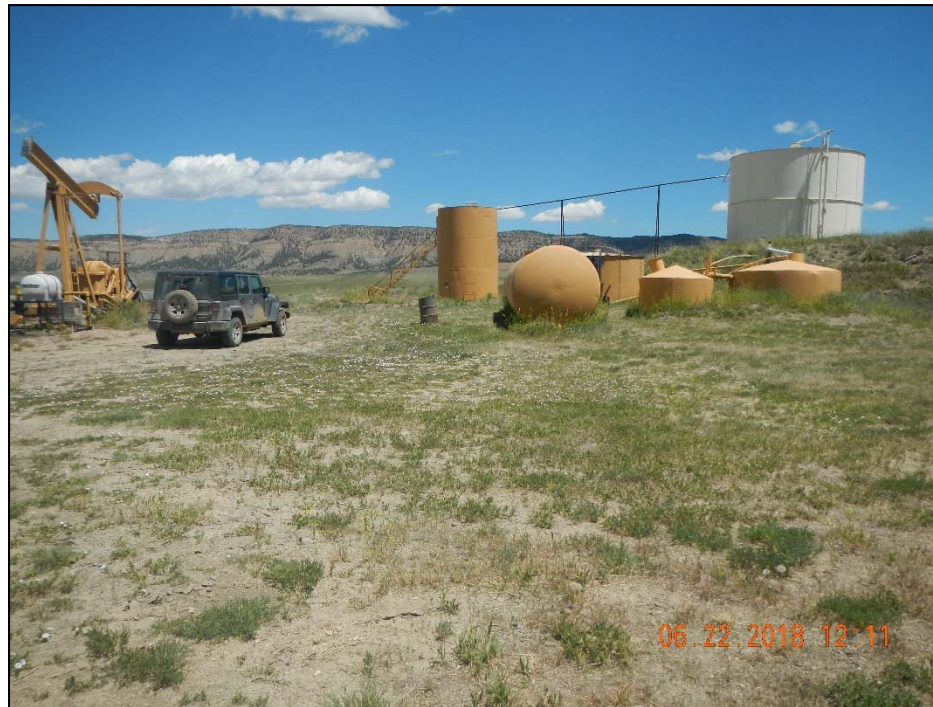
Photo 1. Overview of location taken at entrance facing northeast.

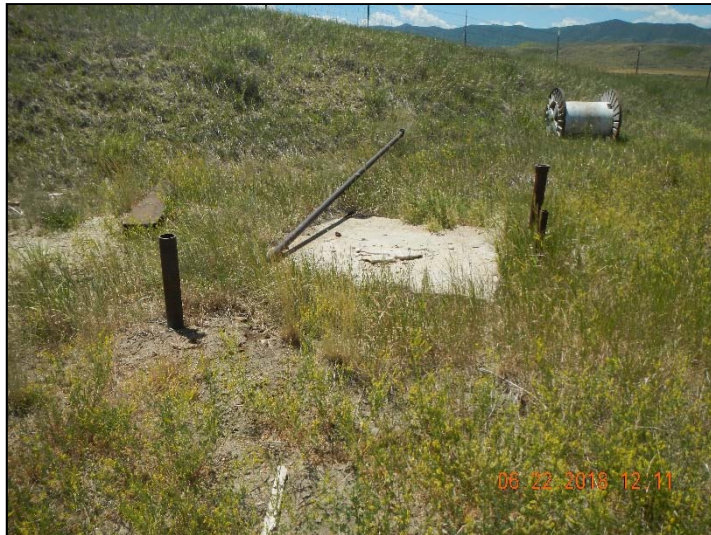
Photo 2. Risers at entrance.
6/22/2018

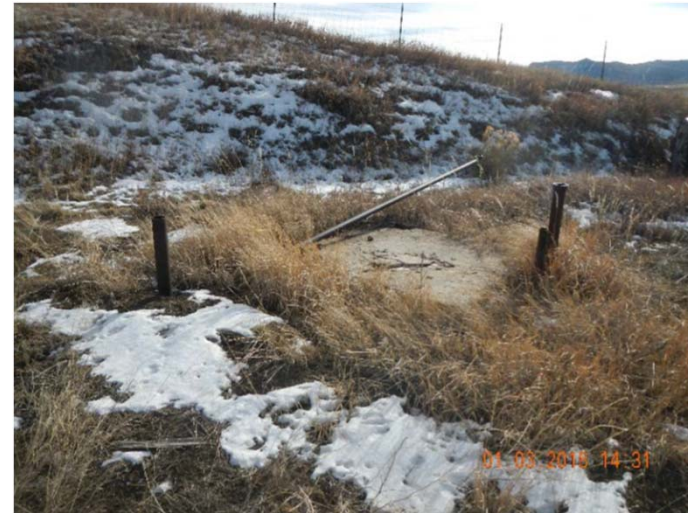
Photo 3. Risers at entrance.
1/3/2018

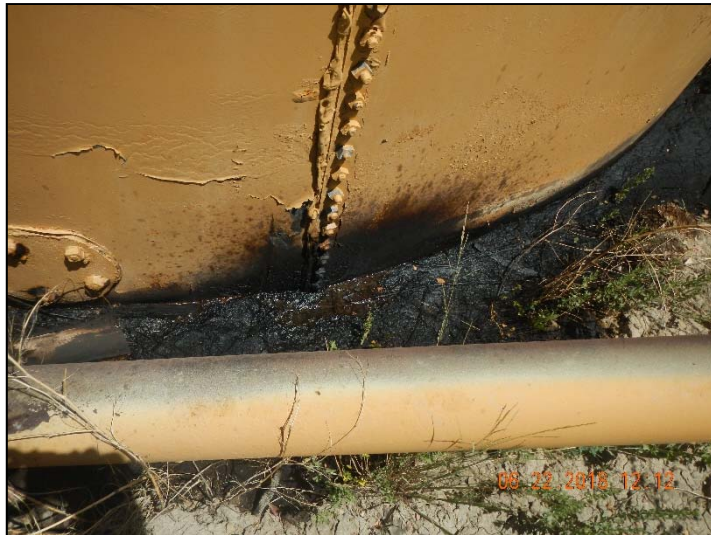
Photo 4. Free fluid at tank base.
6/22/2018

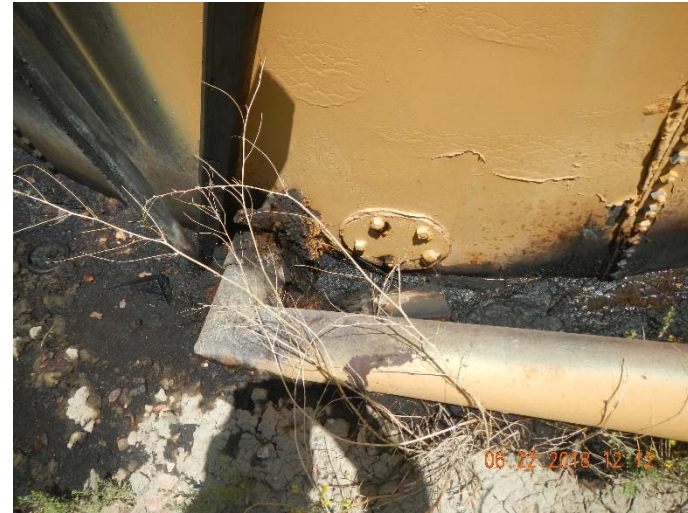
Photo 5. Free fluid at tank base.
6/22/2018

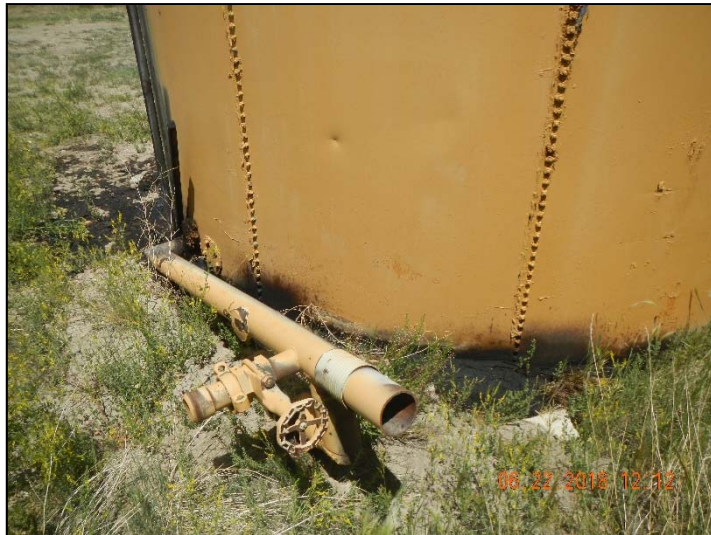
Photo 6. Free fluid and stained soil at tank base.
6/22/2018

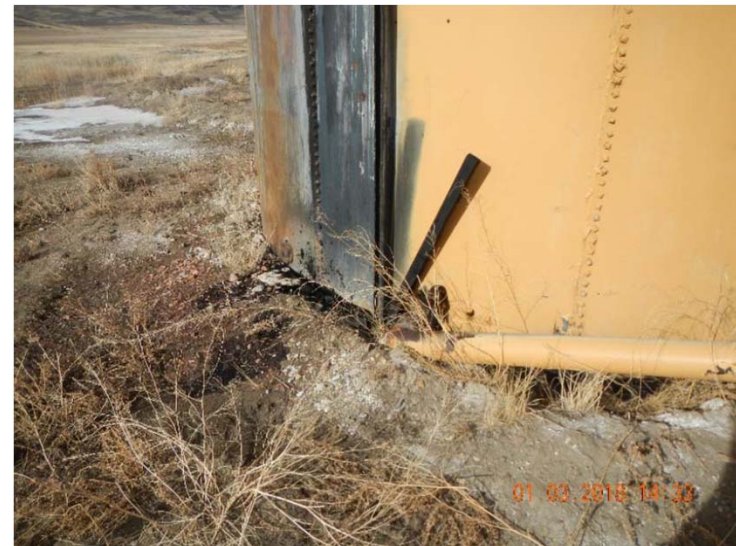
Photo 7. Free fluid and stained soil at tank base.
1/3/2018

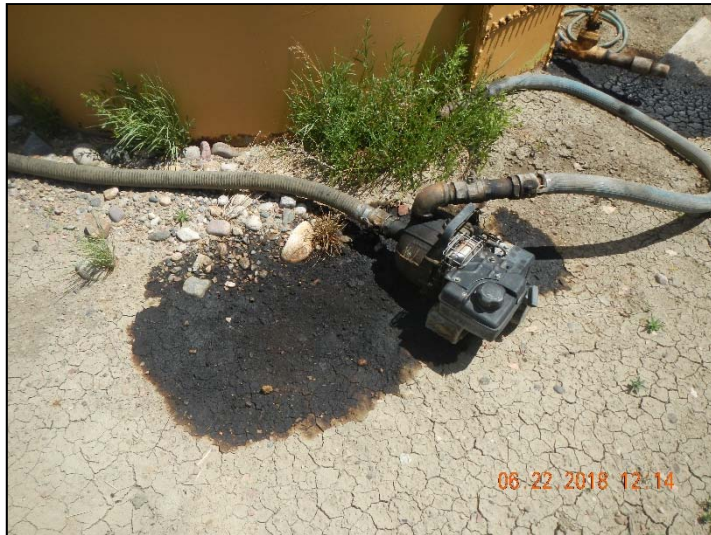
Photo 8. Stained soil.
6/22/2018

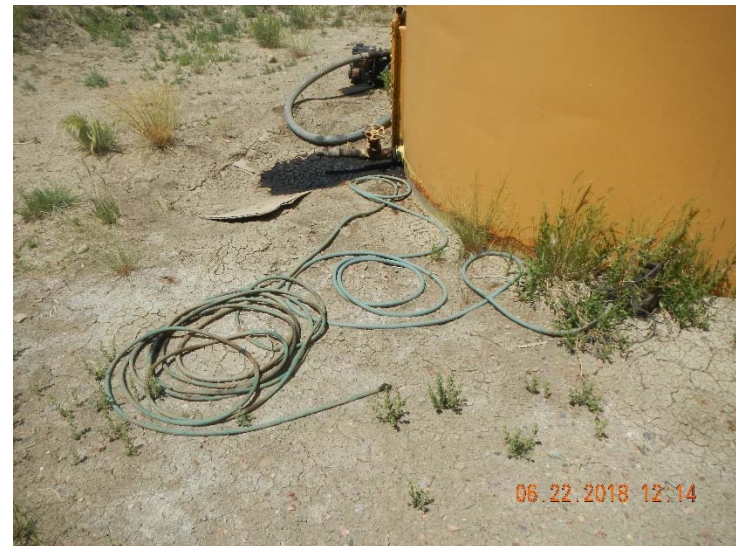
Photo 9. Stained soil and debris.
6/22/2018

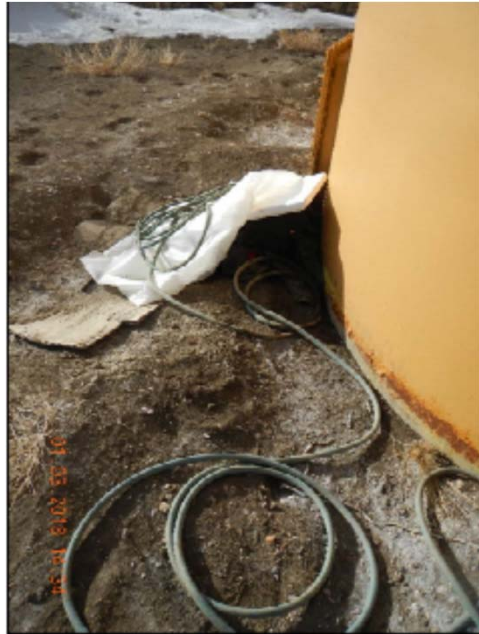
Photo 10. Stained soil and debris.
1/3/2018

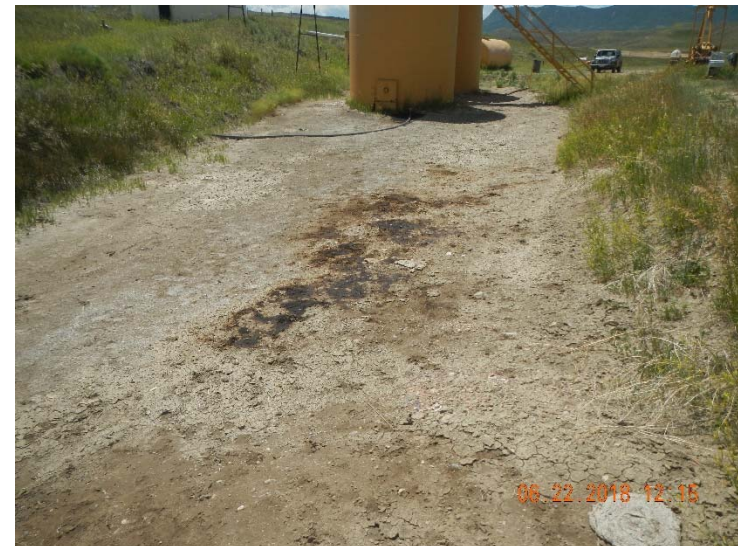
Photo 11. Stained soil.
6/22/2018

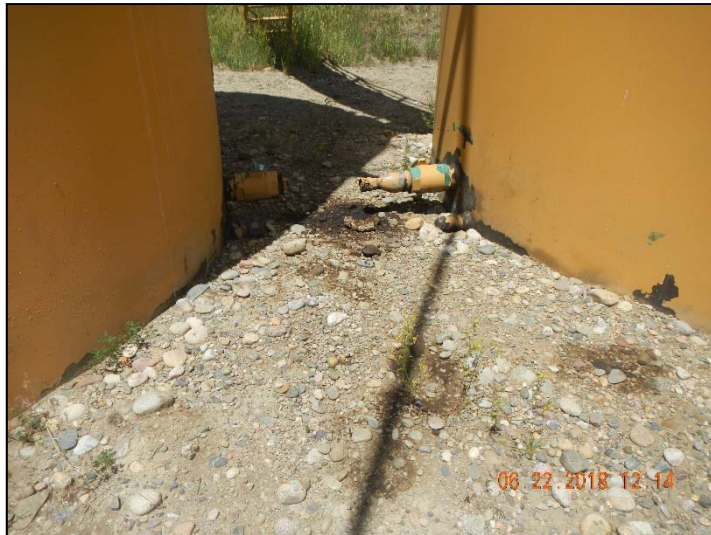
Photo 12. Stained soil at tank loadouts.
6/22/2018

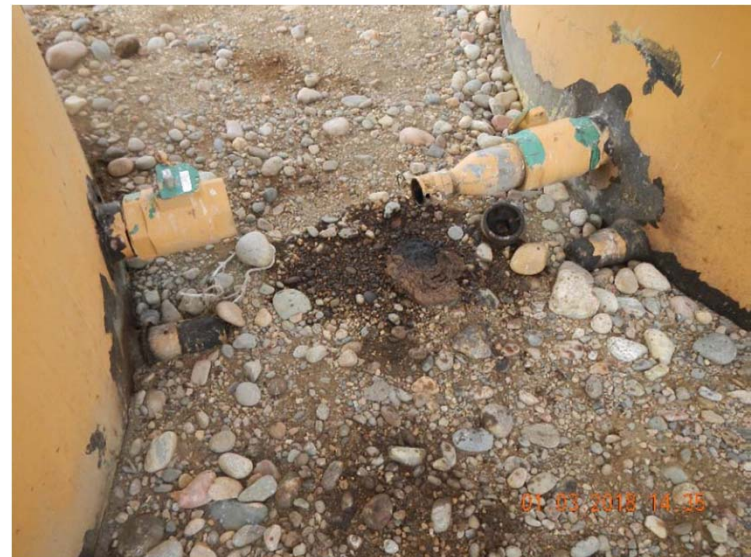
Photo 13. Stained soil at tank loadouts.
1/3/2018

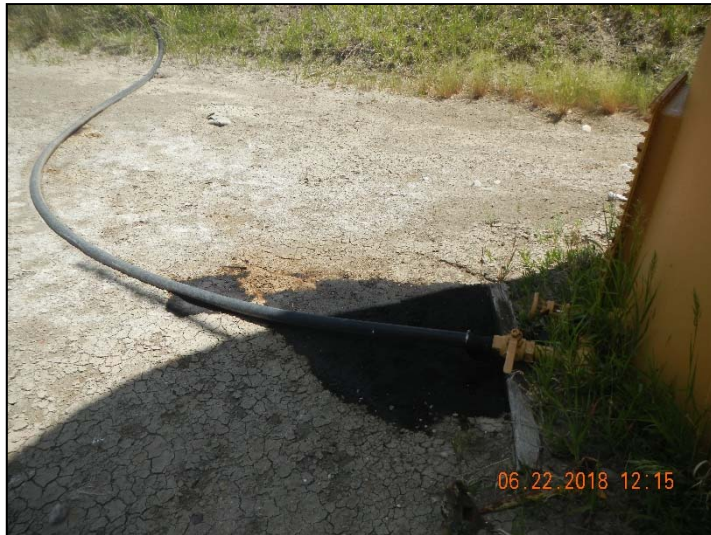
Photo 14. Stained soil at tank loadout.
6/22/2018

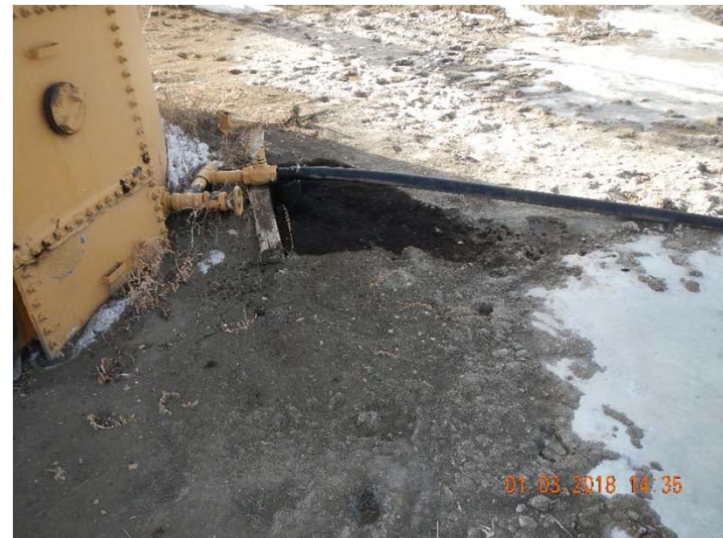
Photo 15. Stained soil at tank loadouts.
1/3/2018

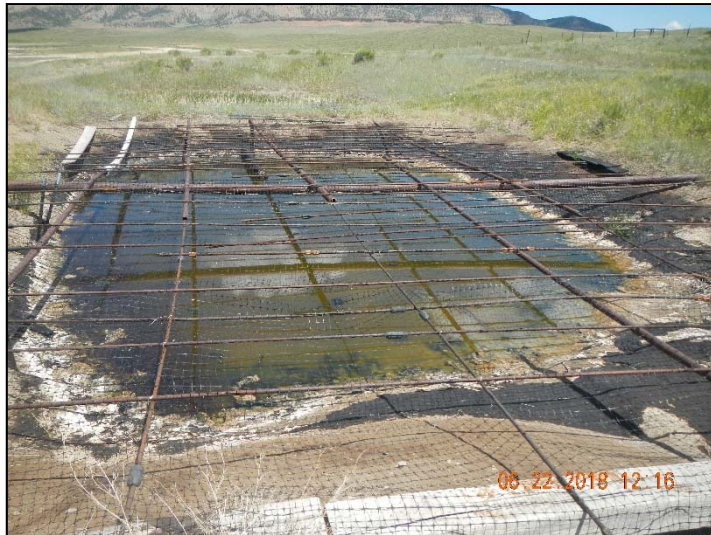
**Photo 16. Pit with gaps in netting, oil, less than
2 feet of freeboard
6/22/2018**

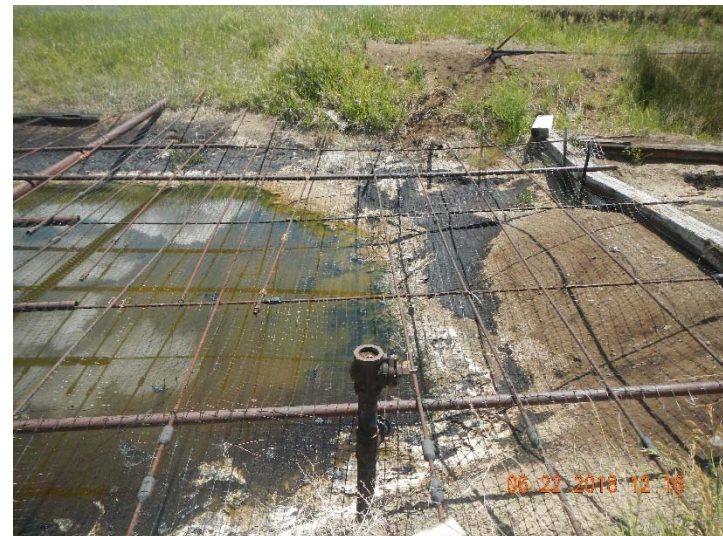
**Photo 17. Pit with unmarked riser.
6/22/2018**

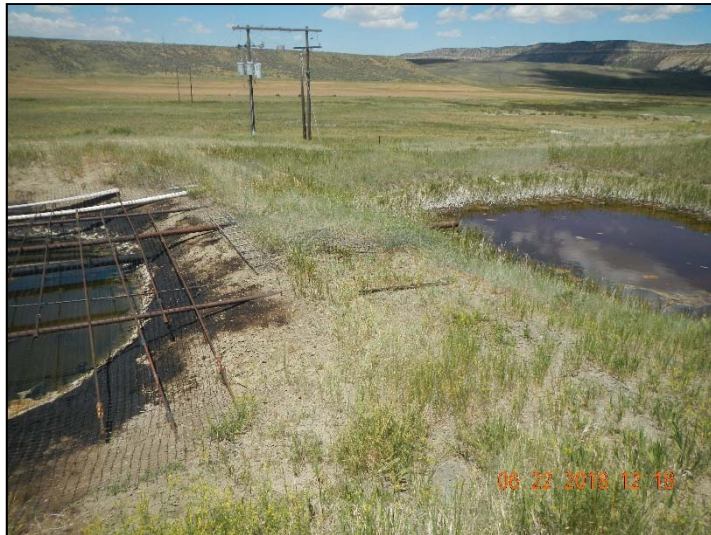
Photo 18. Pit with gaps in netting, oil, less than 2 feet of freeboard.
6/22/2018

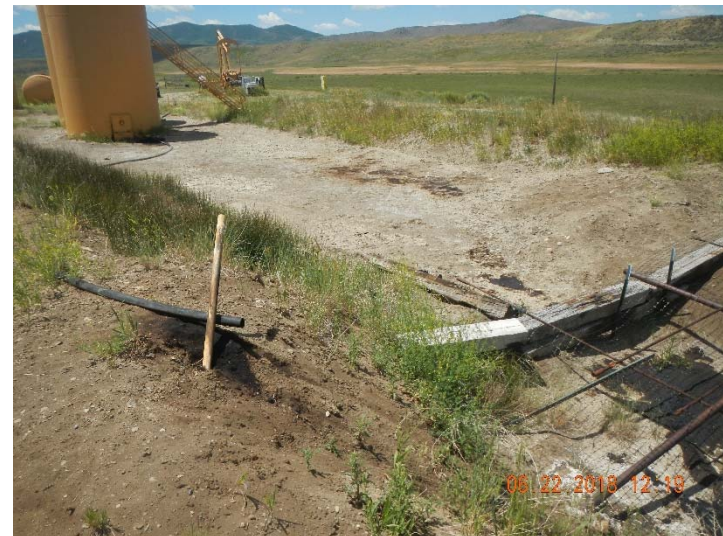
Photo 19. Stained soil on east side of pit with "flowline".
6/22/2018

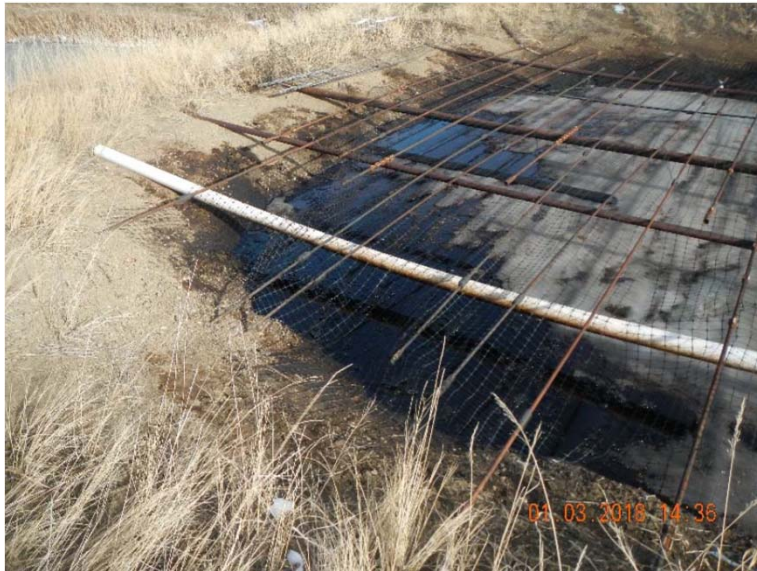
Photo 20. Pit with gaps in netting, oil, less than 2 feet of freeboard.
1/3/2018

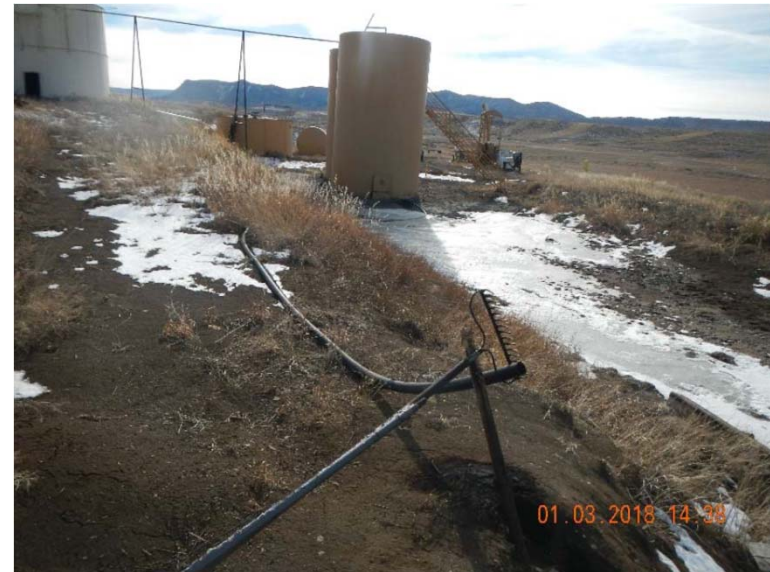
Photo 21. Stained soil on east side of pit with "flowline".
1/3/2018

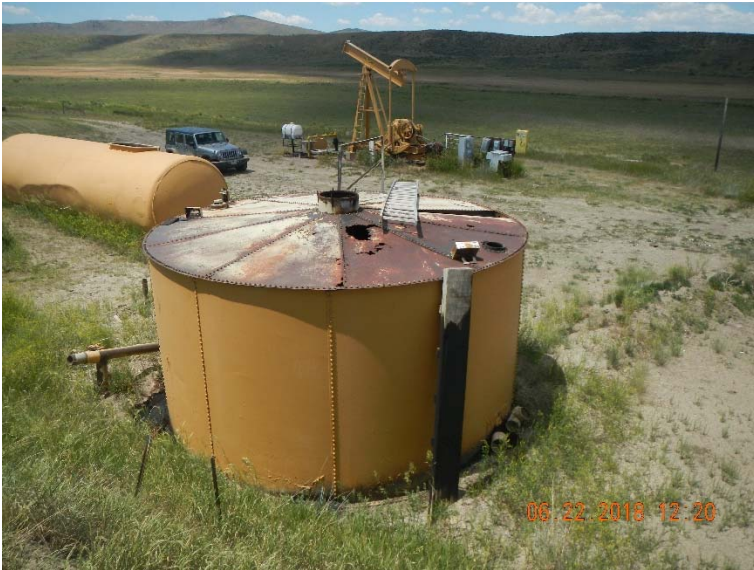
Photo 22. No tank labels, no berm, holes in tank.
6/22/2018

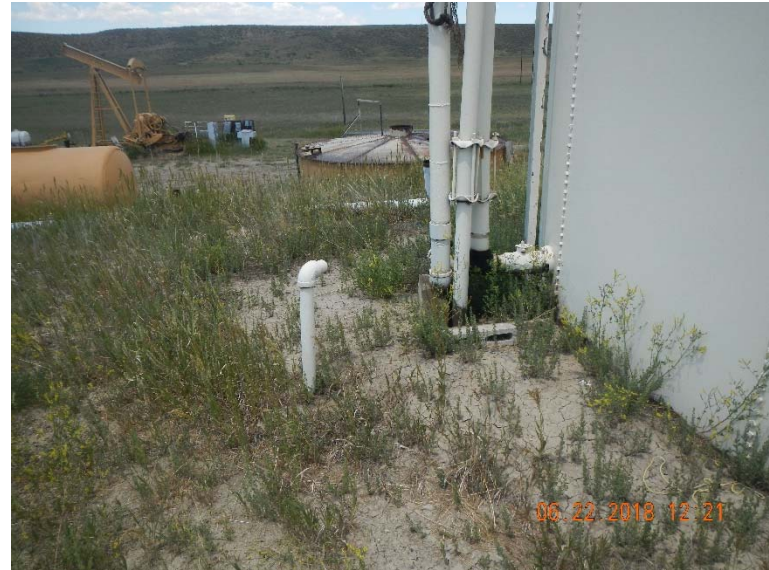
Photo 23. Riser.
6/22/2018
