Inspection Photos
Location Name: Tow Creek 13-11
API: 05-107-06051

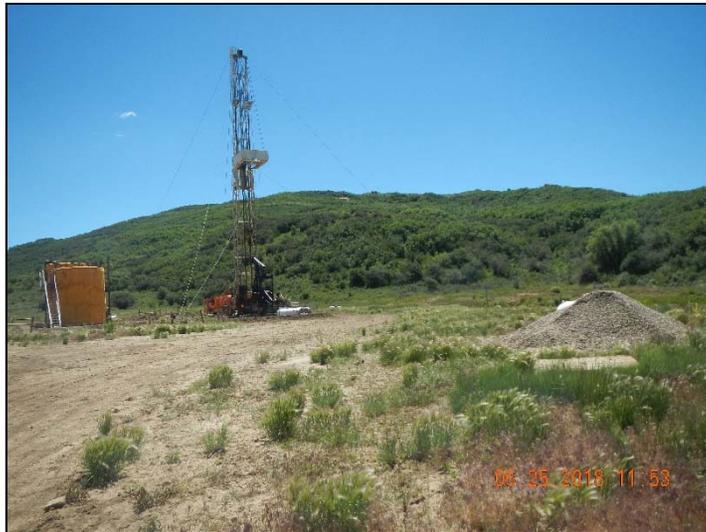
Photo 1. Overview of location taken at entrance facing southeast.

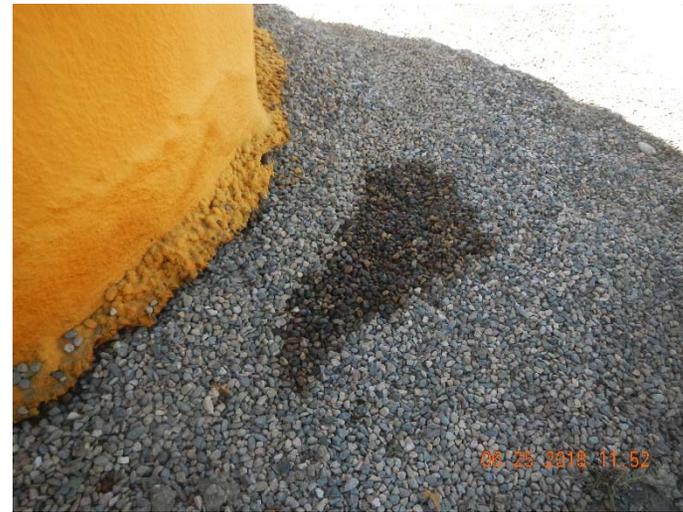
Photo 2. Stained soil at tank base.

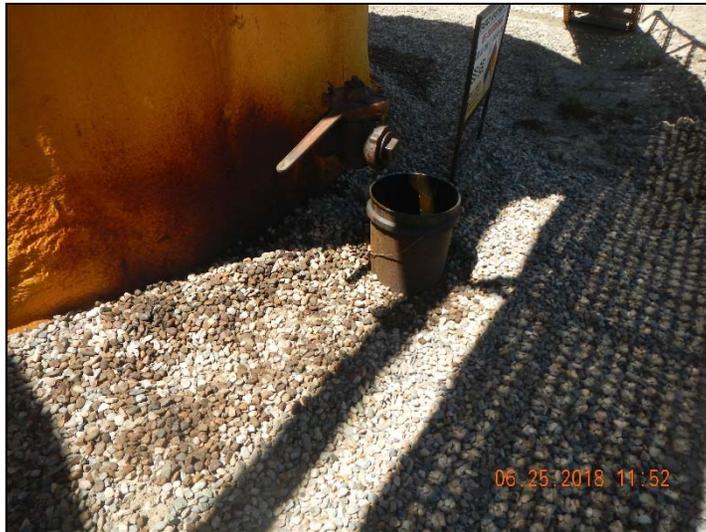
Photo 3. Bucket at loadout with stained soil around base.

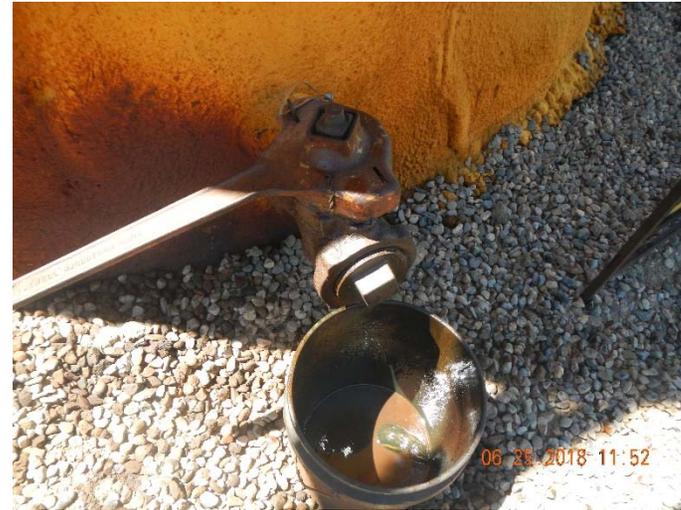
Photo 4. Bucket from photo 3 with fluid in it.
