Well Name : Hazel 3

API # : 067-06397

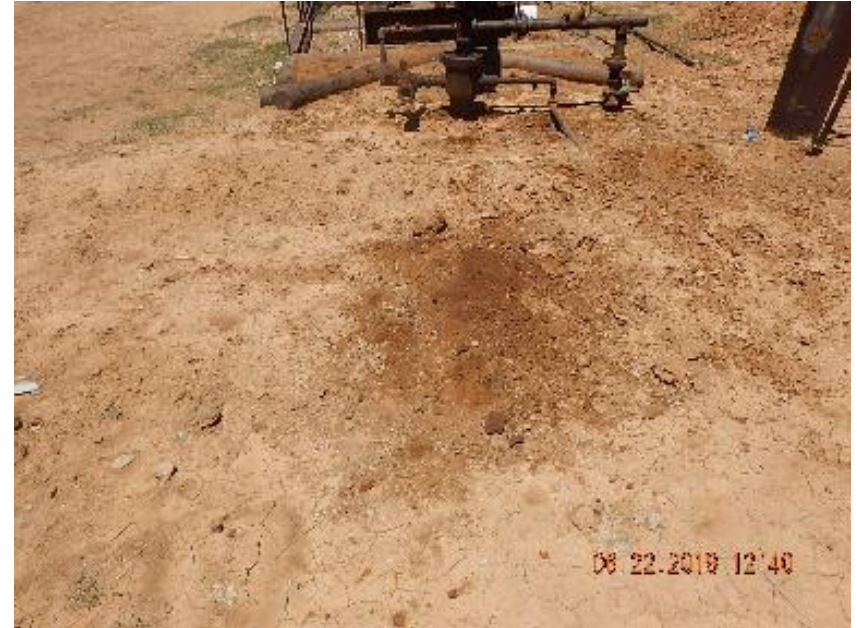
Photo 2: Impacted soil pile at wellhead.

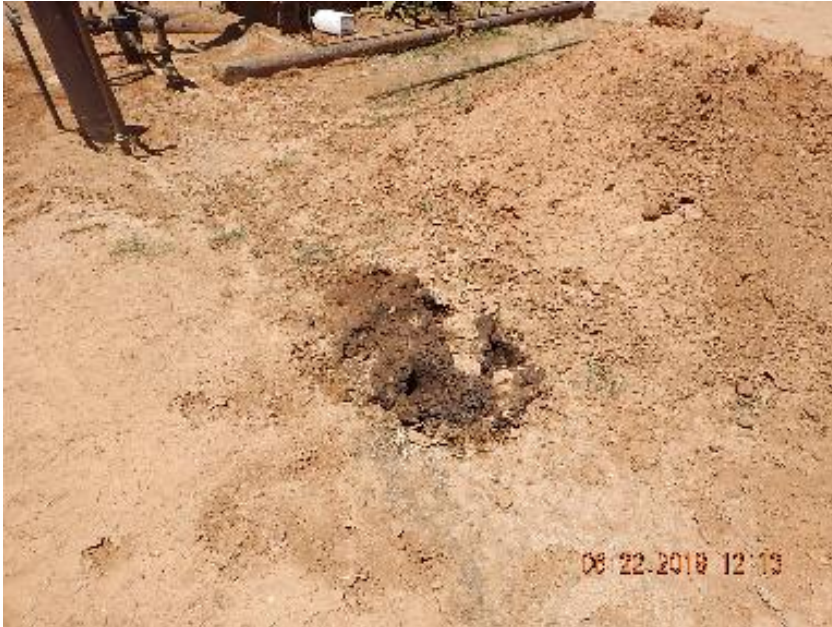
Photo 3: Impacted soil pile at wellhead.

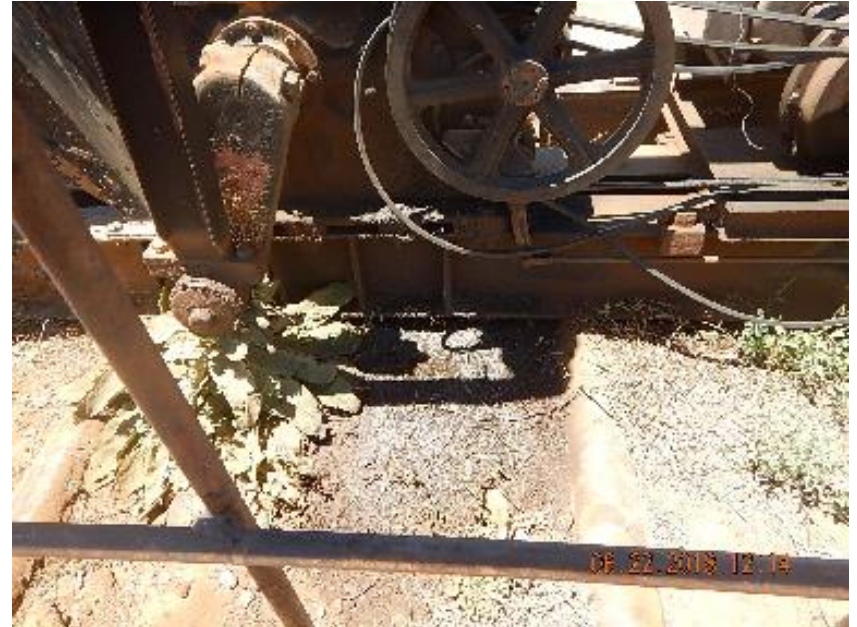
Photo 4: Impacted soil under motor.

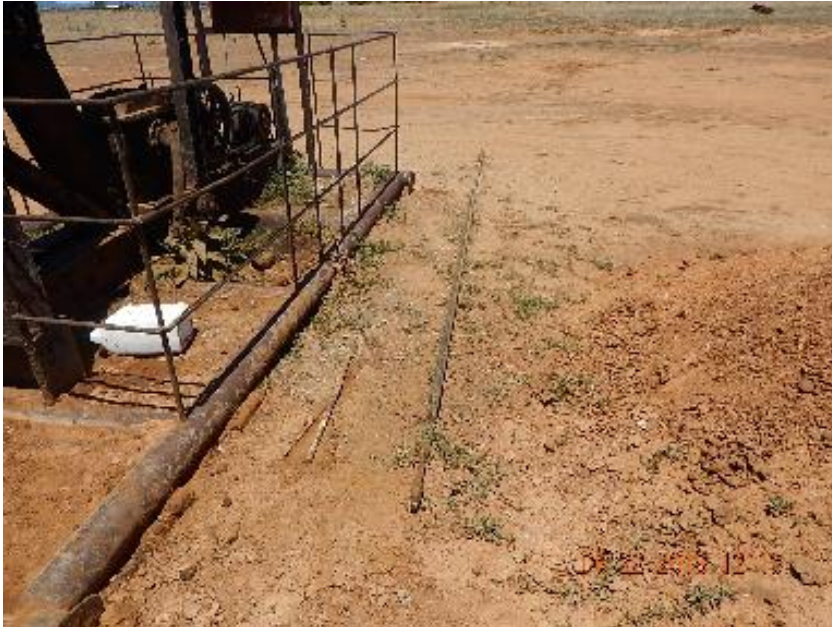
Photo 5: Sucker rod and production related debris at pump jack.

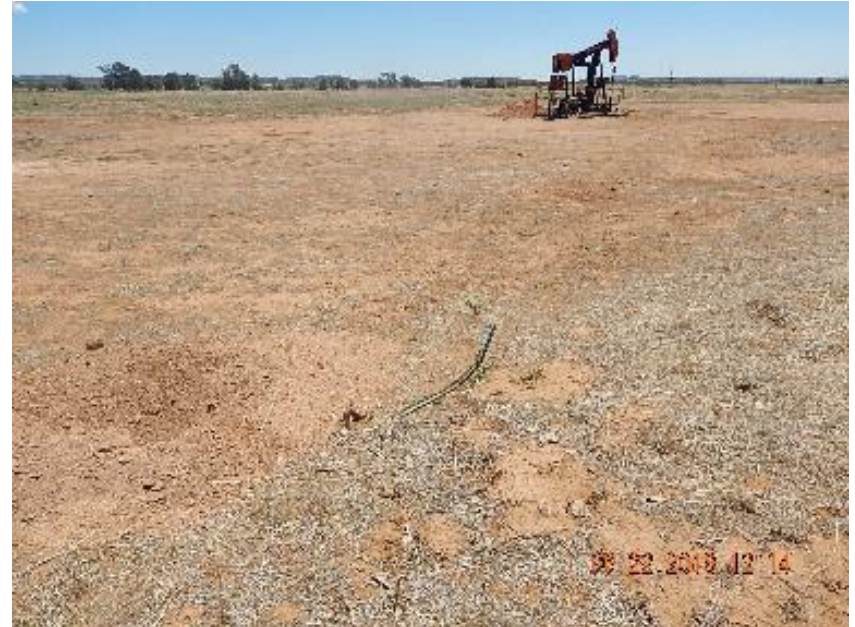
Photo 6: Anchor marker needing repair.
