Inspection Photos
Location Name: Foster State 1
API: 05-081-07821

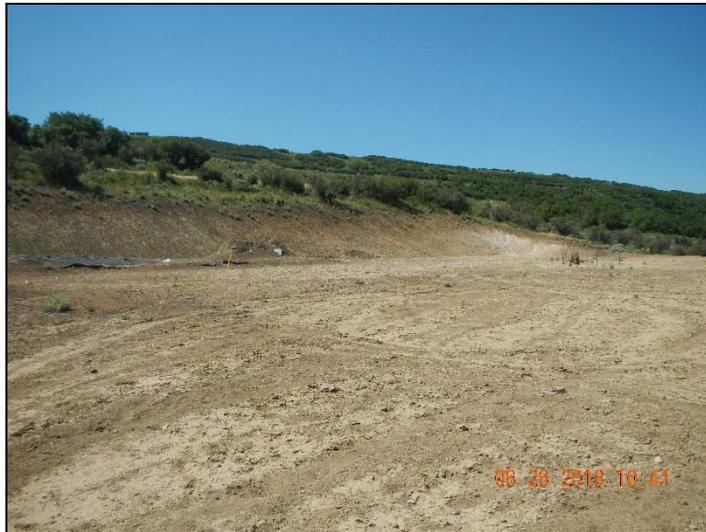
Photo 1. Overview of location taken at entrance facing southwest.

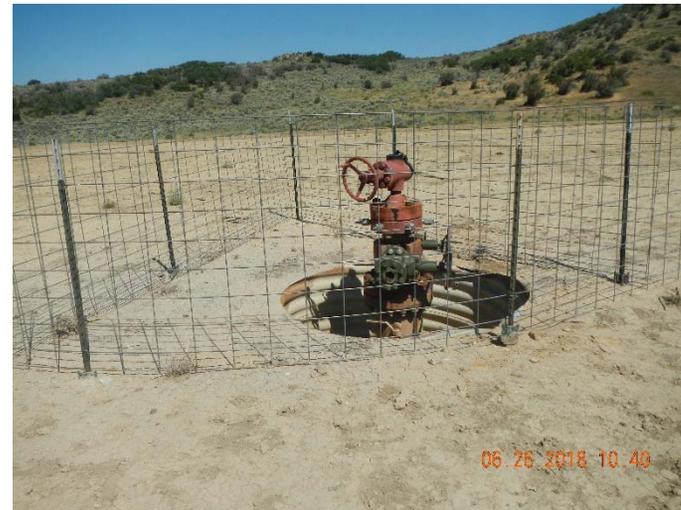
Photo 2. No wellhead sign.

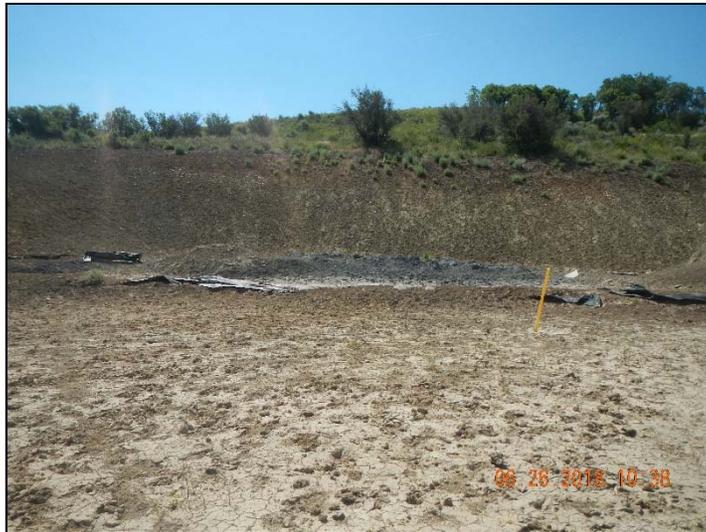
Photo 3. Cuttings stored on location.

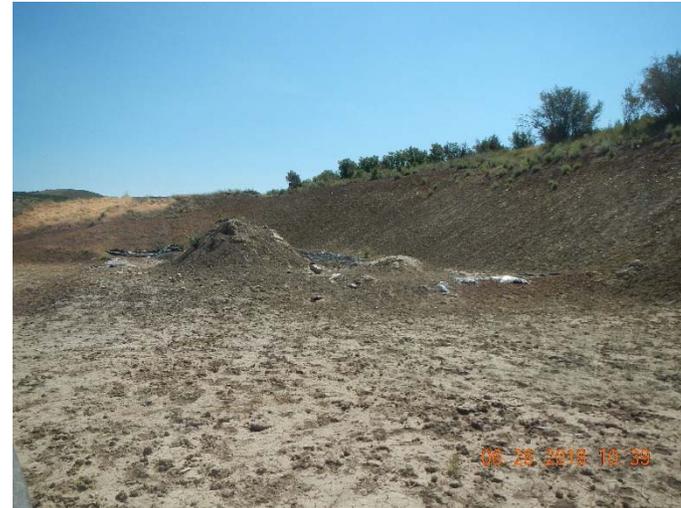
Photo 4. Cuttings stored on location.

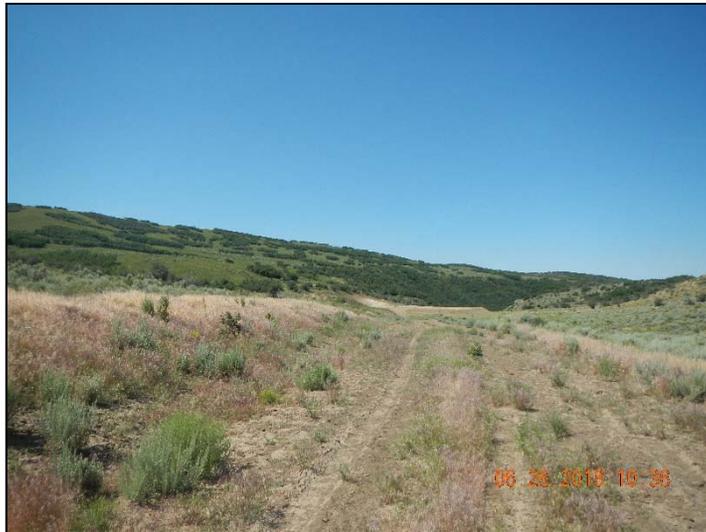
Photo 5. Example of overgrown section of access road.

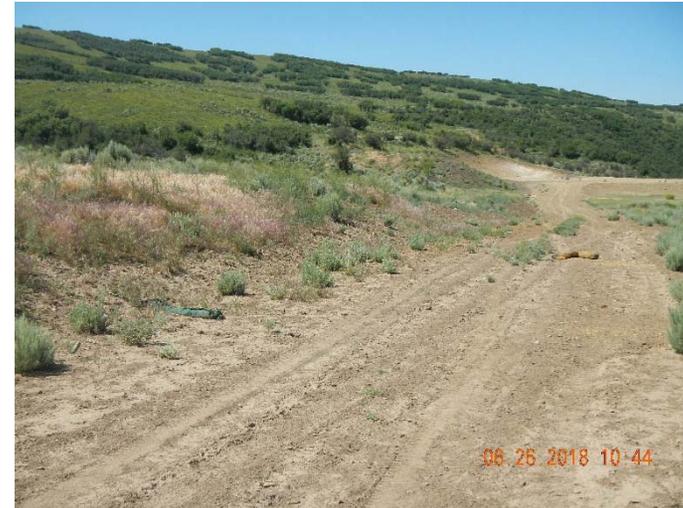
Photo 6. Stormwater debris in road that has been moved/eaten by livestock/wildlife.

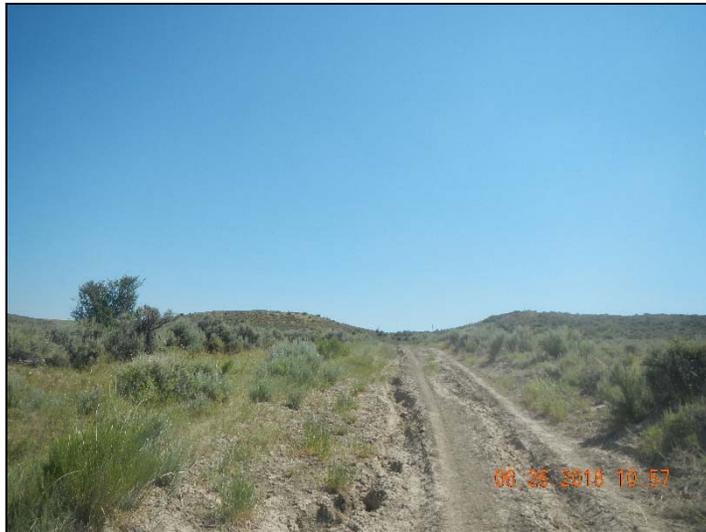
Photo 7. Example of rutted section of access road. Ruts 12-20" deep.

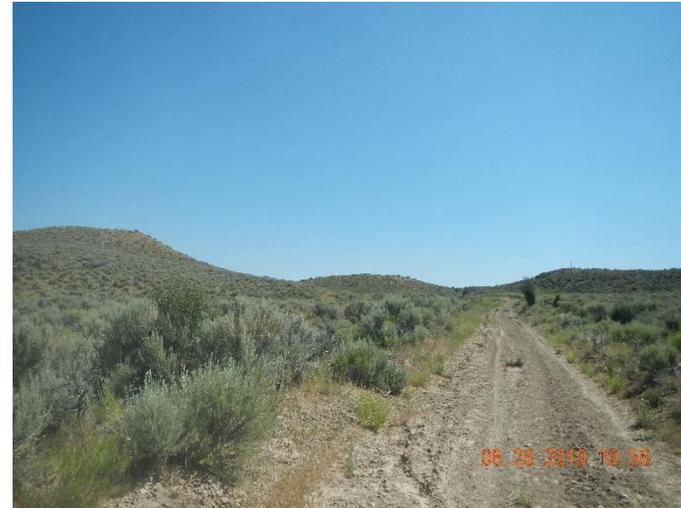
Photo 8. Example of rutted section of access road.
