Inspection Photos
Location Name: Foundation API 045-06153
6/19/2018

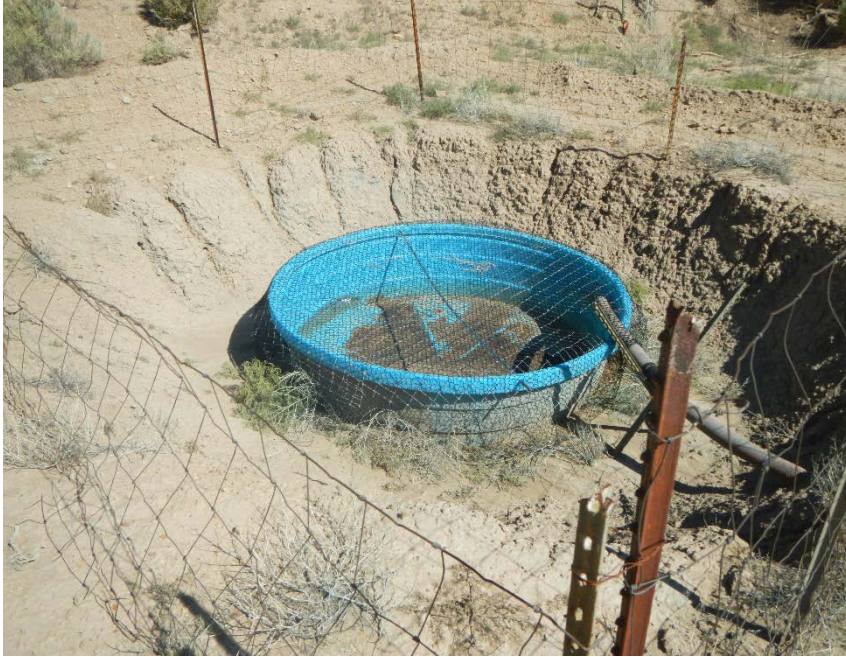
Poly tank/pit looking south

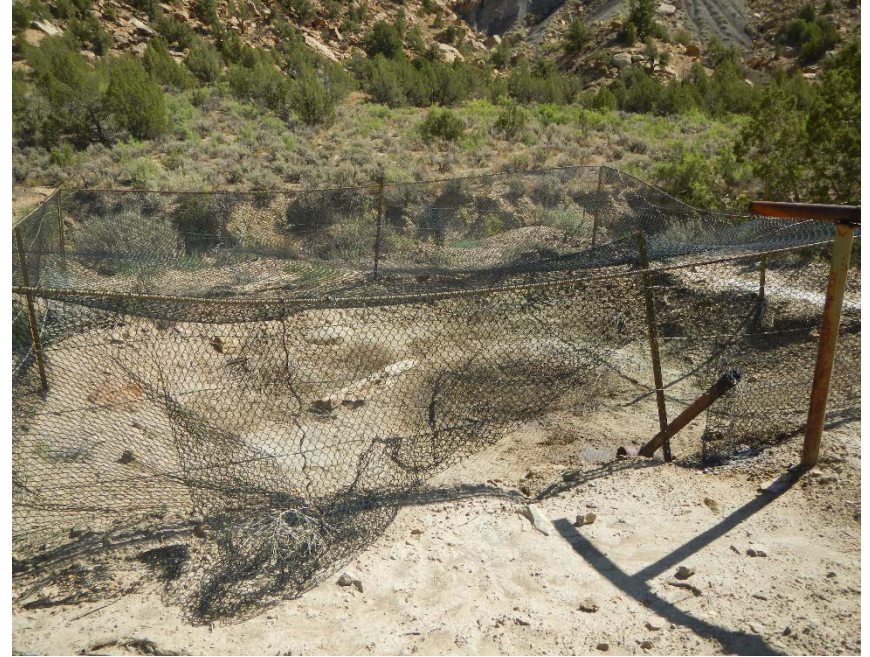
Looking NE , note staining below discharge pipe

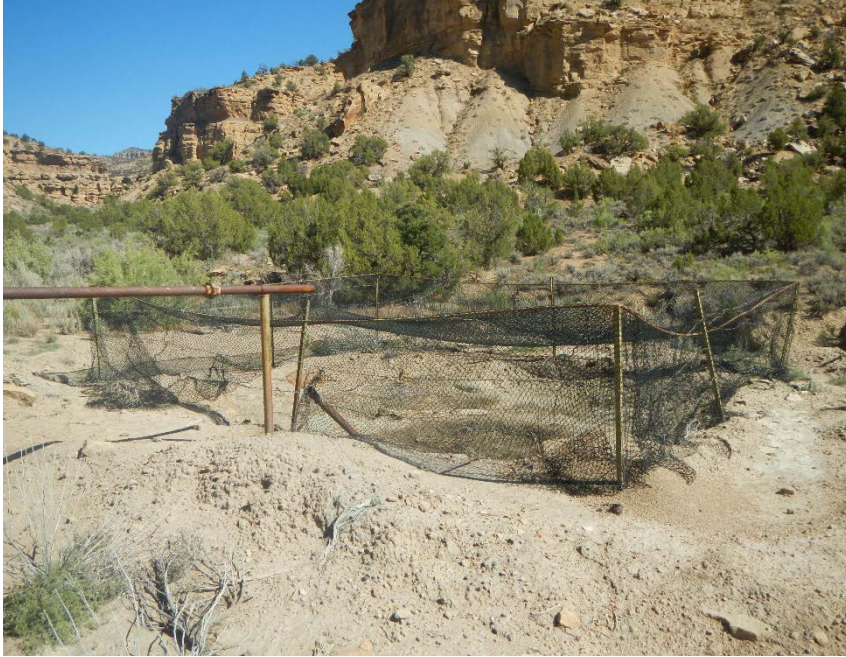
Separator pit looking N.

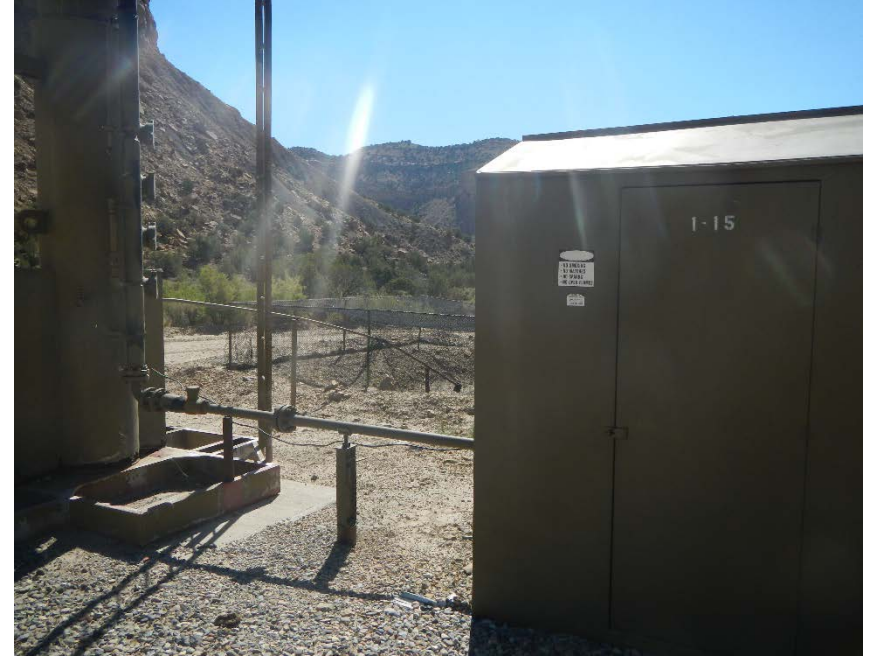
Separator and active pit looking N
