Inspection Photos

Location Name: Sandy Hill Land Application Site, Facility: 448950

Inspection Date: 06/27/2018

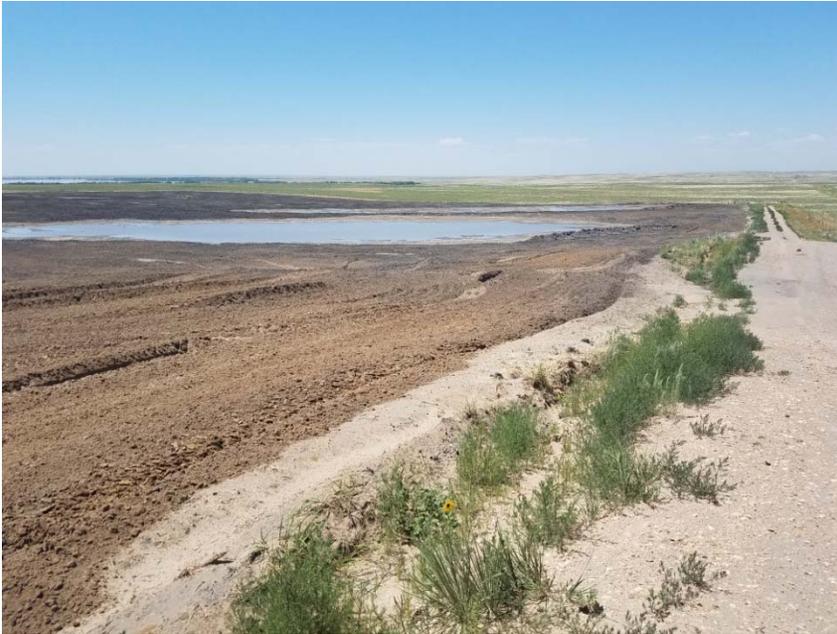
Photo 1 – Center-North area of land application area, looking west.

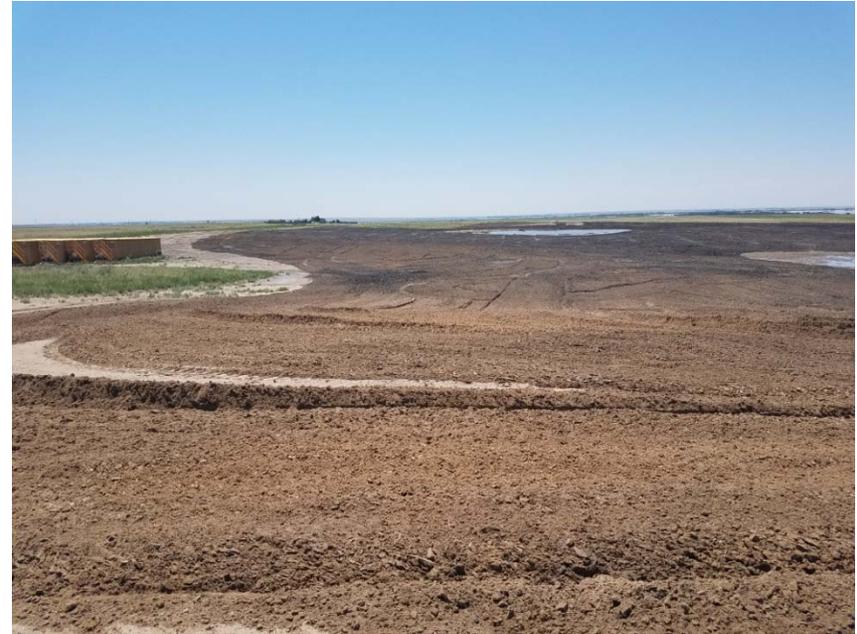
Photo 2 – Center-North Area of land application area, looking south.

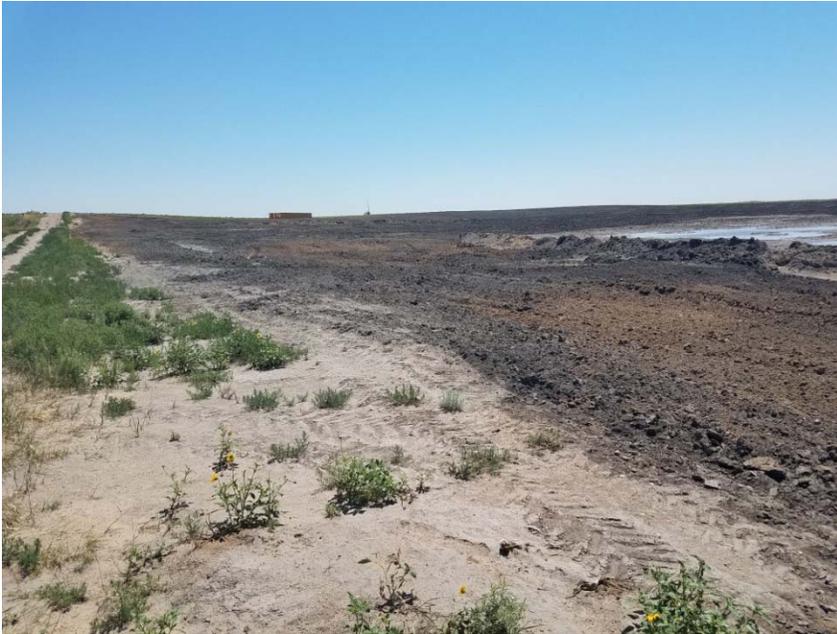
Photo 3 – Northwest corner of land application area, looking east.

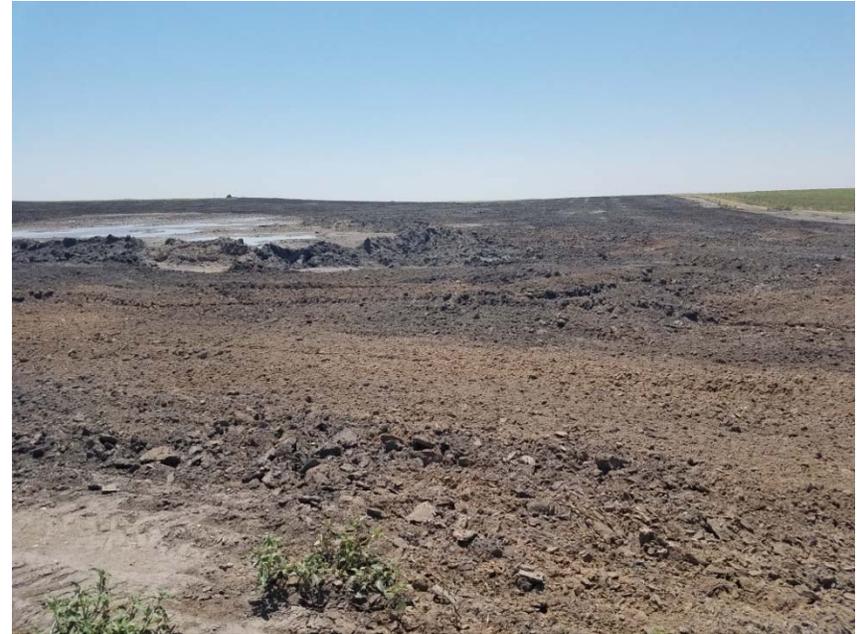
Photo 4 – Northwest corner of land application area, looking south.

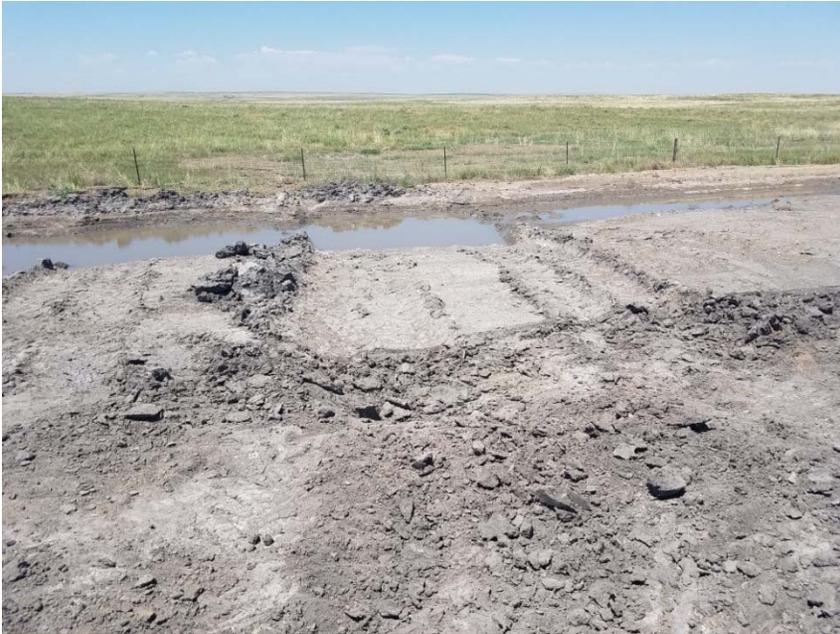
Photo 5 – Area of berm breach and stormwater runoff onto State Land Board property to west.

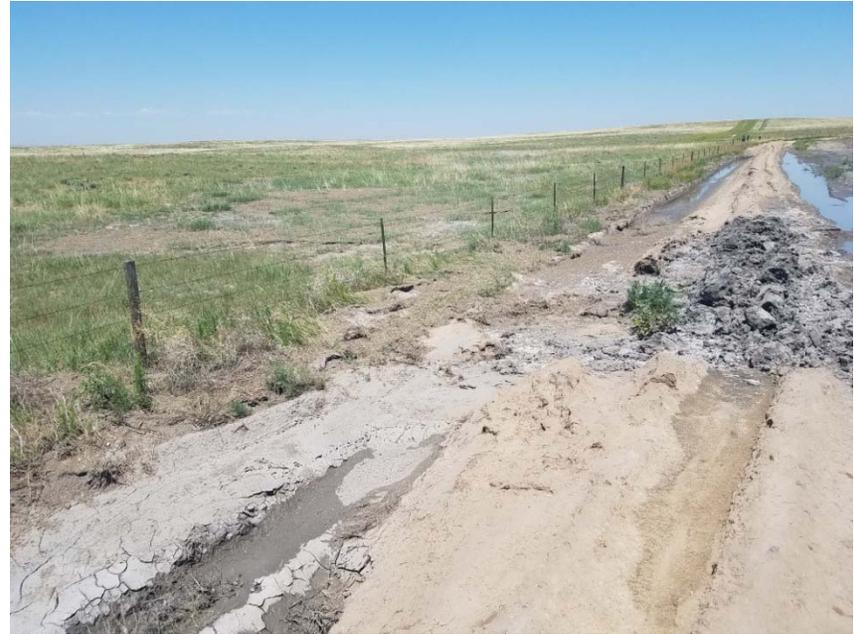
Photo 6 – View of storm water breach and runoff onto State Land Board property to west.

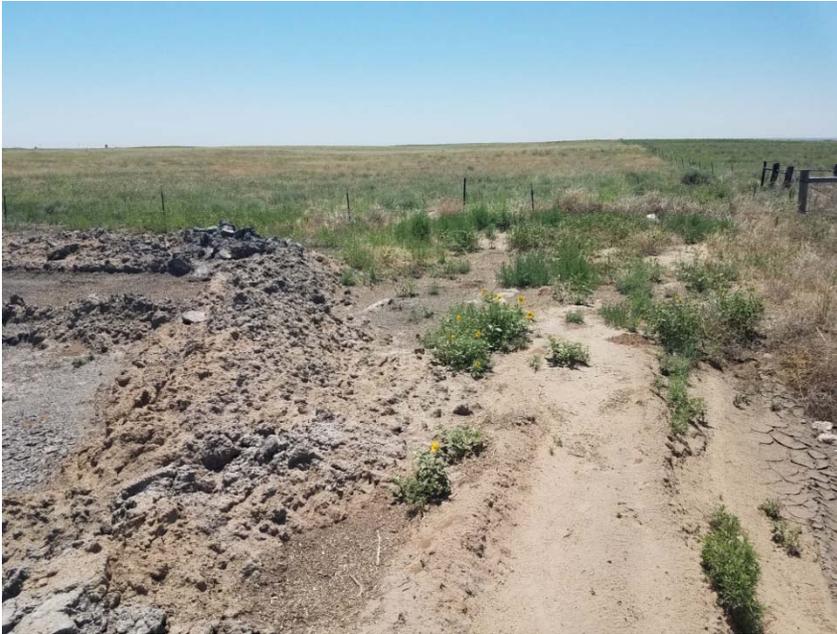
Photo 7 Southwest corner of land application area, looking south.

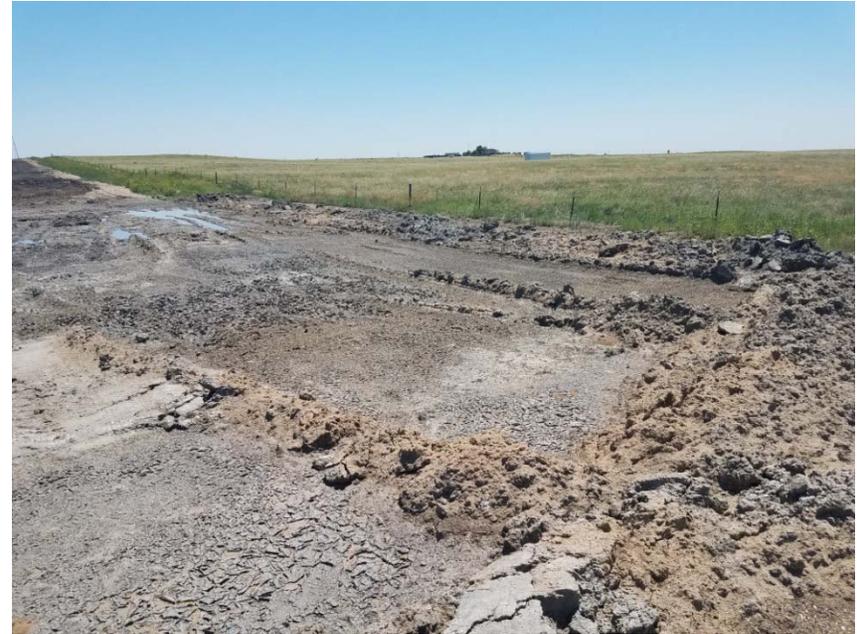
Photo 8 – Southwest corner of land application area looking southeast.

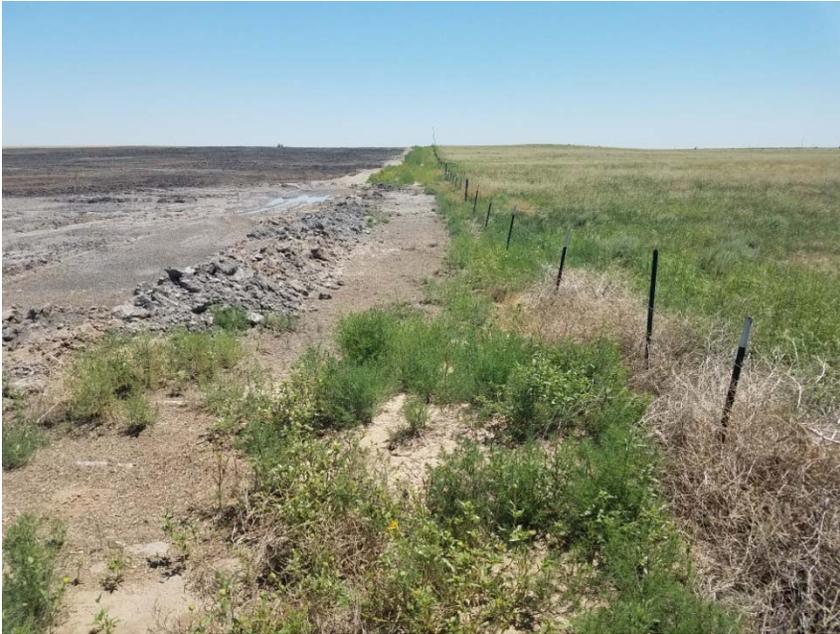
Photo 9– Southwest corner of land application area looking east along south property boundary.

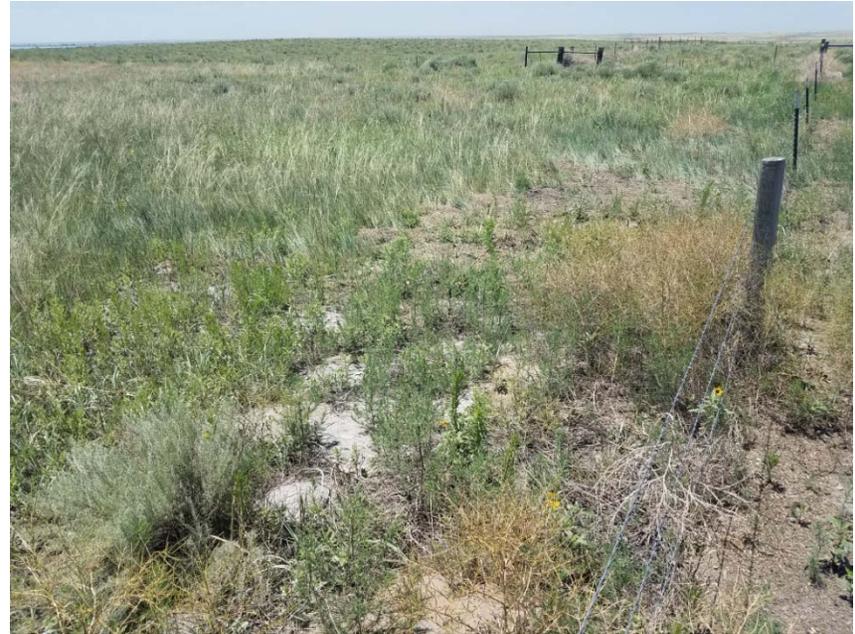
Photo 10 – View of storm water breach and runoff onto private property to south.

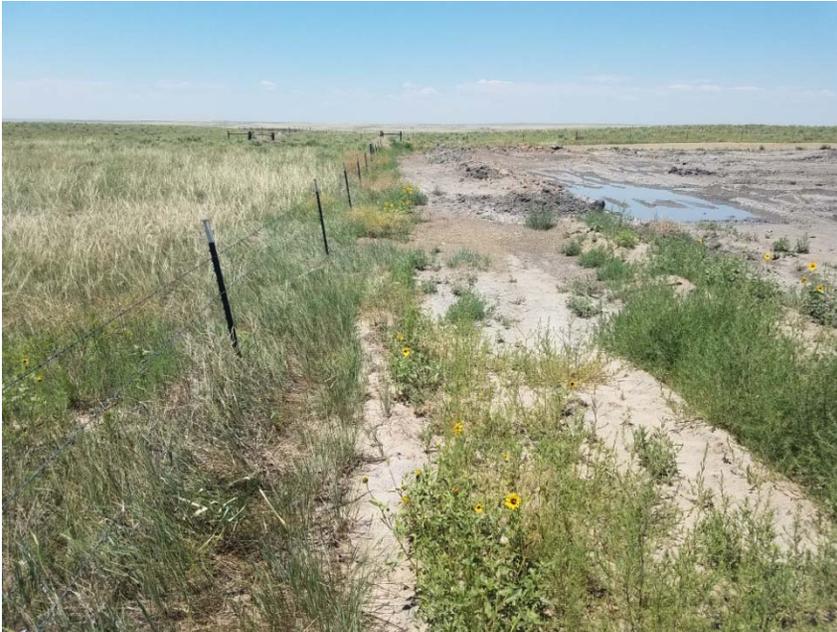
Photo 11 – Viewing west along the south property line of land application area. Area of stormwater runoff in middle of photo.

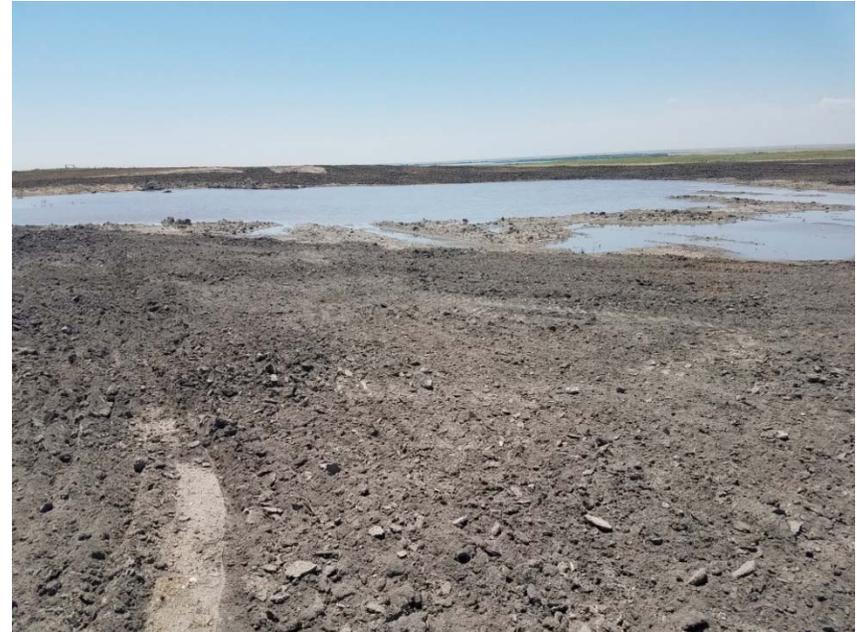
Photo 12 – View of standing stormwater in center of property.
