**Inspection Photo
Robinson C8
API # 045-17107
Inspection # 689301421**

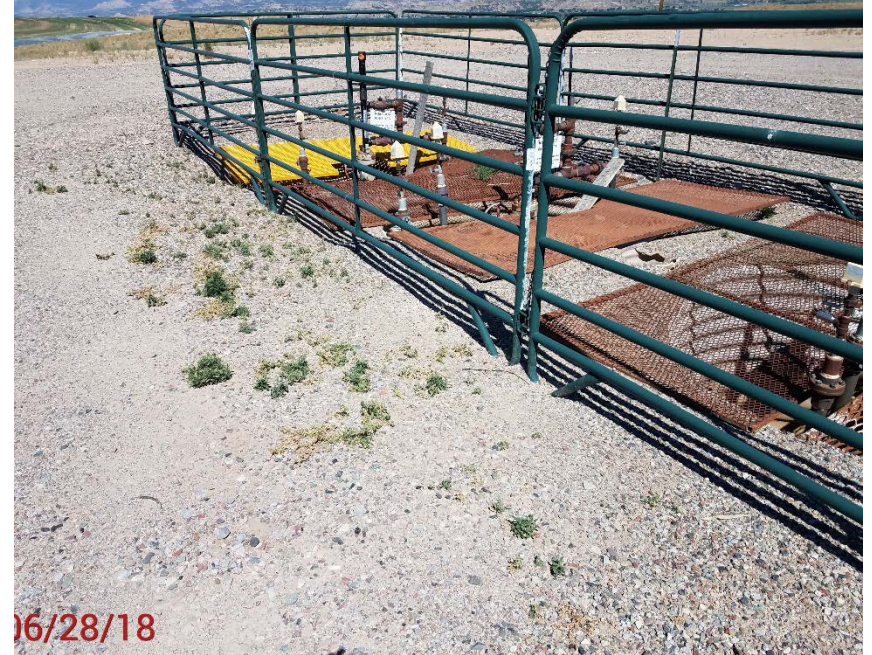
Location Photo #2, weeds near the wellheads

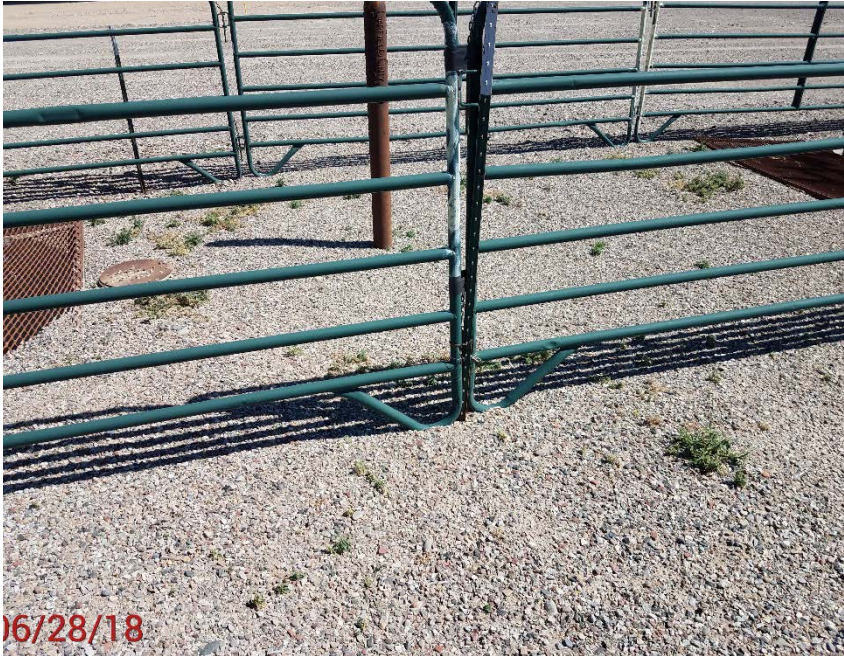
Location Photo #3, weeds near the wellhead

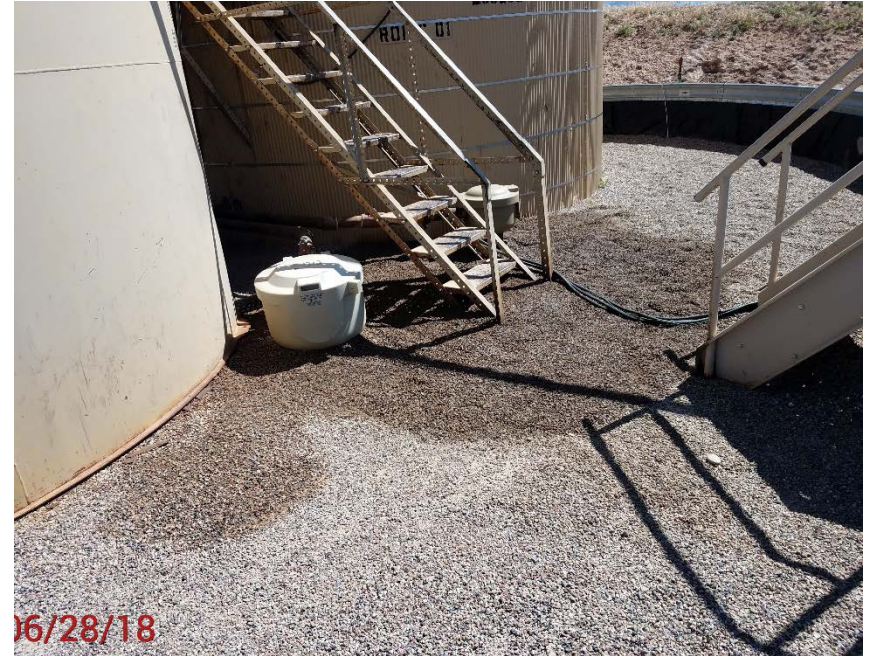
Location Photo #4, Stained rock in battery containment

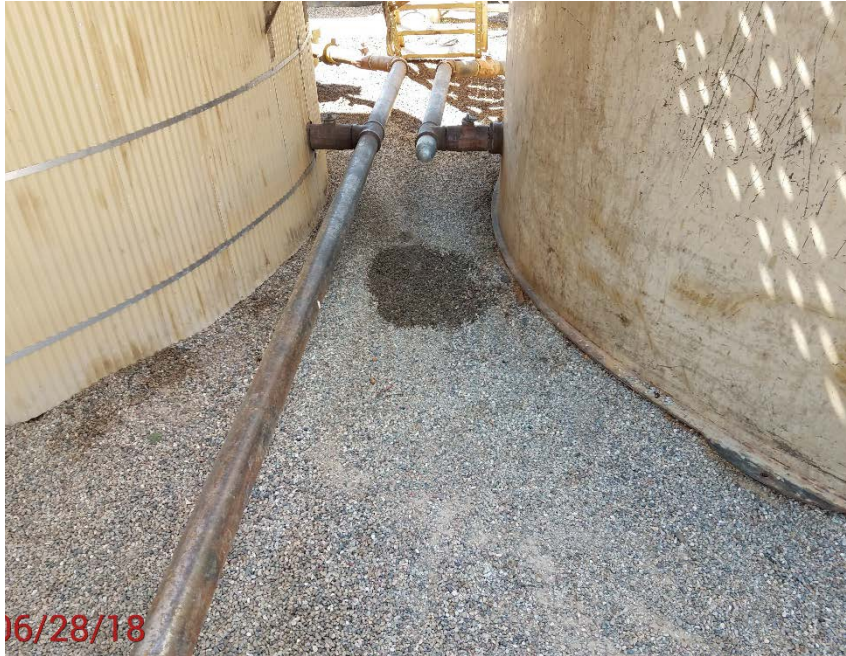
Location Photo #5, Stained rock in battery containment

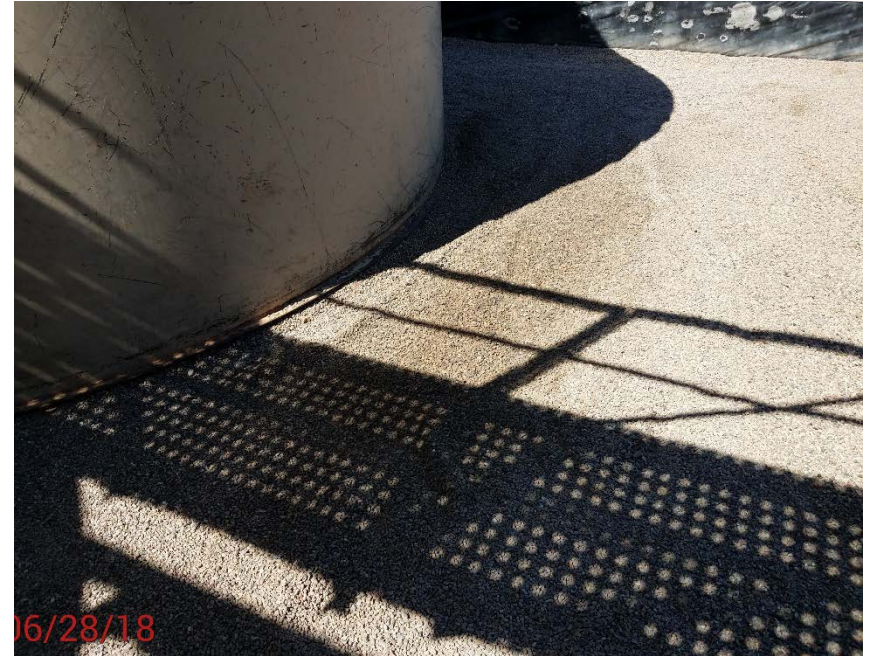
Location Photo #6, Stained rock in battery containment

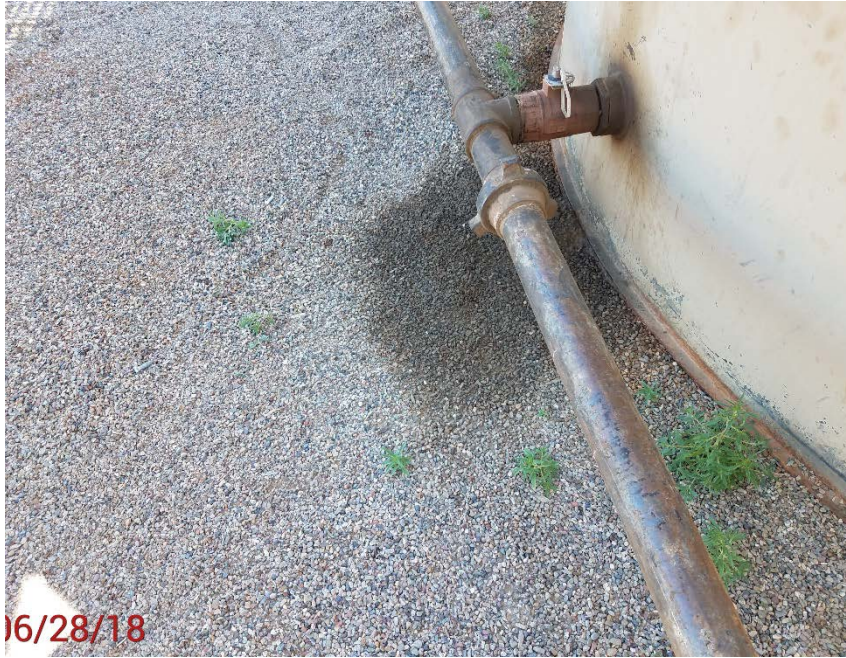
Location Photo #7, Stained rock in battery containment

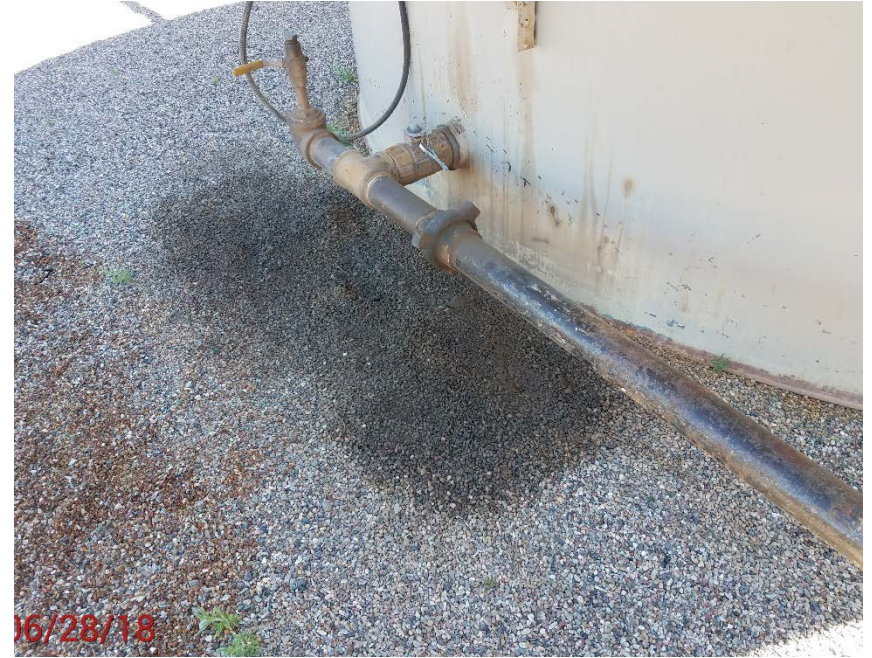
Location Photo #8, Stained rock in battery containment

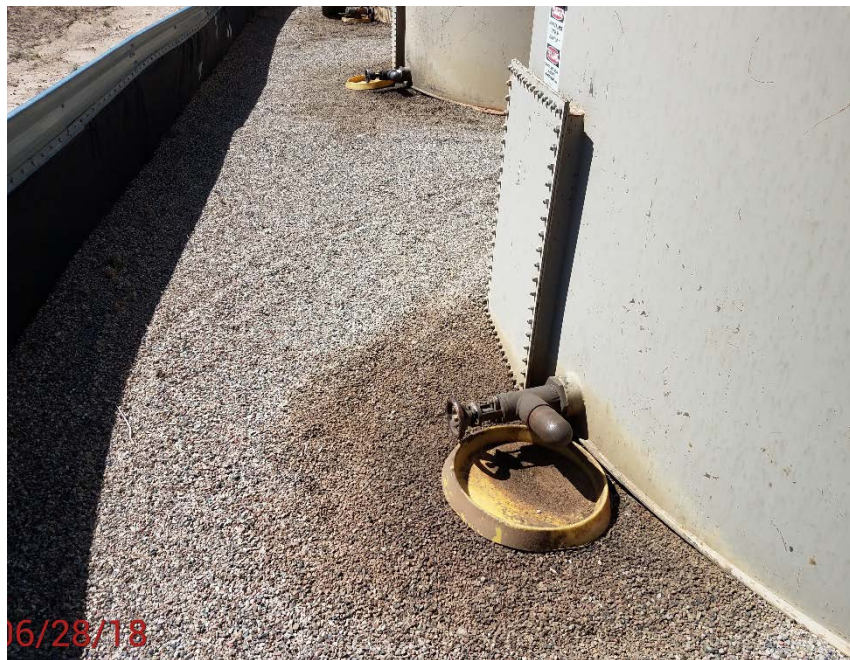
Location Photo #9, Stained rock in battery containment

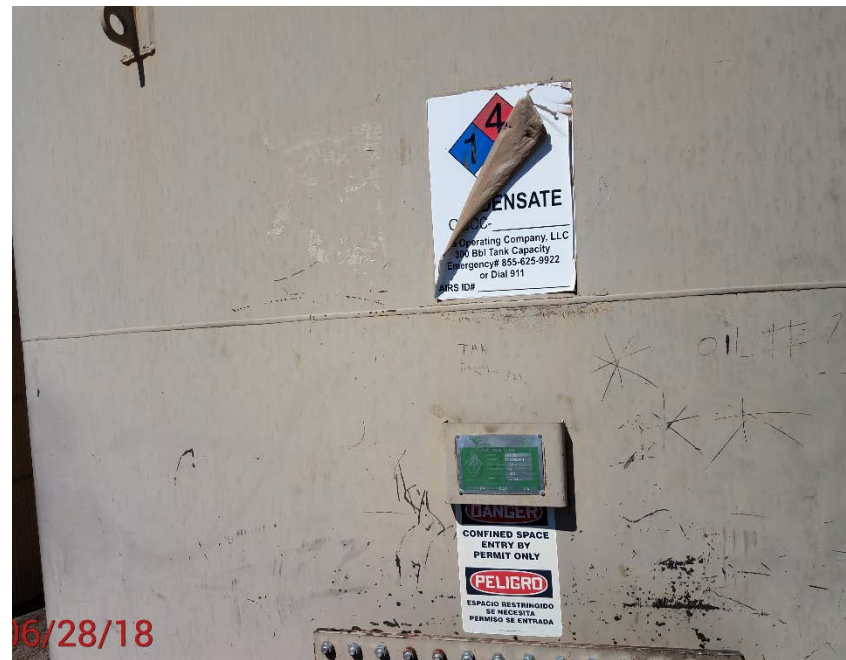
Location Photo #10, Tank sign non legible
