Inspection Photos 06/29/18
Location: NGL Water Solutions C6A Well and UIC Disposal Facility
API # 05-123-40968

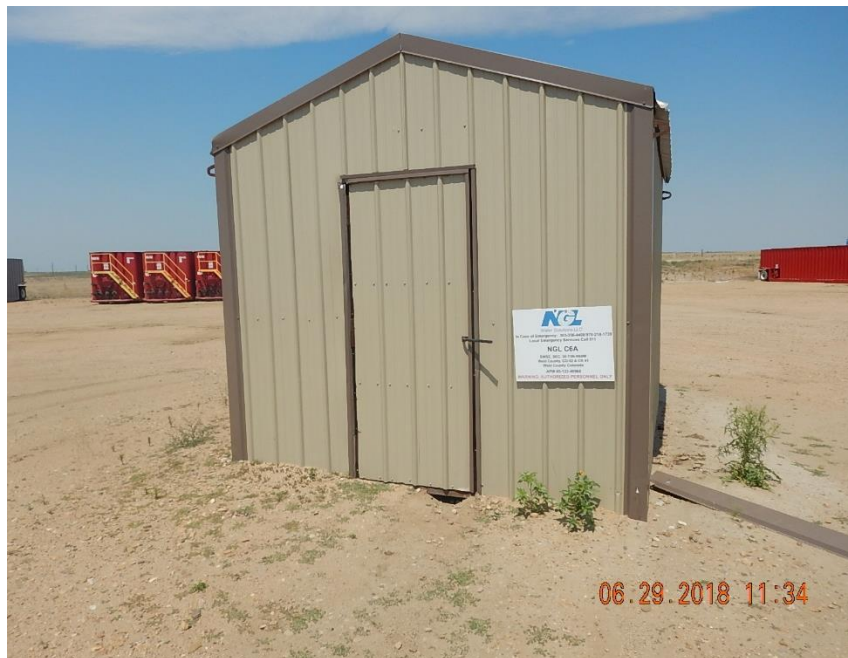
Signage and wellhead housing (looking west)

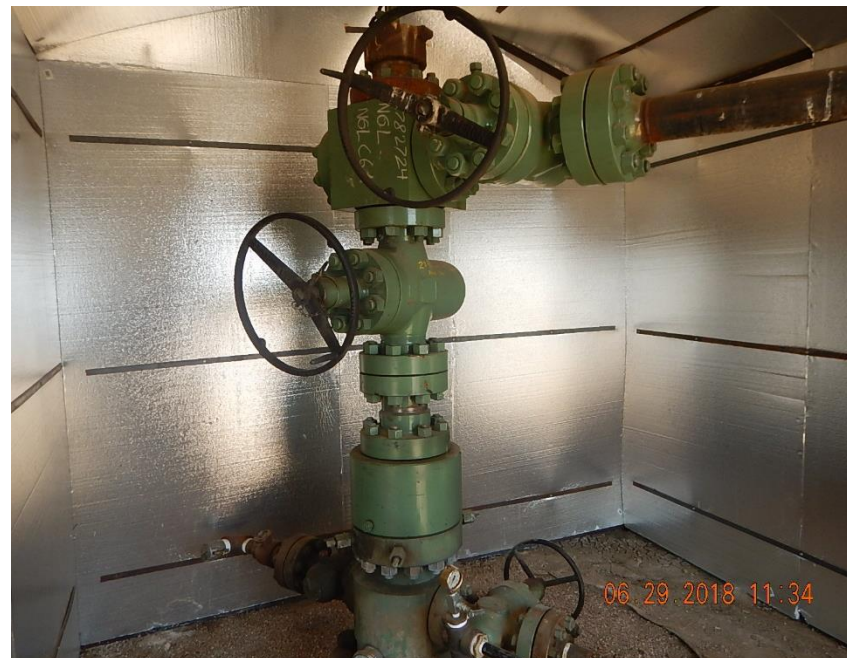
View of wellhead tree in building

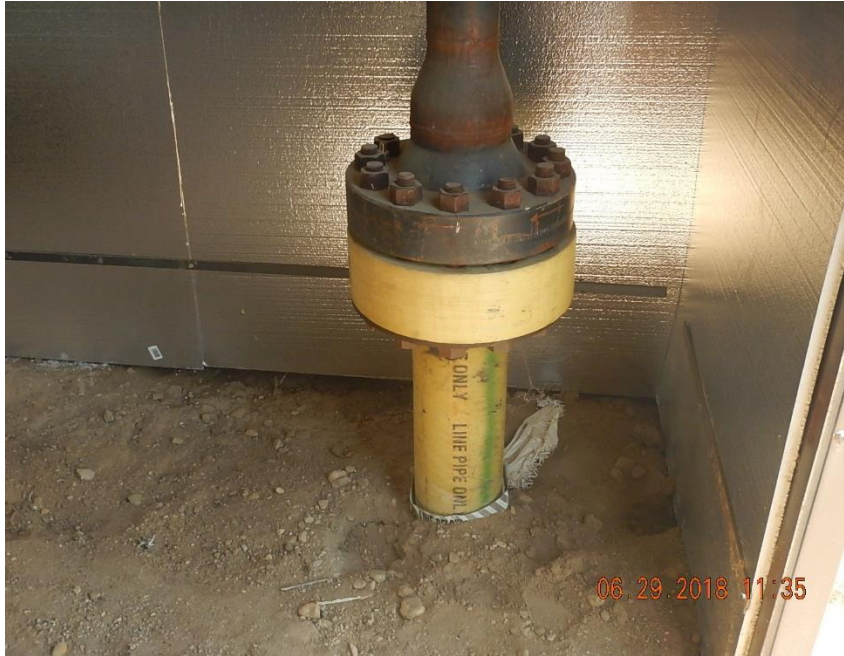
Photo of flanged connection at wellhead (this connection did not fail)

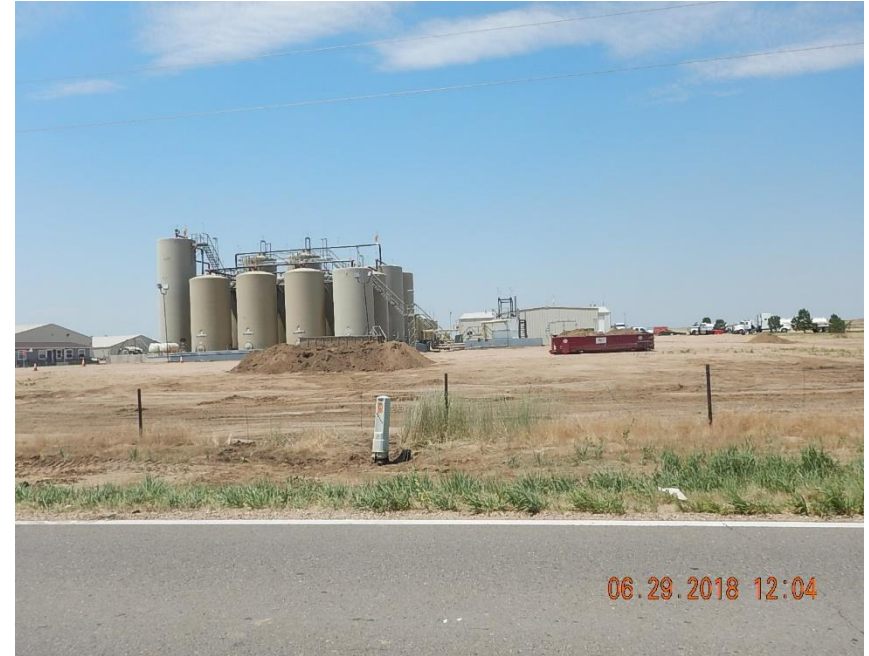
View of NGL C6A facility and battery looking west; note the impacted soils being remediated at west end of location.

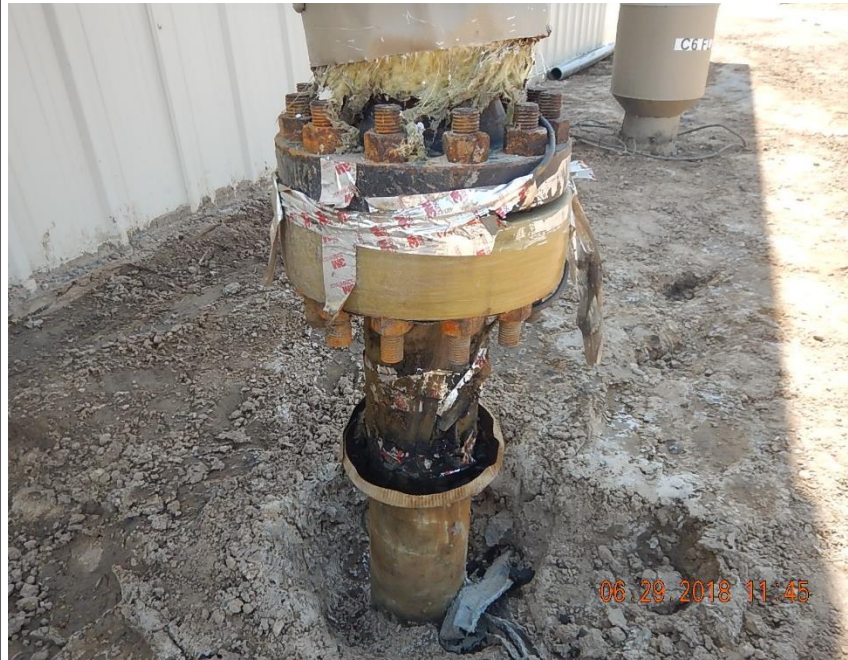
Failed C6A flange connection resulting in spill; at west end of pump building; insulation removed

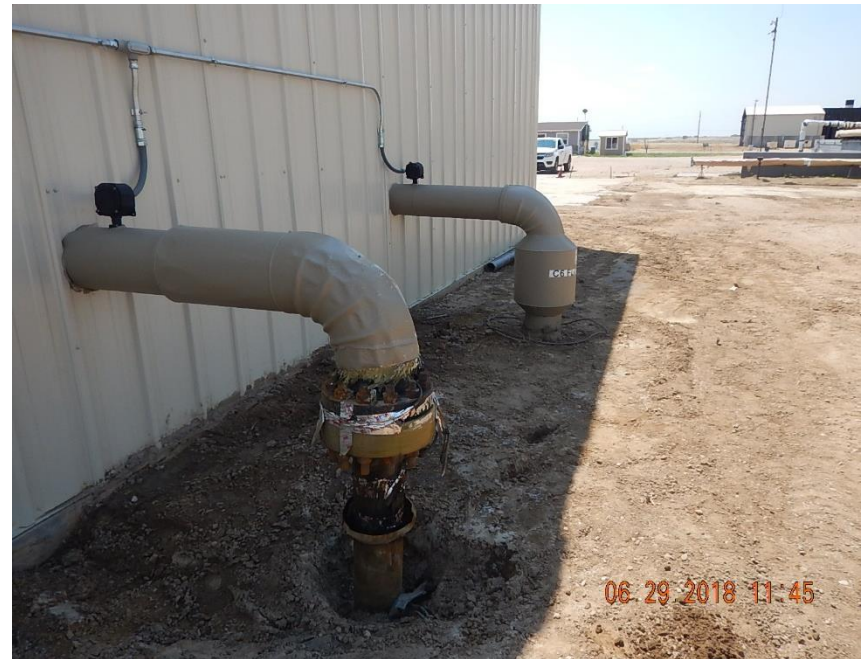
View of both the C6 and C6A produced water injection flowlines at the discharge of the injection pumps.

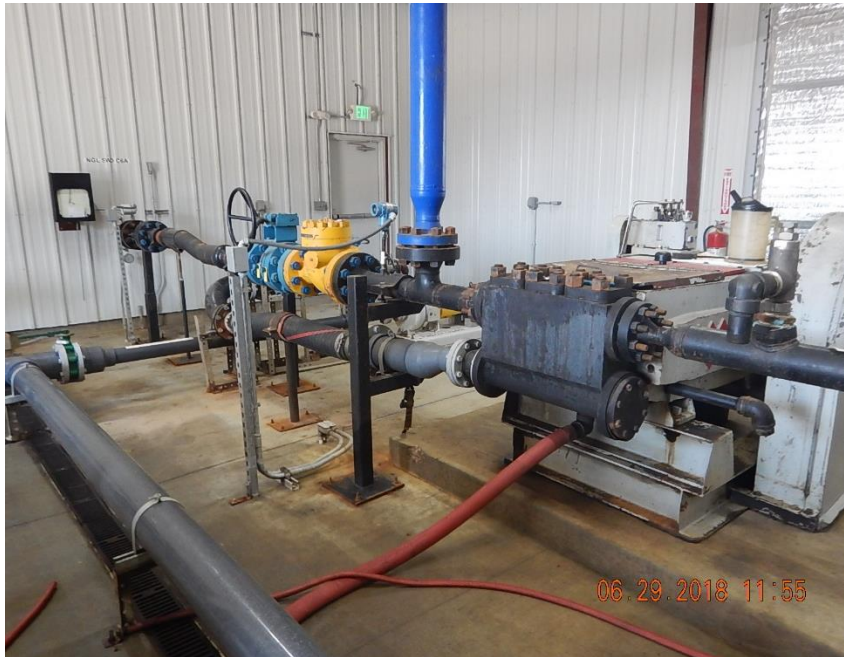
Photo of the C6A injection pump flowline tie in - inside pump building

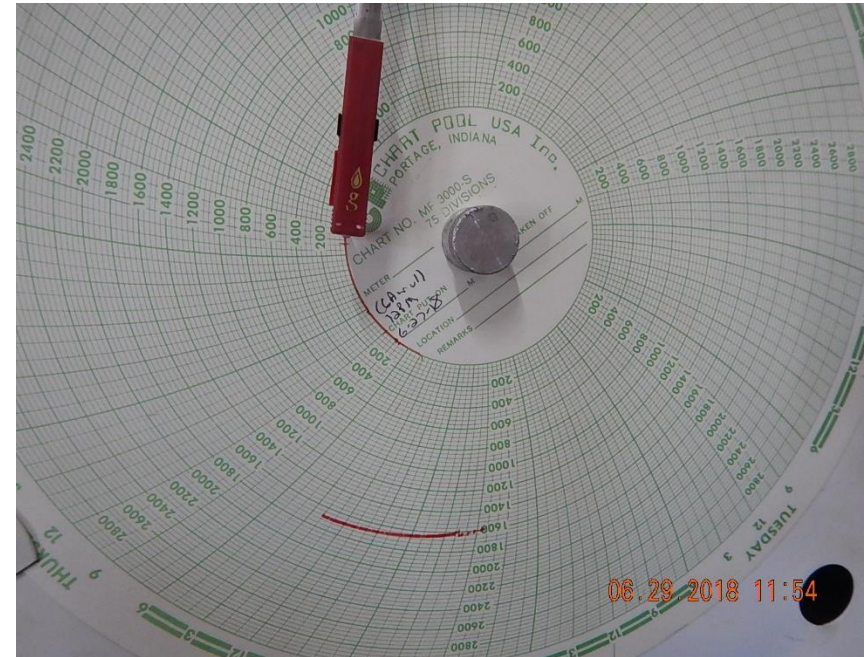
Photo of injection pressure chart at the time of failure
