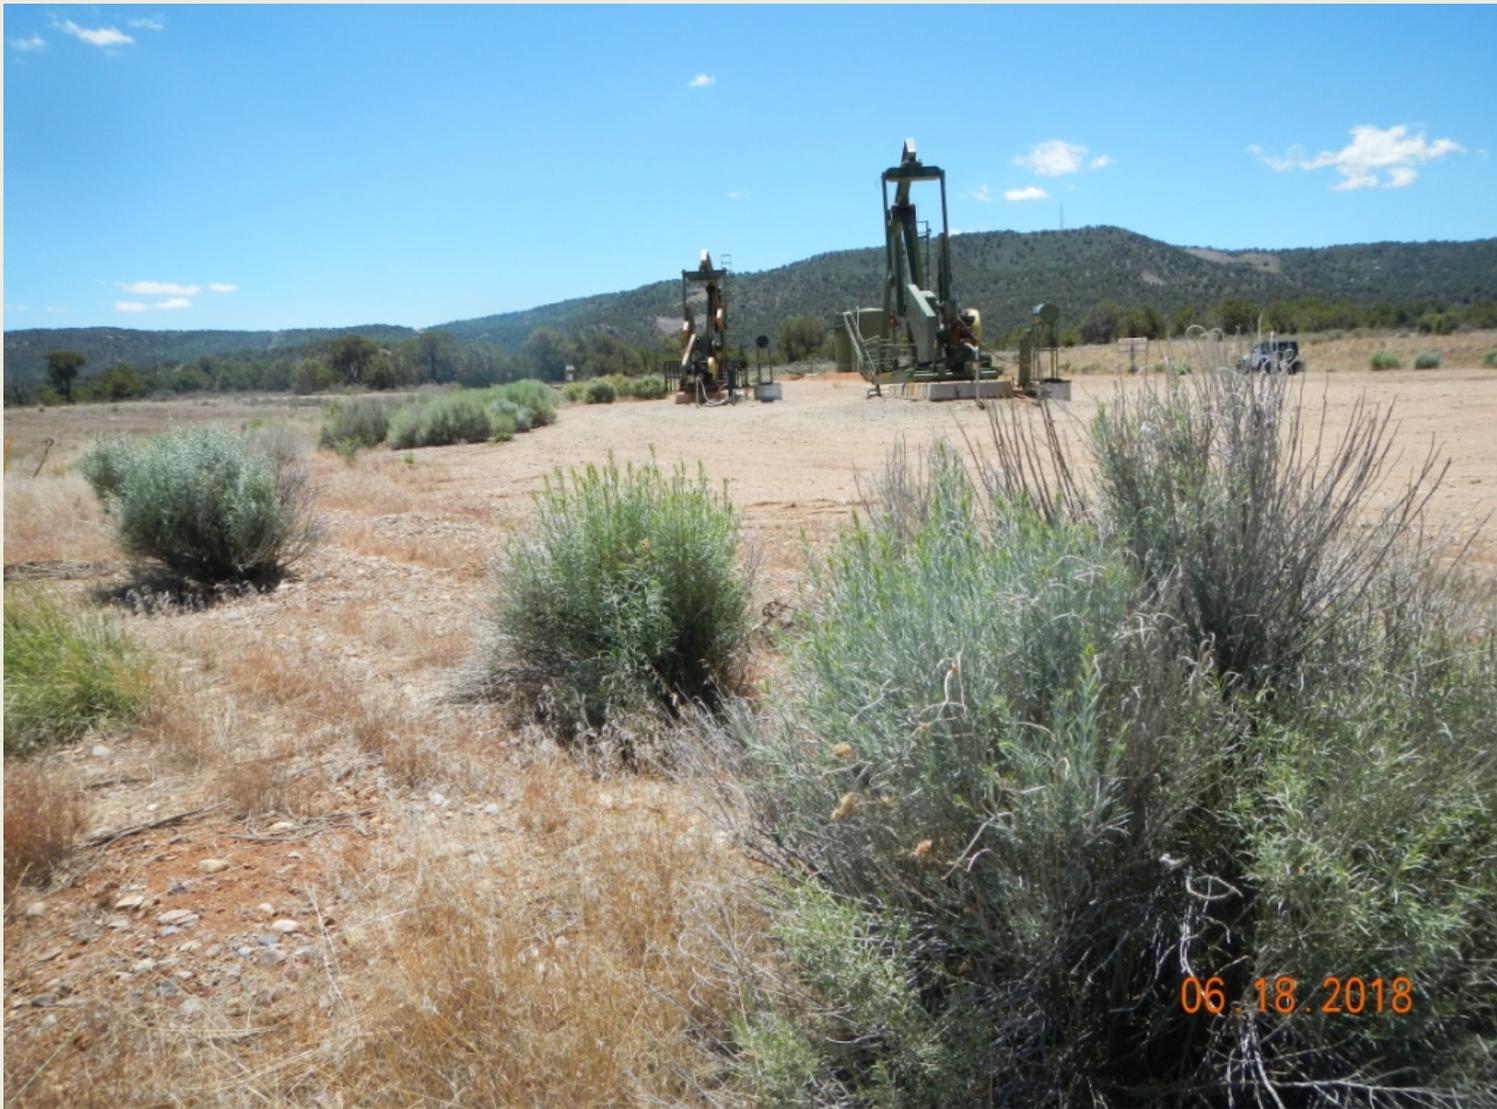
**Photo 1. View of the project area from the northwestern corner facing center.**

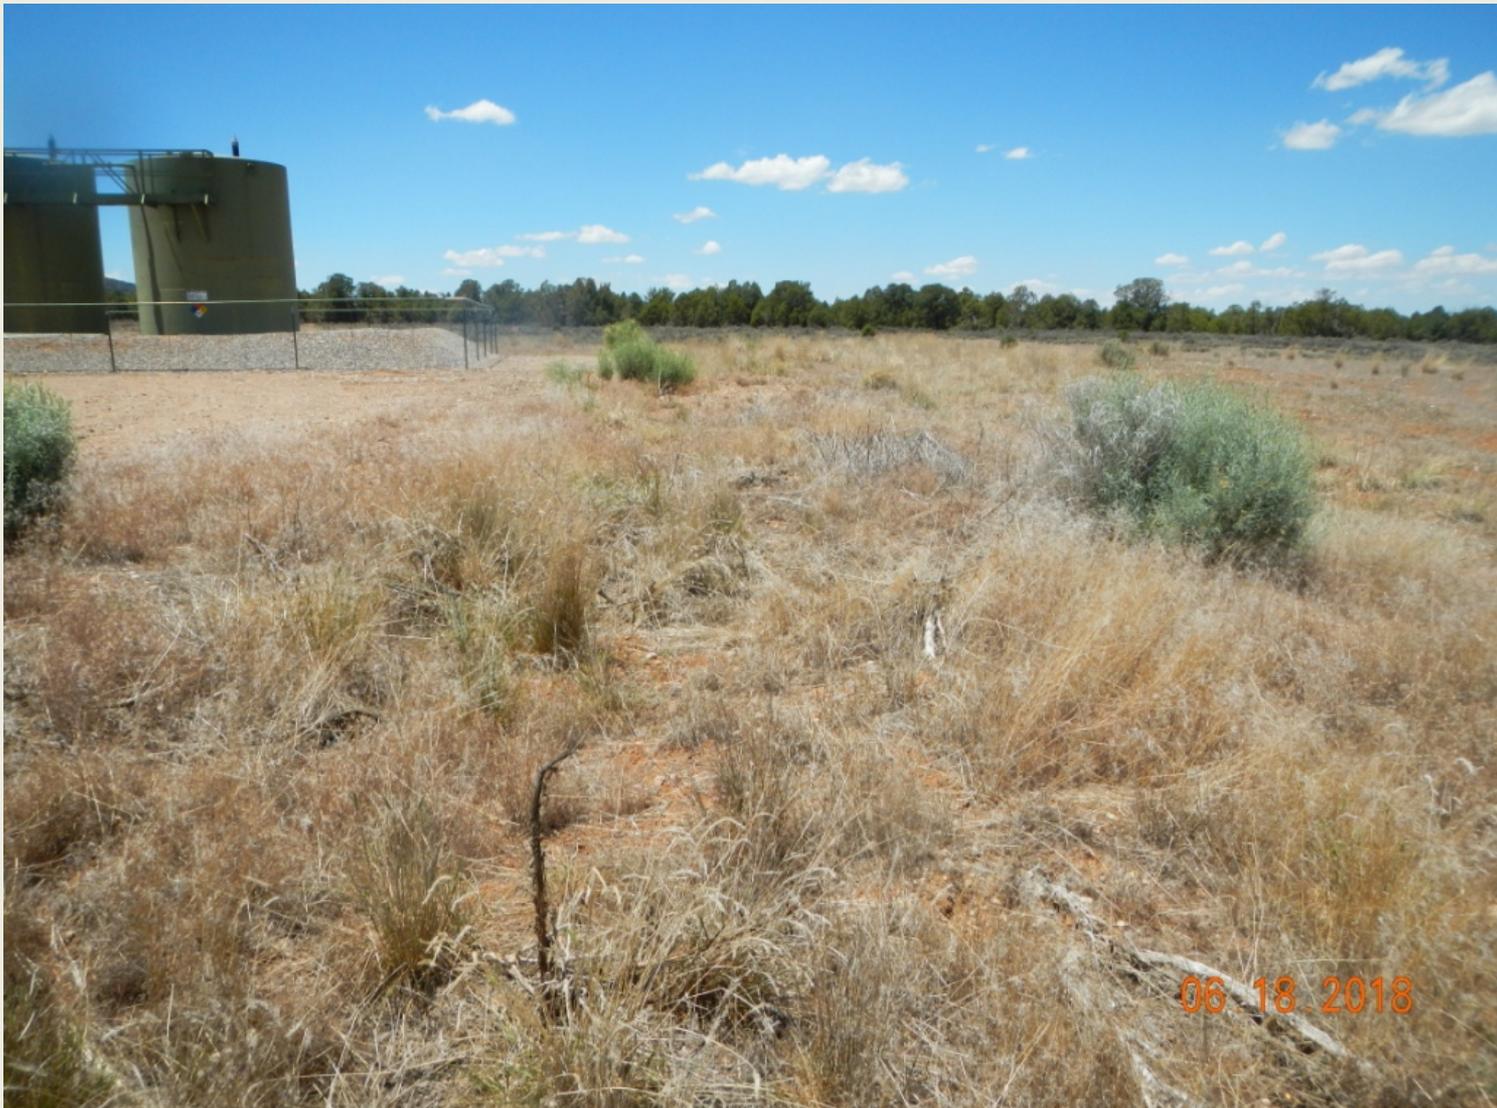
Photo 2. View of the western portion of the project area from the northwestern corner facing southward. Revegetation is progressing and comprised of grasses and shrubs such as intermediate wheatgrass (*Thinopyron intermedium*), crested wheatgrass (*Agropyron cristatum*), and rubber rabbitbrush (*Chrysothamnus nauseosus*).

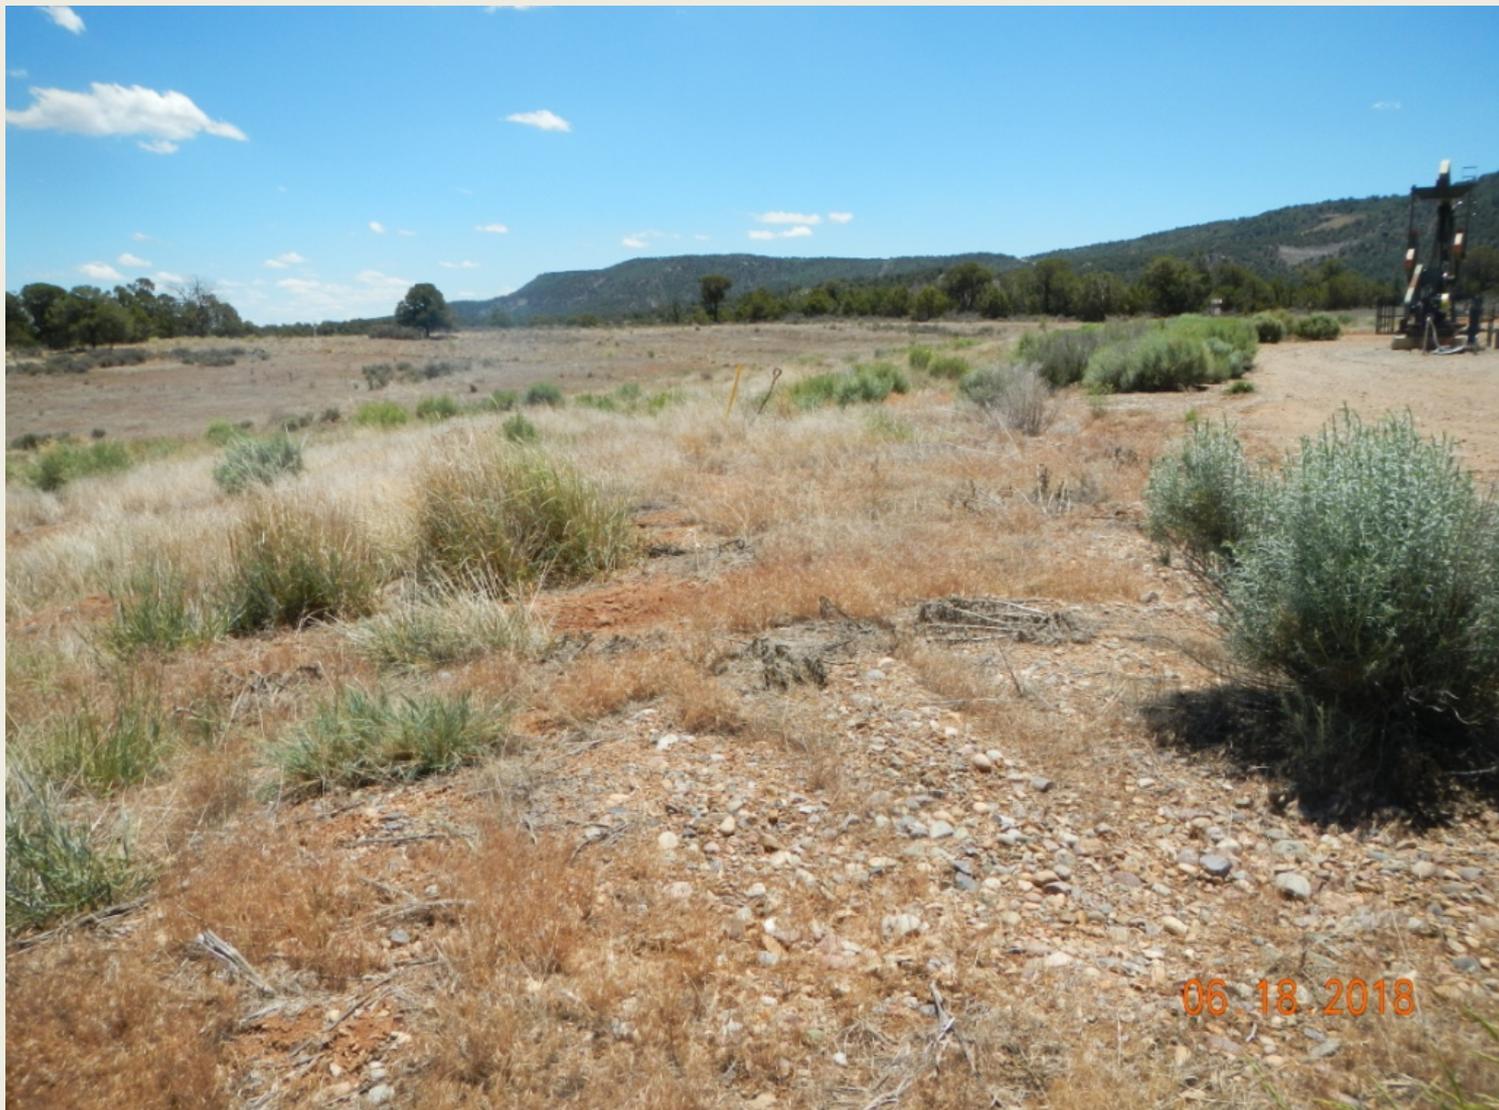
**Photo 3. View of the northern portion of the project area from the northwestern corner facing eastward.**

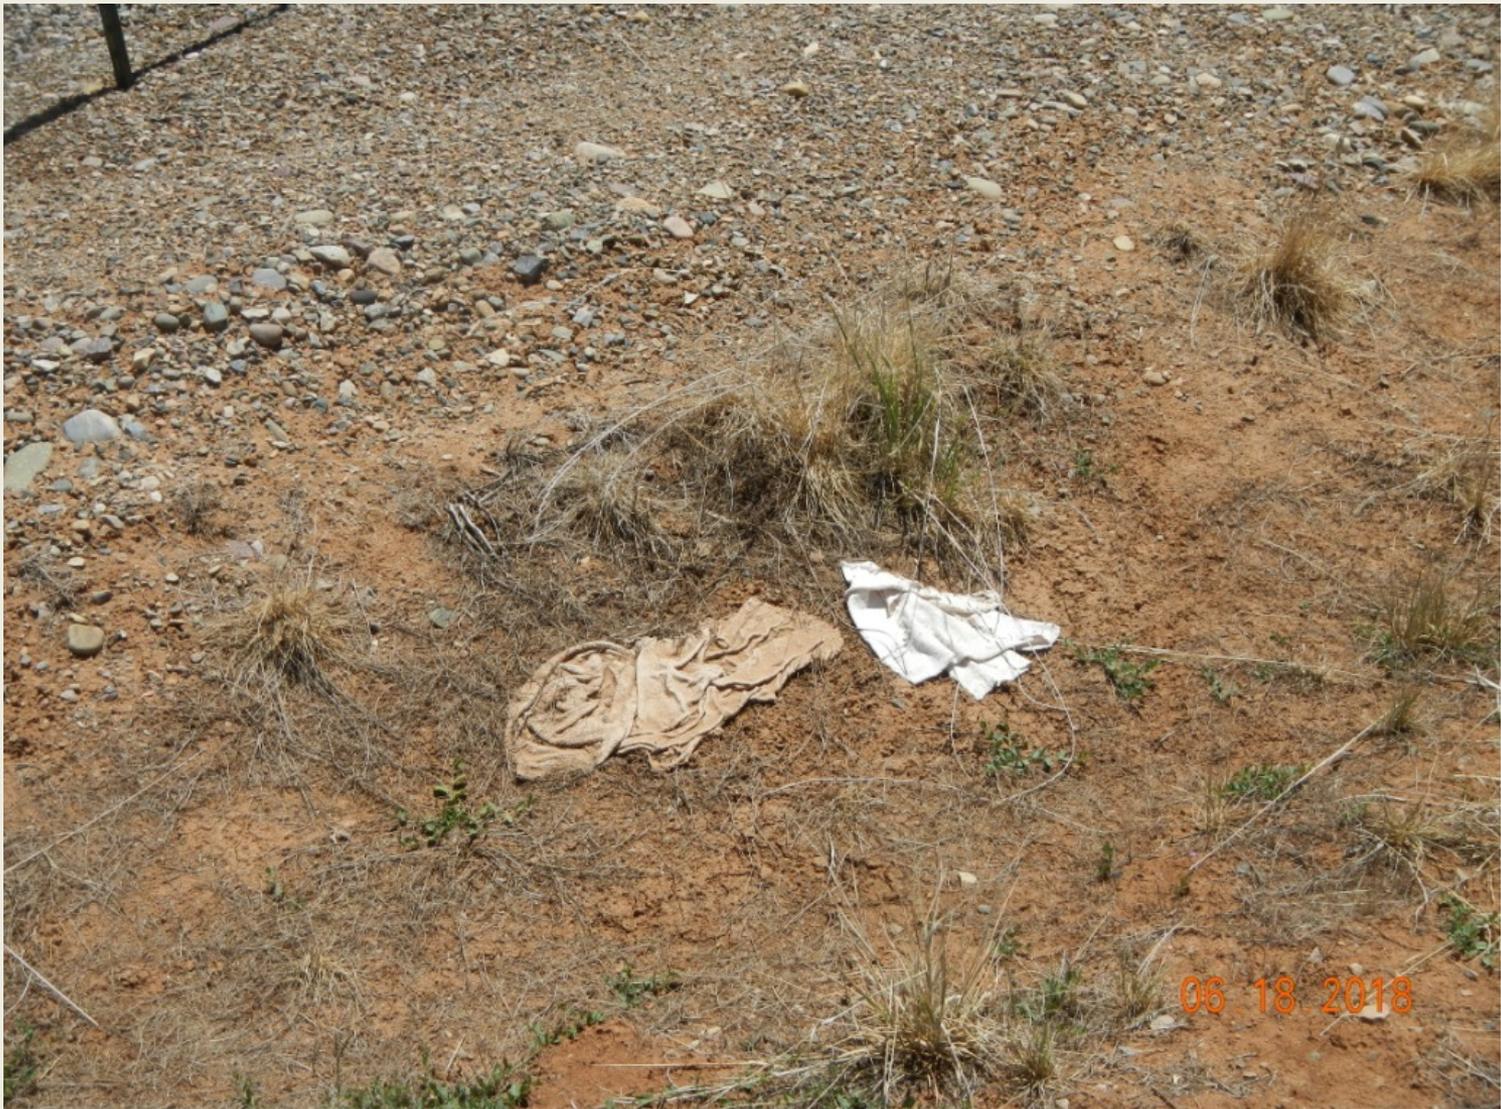
**Photo 4. View of dirty rags along the edge of the working area.**

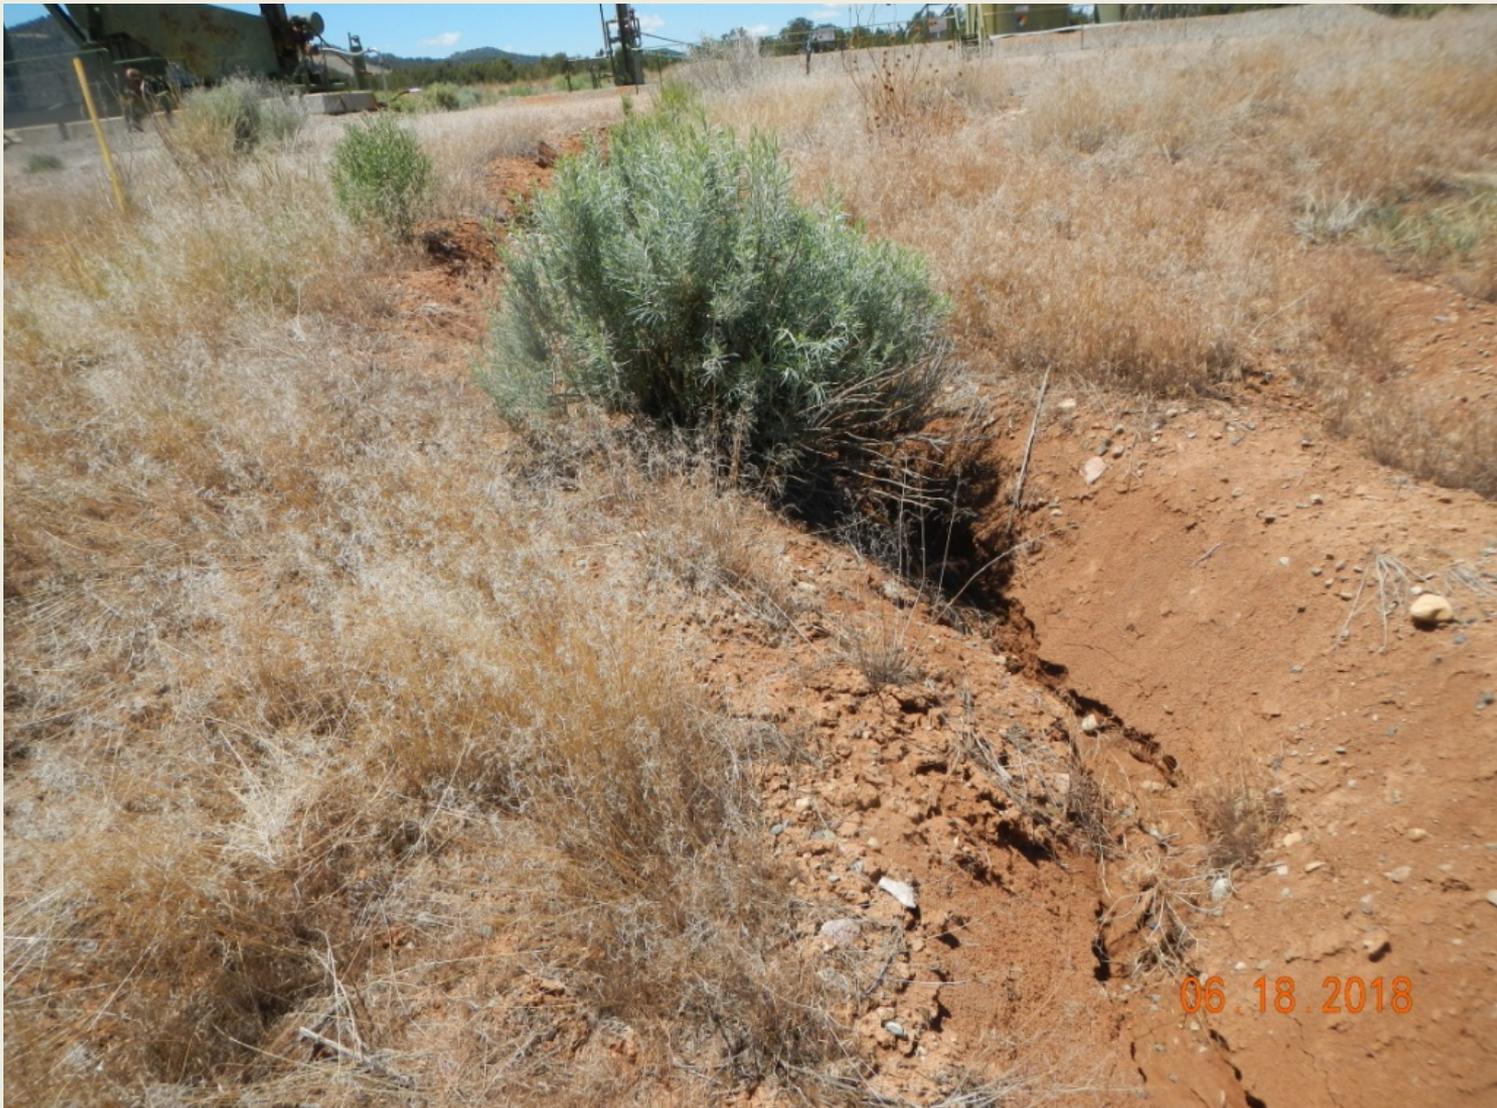
**Photo 5. View erosional channel approximately 2.5 feet wide and deep in the northern portion of the project area. Stormwater controls are needed to stabilize erosion here.**

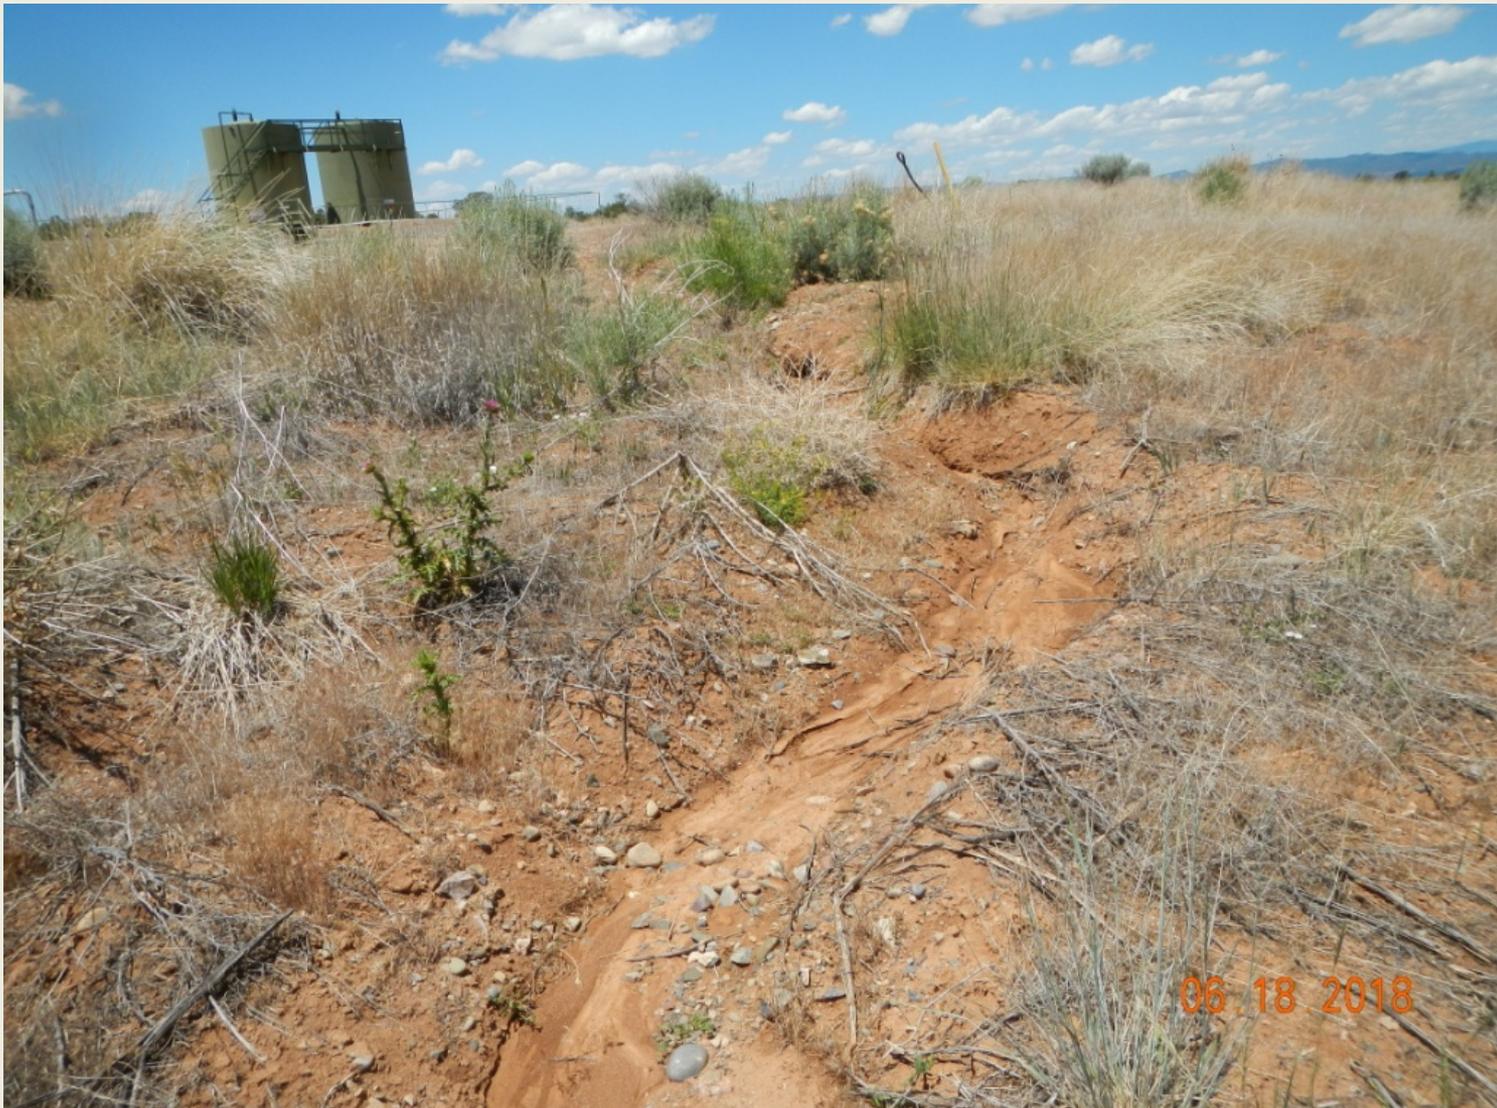
**Photo 6. View of another erosional channel approximately 2 feet wide and deep in the northern portion of the project area. Stormwater controls are needed to stabilize erosion here.**

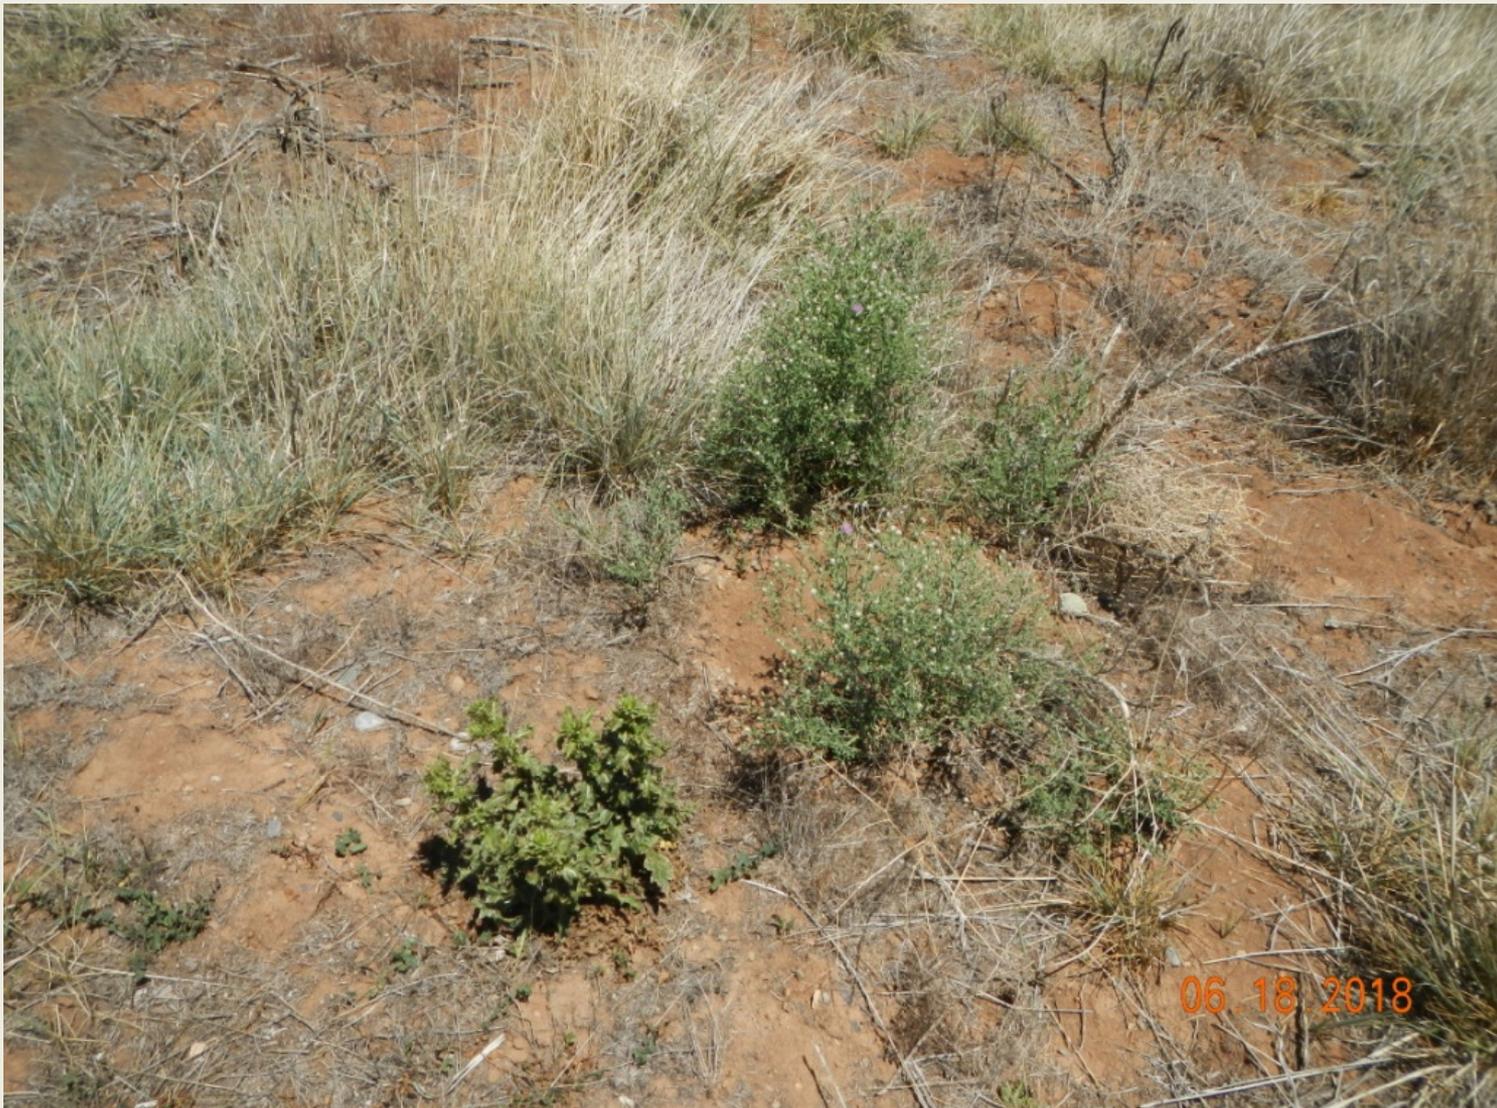
**Photo 7. View of musk thistle (*Carduus nutans*) and Russian knapweed (*Rhaponticum repens*) within the northern interim reclamation area.**

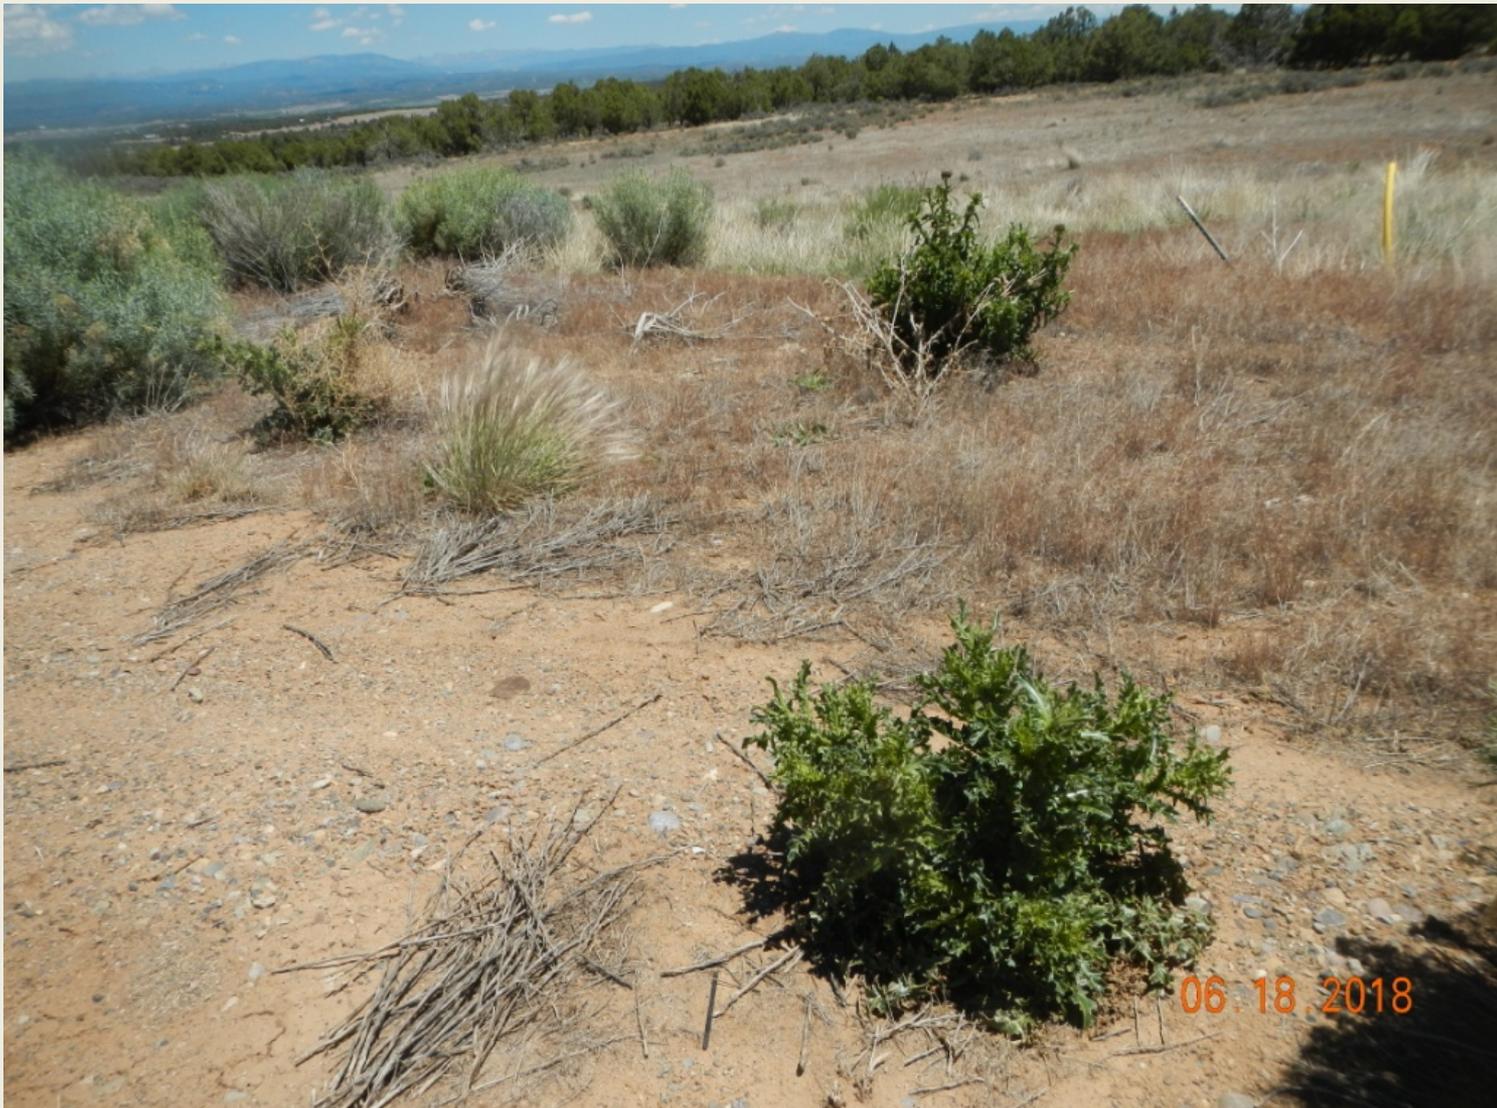
**Photo 8. View of lush musk thistles within the northeastern portion of the project area.**
