Inspection Photos

Location Name: Roan Creek Evaporation Pit

Location ID: #391314 / Pit Facility ID #116525

Inspection Date: June 20, 2018

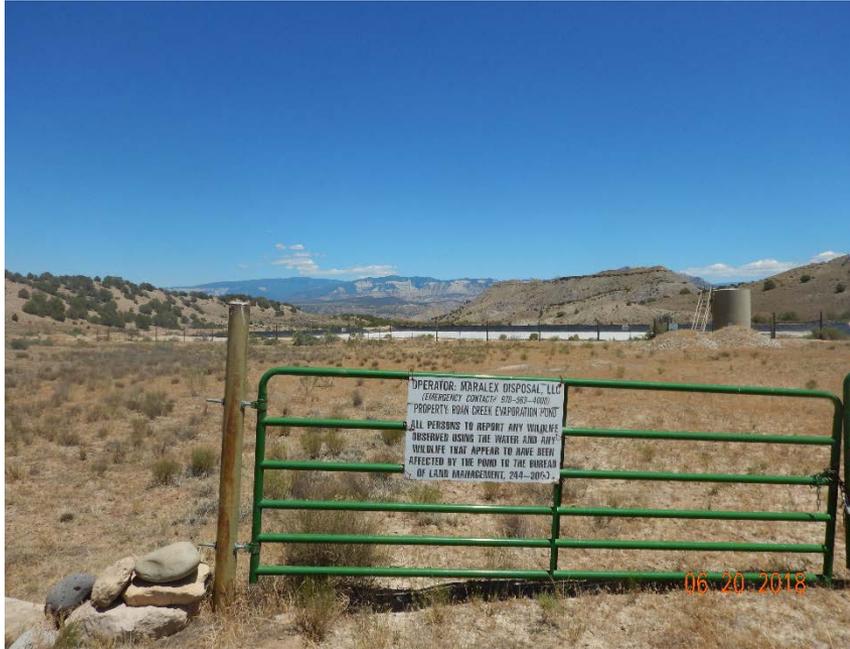
Photo #1 – Facility sign and gate located at SW corner entrance.

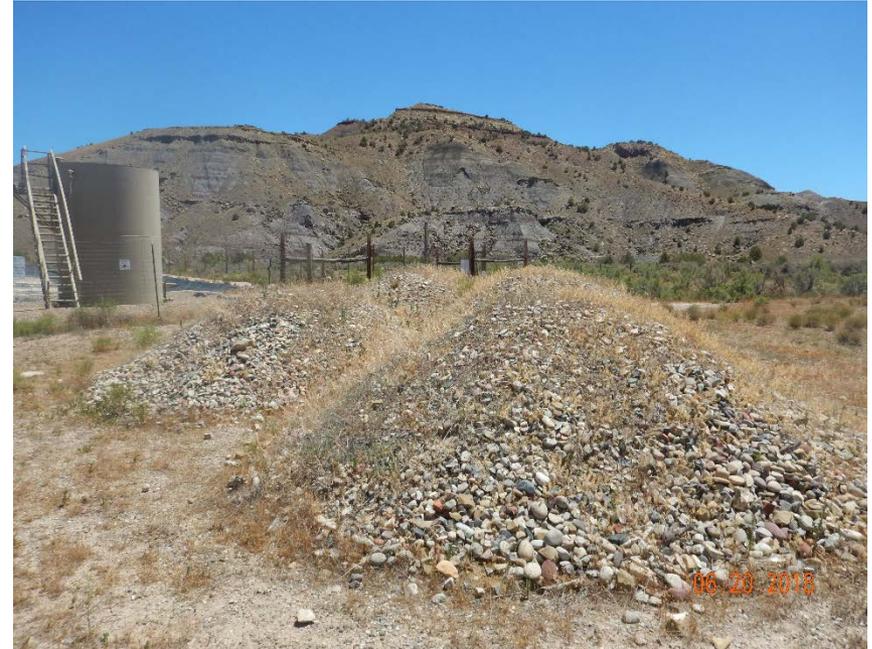
Photo #2 – Gravel stockpiles remaining outside of fenced area.

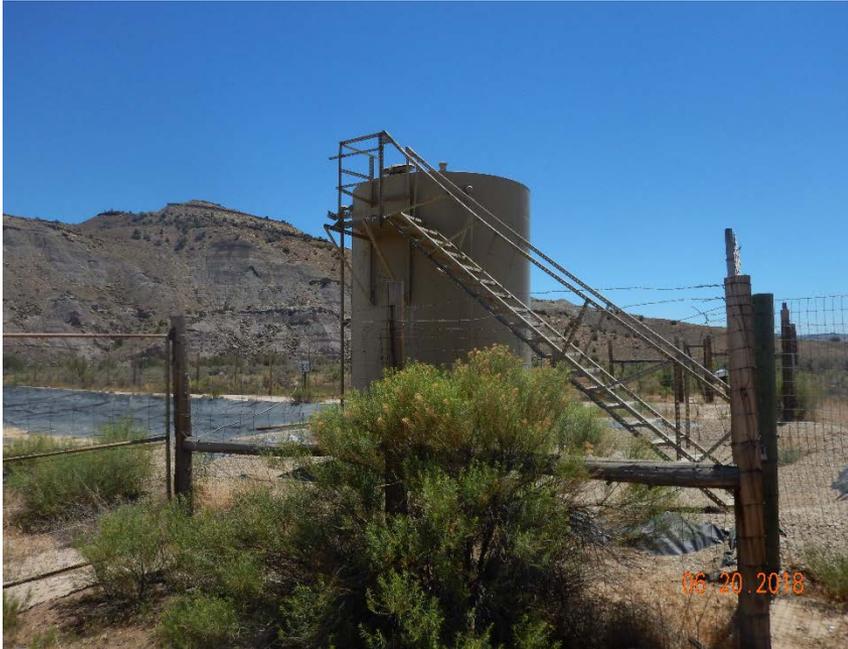
**Photo #3 – Site-wide, uncontrolled weeds along fence line.
Photo taken at SW corner of pit.**

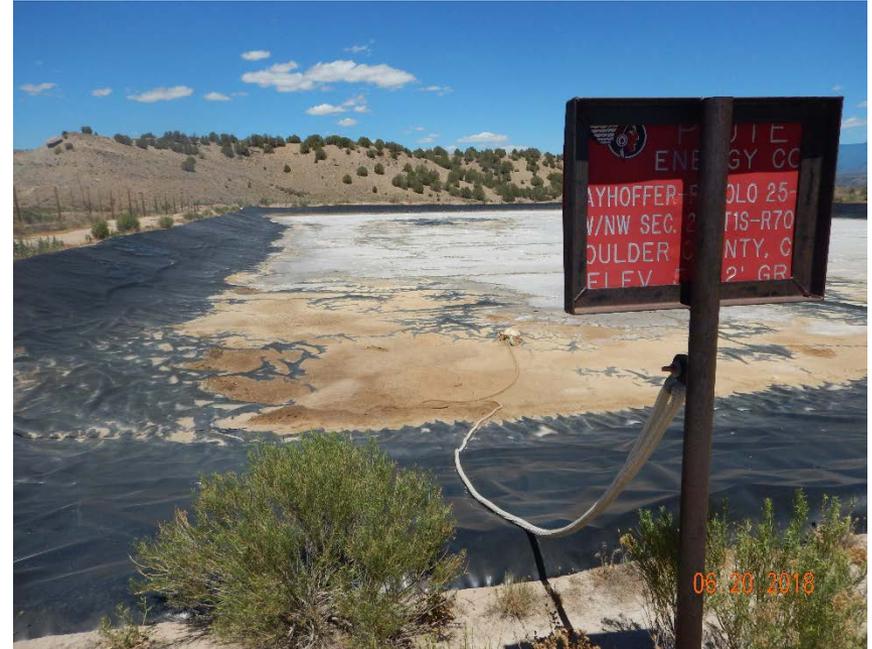
**Photo #4 – View from SW corner of pit, looking north. Note
sediment and salt remain on top of pit liner and weeds are
encroaching along pit perimeter.**

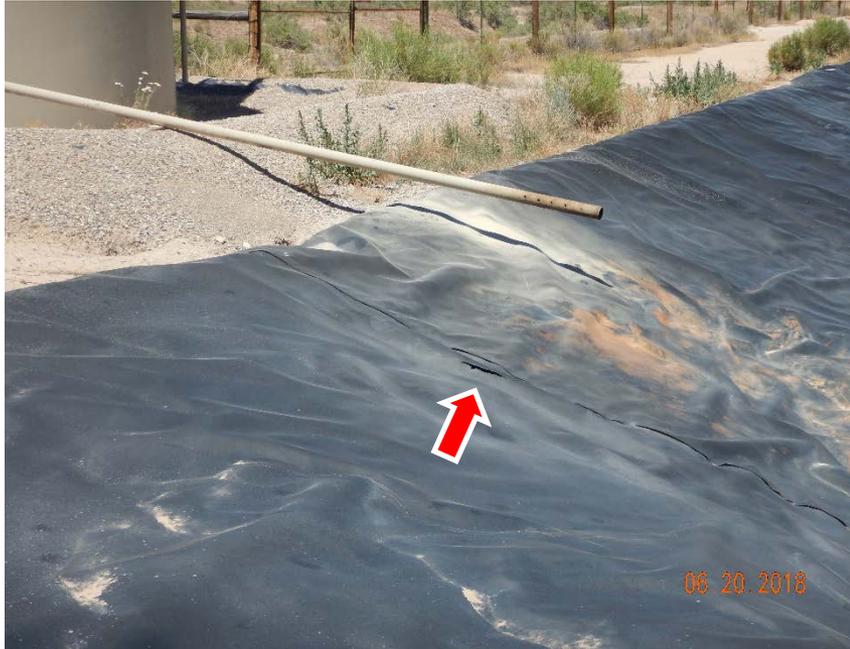
Photo #5 – Torn liner at SW corner of pit, below inlet from produced water tank.

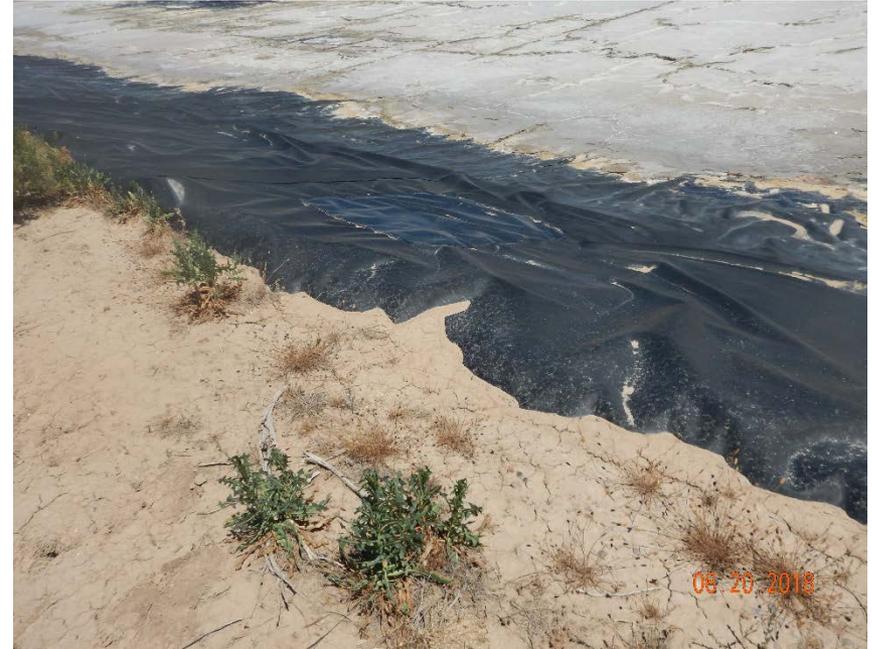
Photo #6 – Weeds and sediment transport encroaching on pit liner (west berm).

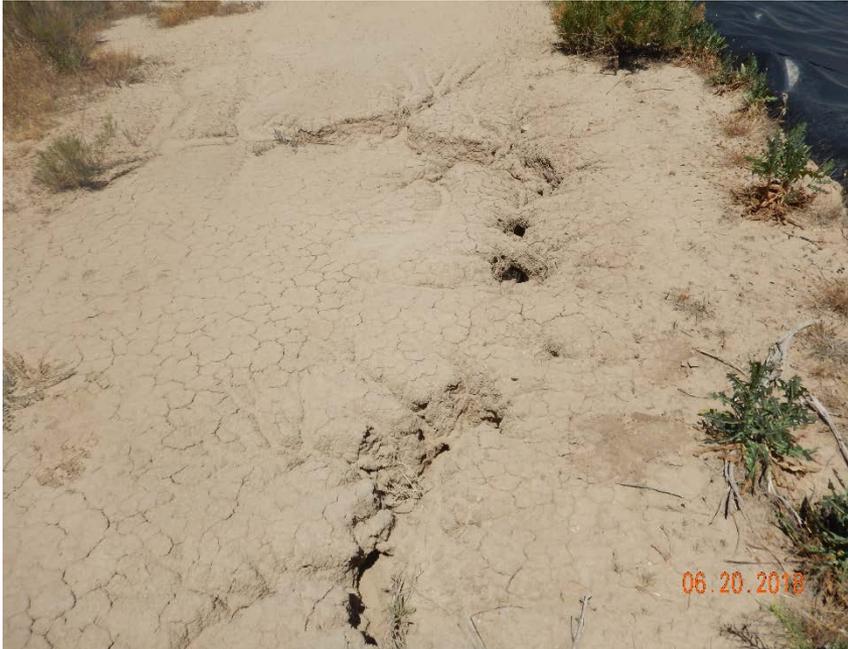
Photo #7 – Erosion on top of west berm.

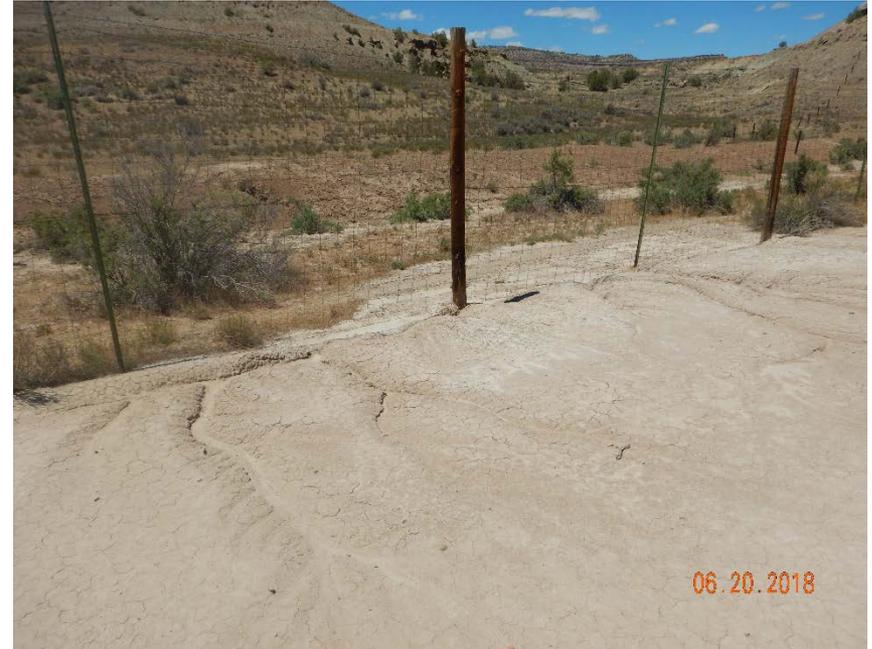
Photo #8 – Berm erosion with off-site sediment transport around pit perimeter (west berm).

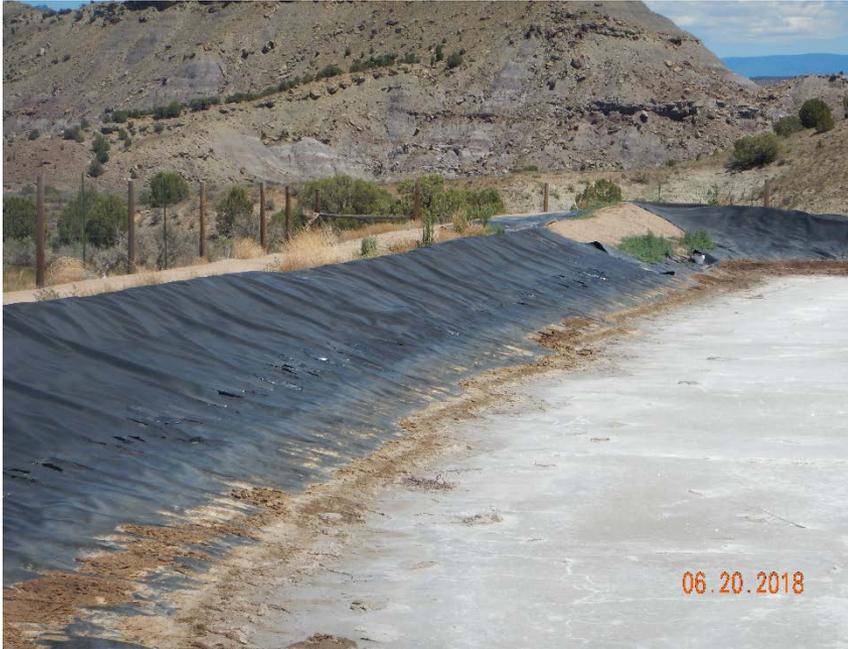
Photo #9 – Pit liner remains compromised at NE corner, as first indicated in December 19, 2017 Field Inspection Report #689100109.

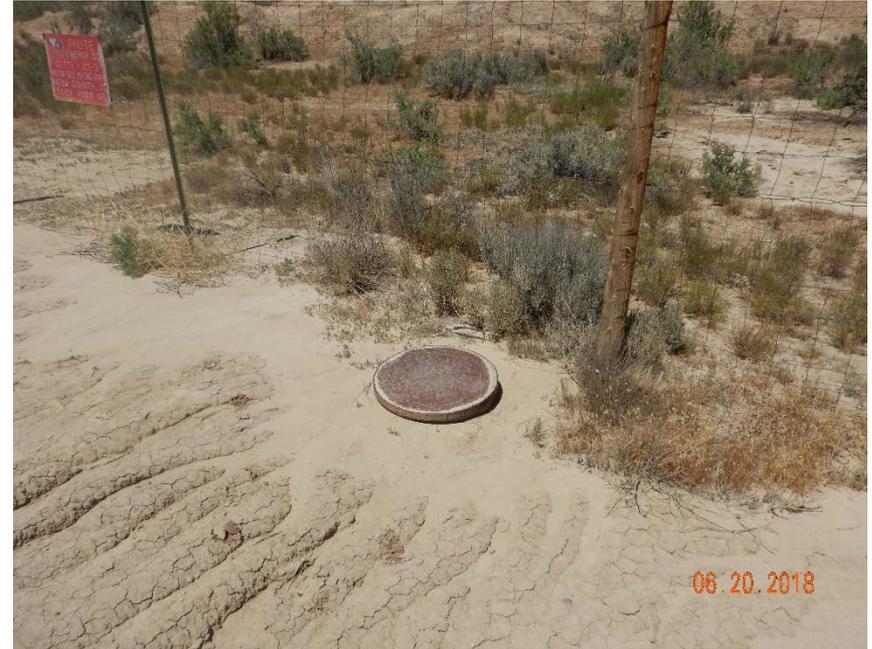
Photo #10 – Evidence of erosion and sediment transport at leak detection system cover on north side of pit

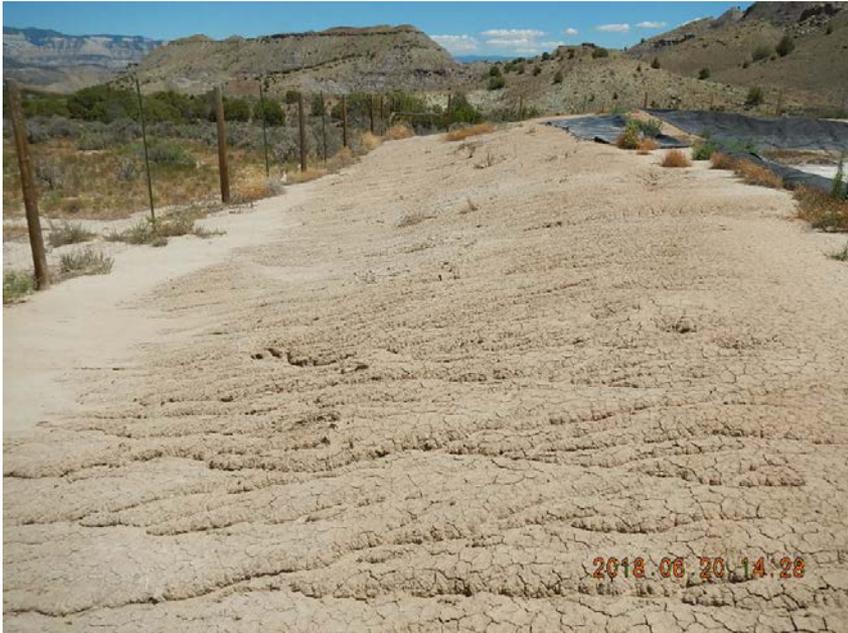
Photo #11 – More berm erosion and off-site sediment transport along north berm.

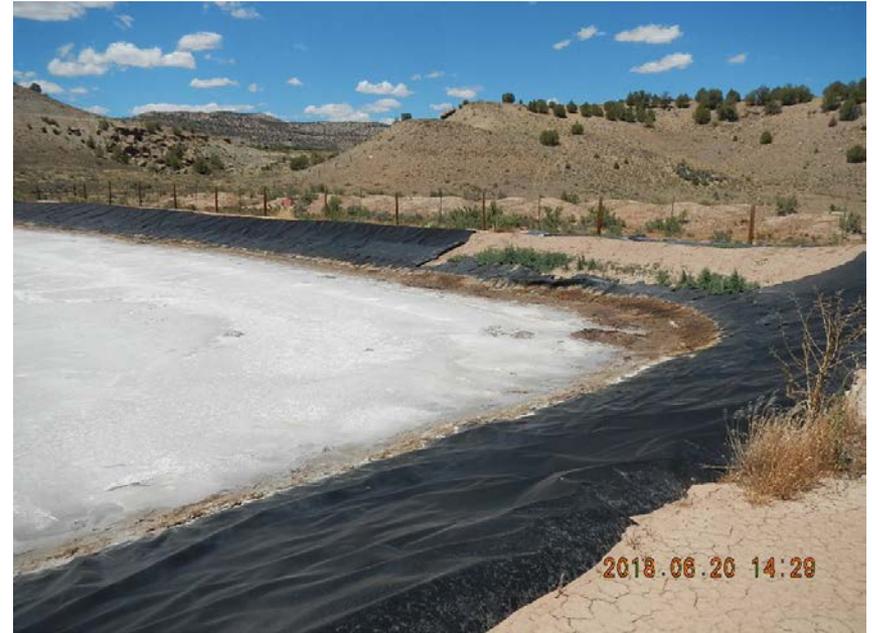
Photo #12 – Weeds growing in compromised liner area at NE corner of pit.

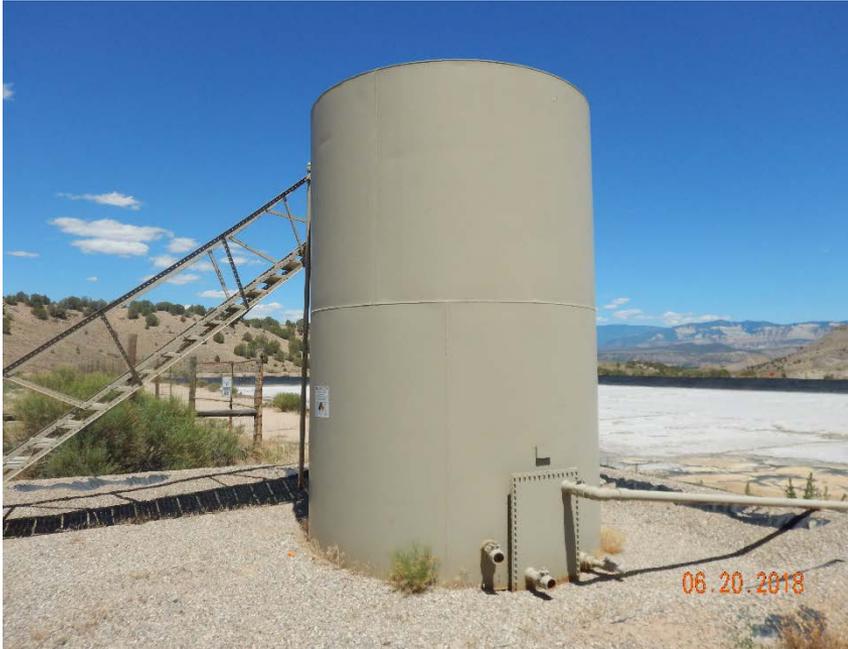
Photo #13 – 300 bbl produced water AST in lined earthen berm at SW corner of pit.

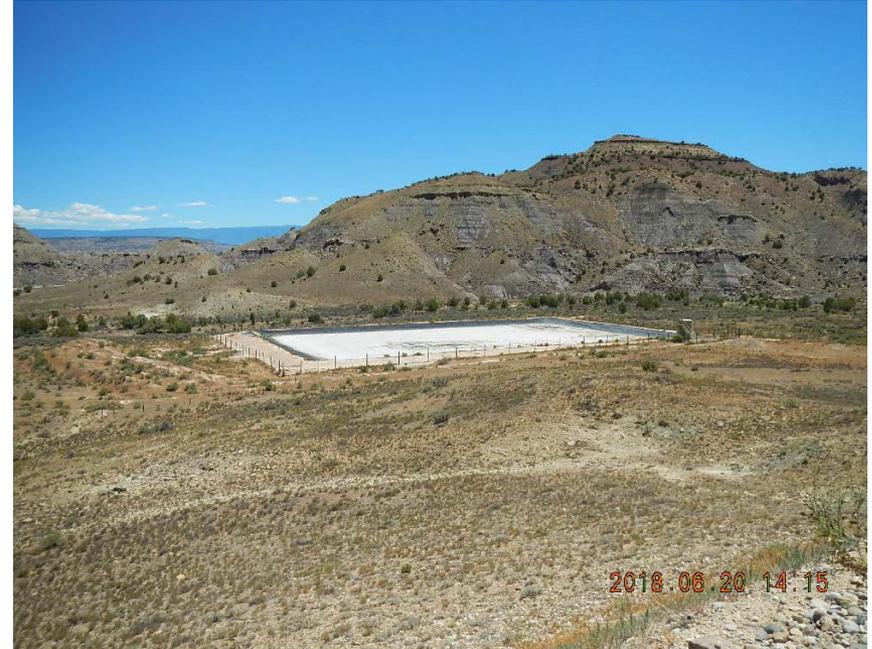
Photo #14 – Overview of facility from NW.
