Well Name : Marquez A 1  
API # : 007-06165

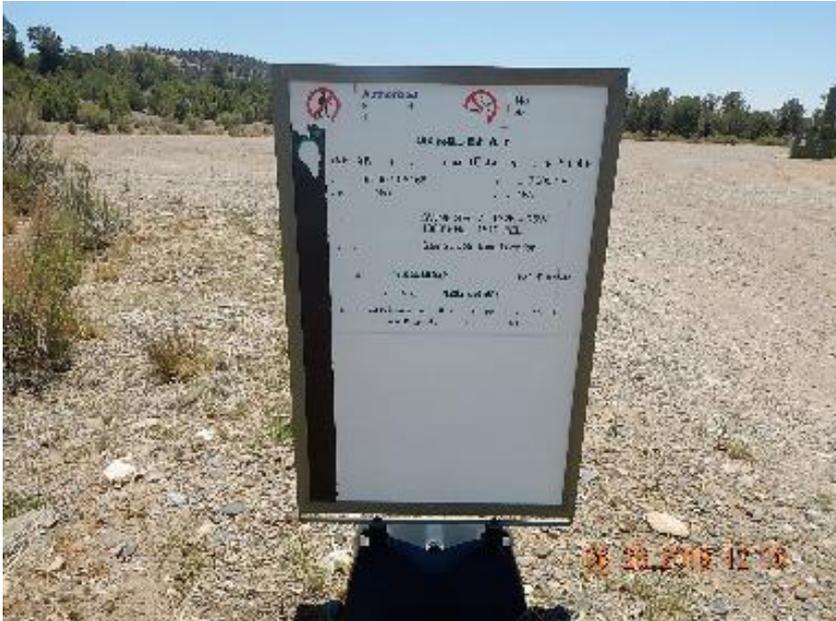
Photo 1: Wellhead sign.

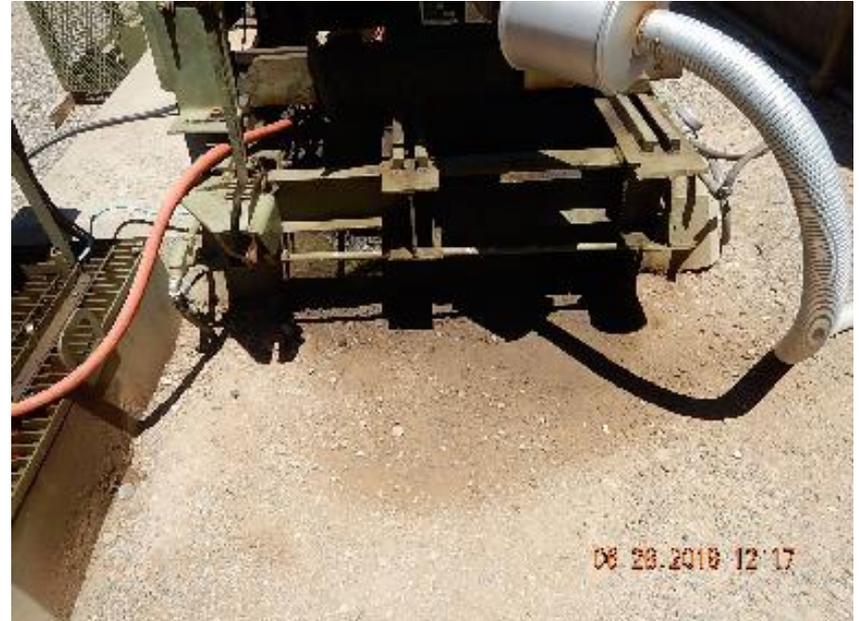
Photo 2: Impacted soil and gravel at rear of pump jack.

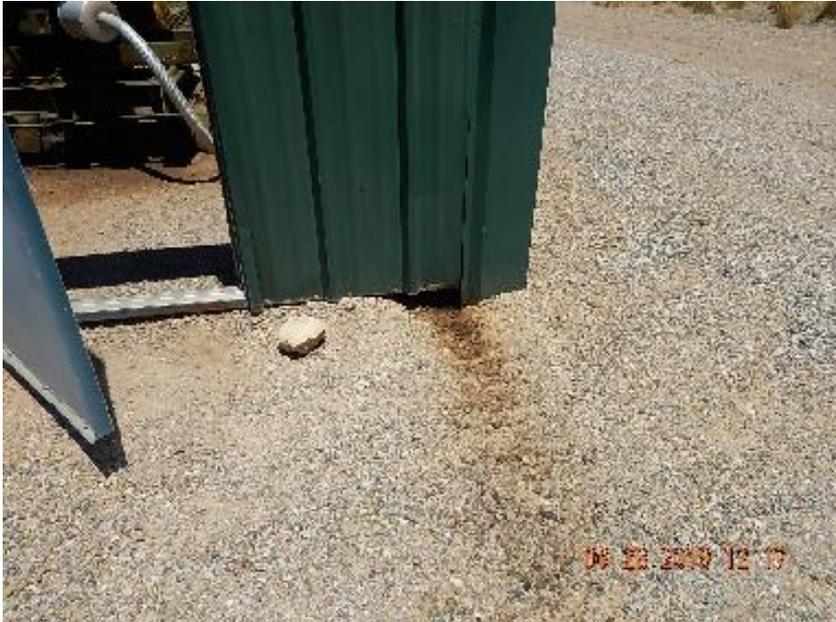
Photo 3: Impacted soil and gravel at exhaust outlet.

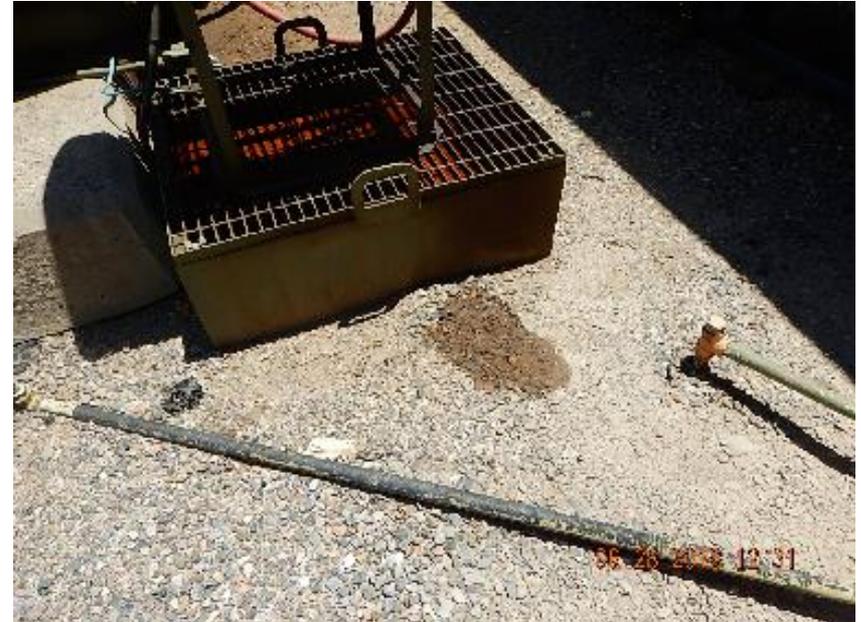
Photo 4: Impacted soil and gravel at lube oil tank spill prevention.

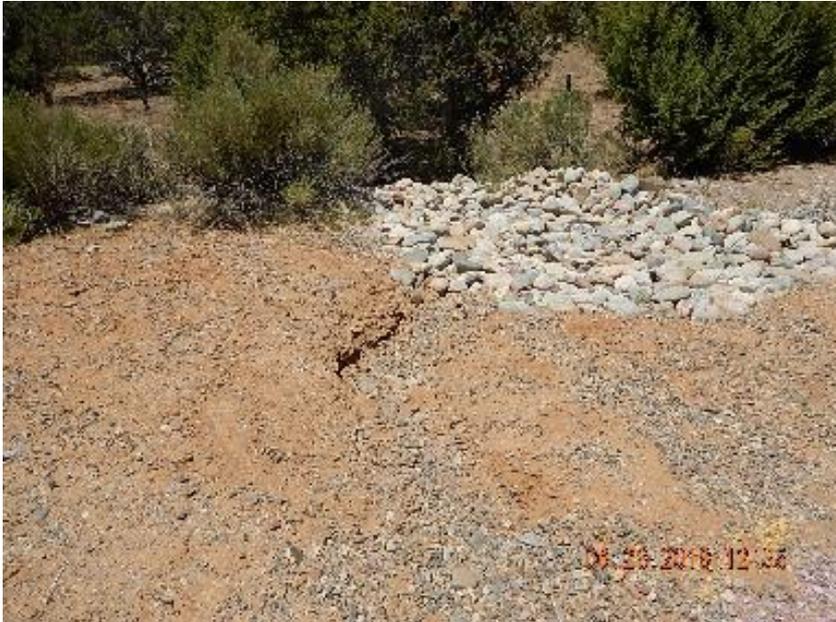
Photo 5: Erosion channel developing at front of rock run down.

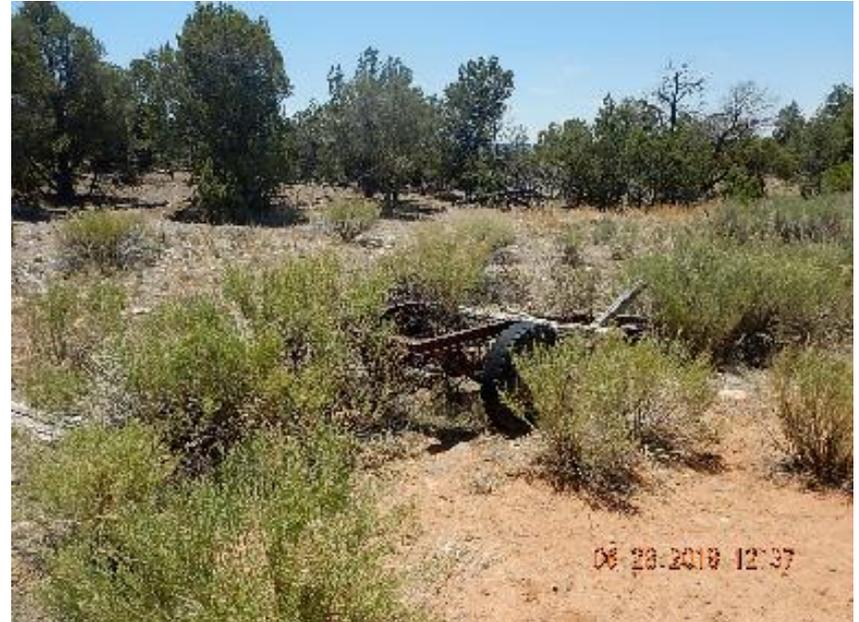
Photo 6: Vehicle frame on S perimeter.
