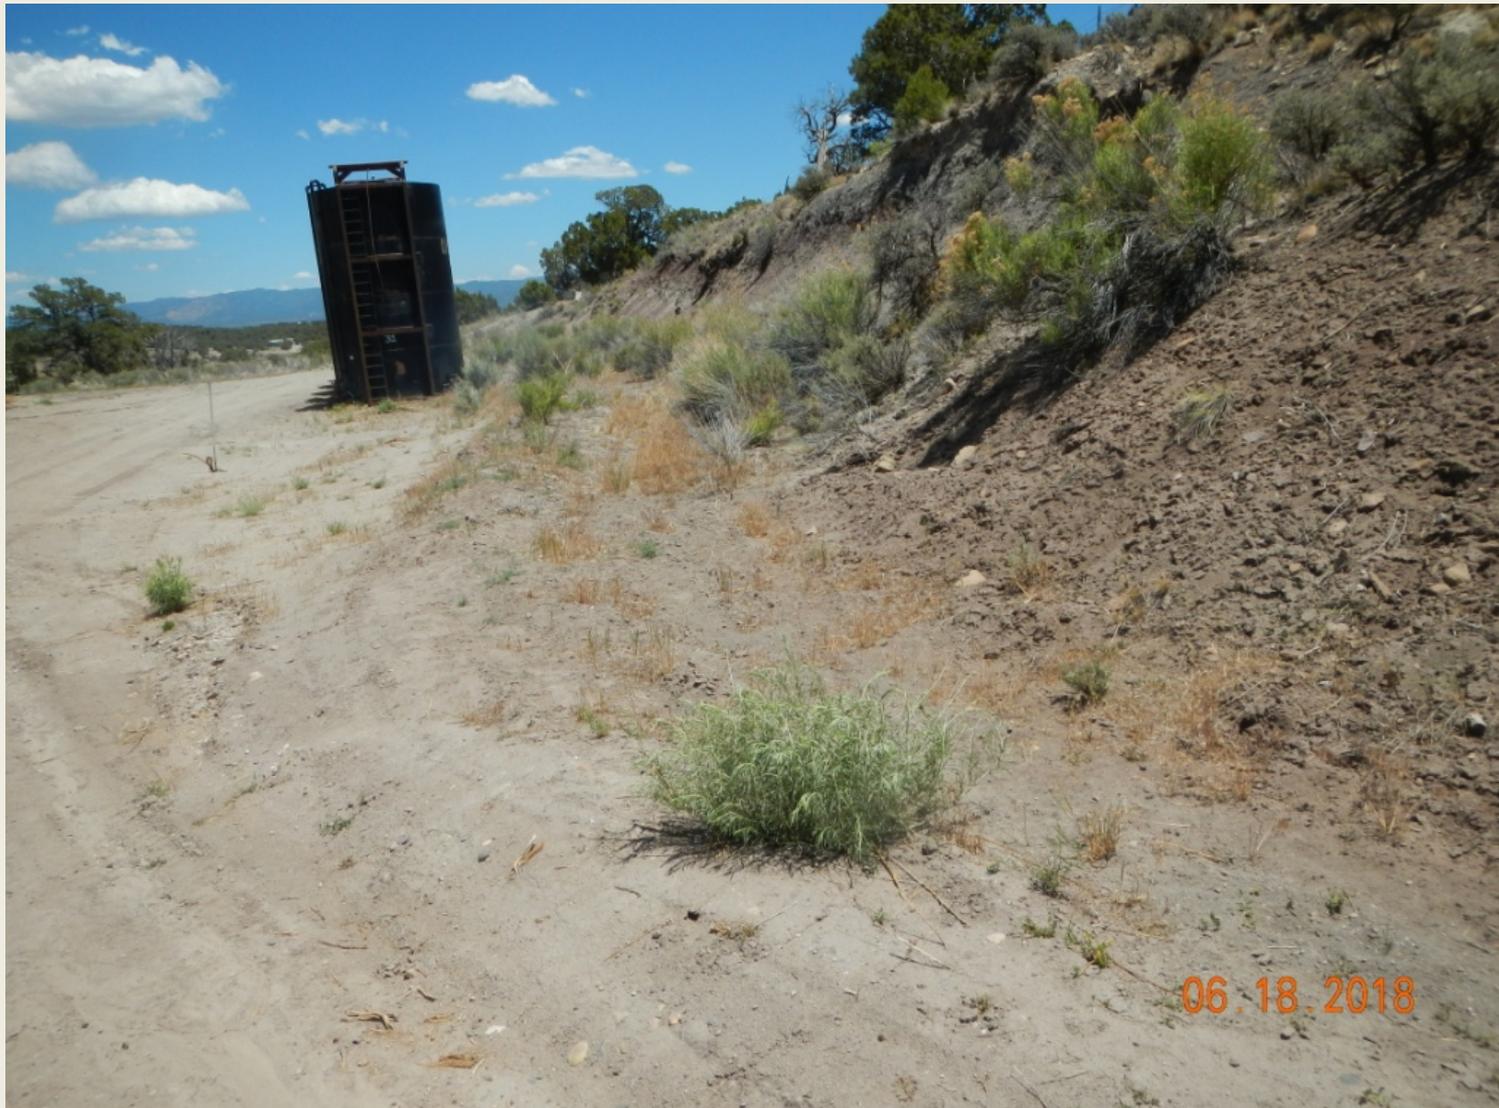
Photo 1. View of the project area from the southwestern corner facing eastward. Southern cut-slope does not appear stabilized as a result of undercutting at the top of the slope and sediment deposition at the toe of the slope. Stormwater controls need to be installed to stabilize erosion on the southern cut-slope

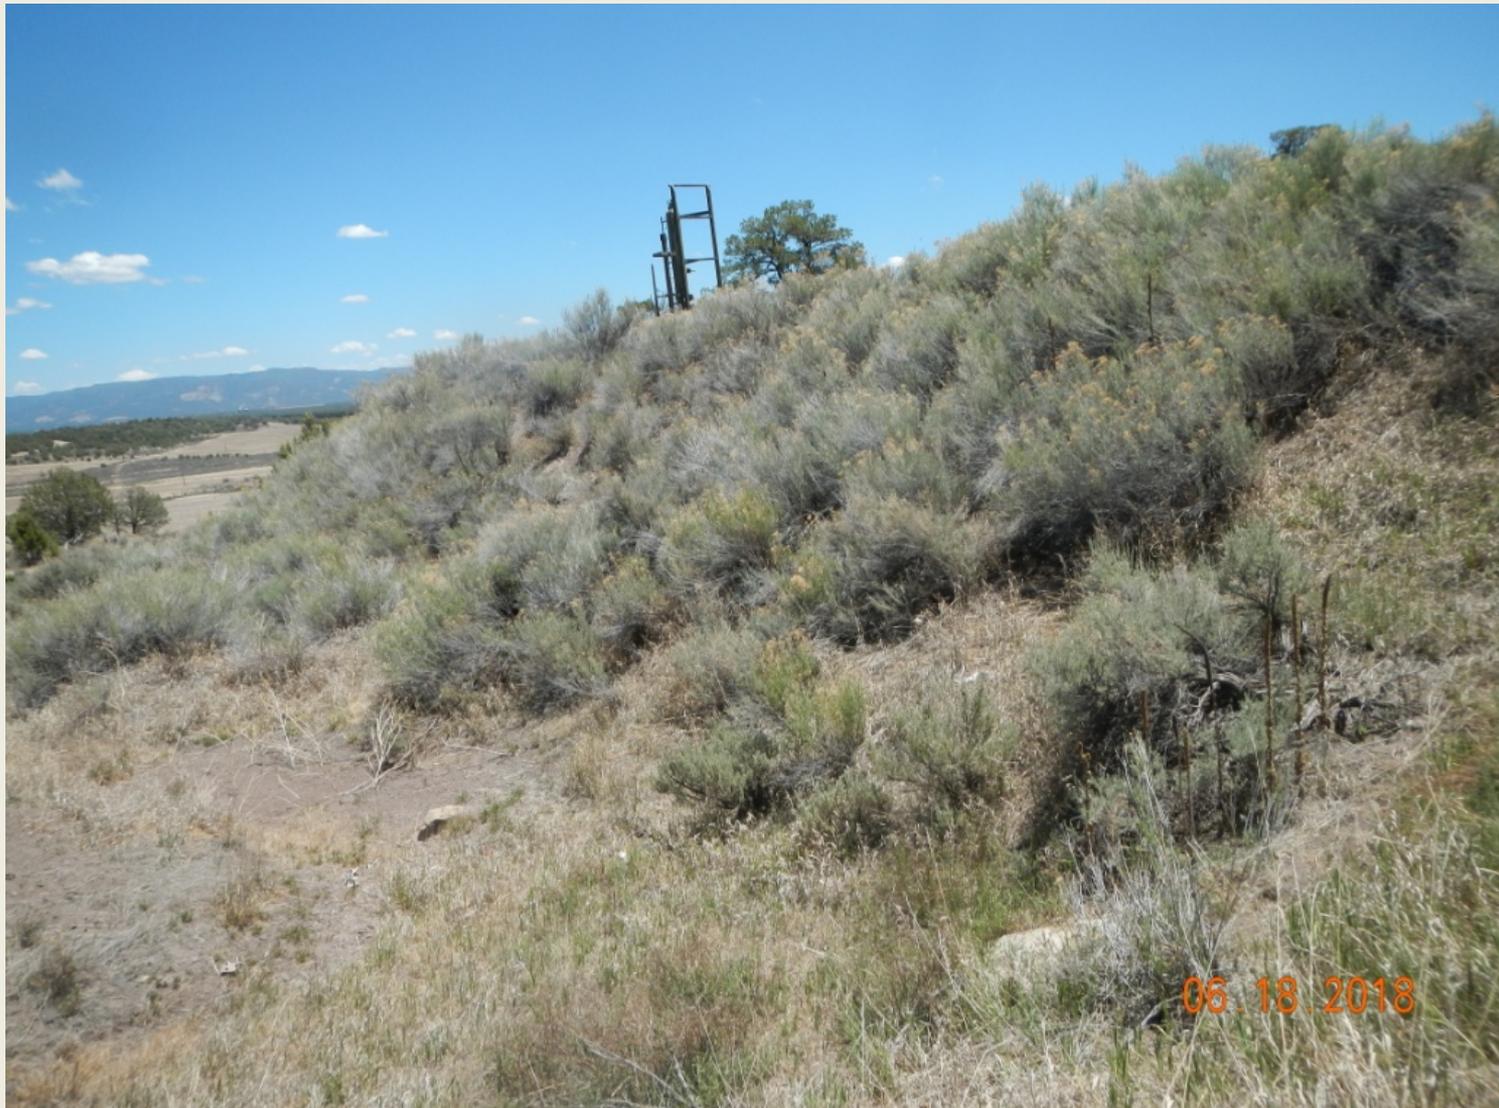
Photo 2. View of the northern portion of the project area from the northern edge facing eastward. Revegetation is progressing with shrubs and grasses such as rubber rabbitbrush (*Chrysothamnus nauseosus*) and smooth brome (*Bromus inermis*).

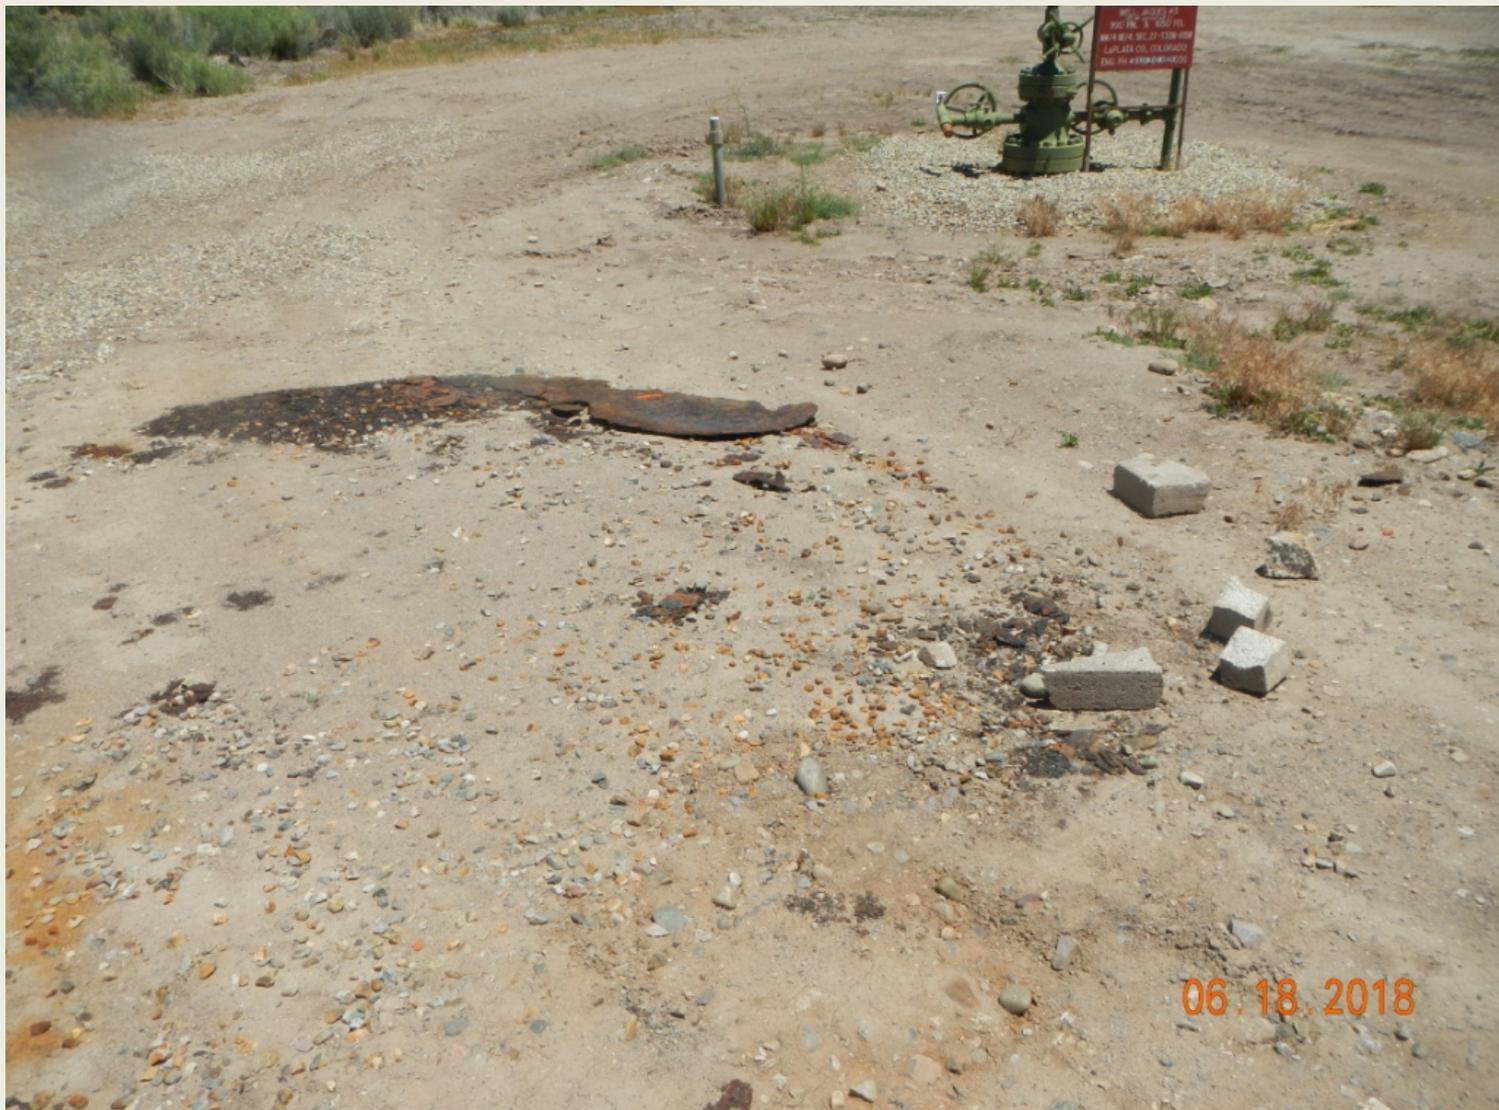
Photo 3. View of metal and cement debris near the well head.

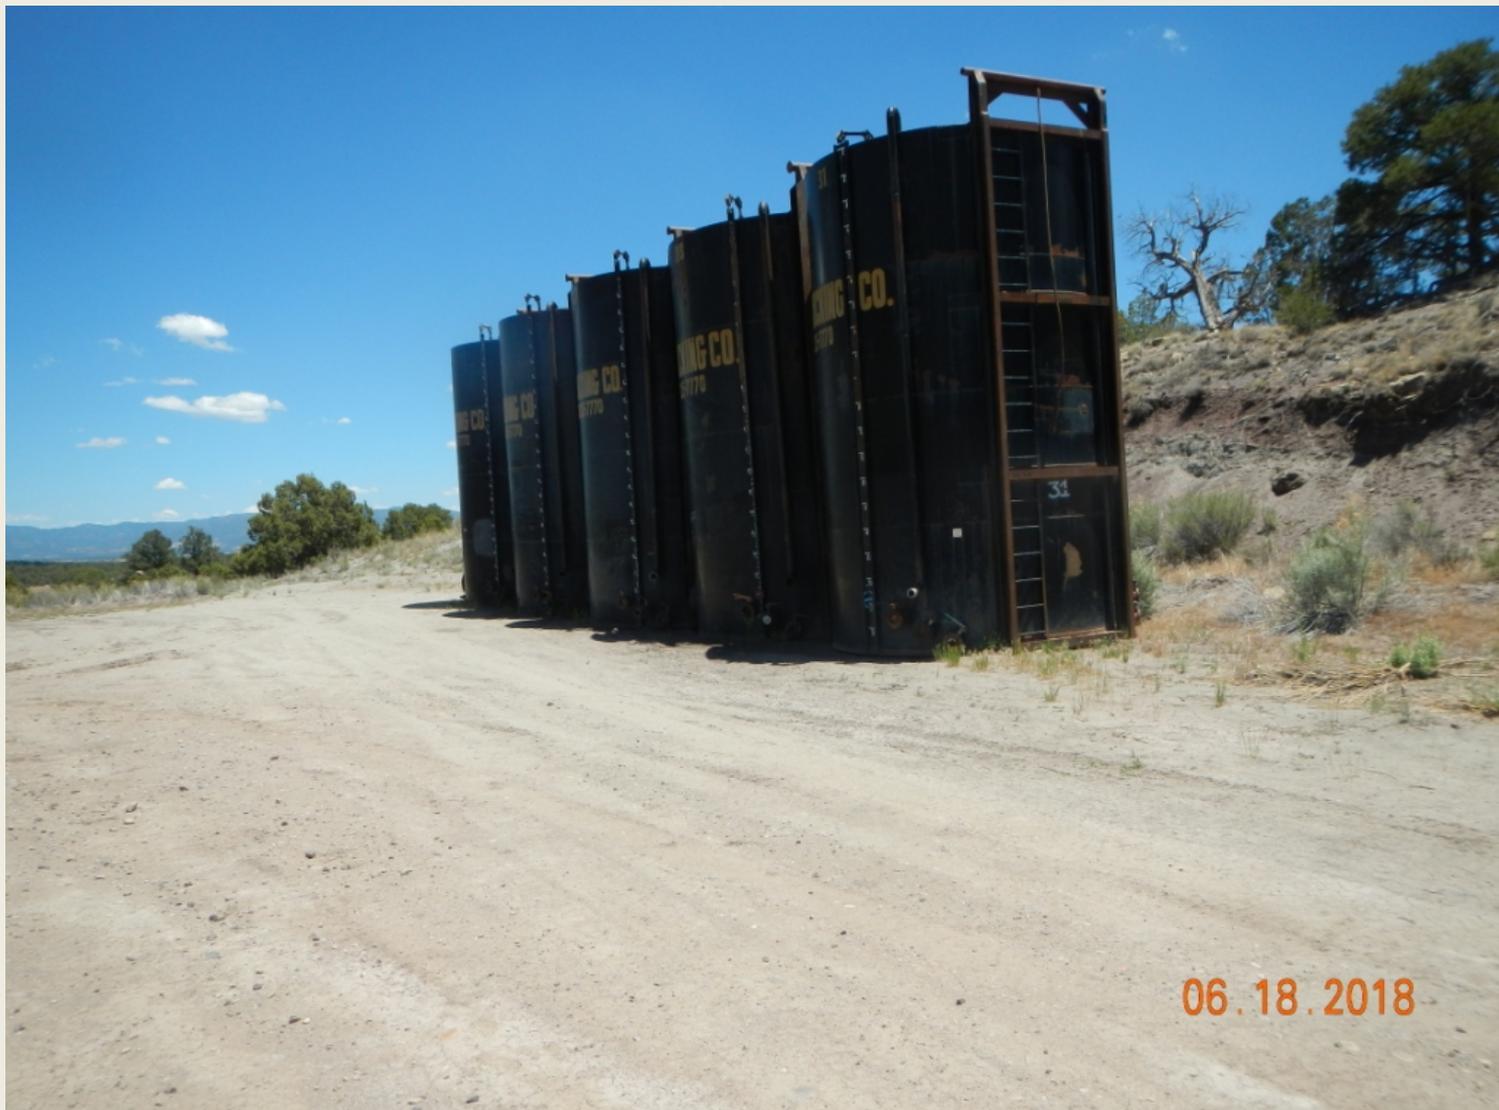
Photo 4. View of unused tanks stored in the southern portion of the project area.

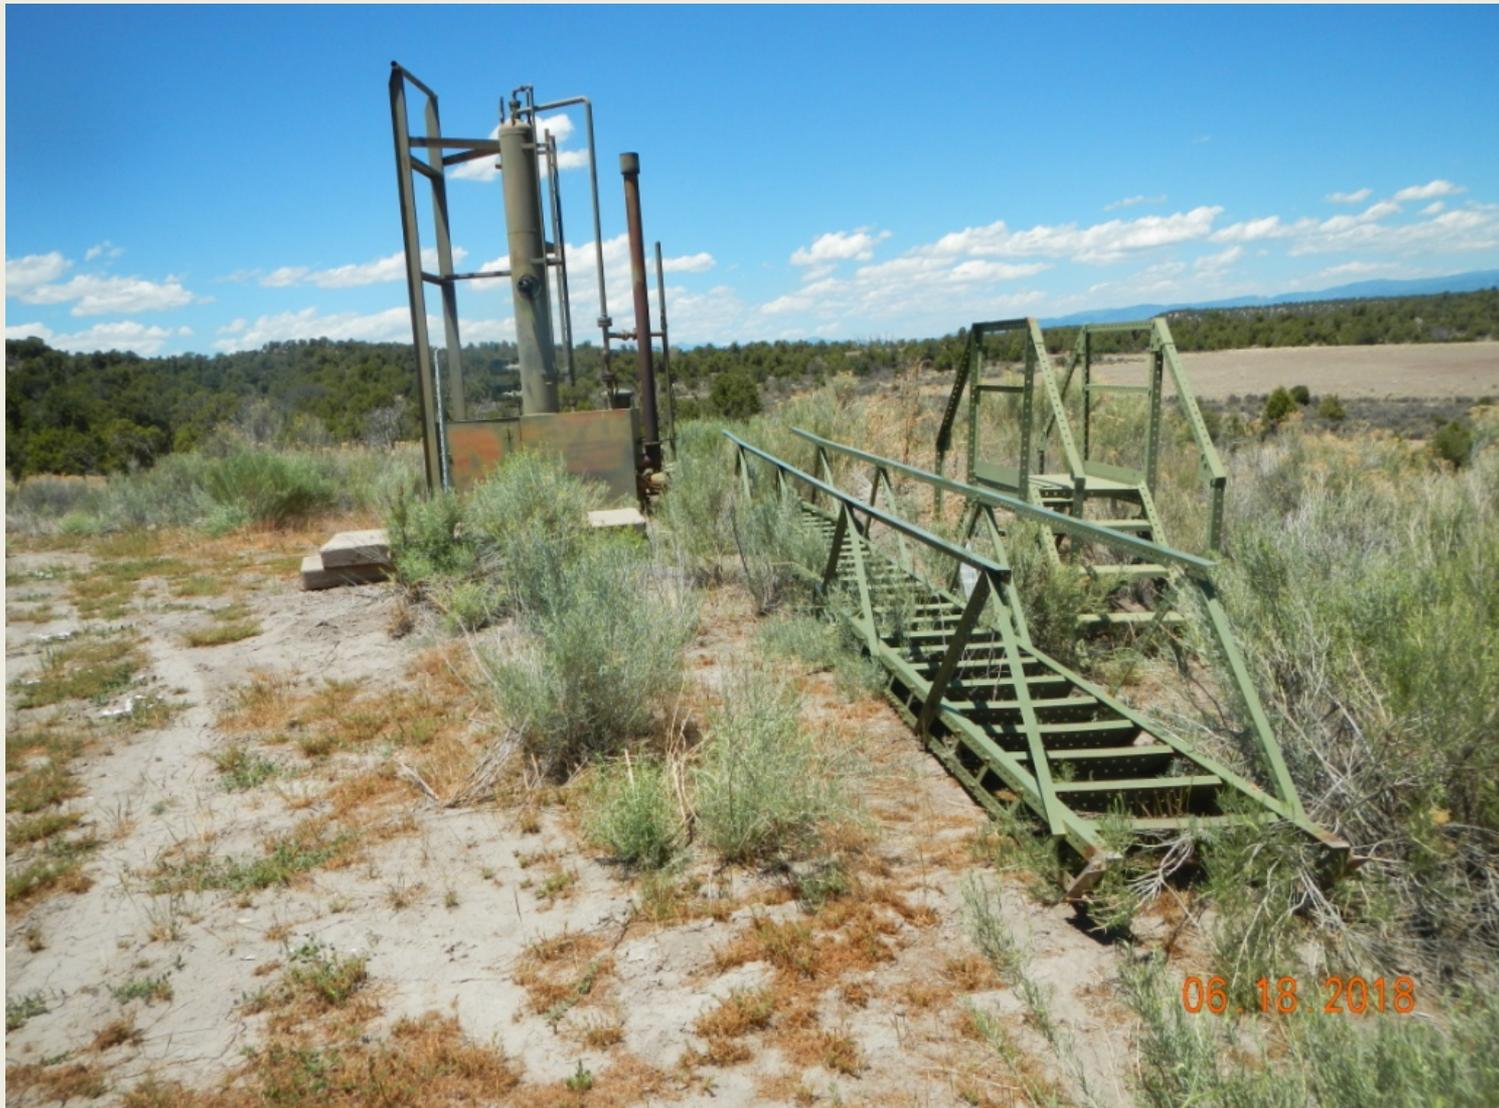
Photo 5. View of unused equipment in the northeastern portion of the project area.

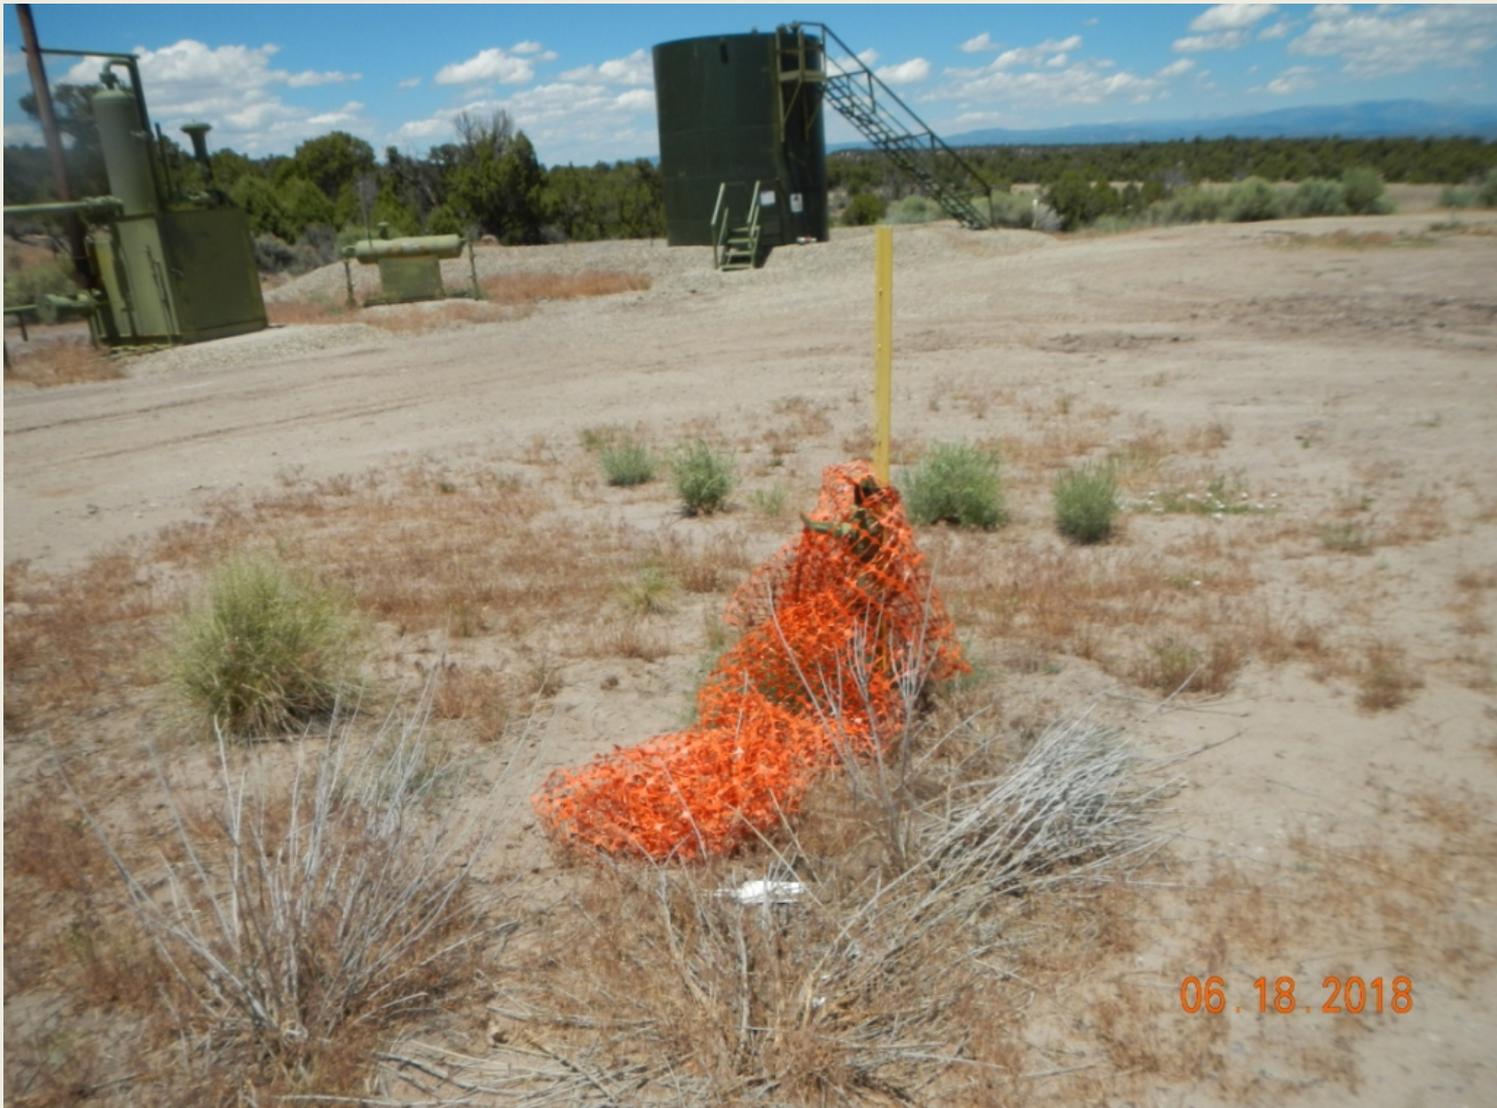
Photo 6. View of orange fencing debris in the western portion of the project area.
