Inspection Photos  
Location Name: C F & I Corp. 1  
API: 05-081-05571

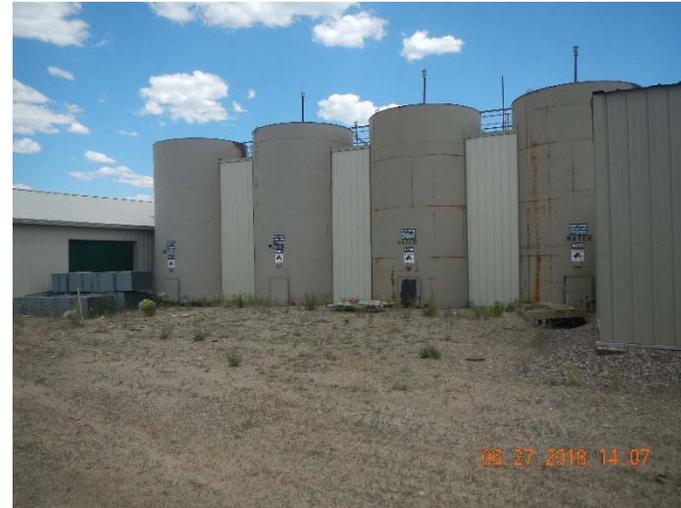
**Photo 2. No berm around produced water tanks. (Front view)**

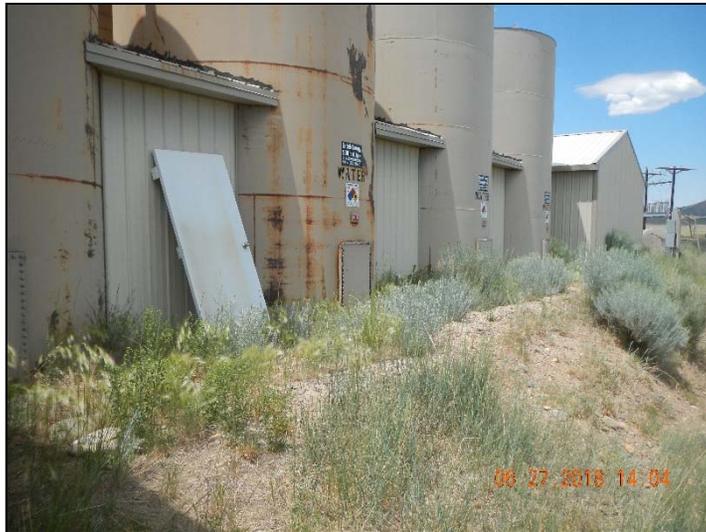
**Photo 3. No berm around produced water tanks.  
(Rear view)**

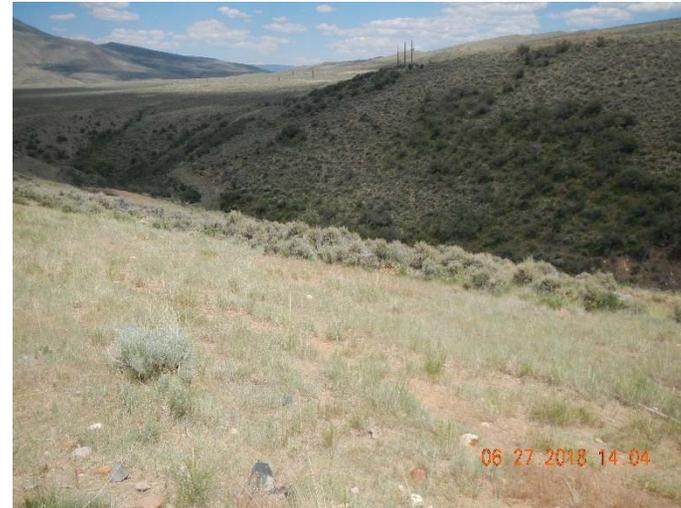
**Photo 4. Standing adjacent to location boundary in  
same spot as Photo 3 was taken looking down into  
drainage gully that location borders.**
