**HOAGLUND W-33-2 Pad**  
**Api# 05-045-06524**  
**Inspection # 689701580**

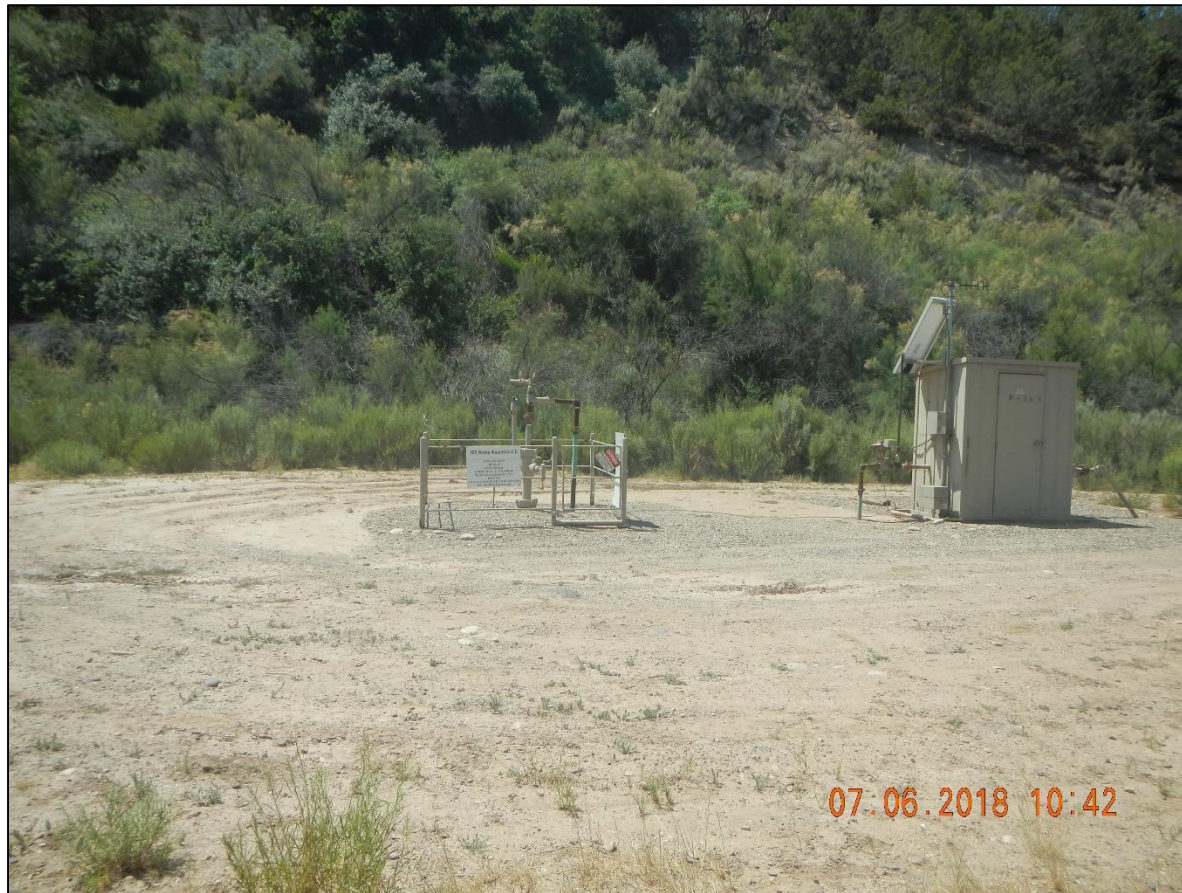
**Location photo.**

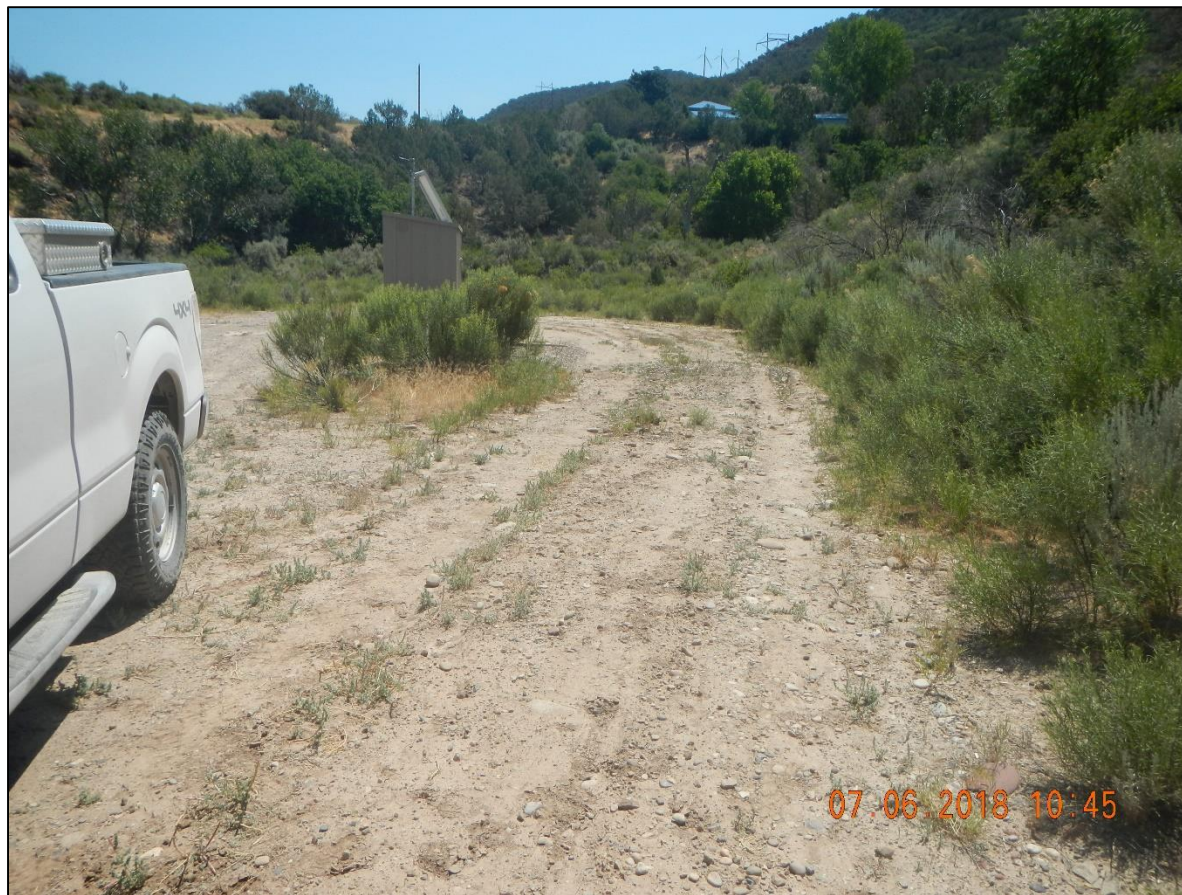
**Location photo. Weeds near well and meter shed.**

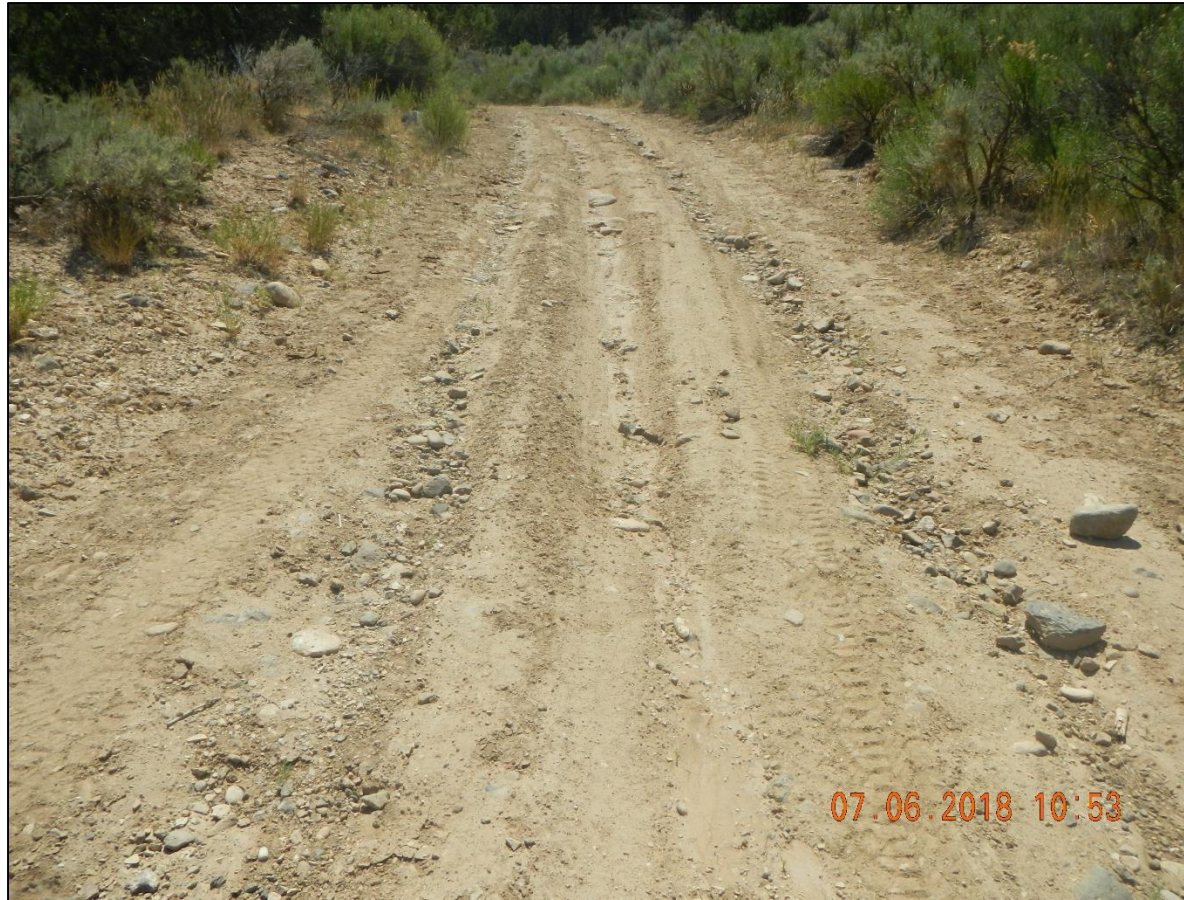
**Erosion of ruts on road to location.**

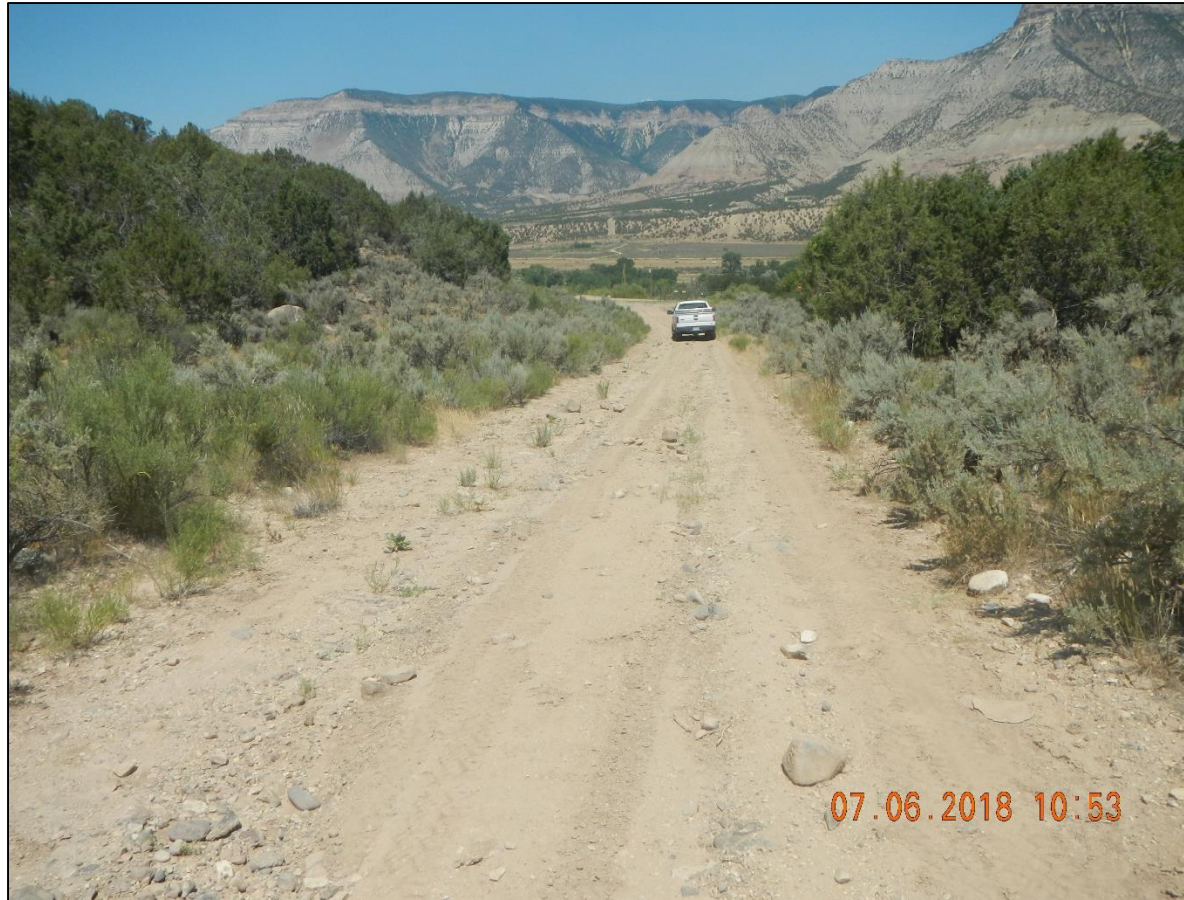
**Erosion of ruts on road to location.**

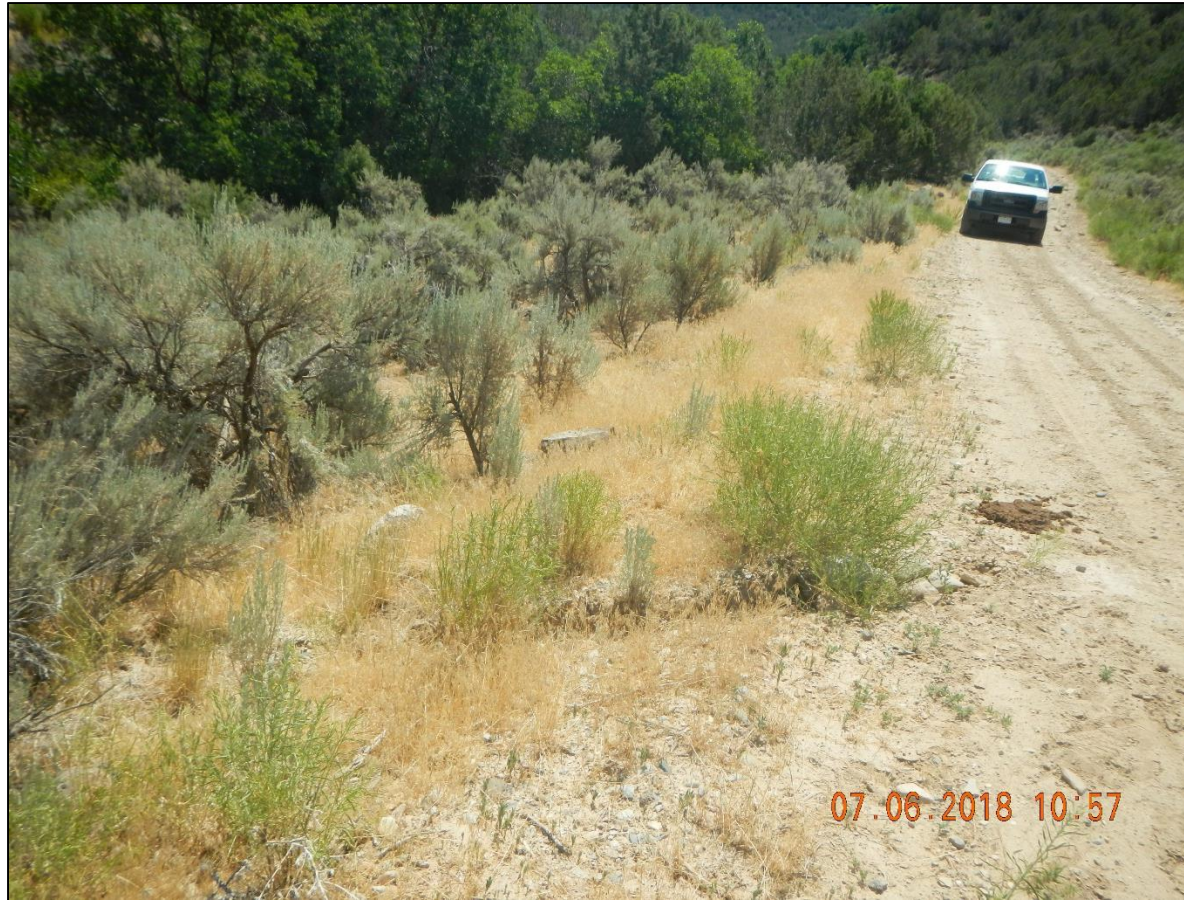
**Erosion rill on side of access road.**

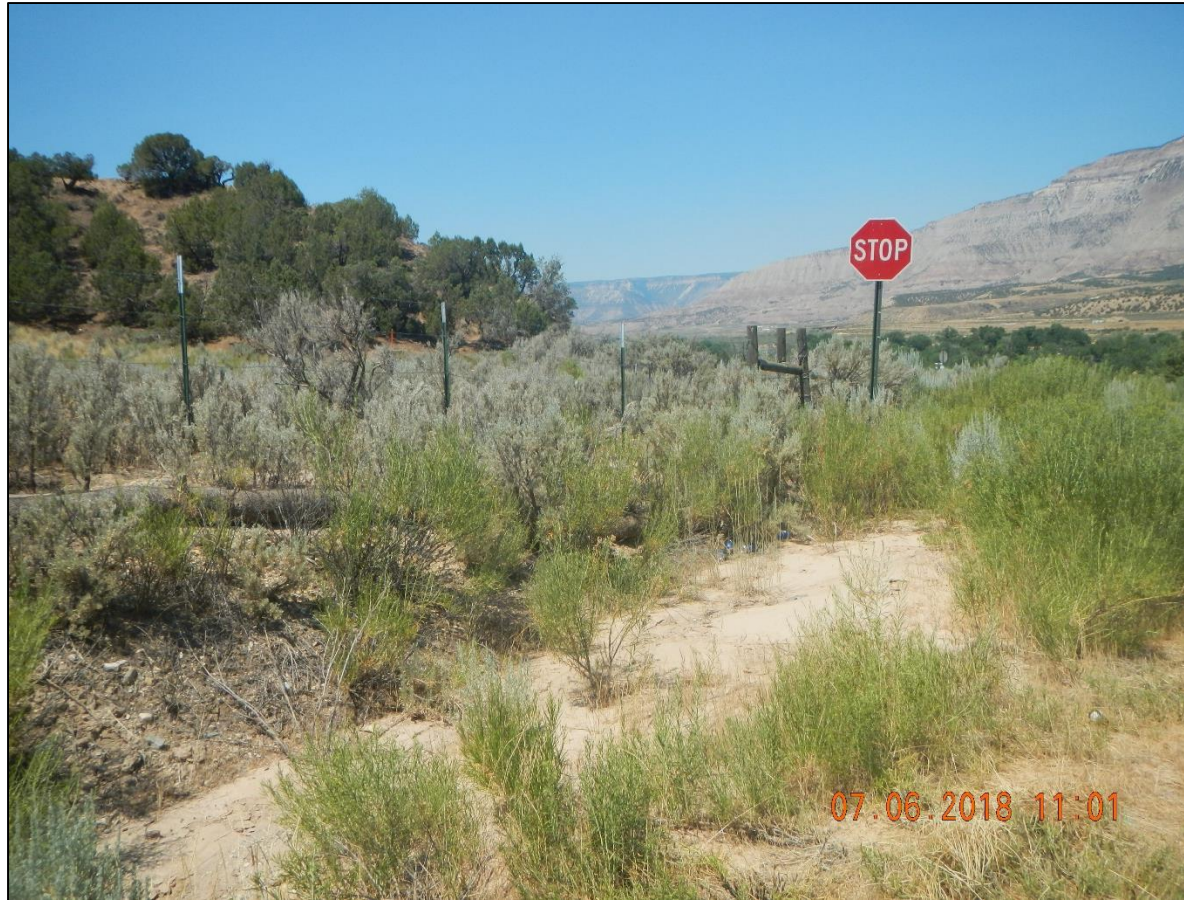
**Trash and sediment build up at gated entrance of location.**

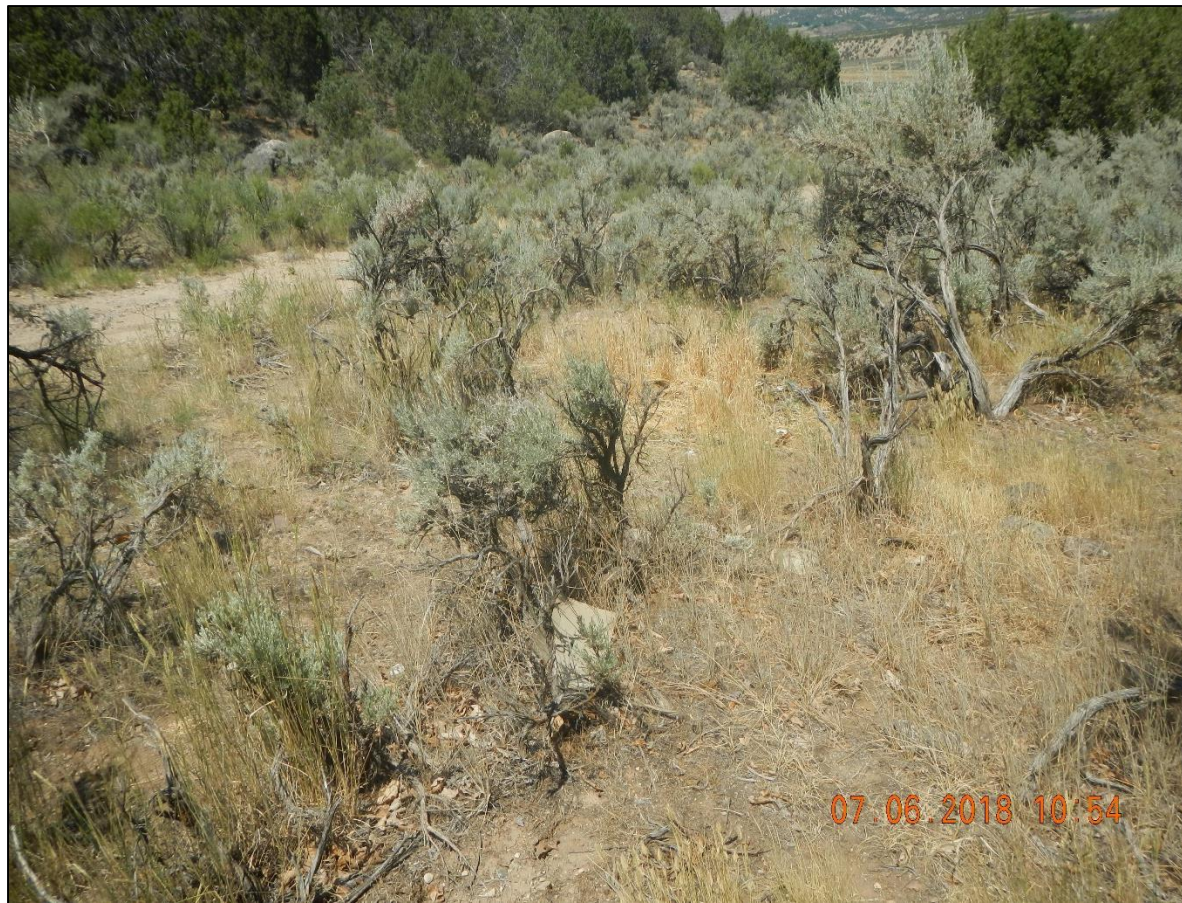
**Trash debris.**

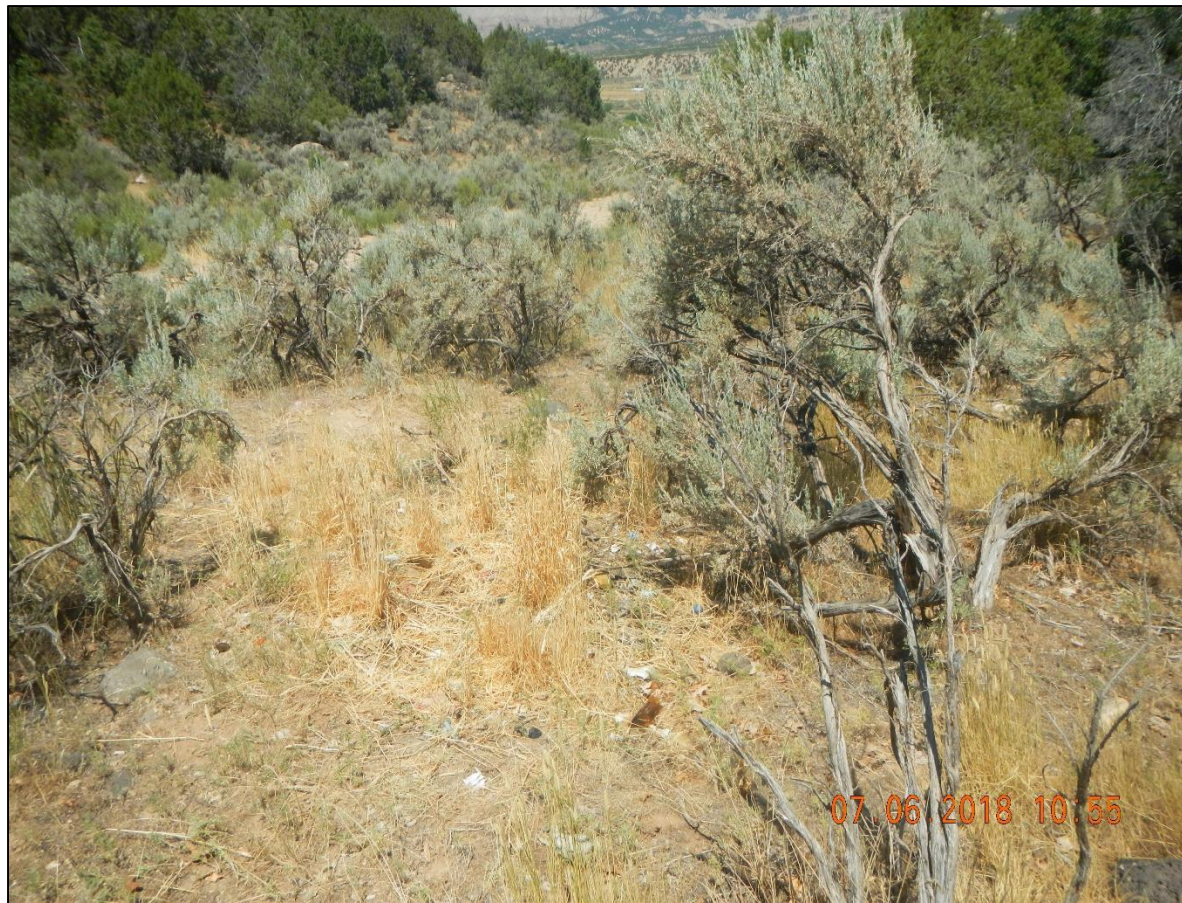
**Trash debris.**
