Inspection Photos
Location Name: Fitzhugh #6
API: 05-007-05038

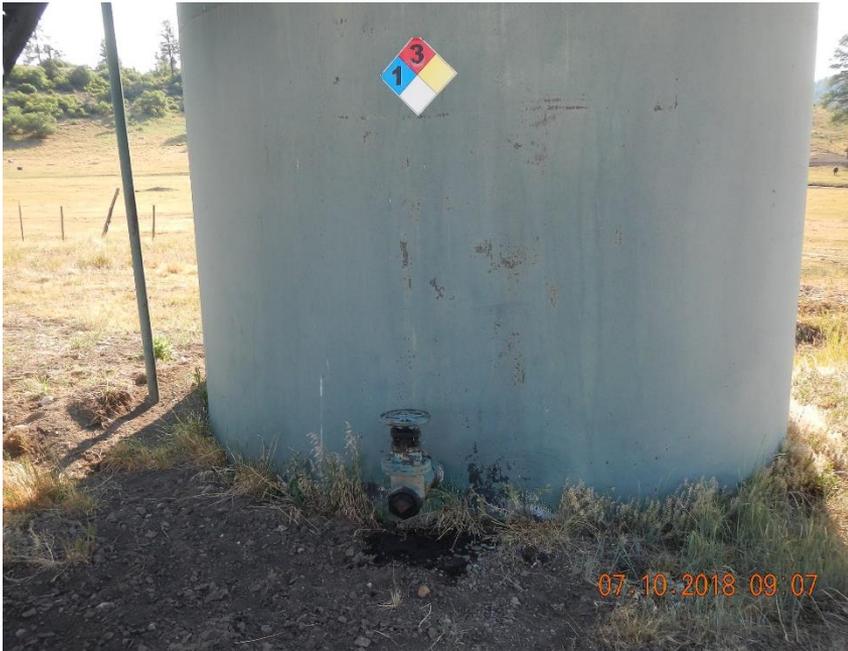
Stained soil beneath load out valve on AST.

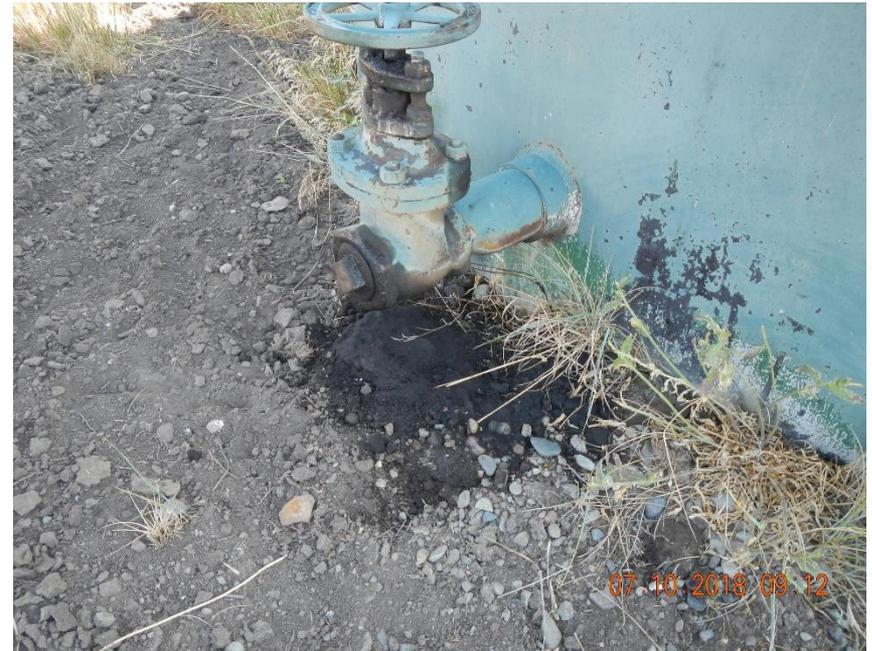
Close up view of oil stained soil.

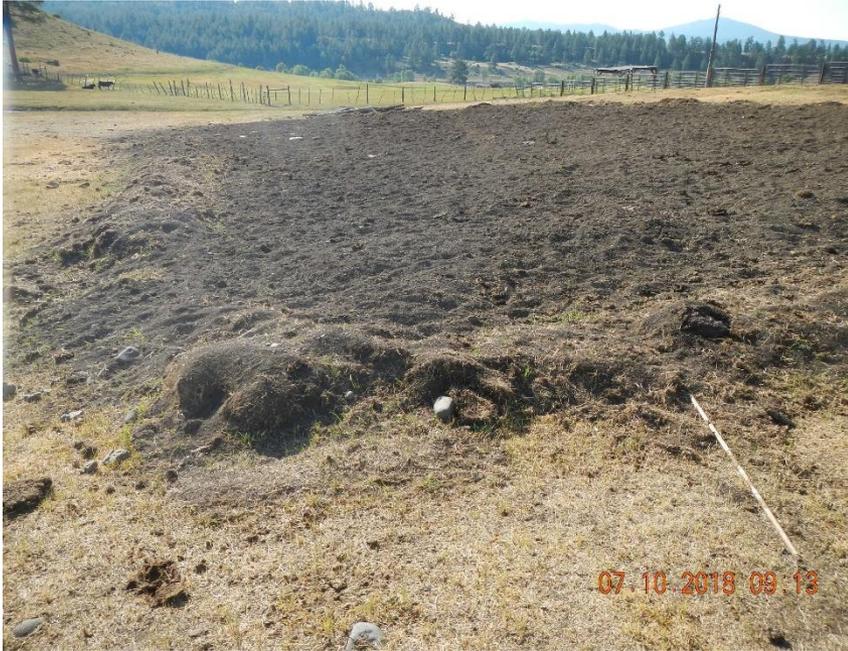
Northwest corner of land farm treatment cell.

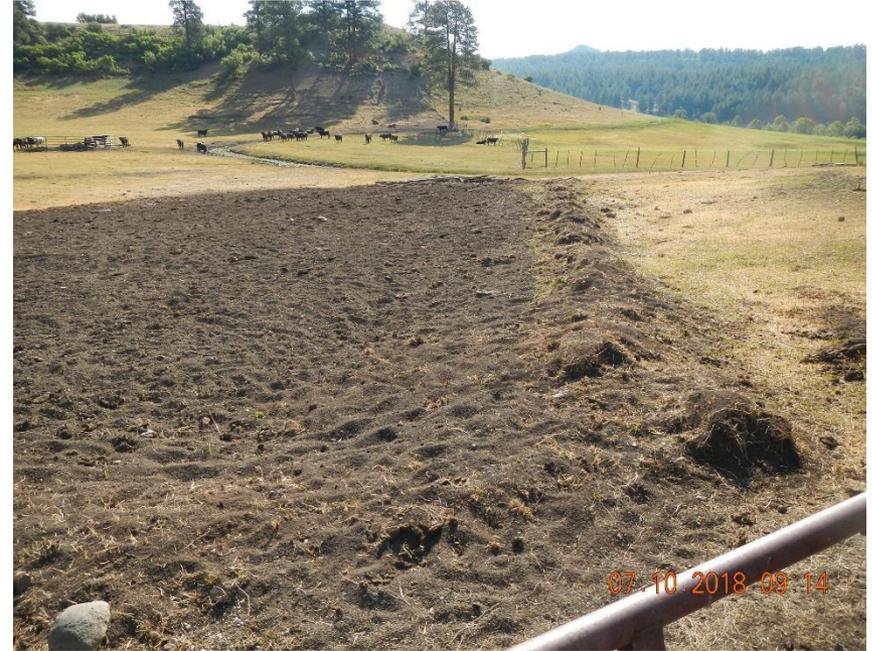
Southern edge of treatment cell.

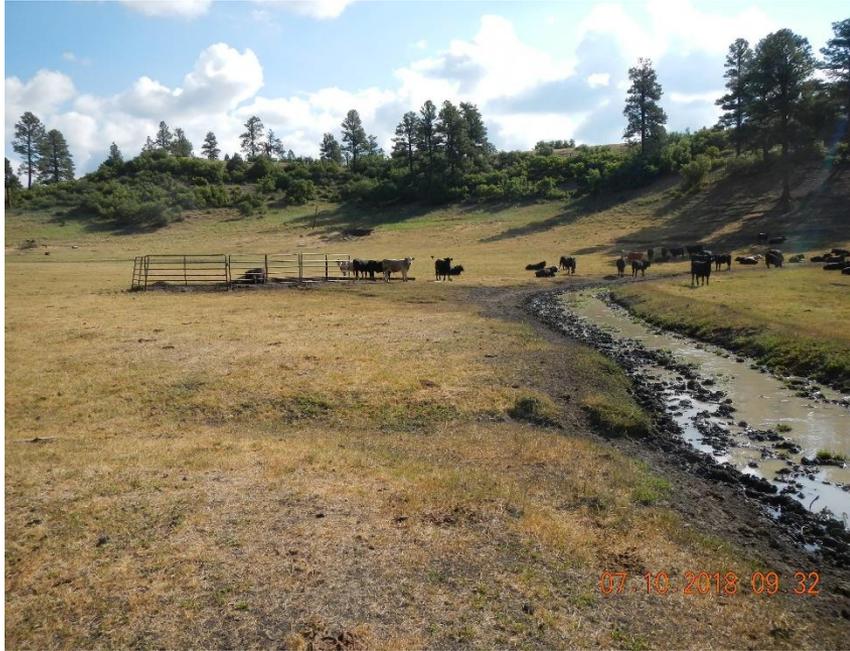
Fitzhugh #11 open excavation (behind stock panels).

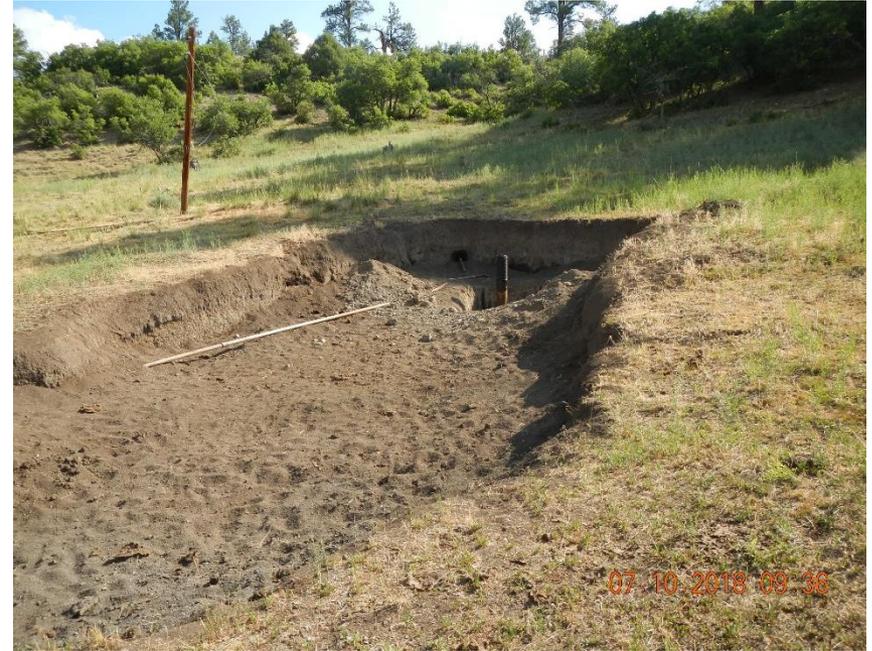
Fitzhugh #7 open excavation.

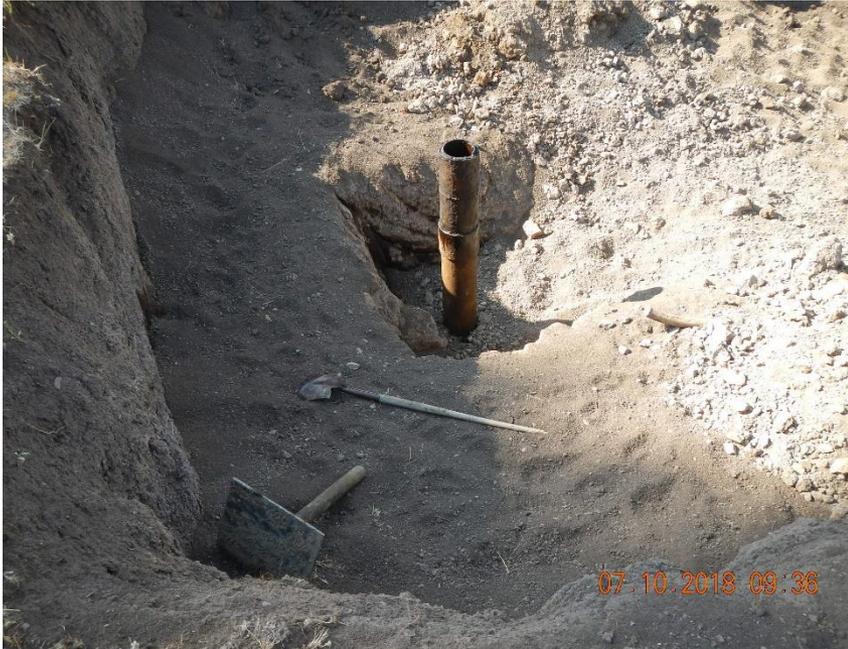
Fitzhugh #7 PA marker and well casing.

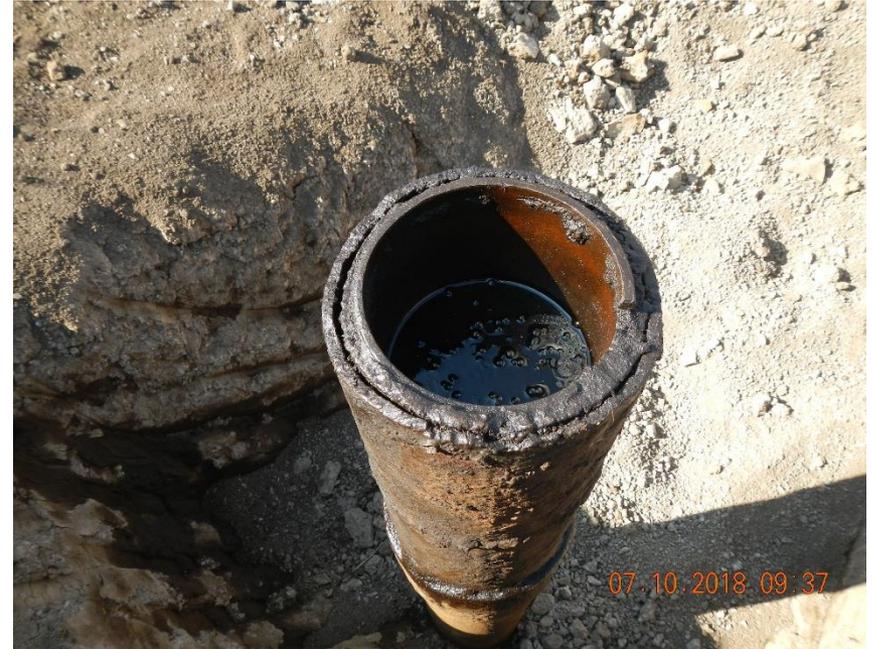
Fitzhugh #7 casing with fluids.

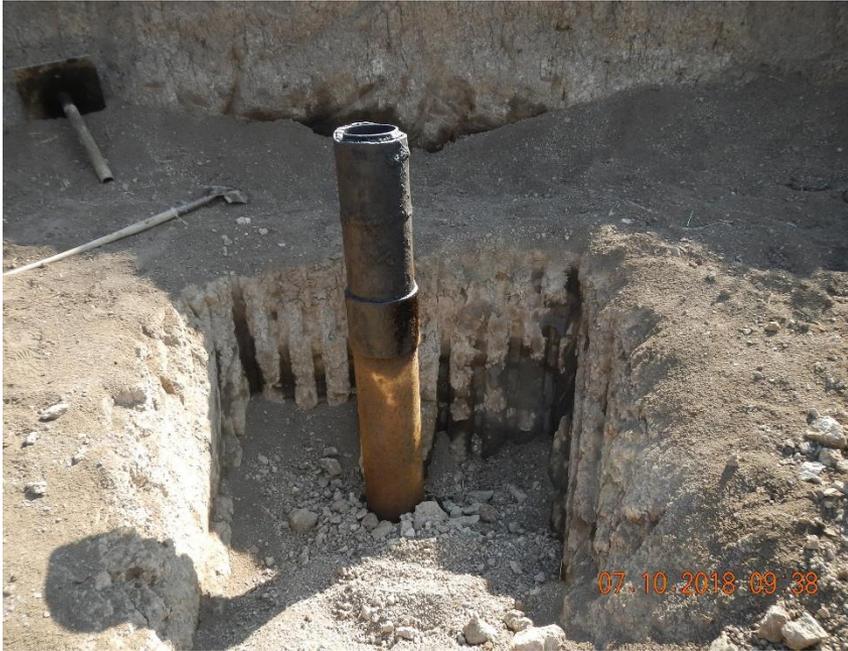
Fitzhugh #7 with oil stained soil.

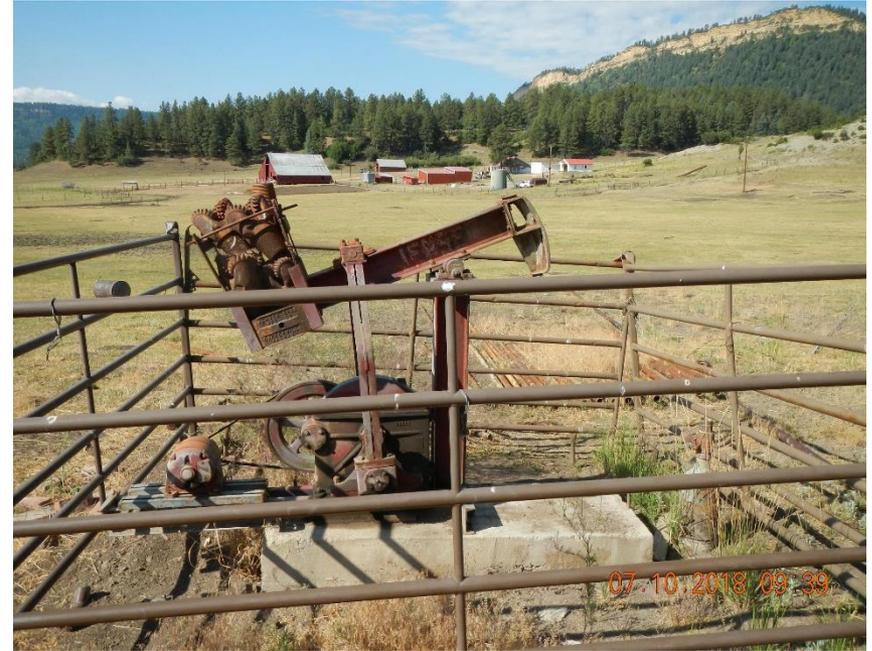
TA domestic gas supply well.

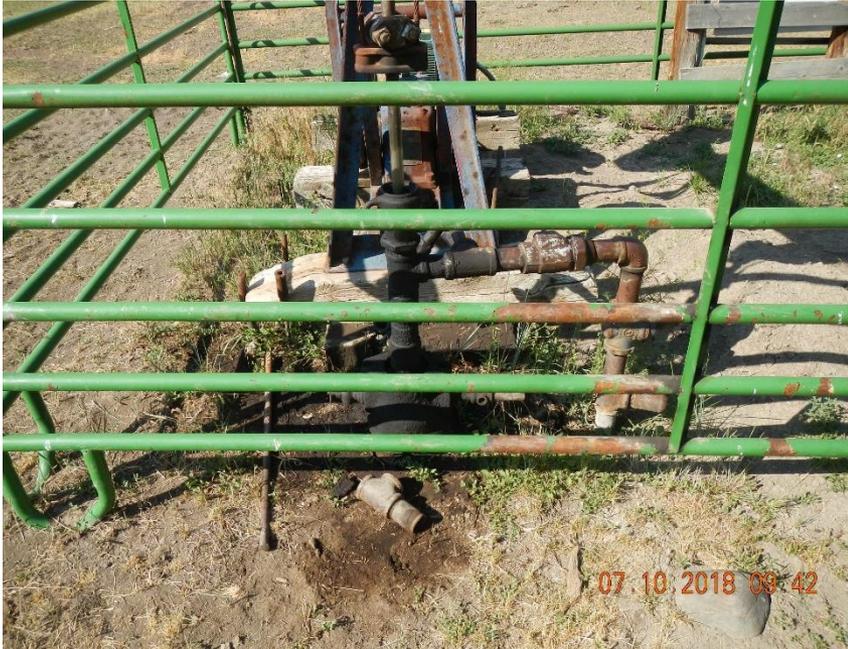
Oil stained soil and well head at the Fitzhugh #6.

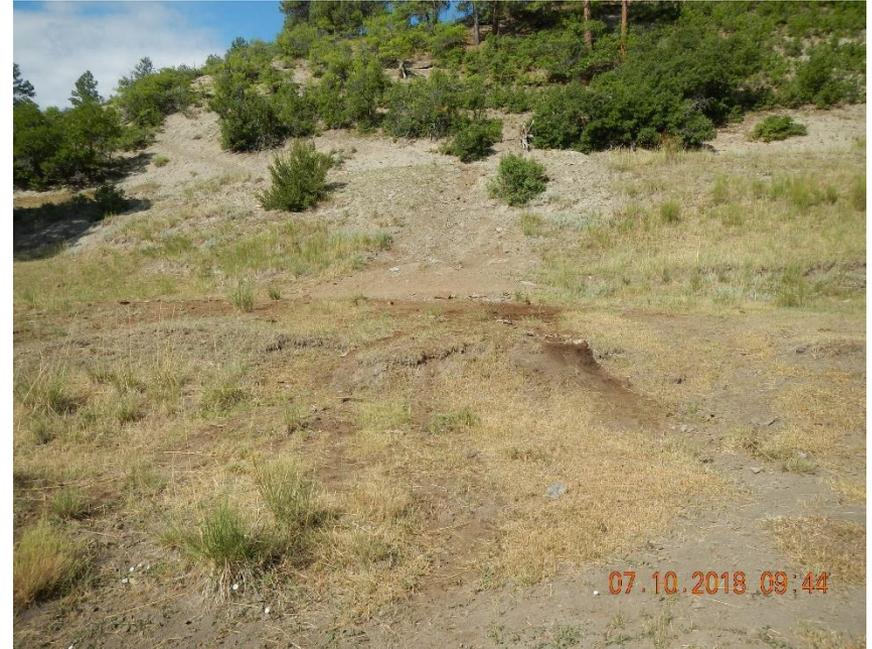
Oil staining downhill of the Fitzhugh #15.

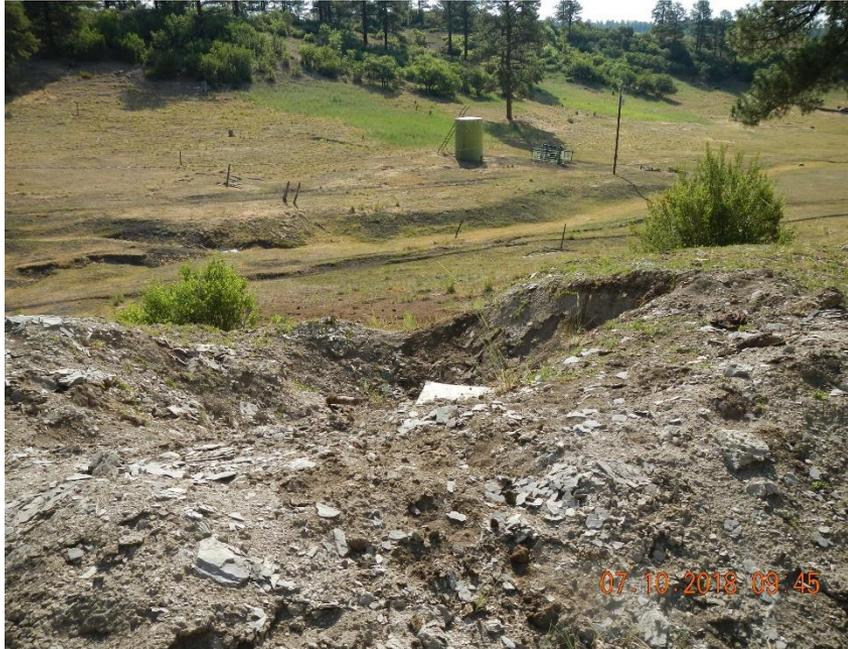
**PA marker for Fitzhugh #15 and abandoned flow line.
Fitzhugh #6 in the background.**

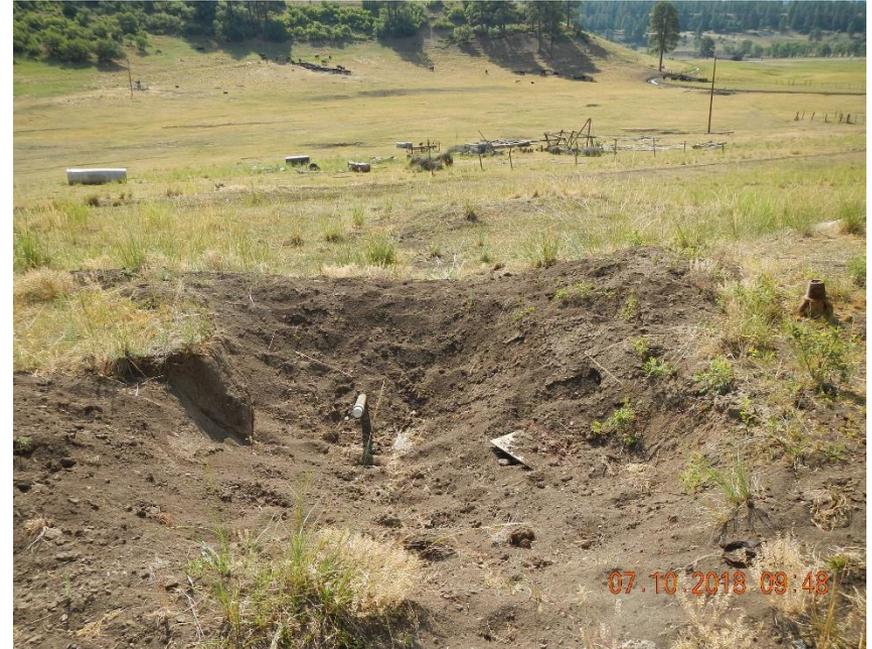
Fitzhugh #14 PA marker and abandoned flow line.

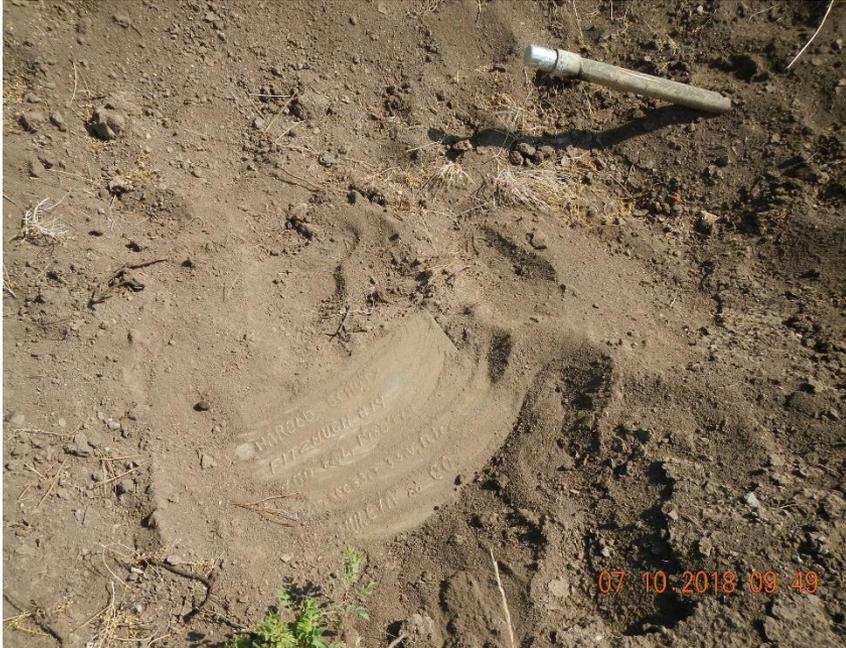
PA marker for Fitzhugh #14 and abandoned flow line.

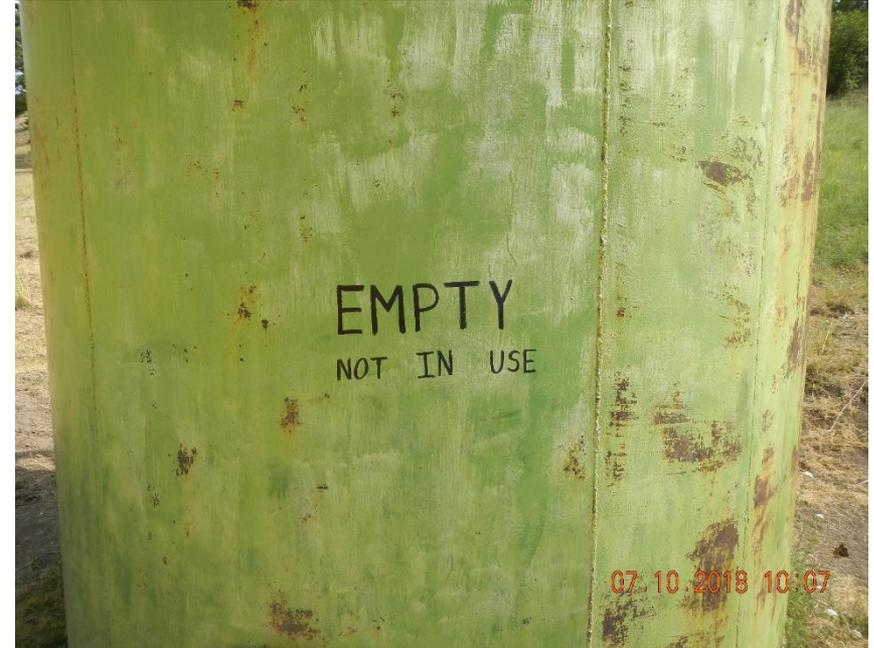
AST near Fitzhugh #6 labeled "Empty Not In Use".
