Inspection Photos
Location Name: Chavez #1
API: 05-007-06120

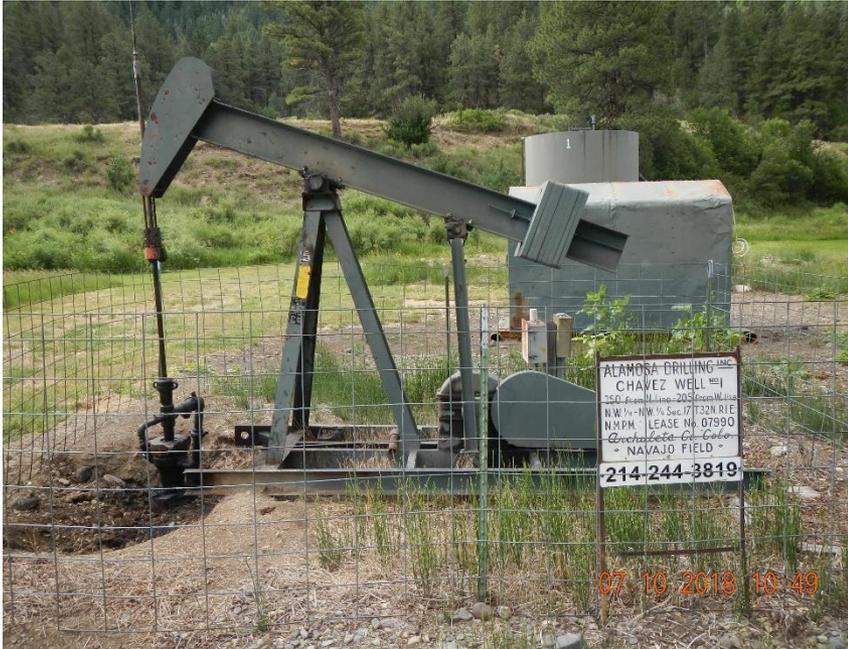
Chavez #1 pump jack and well head.

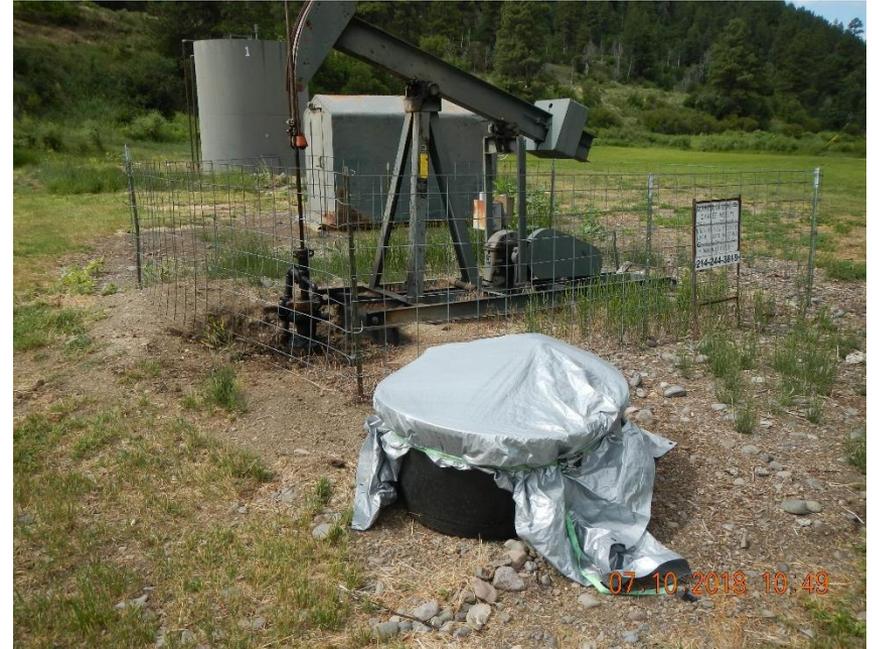
Stock tank with stained soil from excavation around well head.

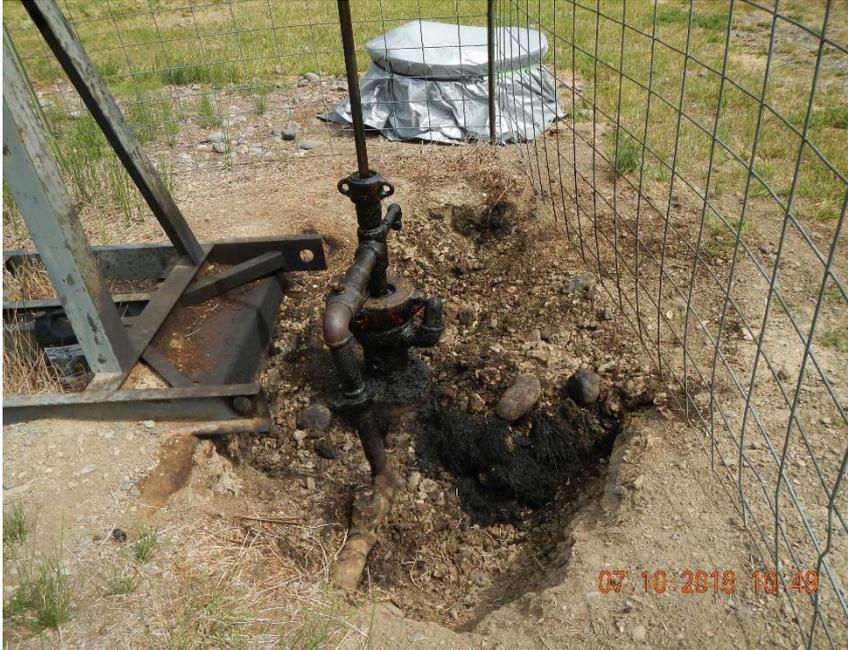
**Removal of stained soil around well head has begun.
Excavation is approximately 2' deep currently.**

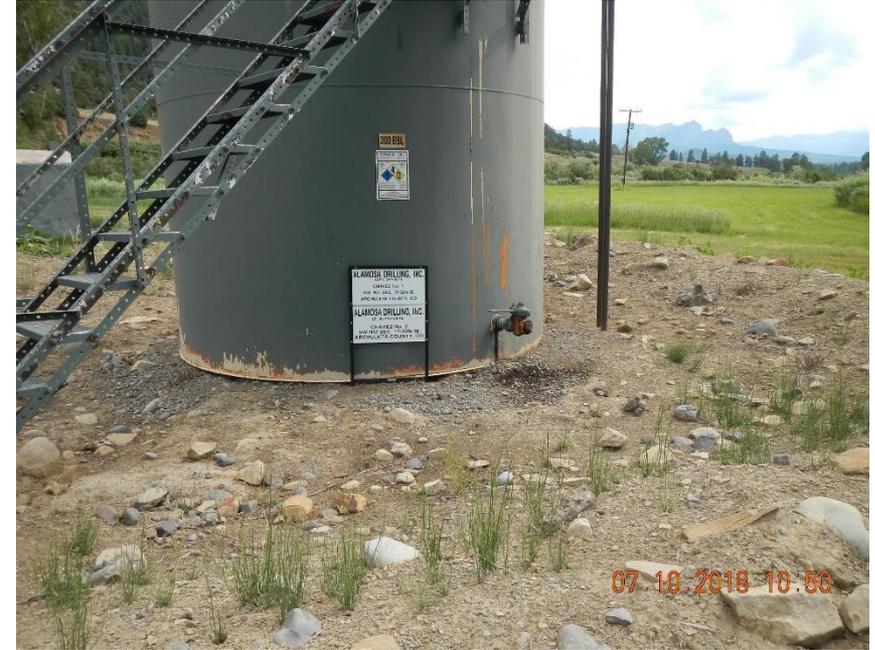
Sign has been added to tank battery for Chavez #2.
