### Photo log for Response to June 12, 2018 Inspection

COGCC conducted an inspection of the Lilli Unit 12-6 location (Location ID 327025) on June 12, 2018 (Document 684905506). During that inspection, COGCC made the following observation:

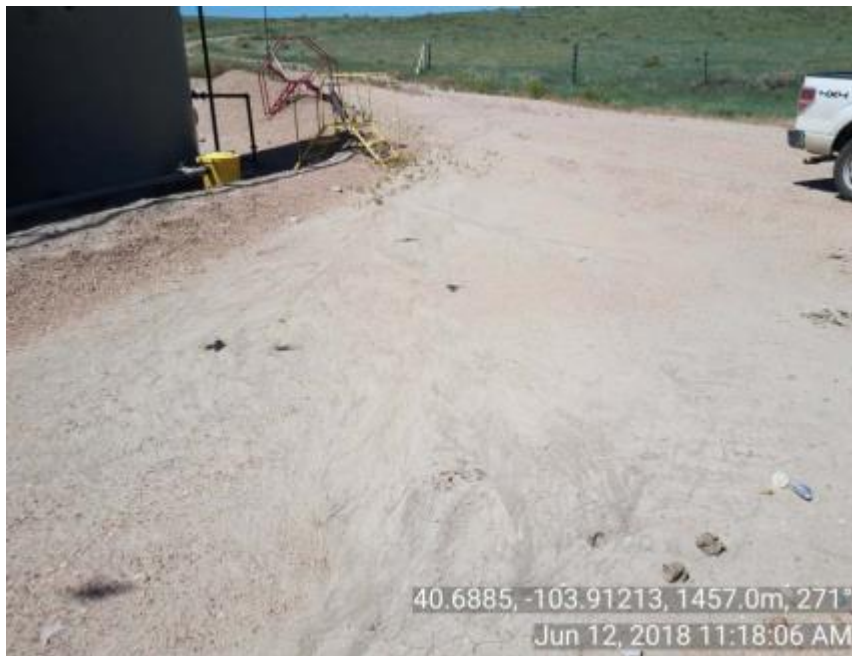
**COGCC – 6/12/18**

Storm Water: Stormwater erosion on NW corner of location. Install or repair required BMPs per Rule 1002.f.

COGCC Photo 5: Stormwater erosion on NW side of location

Response: Noble repaired the erosion.
