# Inspection Photos

Operator: FOUNDATION ENERGY  
MANAGEMENT LLC - 10112

Location ID: 327361

Inspection Doc. Number: 682503572  
Weld County, CO

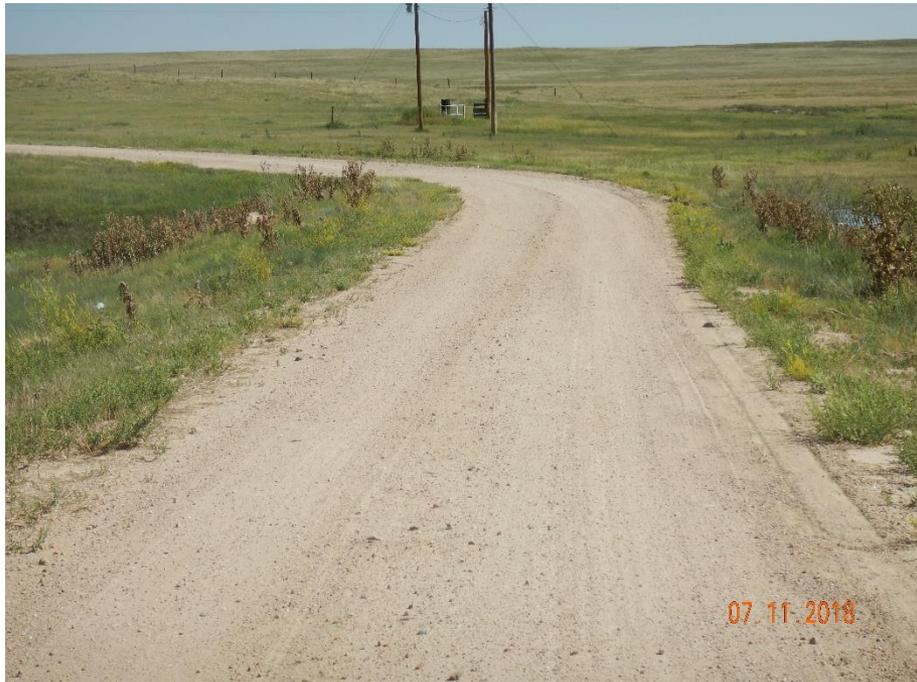
**Photo 1:** Photo taken from the main access road, facing north. Photo shows scotch thistle has desiccated.

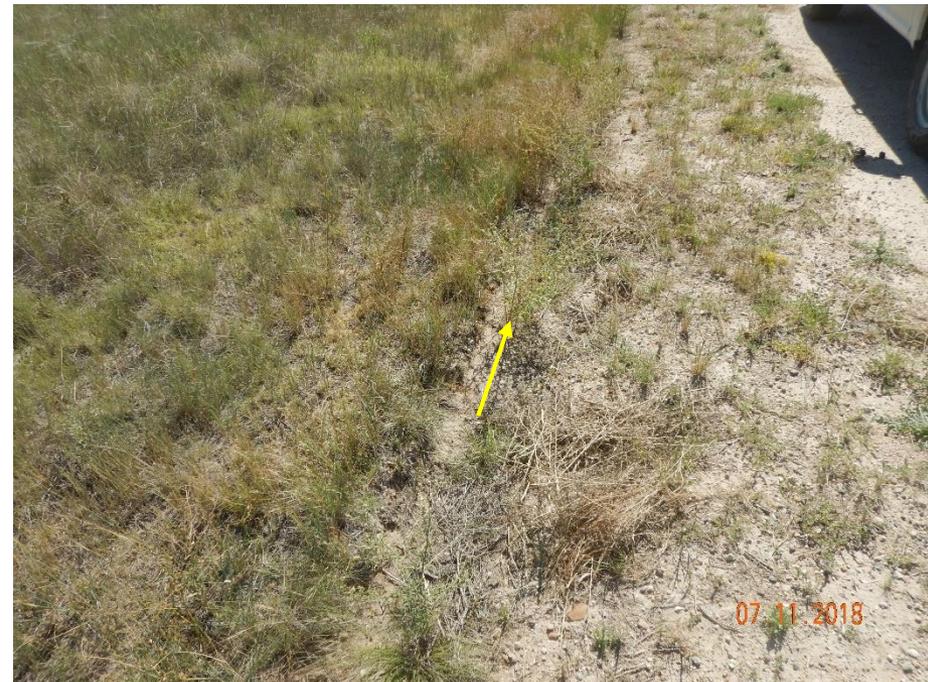
**Photo 2:** Photo taken from the main access road, east of the location. Previous inspection required management and removal of noxious weeds.

Photo shows Diffuse Knapweed (lighter, grey-green plants, white colored flowers) remains prevalent on location and access roads. Though there is evidence of herbicide, spraying does not appear to have been sufficient as many plants appear to be viable and have continued to mature/flower

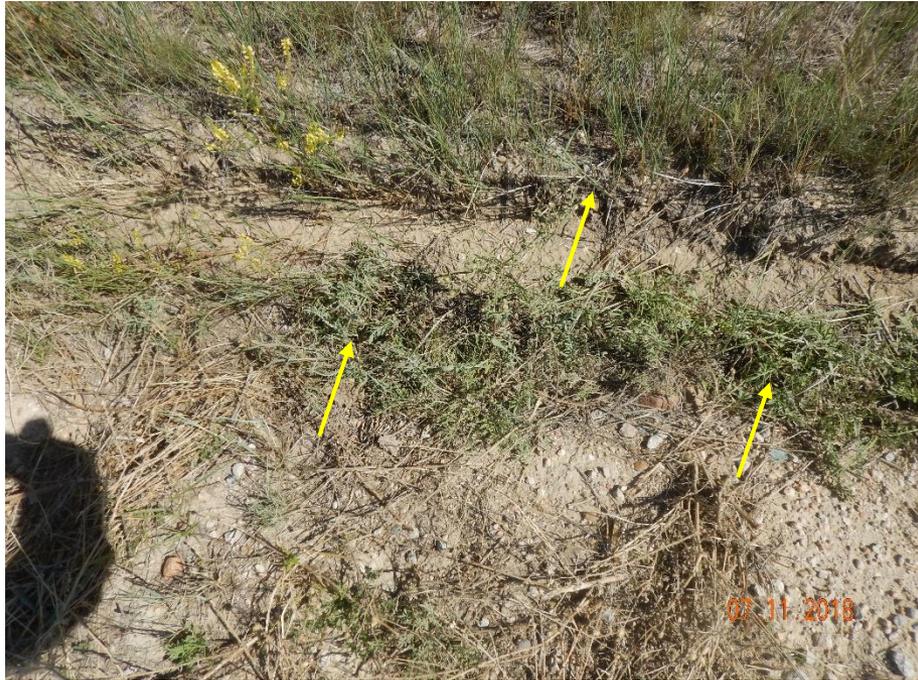
**Photo 3:** See comments under photo 2.

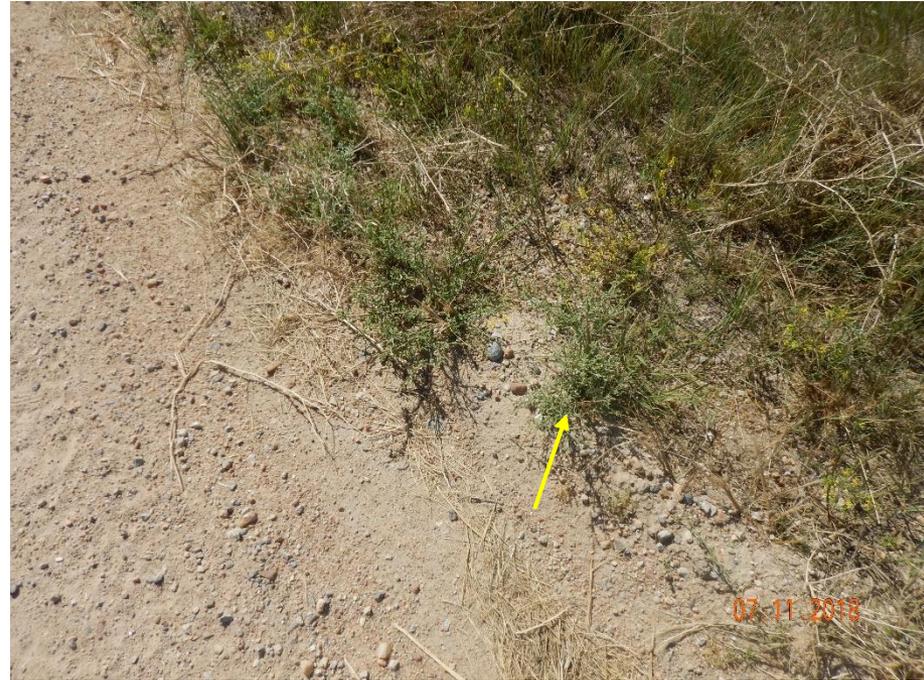
**Photo 4:** See comments under photo 2.

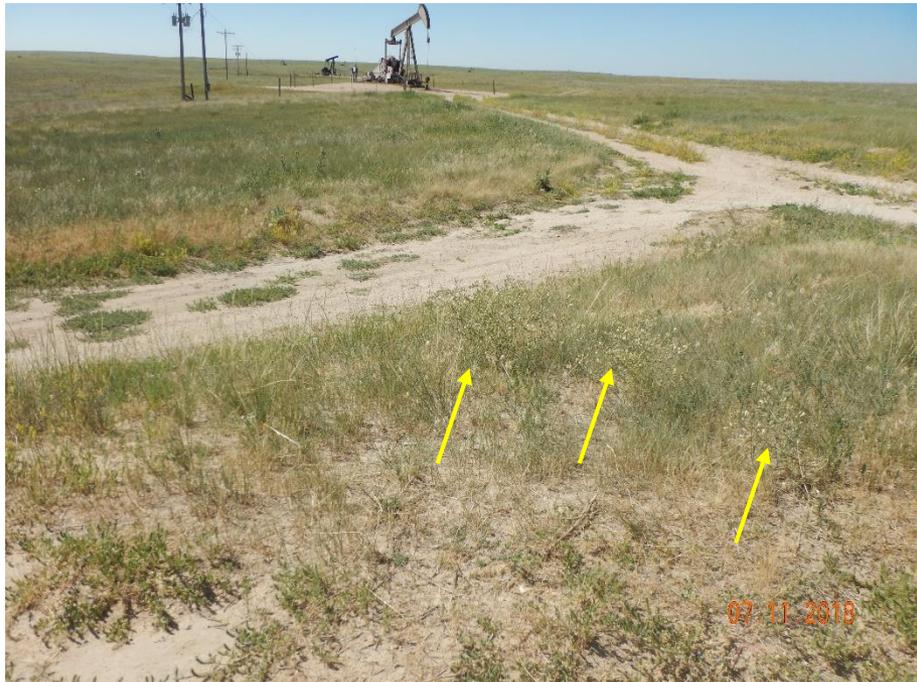
**Photo 5:** Photo taken from the access road, north of the location facing south. See Comments under photo 2.

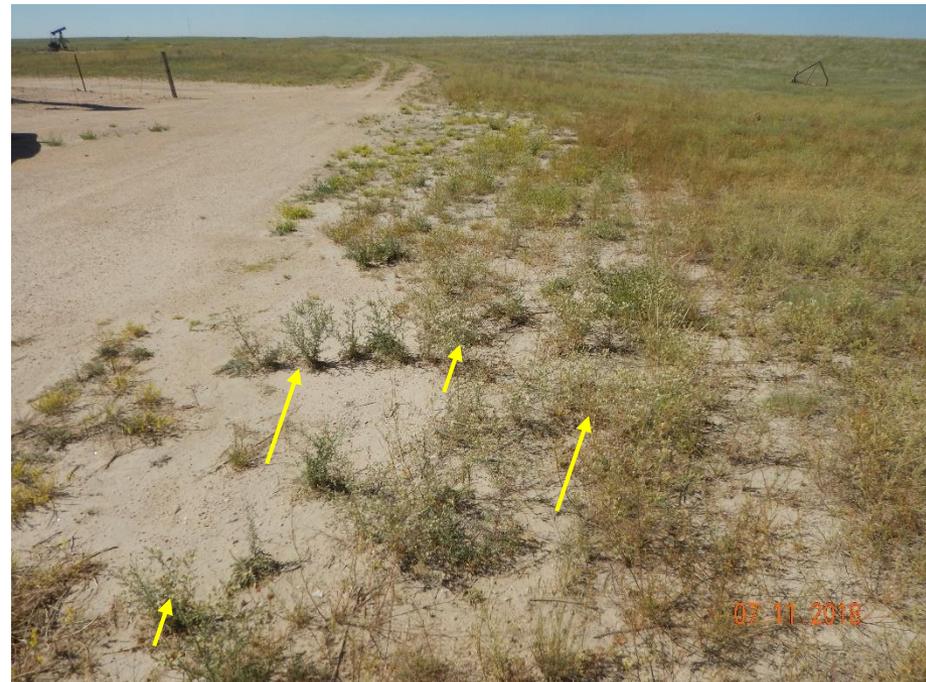
**Photo 6:** Photo taken from the west end of the location, facing south. See comments under photo 2.

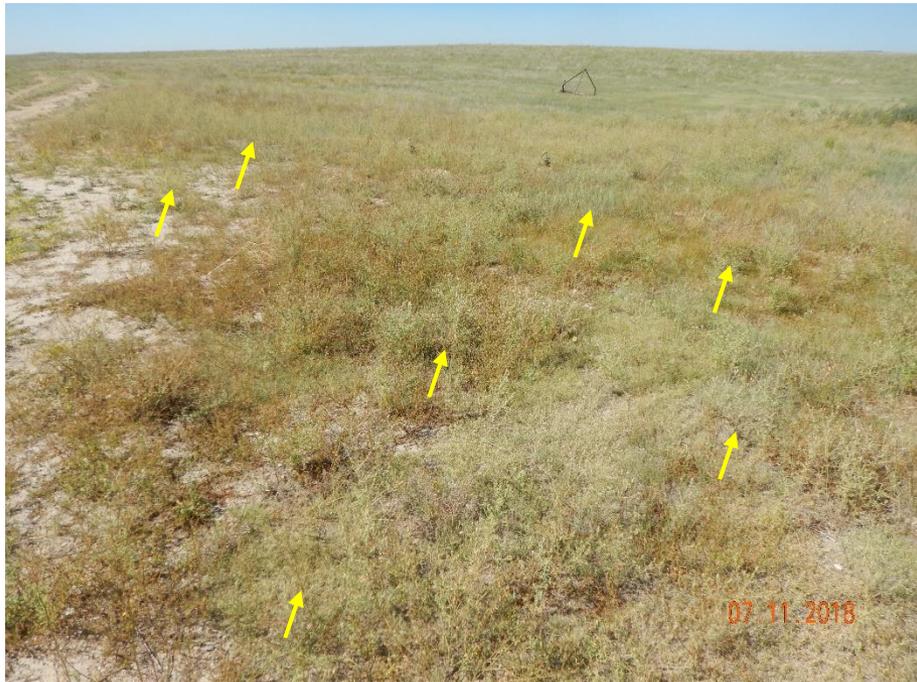
**Photo 7:** Photo taken from the west end of the location, facing south. See comments under photo 2.

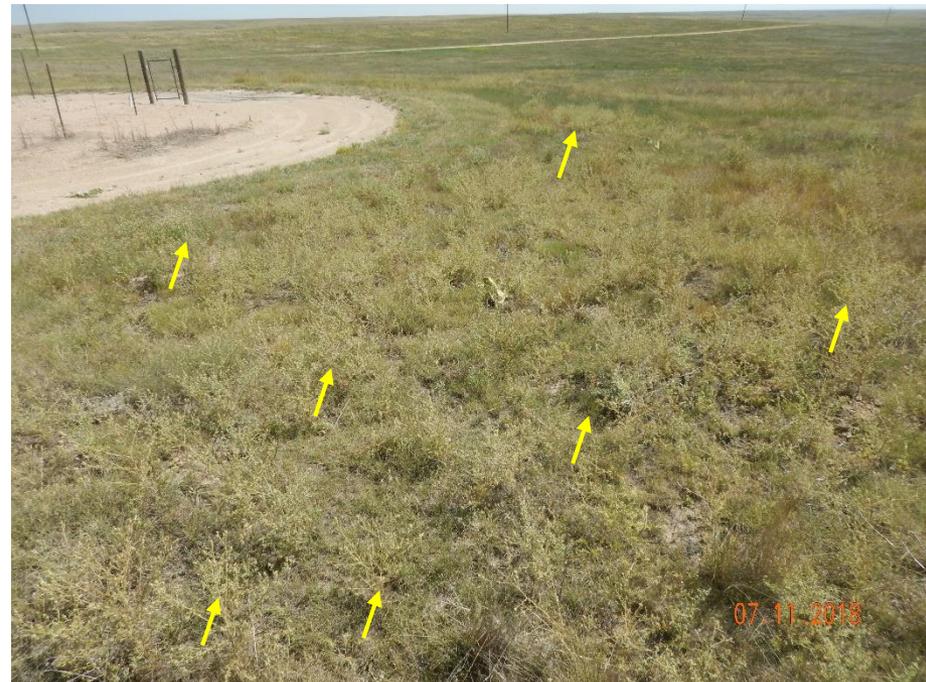
**Photo 8:** Photo taken from the south end of the location, facing northeast. See comments under photo 2.

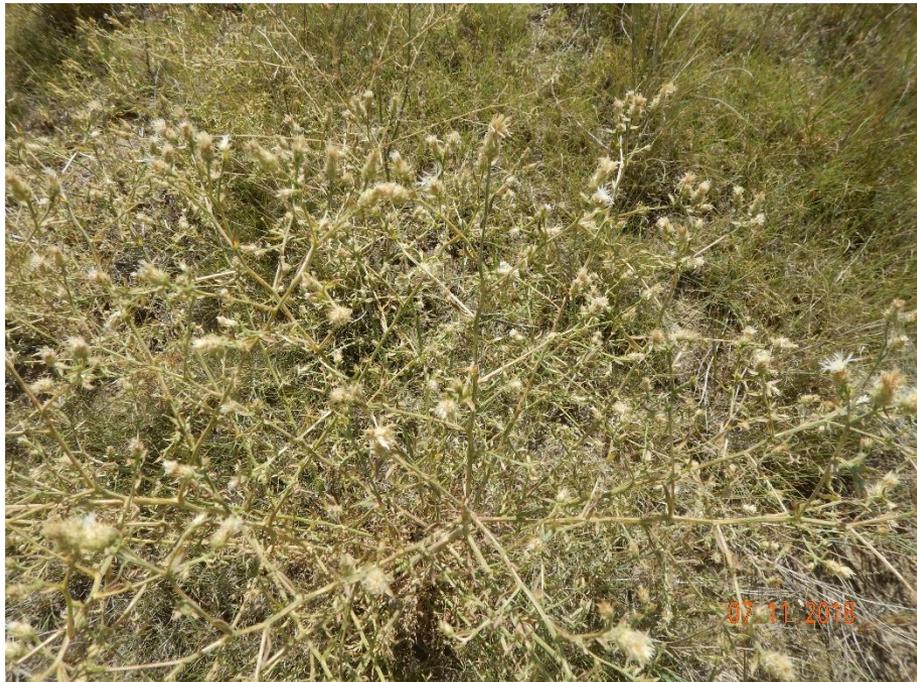
**Photo 9:** Close up photo of Diffuse Knapweed observed on location. Photo shows that though Diffuse Knapweed (lighter, grey-green plants, white colored flowers) appears to have been sprayed w/ herbicide, spraying does not appear to have been sufficient as plant appear to be viable and have continued to mature/flower

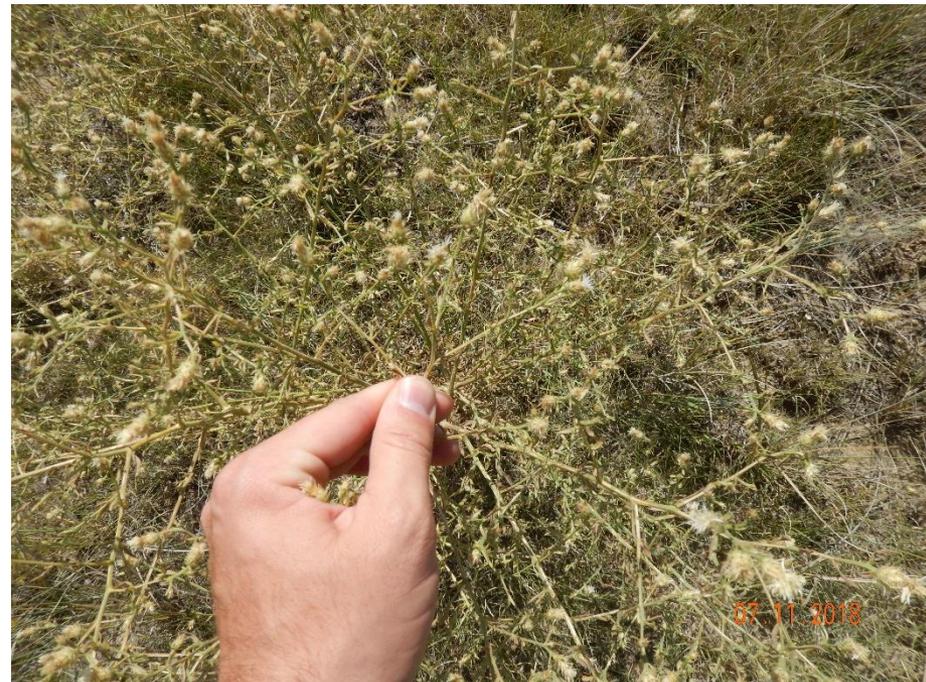
**Photo 10:** See comment under photo 9.
