## Caerus Flow Line Failure Puckett H2 41B-2

Two samples from the Puckett H2 41B-2 well were received November 1<sup>st</sup>, 2017, an eighteen-inch section of flow line and the stem and seat from the well. A six-inch section of the damaged flowline with the through-wall hole was cut out and split., **Photo #1**. **Photo # 2** shows the stem and seat.

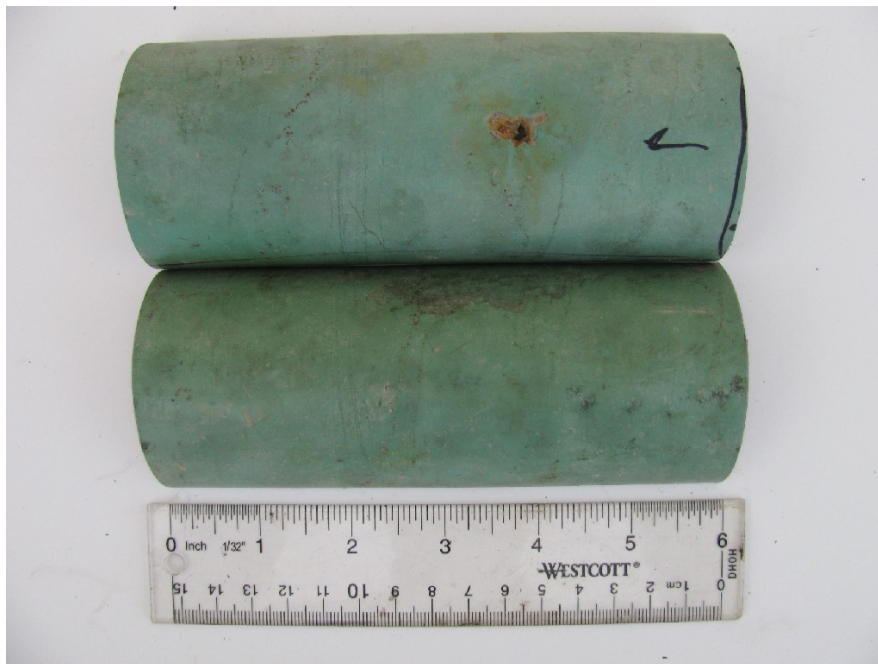
Photo # 1. Cut and split section of flowline with failure, exterior view

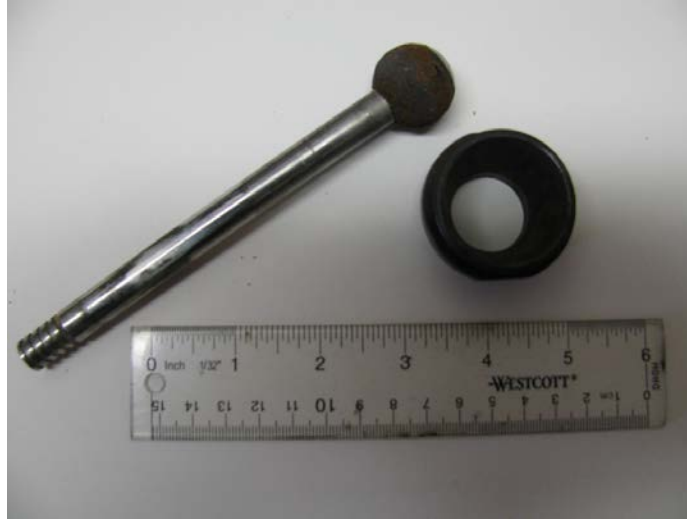
Photo # 2. Stem and seat from the well

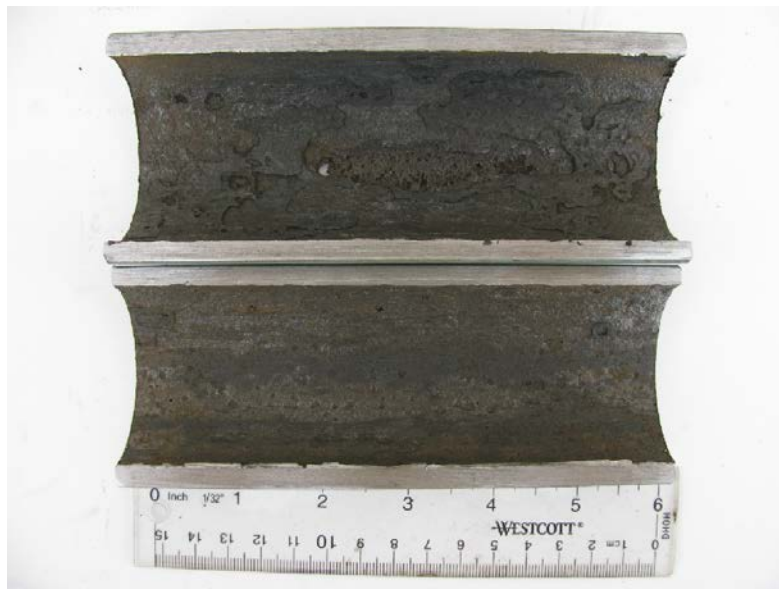
Both the flowline and stem and seat were damaged from corrosion. **Photo # 3** shows the interior view of the flowline sample. There was heavy corrosion on both halves and a through-wall hole on the upper half. The upper half in the photo was more heavily corroded than the lower half. The upper half in the photo with the through-wall hole was oriented on the bottom of the line. Photo #s 4 and 5 are close-up views of the top section in the photo.

Photo # 3. Cut and split flowline with through-wall hole (upper half)

The well is being treated with the combination corrosion scale inhibitor WCW7016 @ 4 q.p.d. and should be switched to CRW9218, a straight corrosion inhibitor. It is not known when the corrosion damage was done. The switch to CRW9218 should be sufficient to prevent and or greatly slow additional corrosion damage from CO<sub>2</sub>.

- Maintain consistent treatment with CRW9218 corrosion inhibitor, starting at a concentration of at least 200 ppm based upon water production or a minimum of 2 quarts per day.
- Install a wellhead and or flowline coupon to monitor corrosion rates.

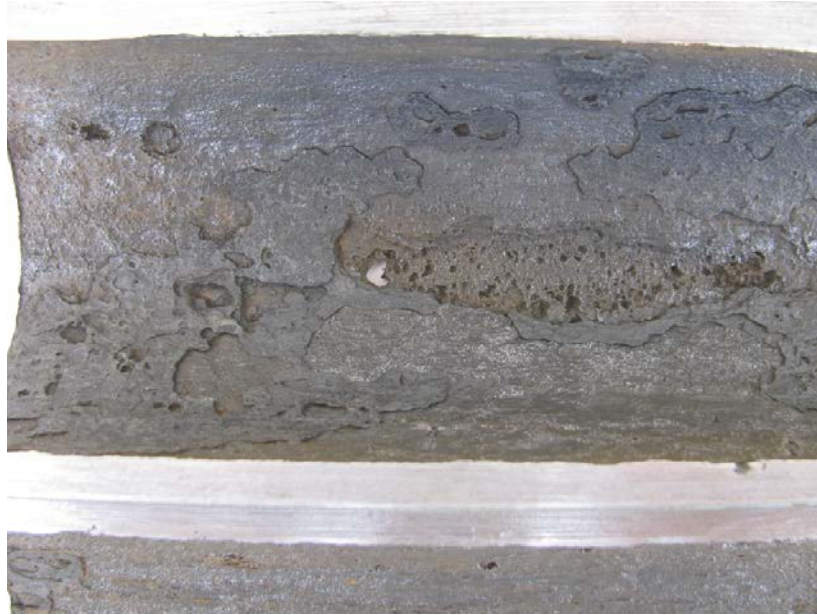
Photo # 4. Close-up of top section, heavily pitted with through-wall hole

The corrosion, especially that shown in **Photo #s 4 and 5** is most likely due to CO<sub>2</sub> acid gas. The orientation of the through-wall hole was at the 6 o'clock position. Pooling of water in this hemisphere likely contributed to the heavier corrosion. This hemisphere had a hard iron carbonate corrosion product deposit consistent with CO<sub>2</sub> corrosion.

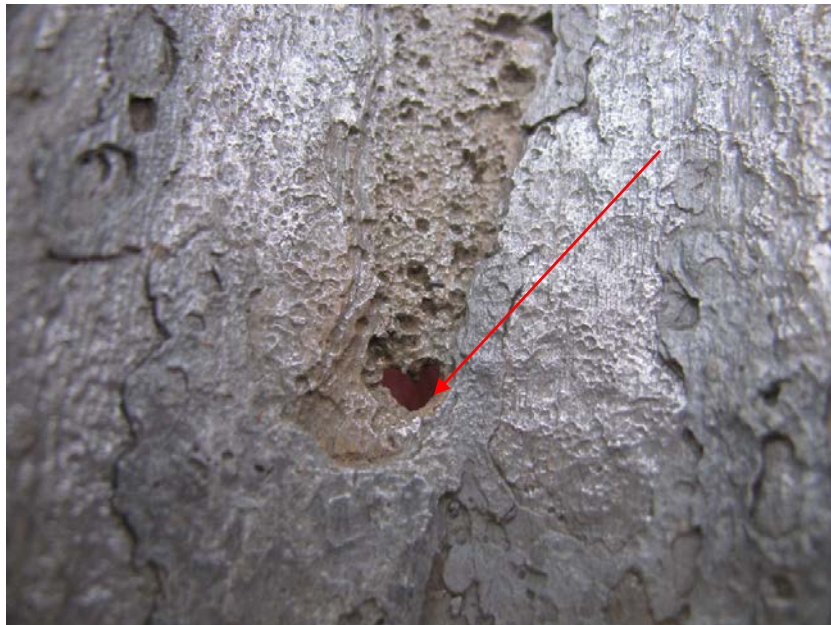
Photo # 5. Through-wall hole noted with red arrow

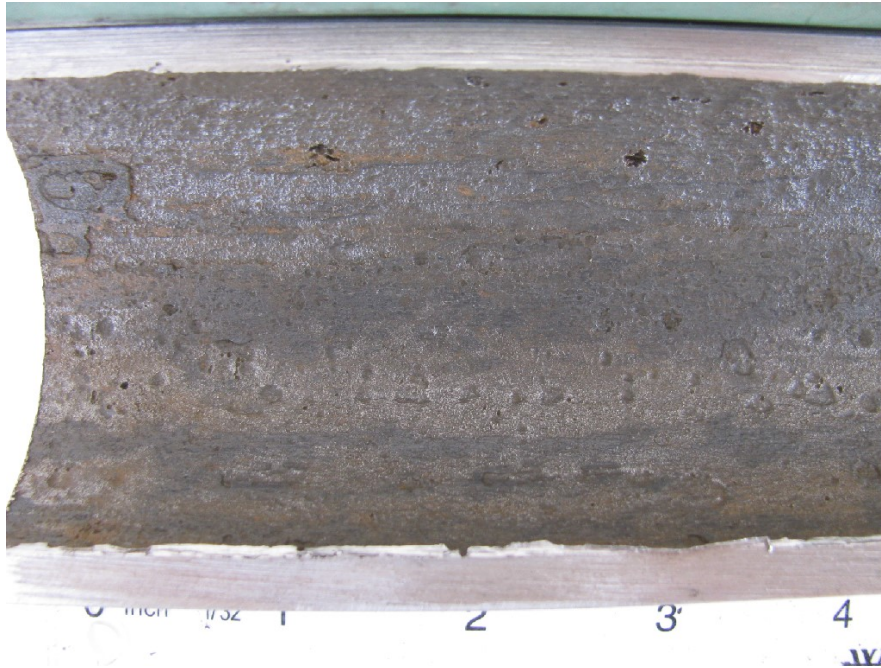
Photo # 6. Lower section of flowline cut-out with light pitting

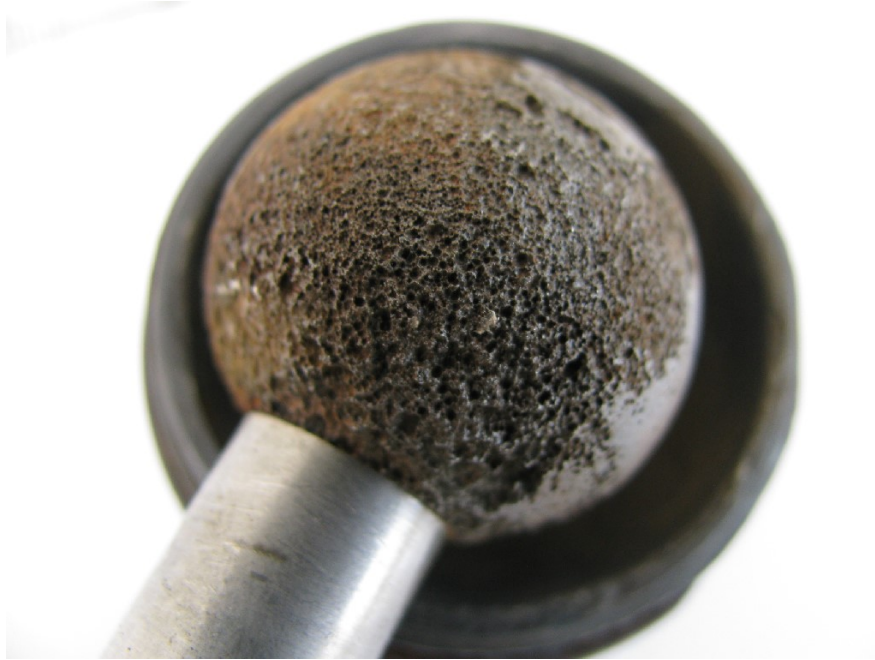
**Photo #s 7 and 8** are views of the stem and seat respectively. The corrosion damage on the stem and seat is most likely from CO<sub>2</sub> corrosion.

Photo # 7. Corrosion damage on the stem

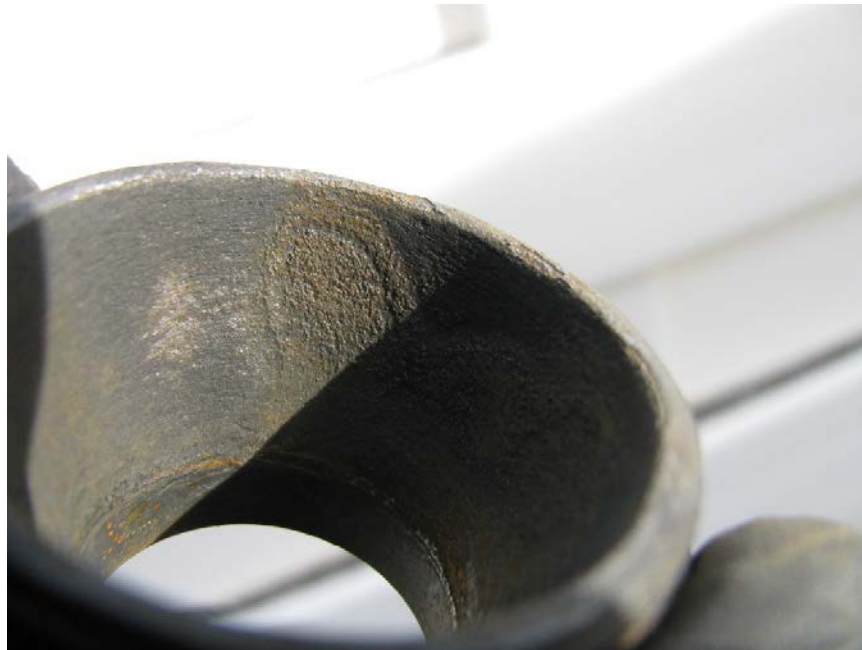
Photo # 8. Corrosion damage on the seat
