GV 24-36
Api# 05-045-06631
Inspection # 689701623

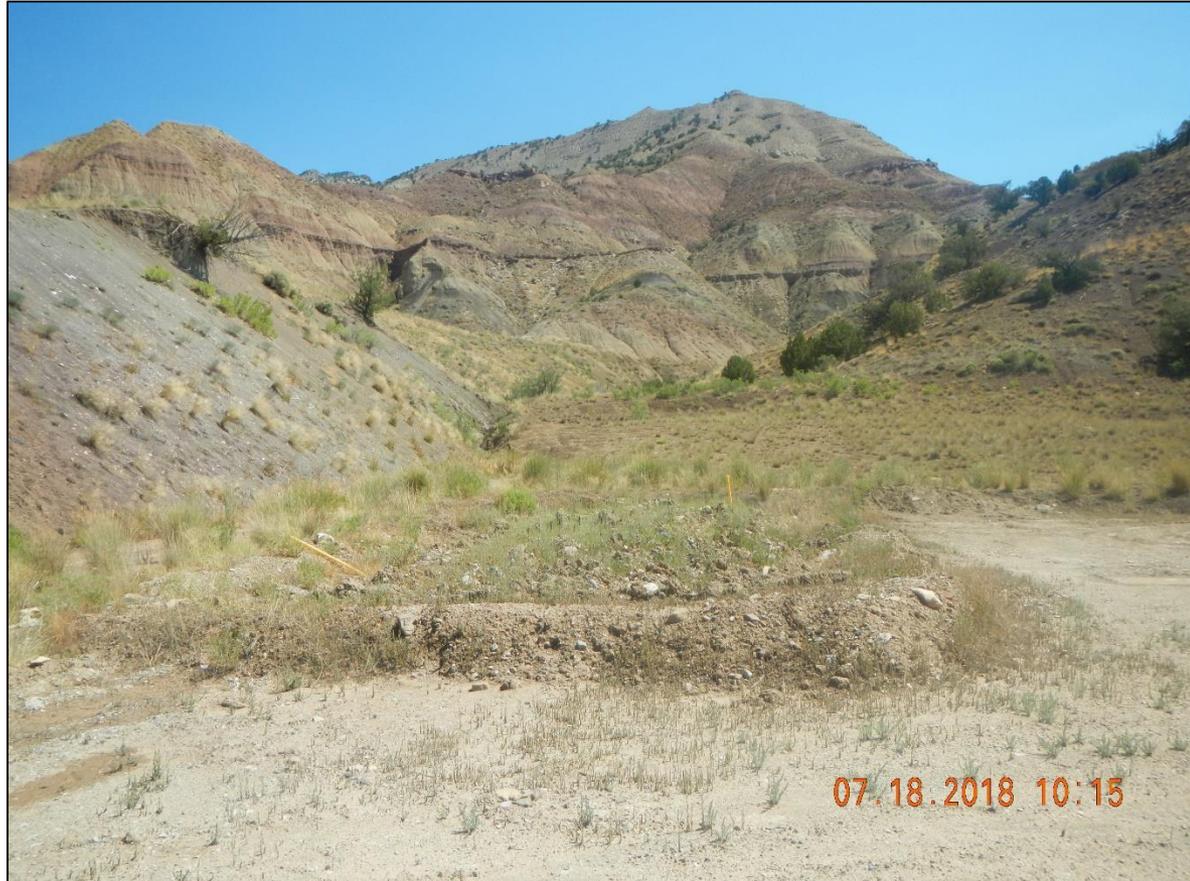
Land farm not being maintained.

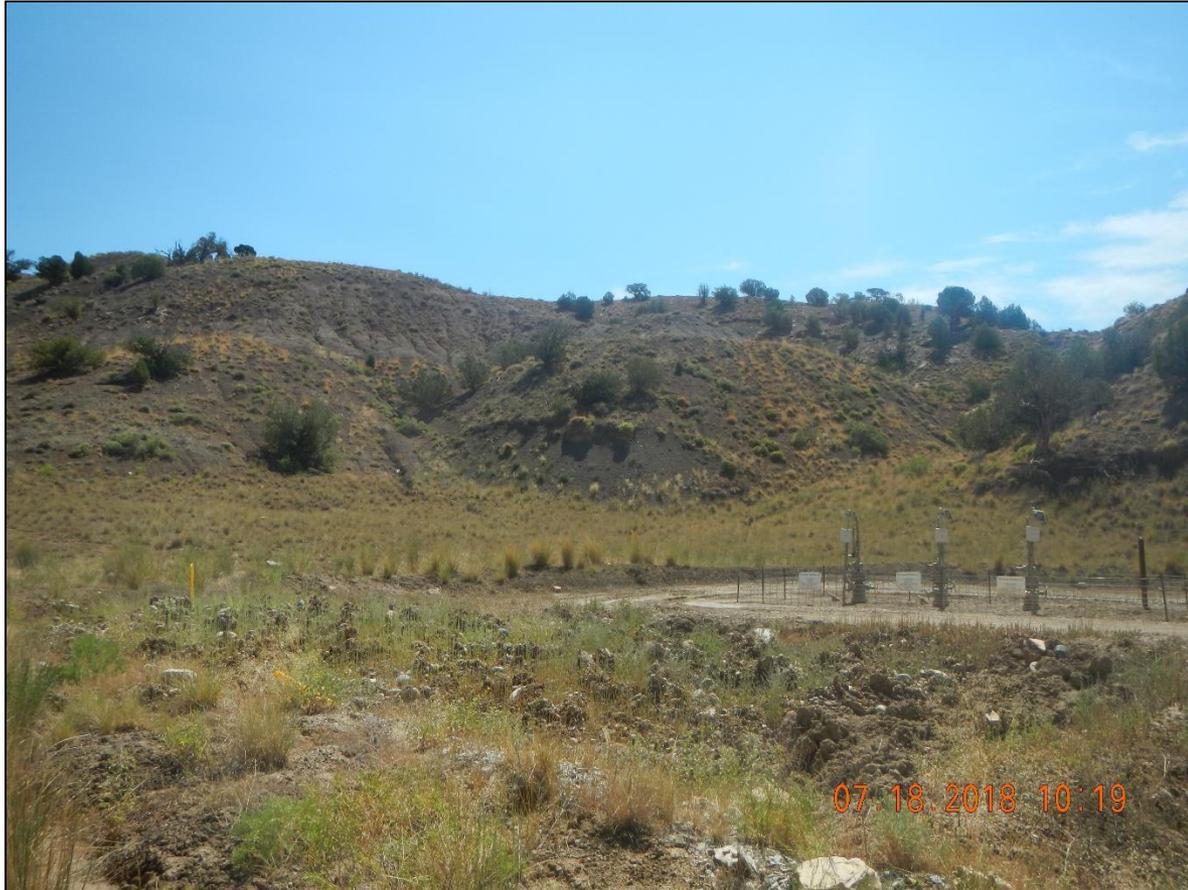
Land farm not being maintained.

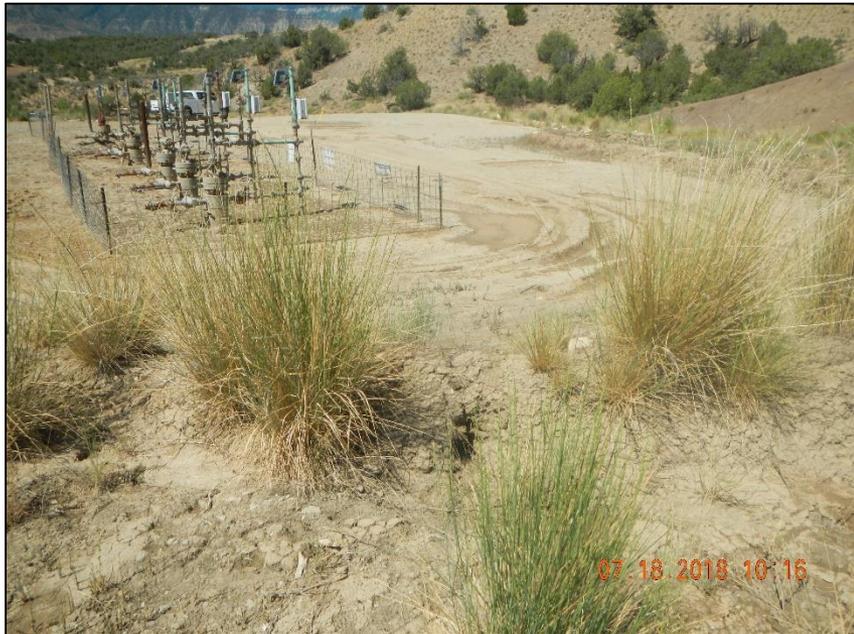
Channeling through location berm east of wells.

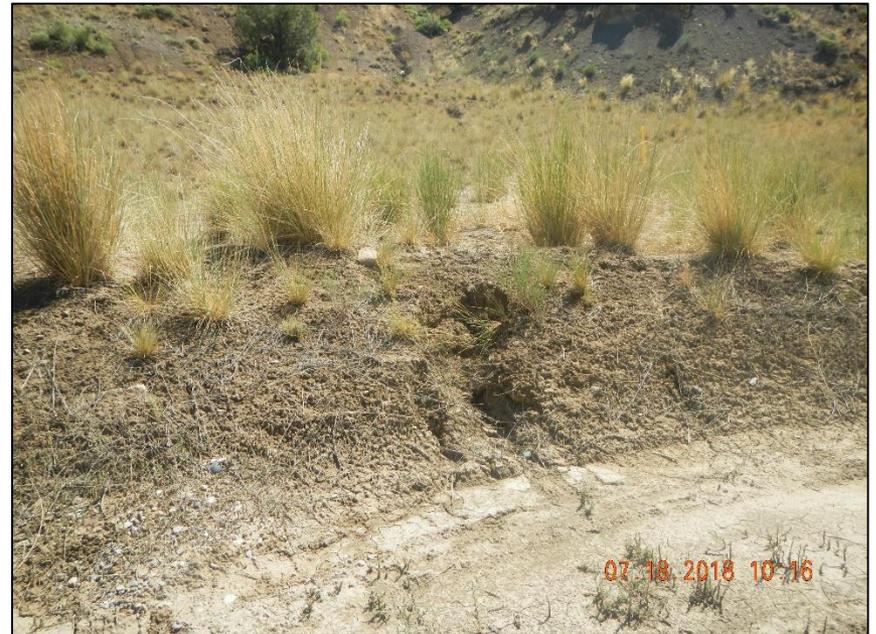
Channeling through location berm east of wells.

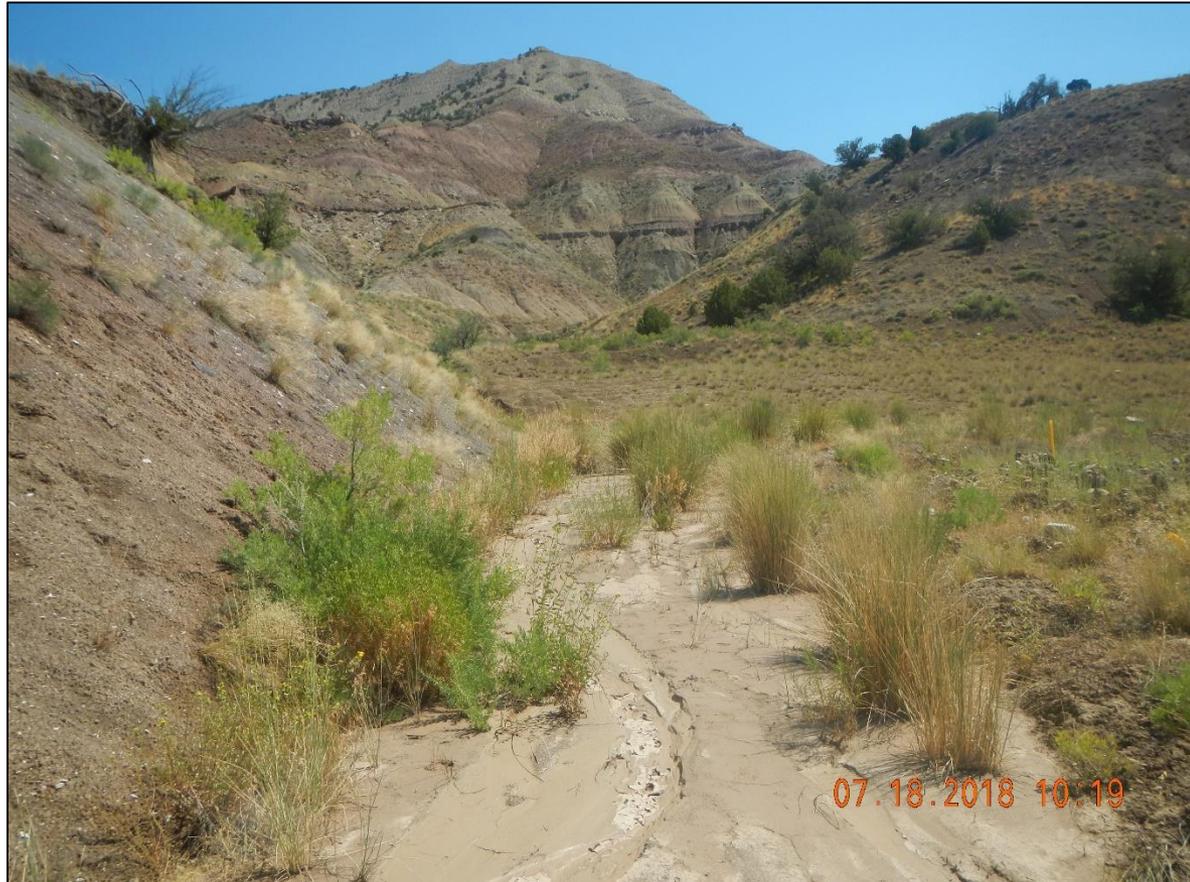
Sediment build up in ditch north wells.
