DOE 2-M-36  
Api# 05-045-06863  
Inspection # 689701629

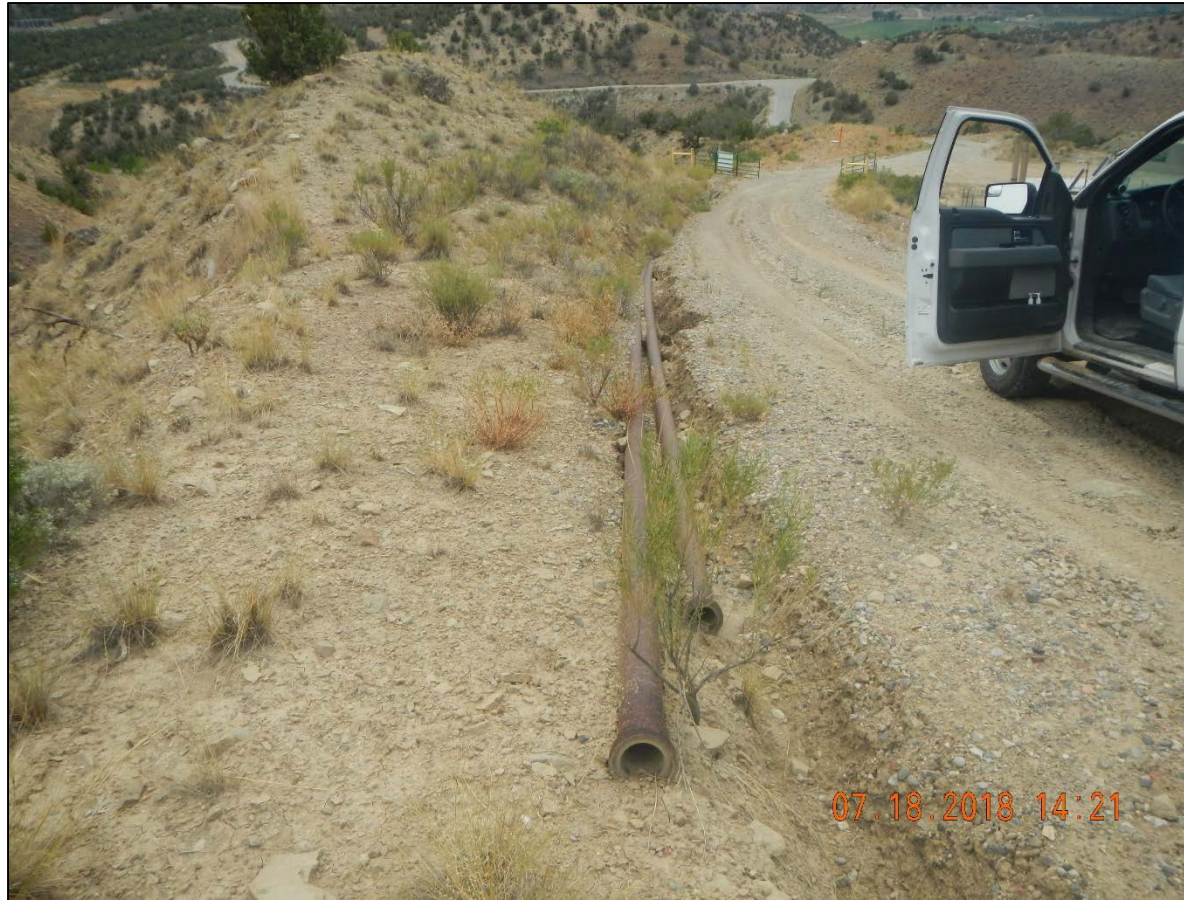
**Unused flow lines in ditch on access road. Near gate between DOE 2-M-36 pad and GM 23-36 pad.**

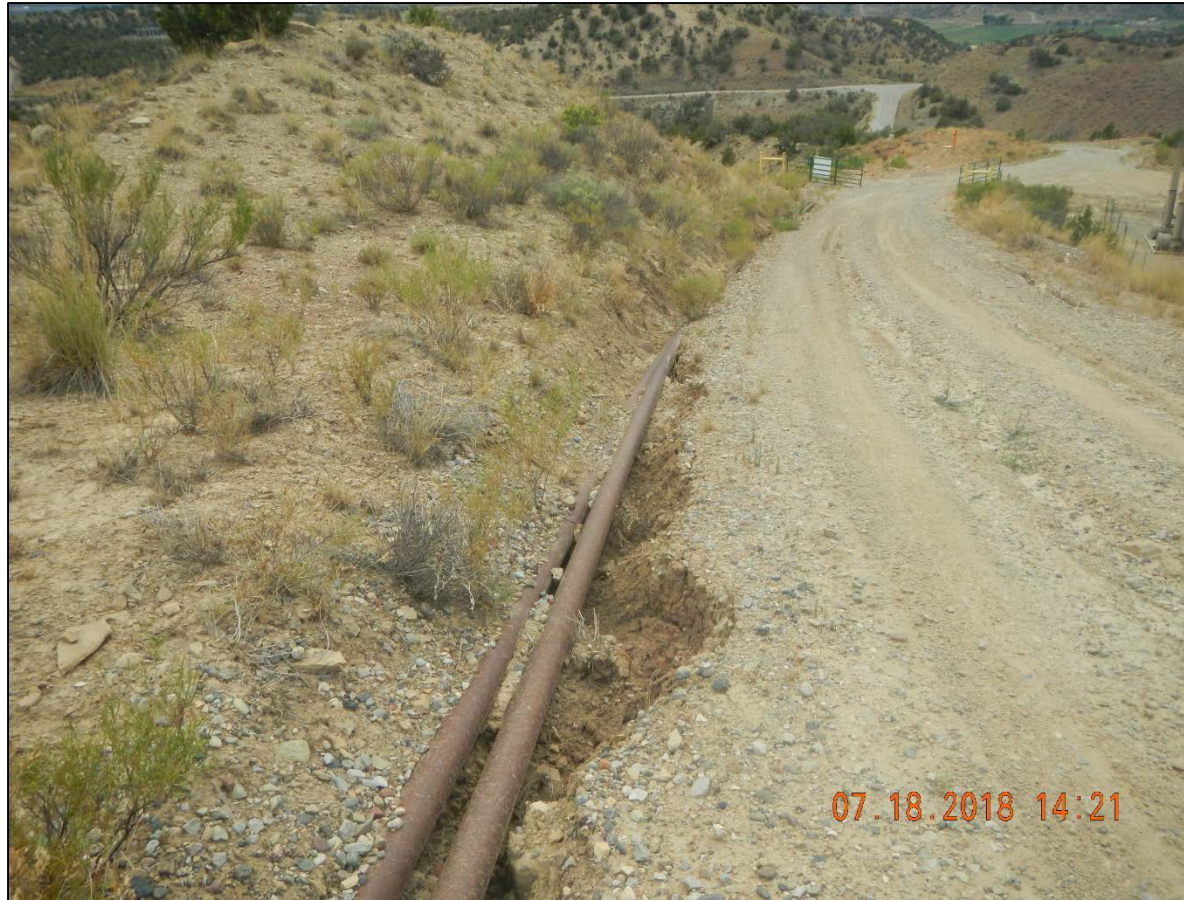
**Erosion of road and ditch.**

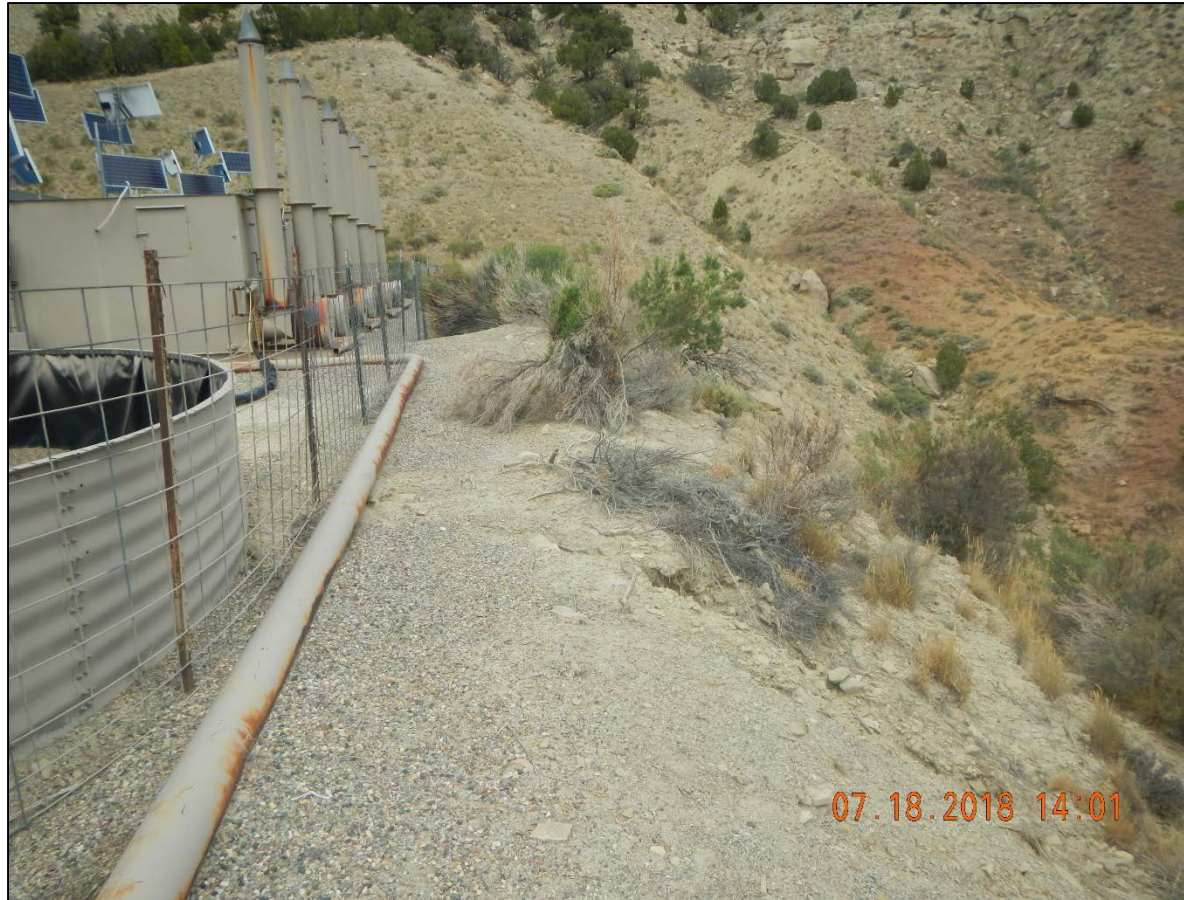
Erosion on edge of location behind separators.

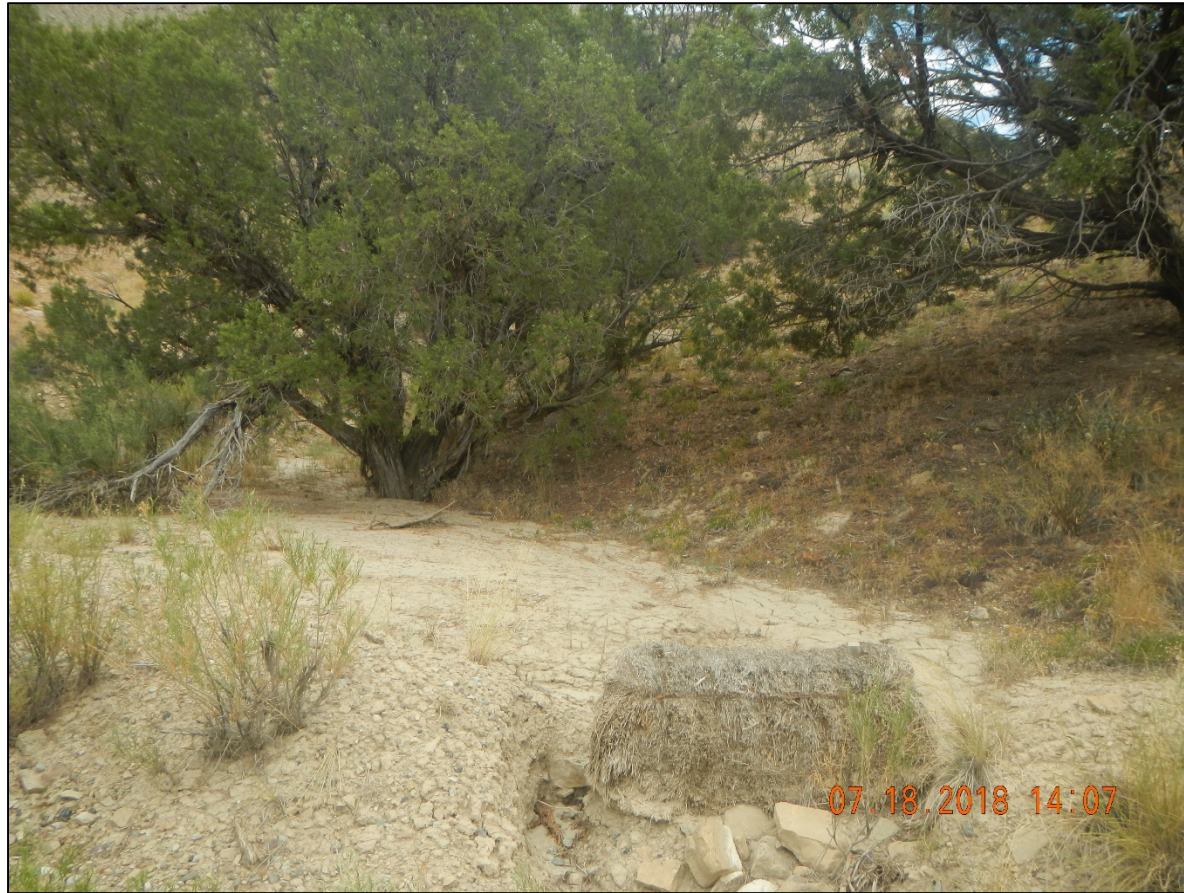
**Sediment build up in check dam and washing around bale.**  
**39.48180 -108.05495**

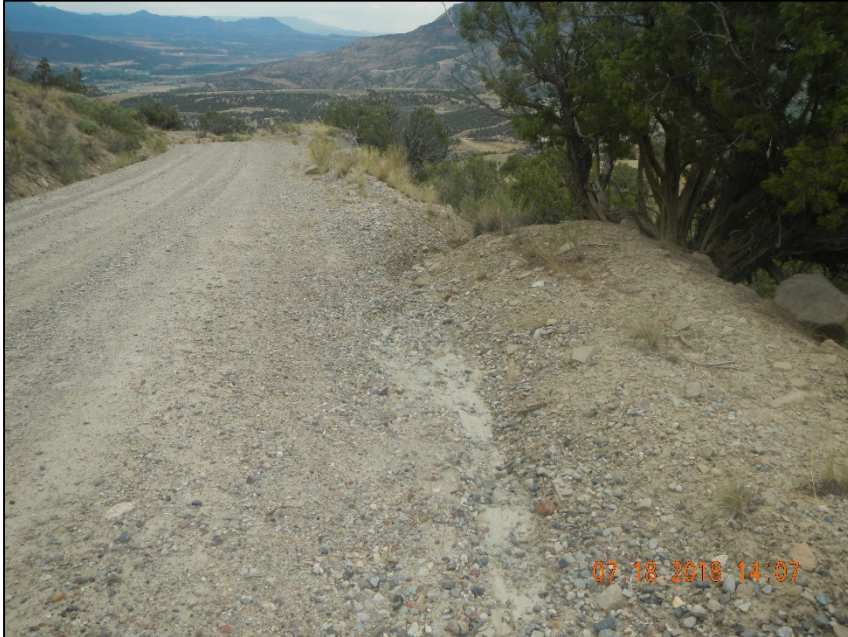
**Washing and erosion of drain run off. 39.48180 -108.05495**

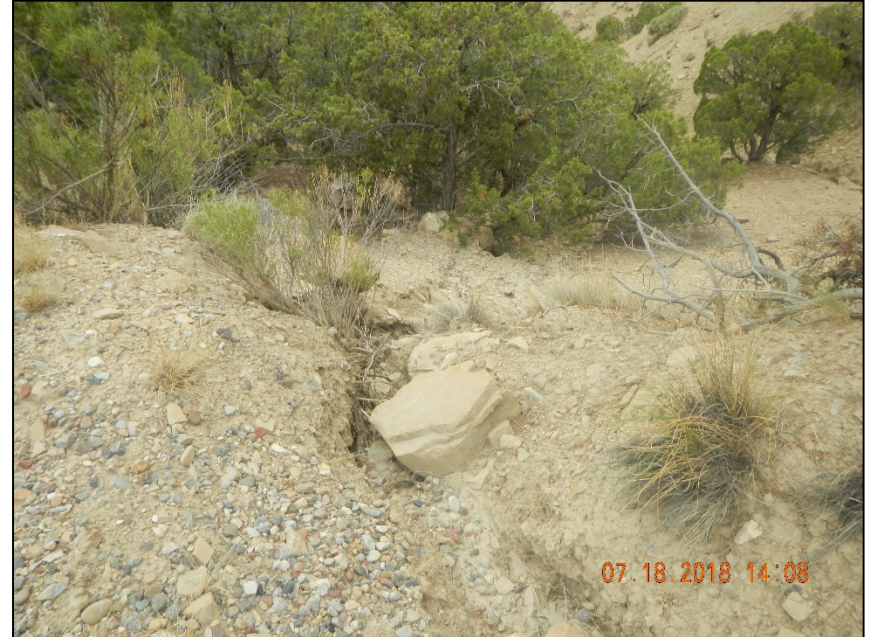
**Washing and erosion of drain run off. 39.48180 -108.05495**

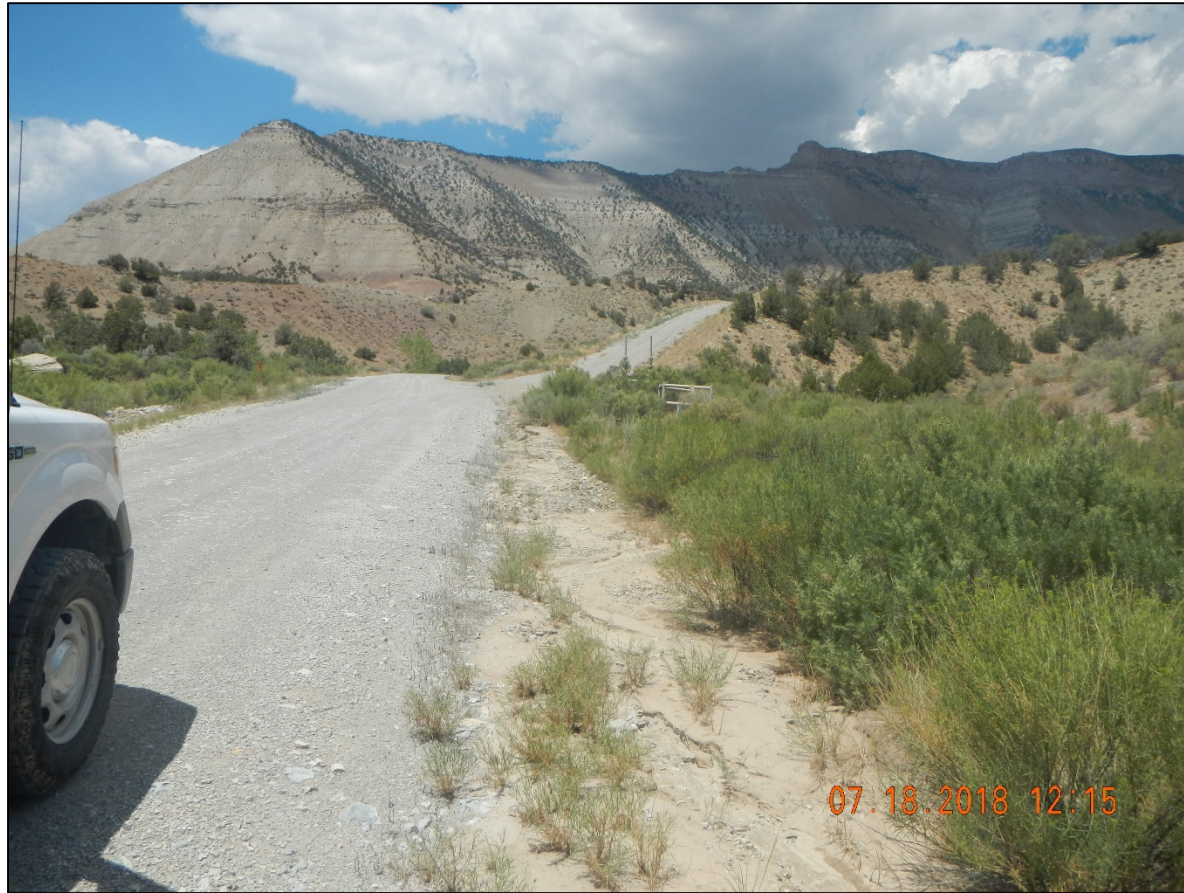
**Sediment in ditch on main road just before access road. 39.47601 -108.06135**

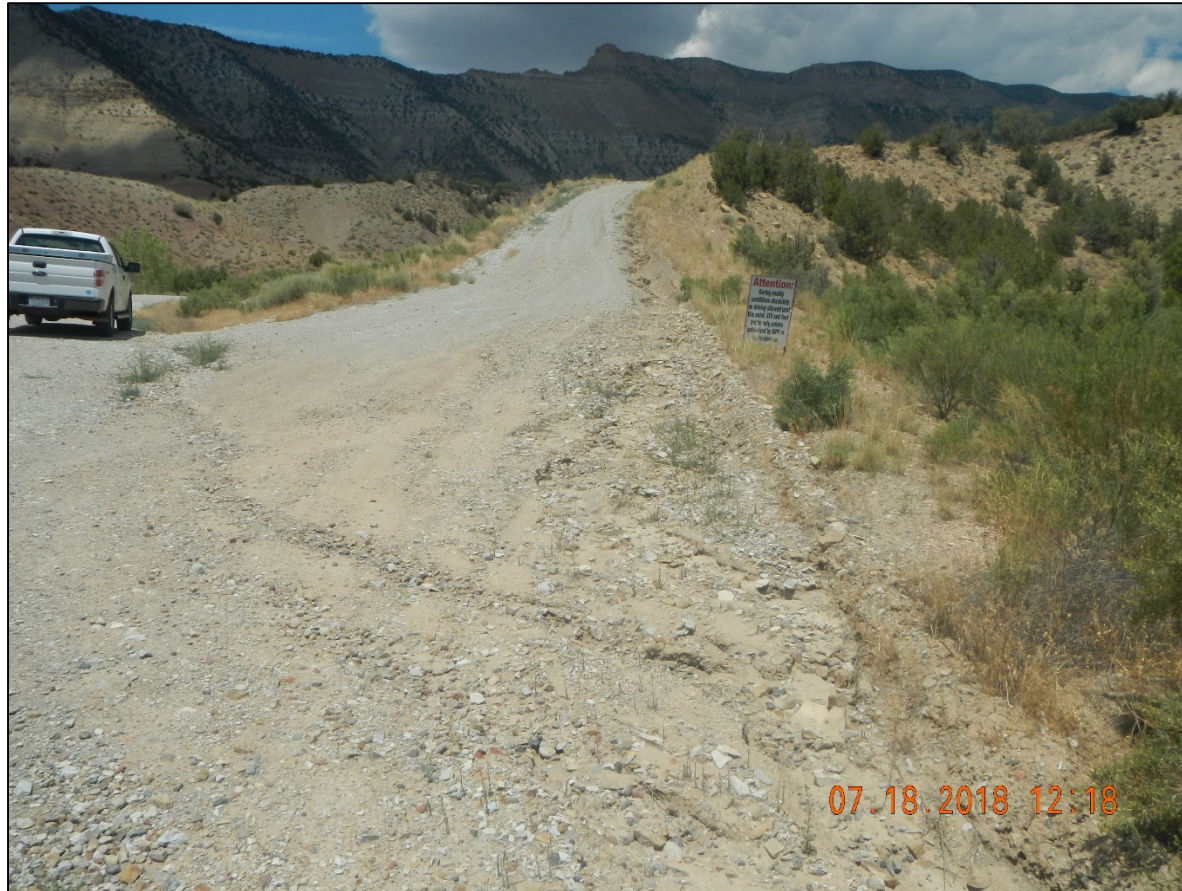
**Sediment in ditch at main and access road intersection.**

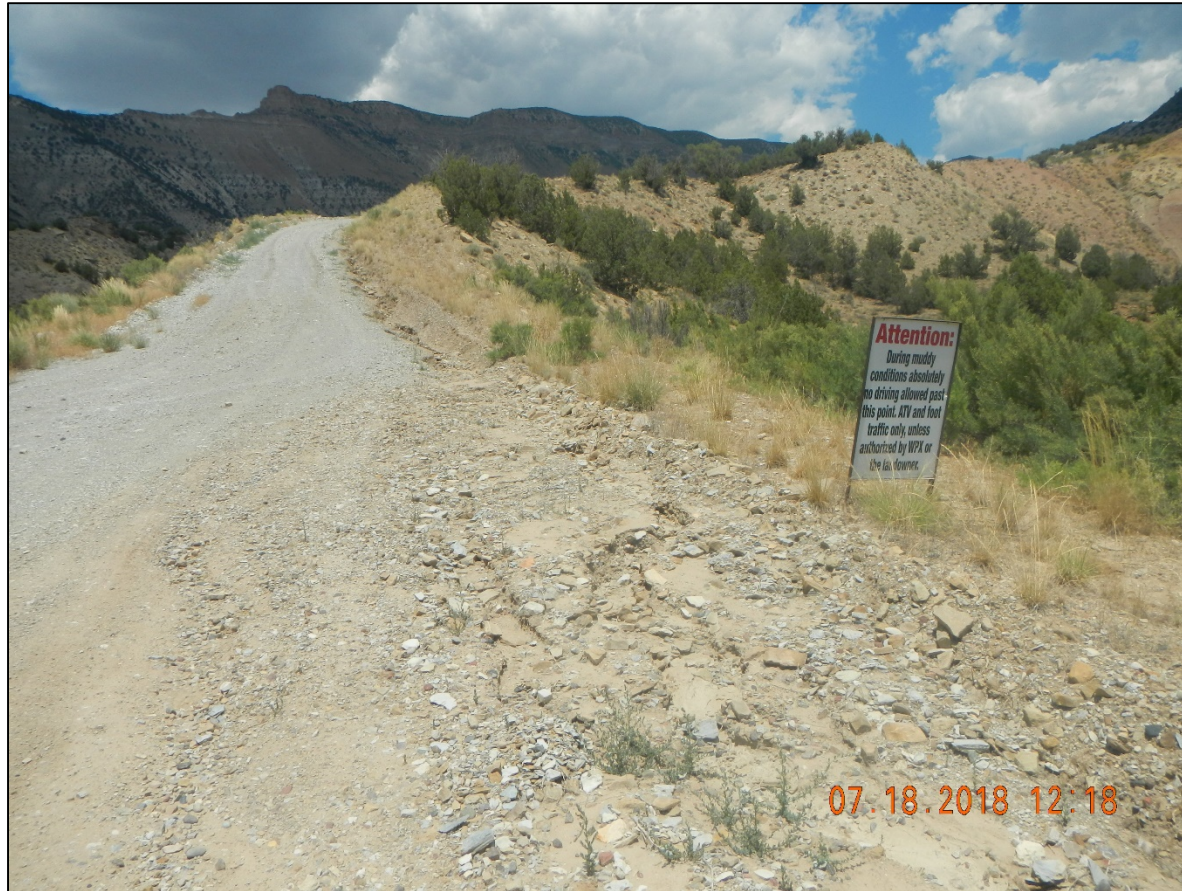
Sediment in ditch at main and access road intersection.

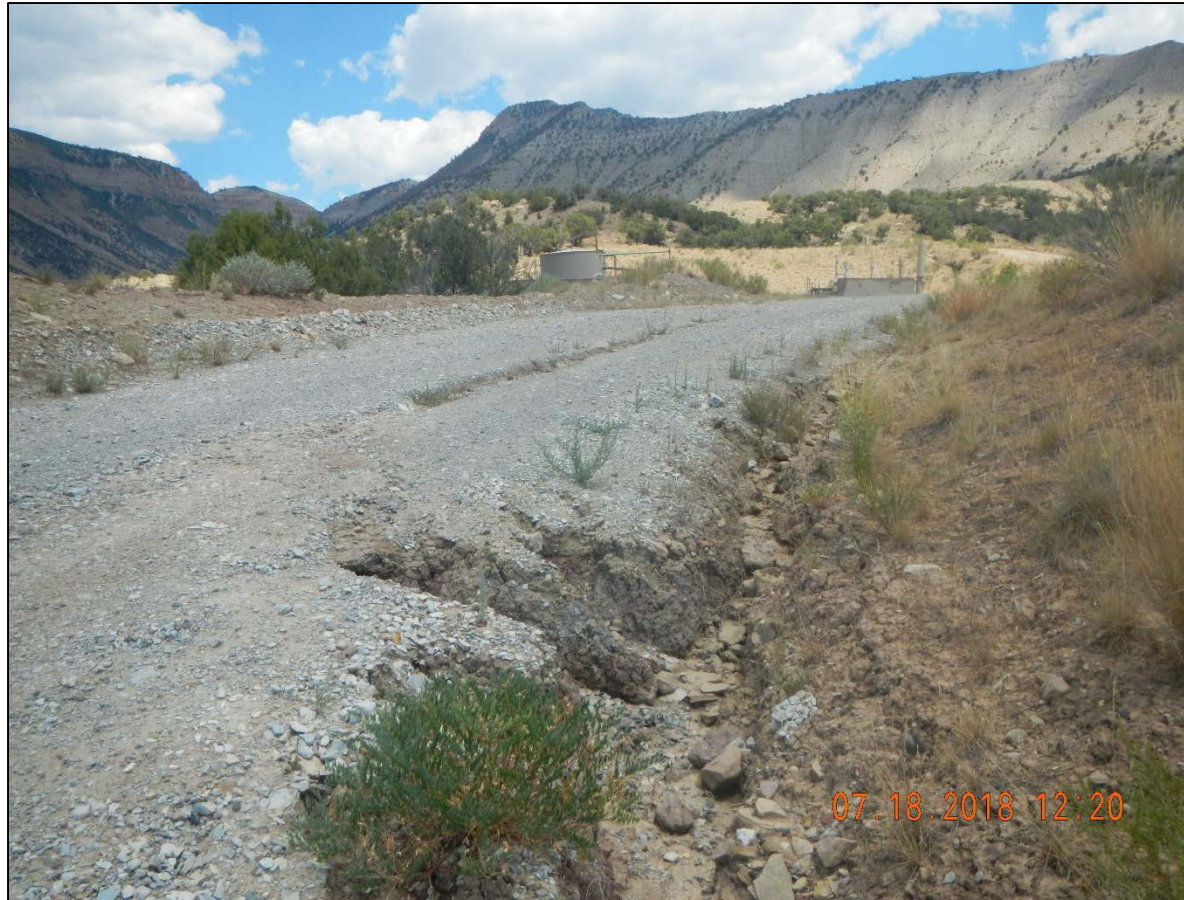
**Washing of road into ditch. Near GM 23-36 location in the back ground.**
