Interim Reclamation and Stormwater Inspection

Operator: BONANZA CREEK ENERGY OPERATING COMPANY LLC - #8960

Well API #: 05-123-35246

Inspection Photos
Location Name: Crow Valley 7-62-24 #2H
Well API #: 05-123-35246

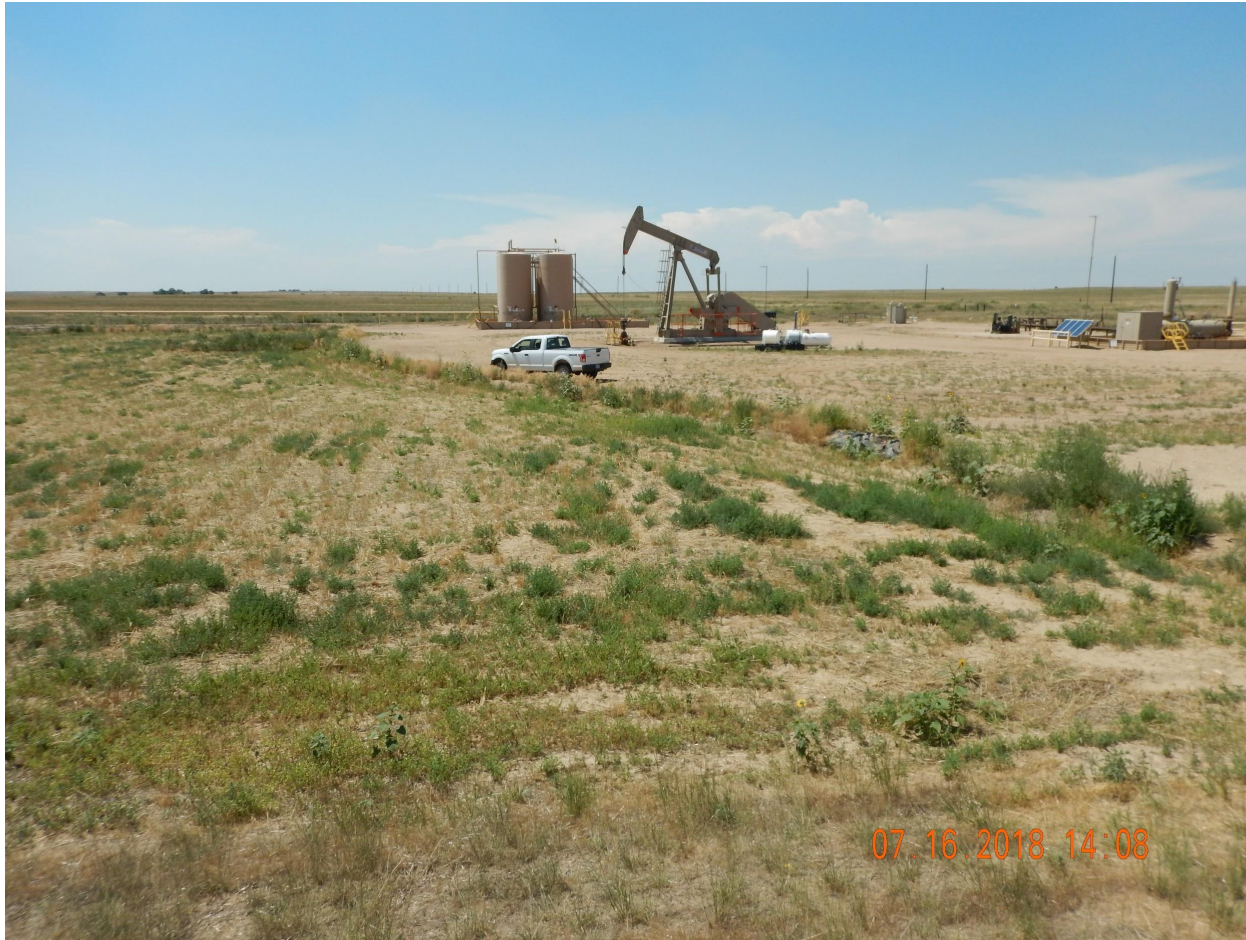
Photo 1. Photo taken from the eastern location on top of the topsoil stockpile, facing West. Appears the Operator has performed interim reclamation activities to reduce disturbance areas only needed for production operations. Photo illustrates the northern interim area and production area.

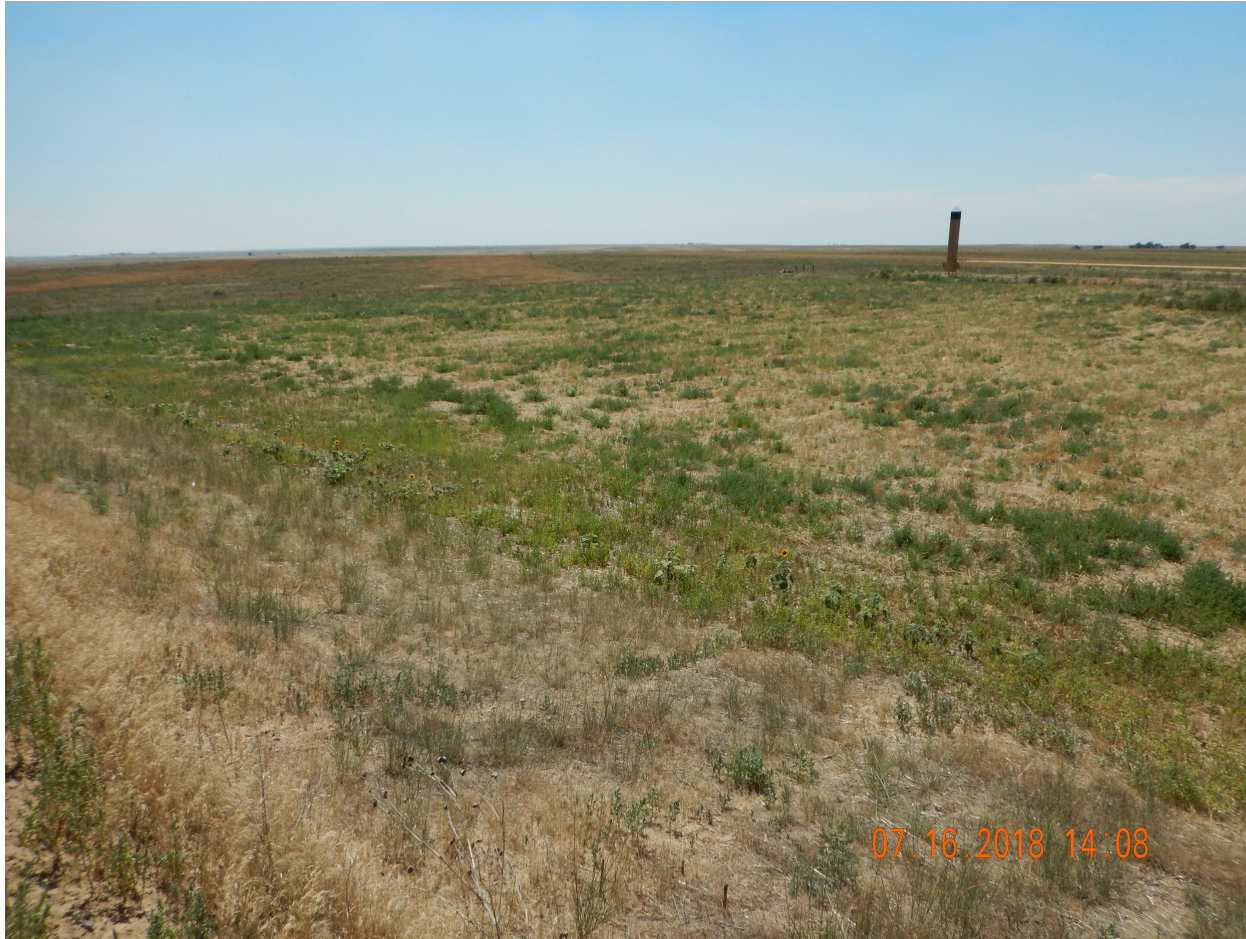
Photo 1. Photo taken from the eastern location on top of the topsoil stockpile, facing Southwest. Photo illustrates the southern interim area.

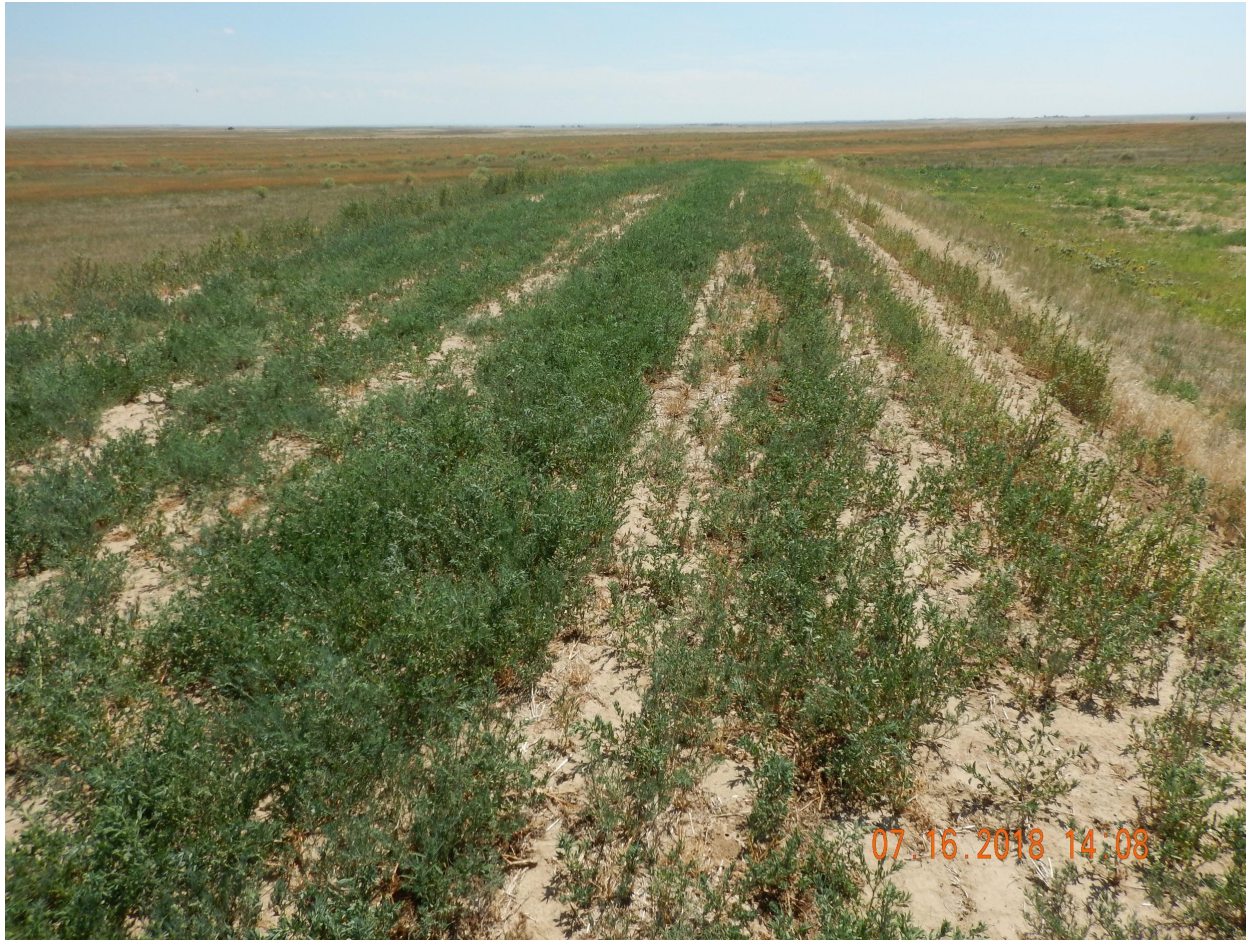
Photo 3. Photo taken from the top of the topsoil stockpile. Photo illustrates weedy, annual vegetation (Kochia and Russian thistle) which has been recently mowed. Operator shall consider re-seeding the topsoil stockpile to help protect weed establishment per Rule 1002.c.

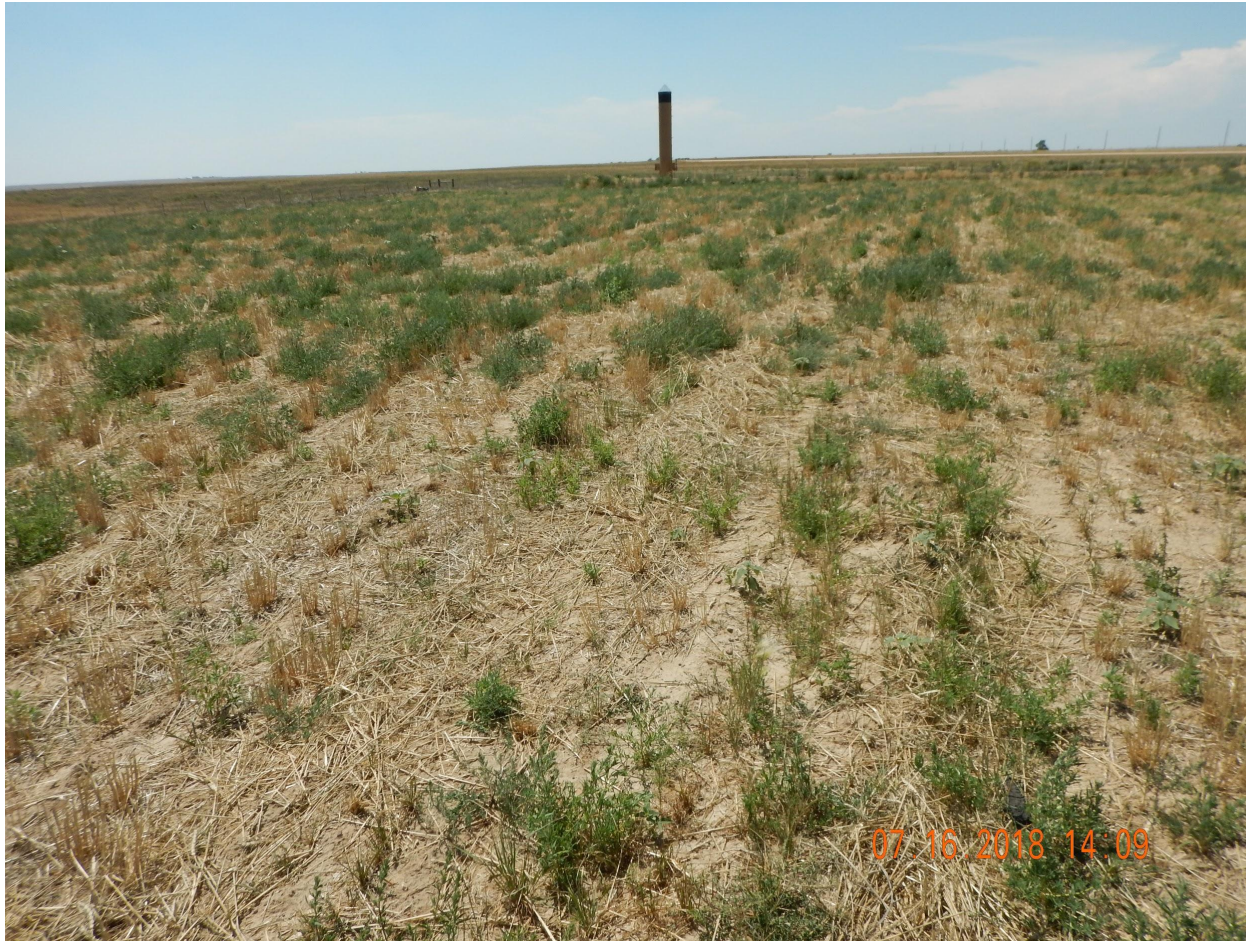
Photo 4. Photo taken from the central interim area, facing West. Appears Operator recently mowed location. Operator shall continue to monitor and manage this site until the location meets Rule 1003 standards.

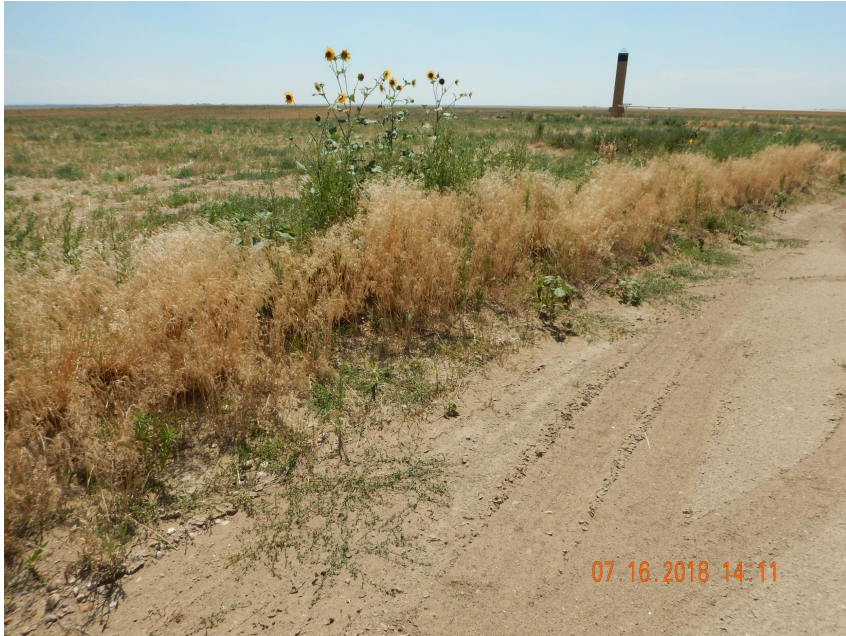
Photo 5. Photo taken from the southeast production area, facing West. Photo illustrates a stormwater berm BMP full of cheatgrass. Operator shall remove cheatgrass, as this will migrate onto interim areas and negatively impact reclamation success. Also, this amount of dead plant material could pose as a fire safety hazard. Operator shall control and manage weeds throughout the entire location.

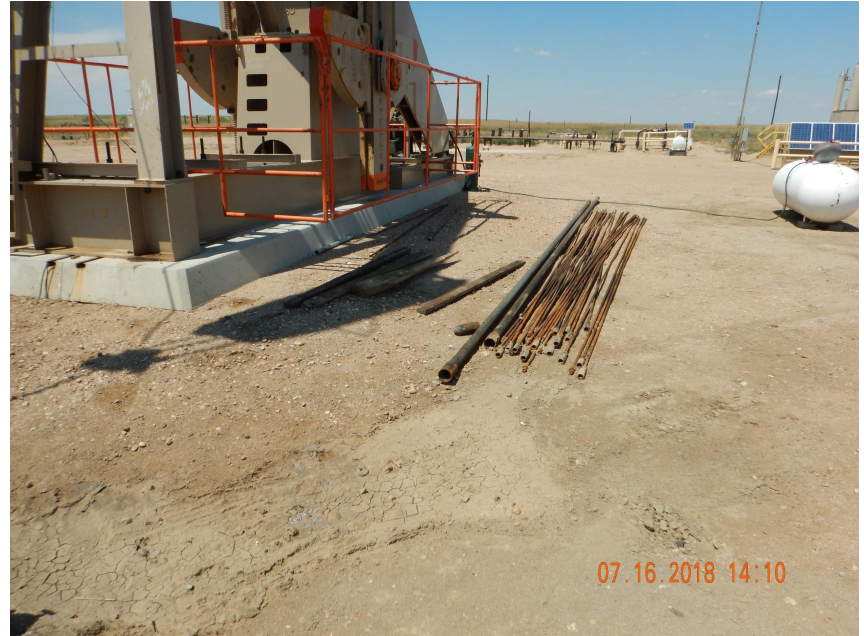
Photo 6. Photo taken from the weedhead, facing North. Unused equipment shall be removed per Rule 603.f.
