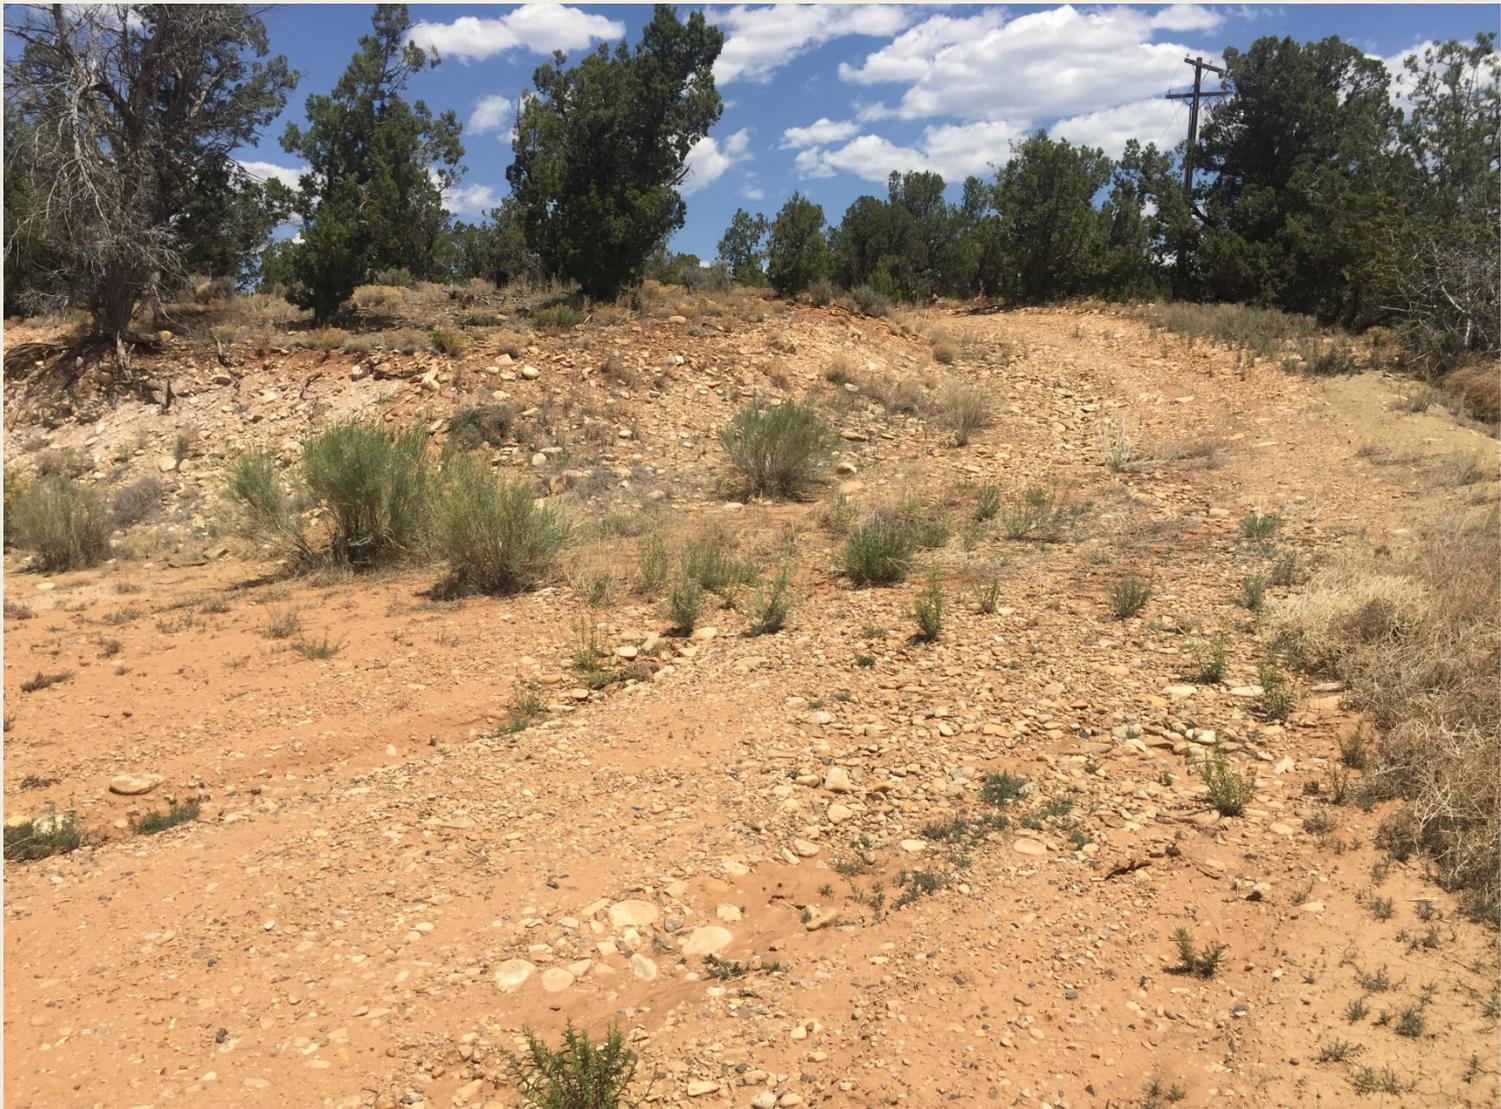
Photo 4. View of the northeastern portion of the project area from the northeastern edge facing northward. Erosion is occurring along the access road.

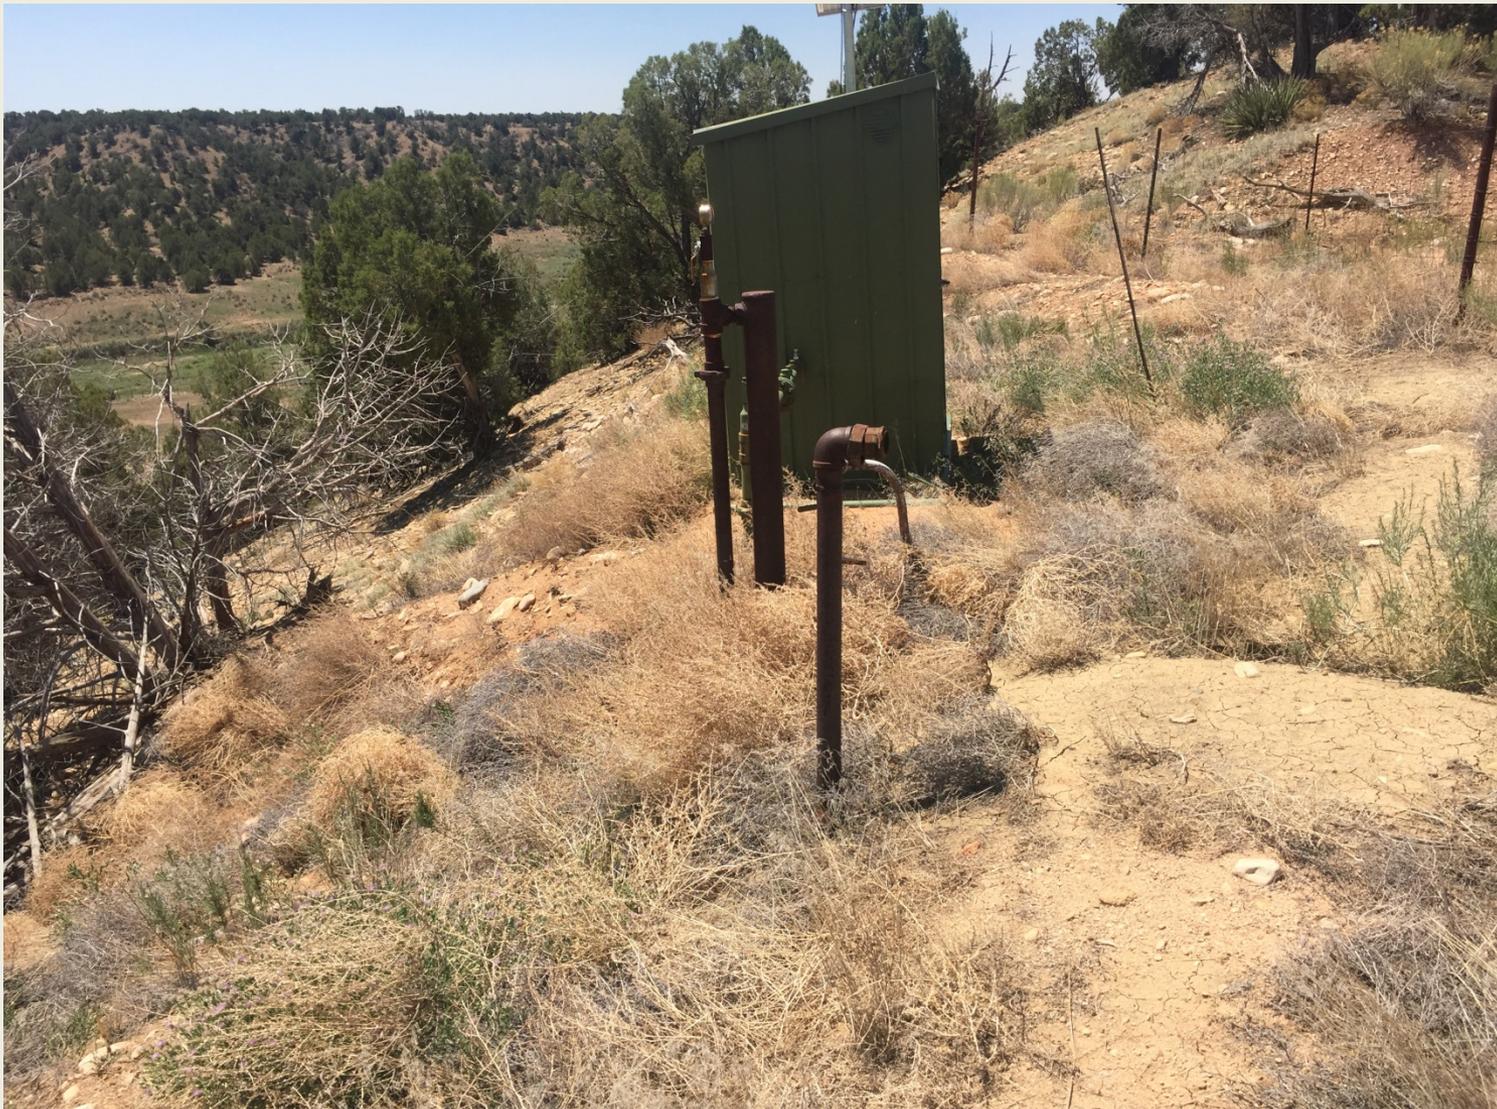
Photo 5. View of facilities in the southern portion of the project area. Liquid is flowing through pipes here.

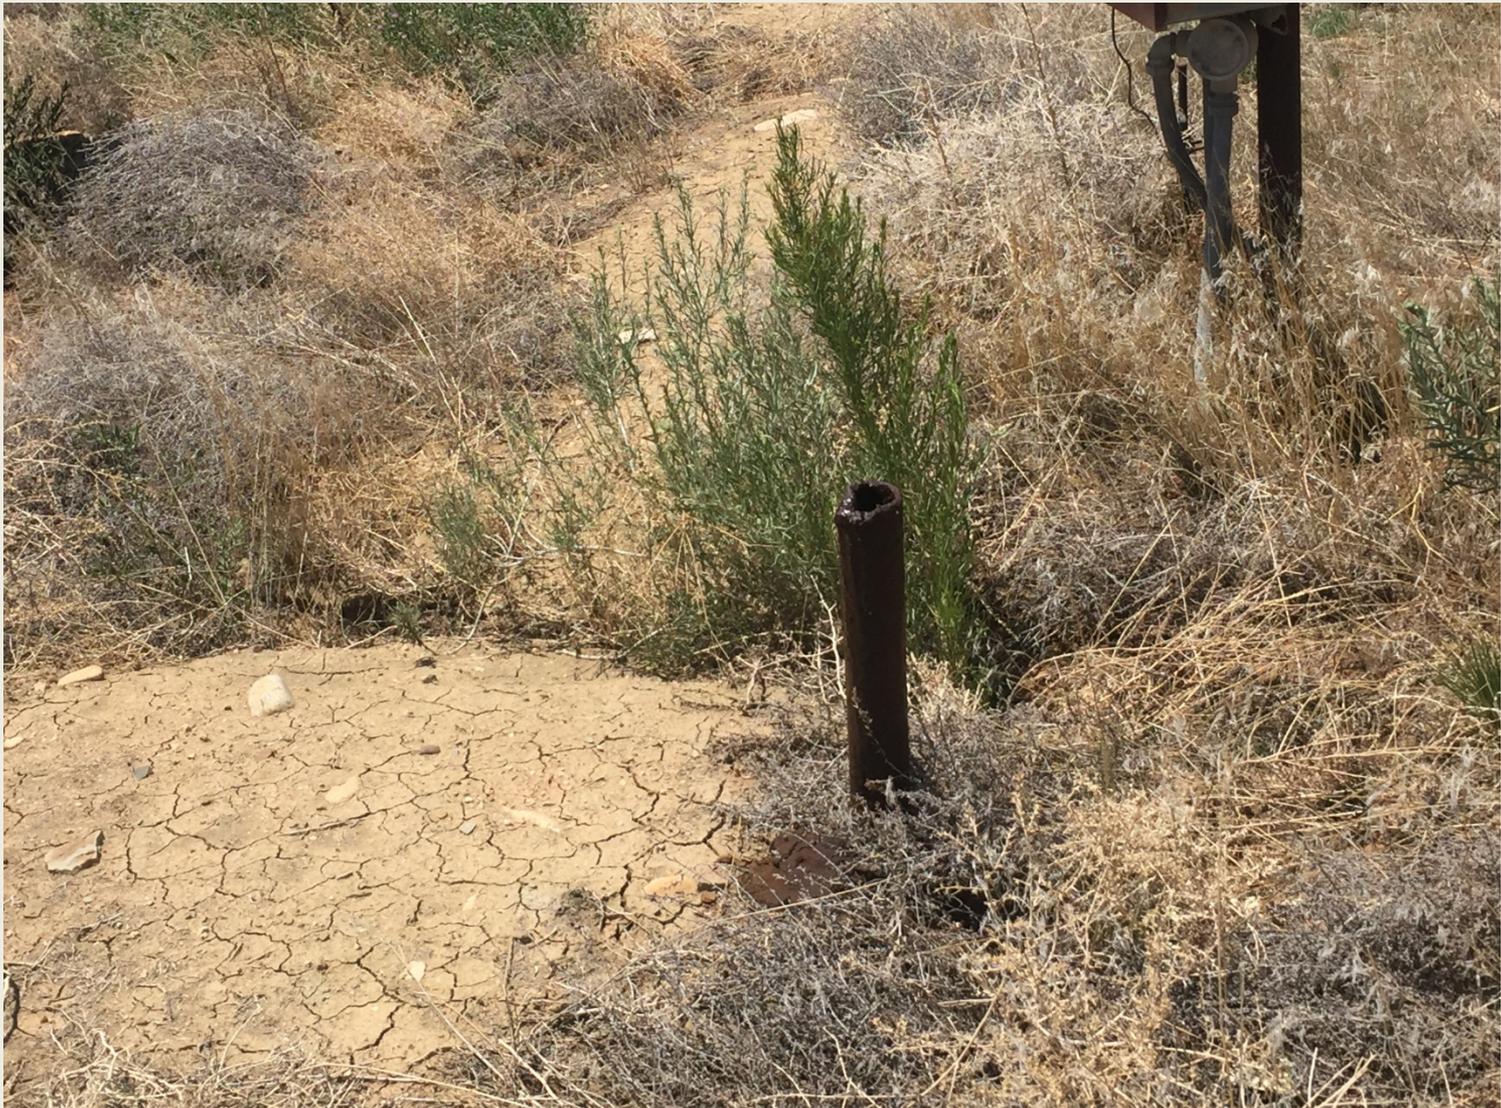
Photo 6. View of open pipe in the southern portion of the project area.

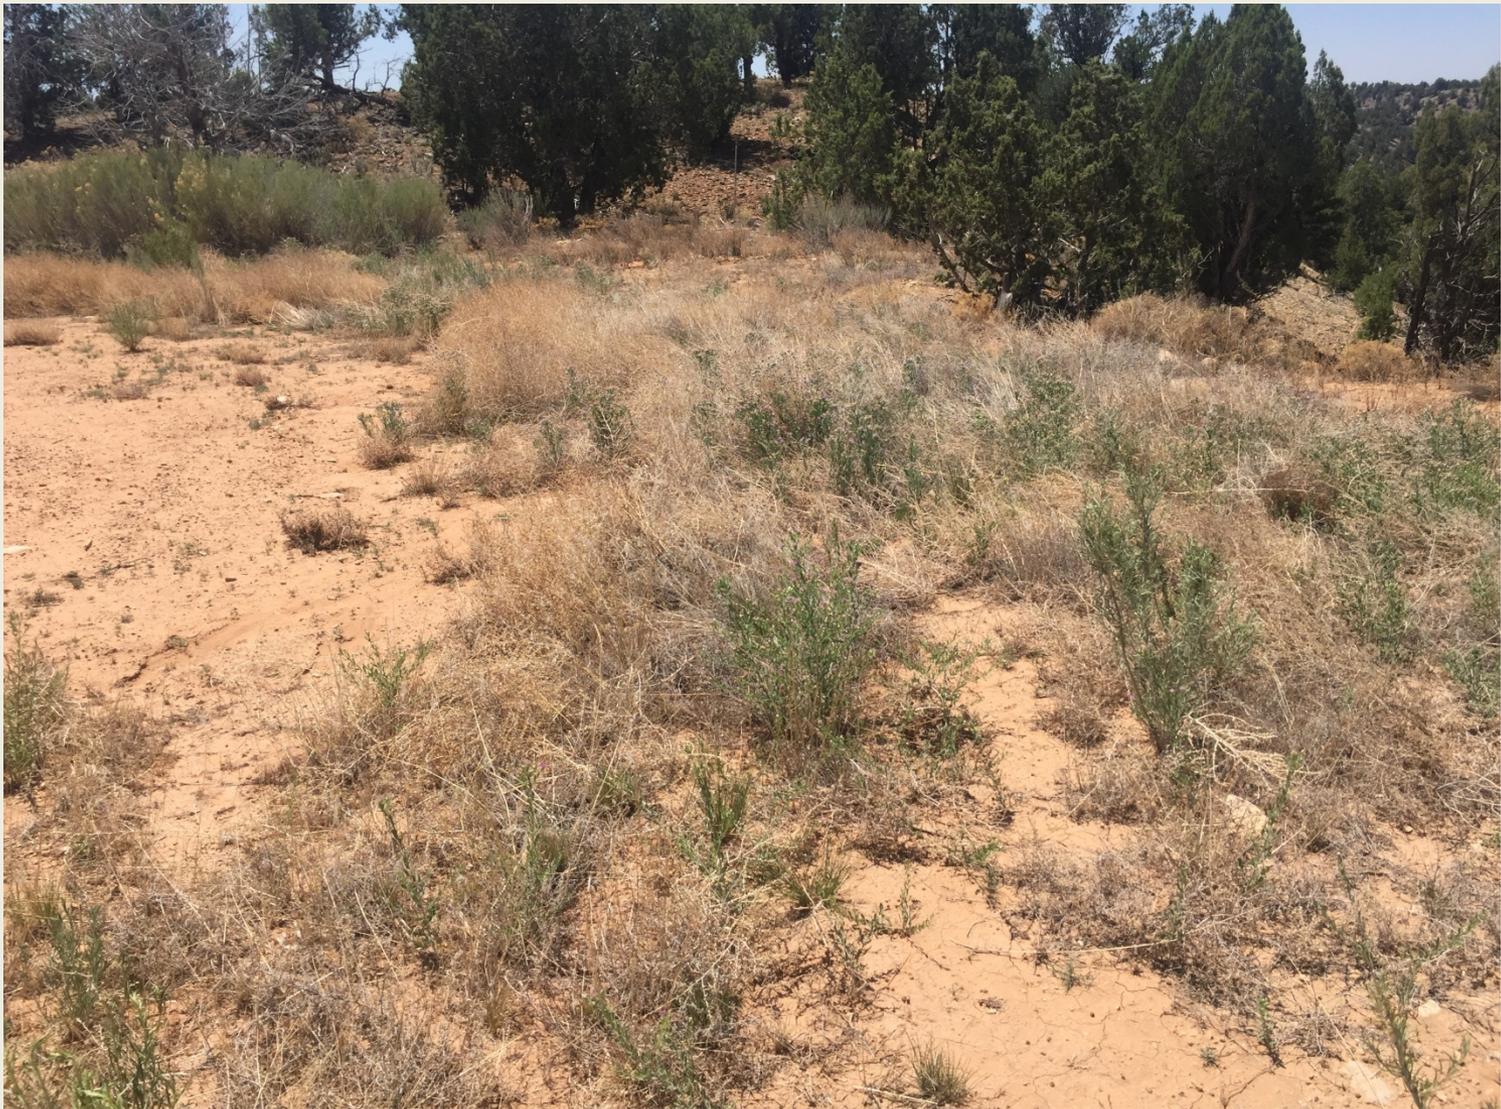
Photo 7. View of Russian knapweed (*Rhaponticum repens*) within the northeastern project area.
