Inspection Photo
Federal RMV 146-19
API # 045-08160
Inspection # 689301570

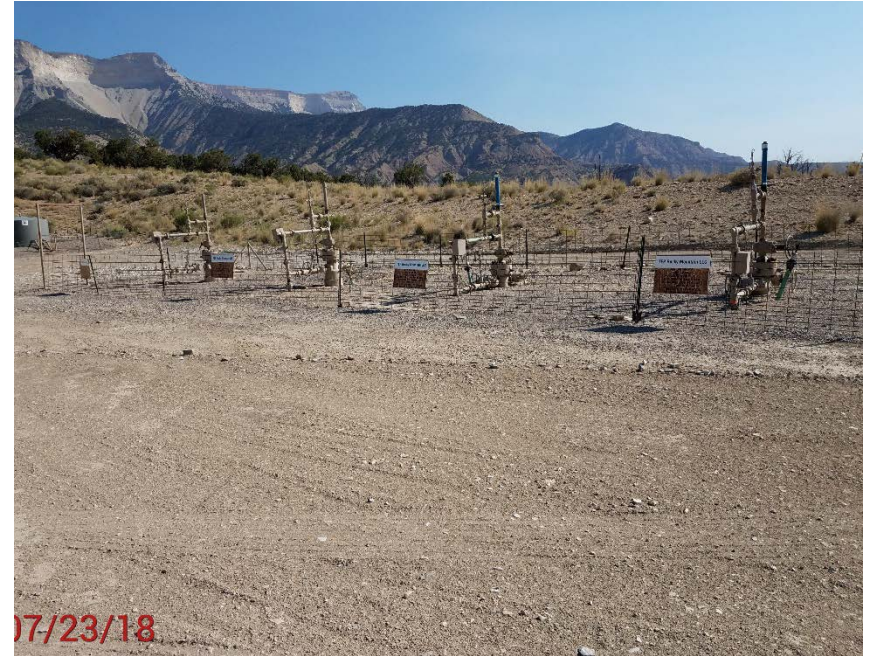
Location Photo #2, 4-non legible wellhead sign.

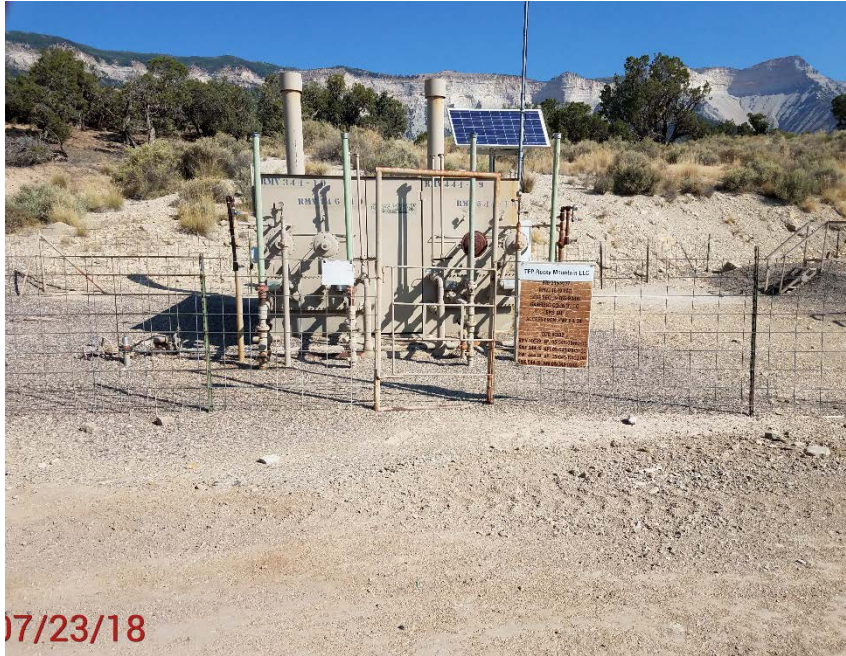
Location Photo #3, non legible battery sign
